Natural hazards in the Cardrona Valley

Otago Regional Council
Private Bag 1954, 70 Stafford St, Dunedin 9054
Phone 03 474 0827 Fax 03 479 0015
Freephone 0800 474 082
www.orc.govt.nz

Published December 2010

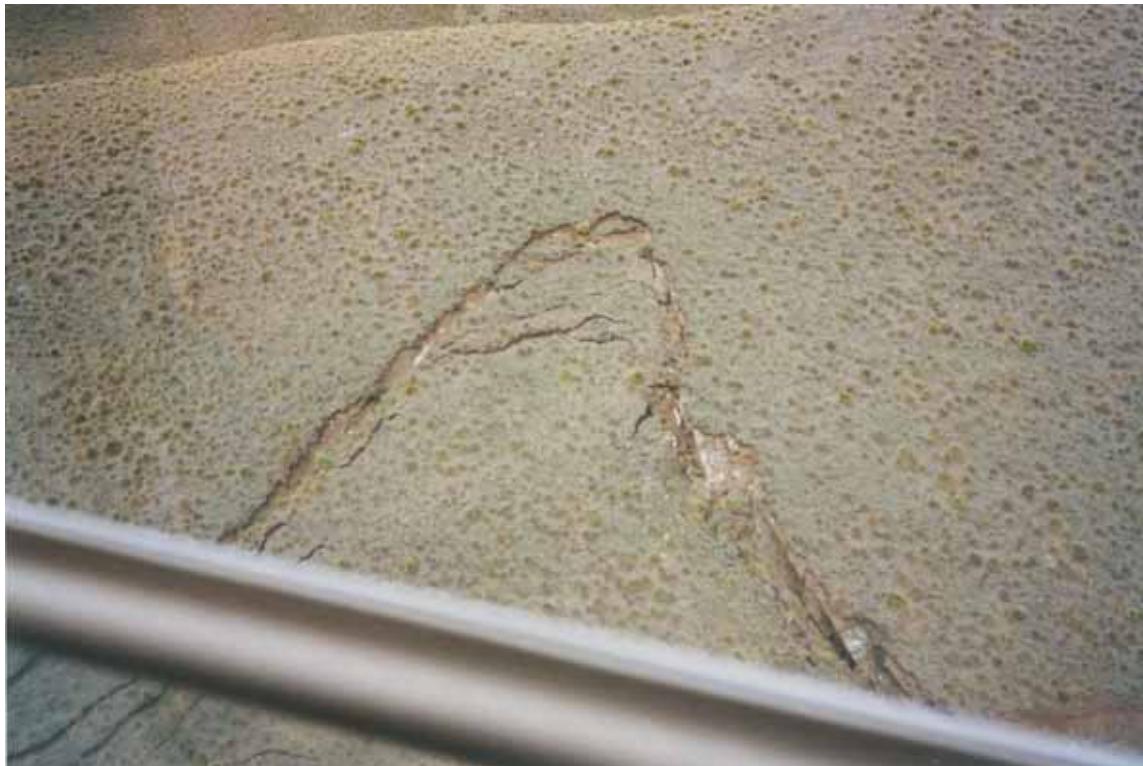
Figure 6.3 Mass movement in the Cardrona River upper catchment resulting from the over-saturation of slopes during the November 1999 flood event

Mass movements, largely in the form of slope failures, have the potential to contribute significant volumes of sediment to the river, which can in turn alter the flood hazard of the river. Slope failure in any part of the valley can contribute sediment directly to the channel through large-scale sliding or smaller amounts over longer time periods through the progressive erosion of active slopes (Figure 6.2). Newly-activated slope failures, such as those observed in November 1999 (Figure 6.3) often expose fresh slopes or bare rock faces that may also erode and contribute fresh sediment to tributaries and the Cardrona River.

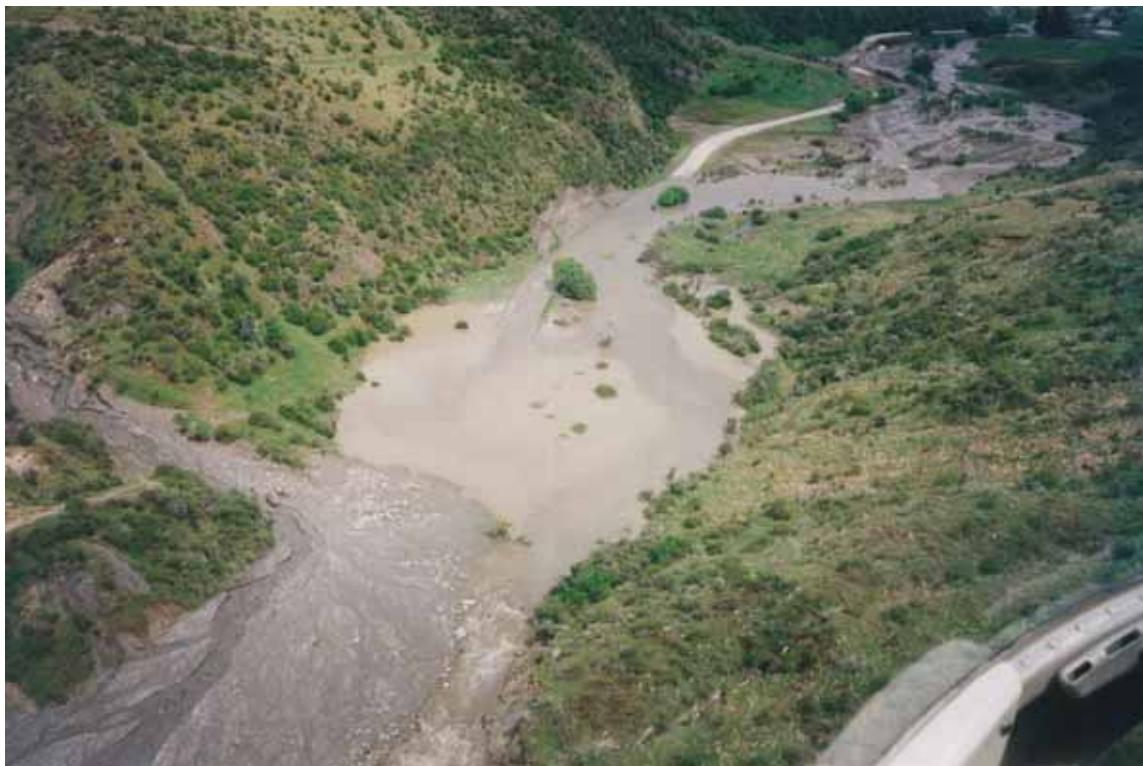
Figure B.3 Debris dam formed over the Cardrona Valley Road in the upper valley reaches looking upstream, November 1999

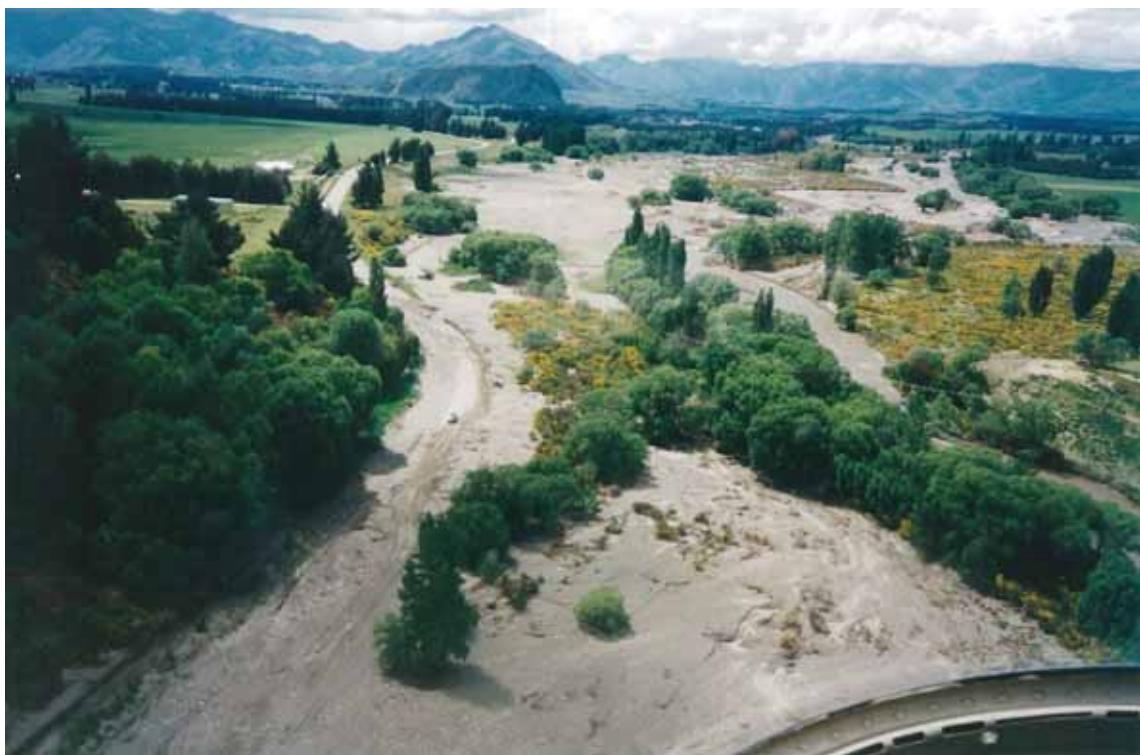
Figure B.9 November 1999 flood sedimentation at The Larches, looking downstream

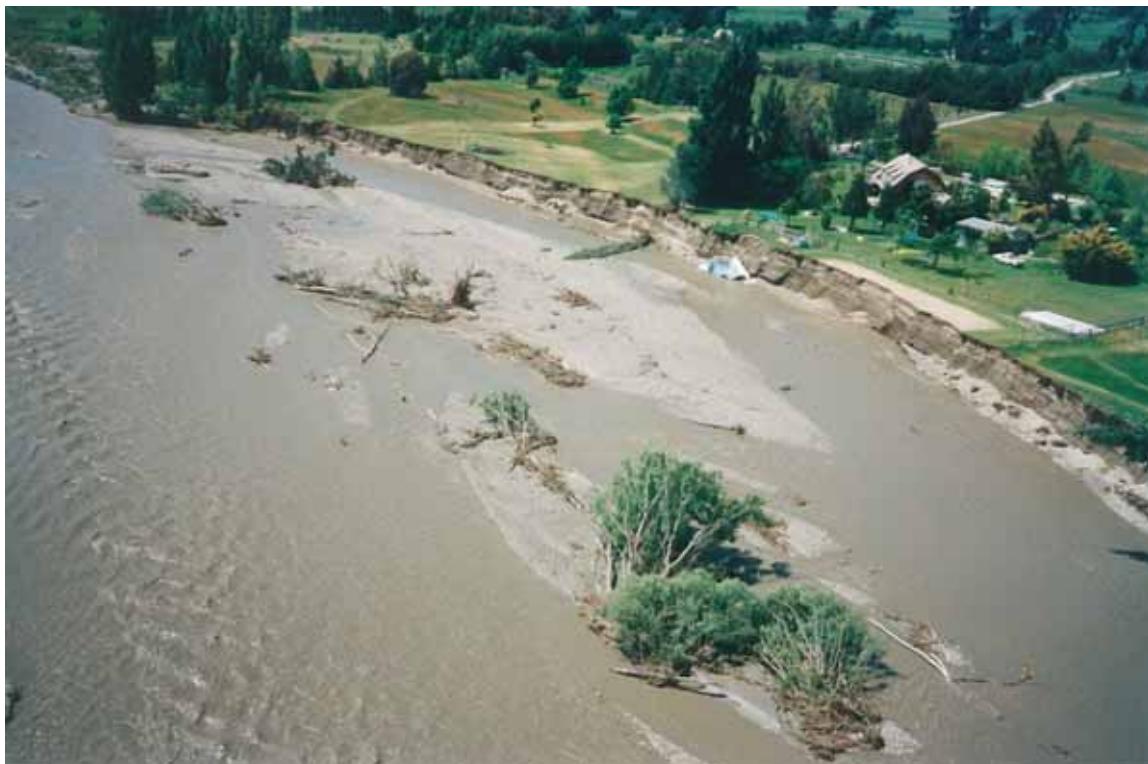
Figure B.11 True right bank erosion downstream of The Larches and upstream of the Ballantyne Bridge looking downstream, November 1999

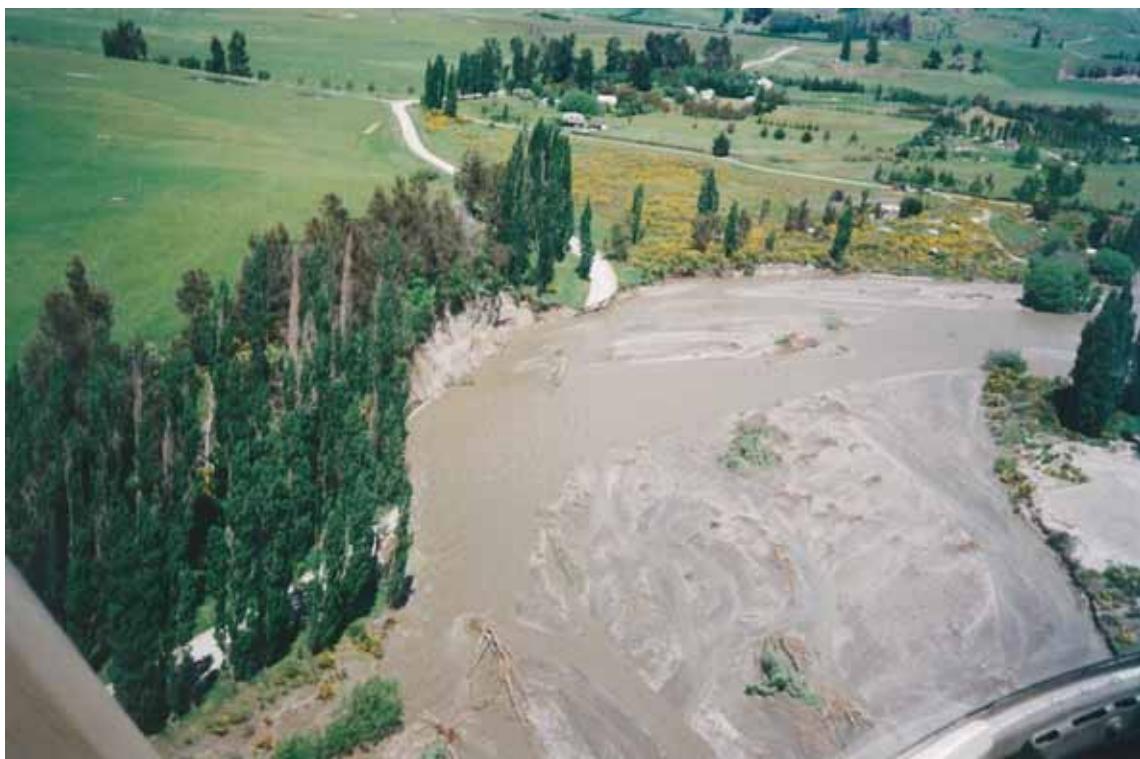
Figure B.12 True right bank erosion downstream of The Larches and upstream of the Ballantyne Bridge looking upstream, November 1999

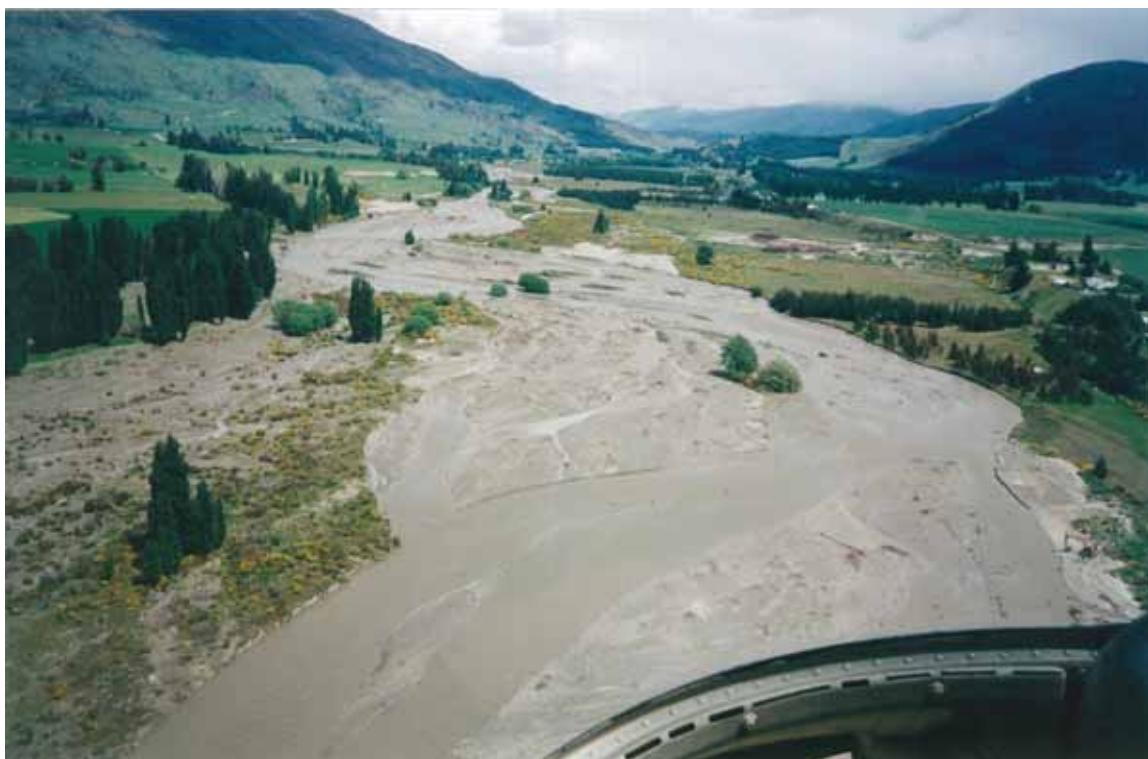
Figure B.13 Flood sedimentation between State Highway 6 and Ballantyne Road looking upstream, November 1999

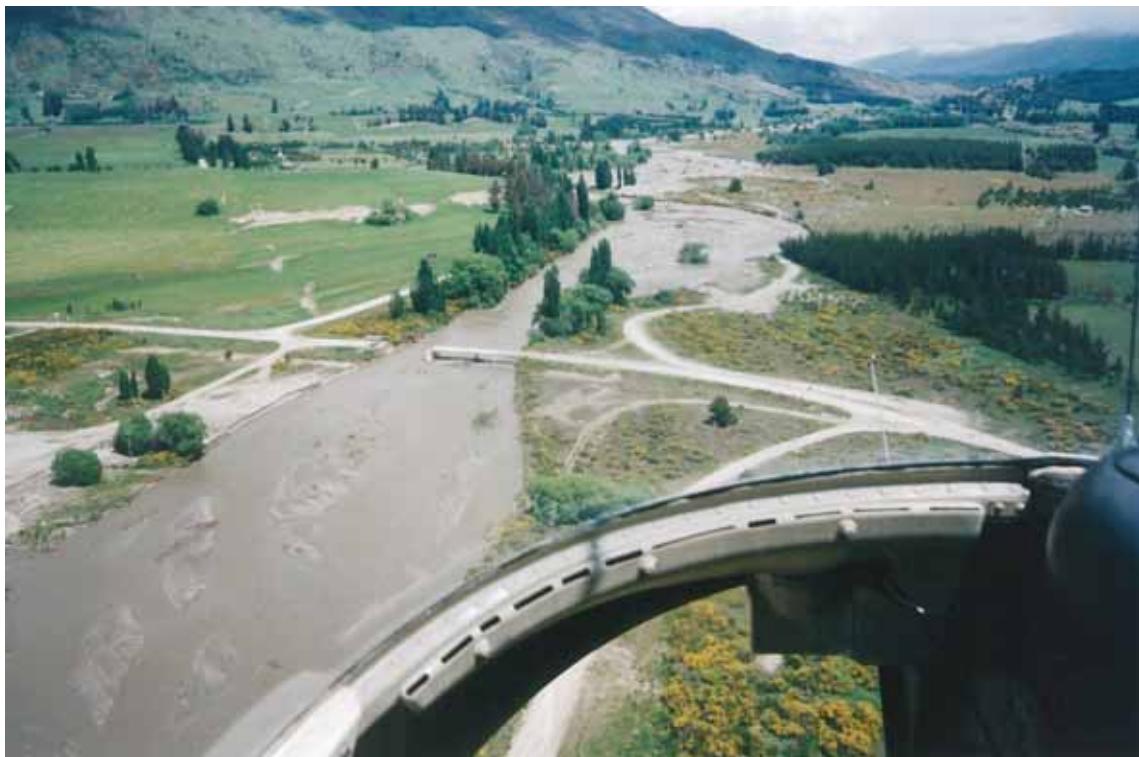
Figure B.14 Flood sedimentation at the Ballantyne Road Bridge looking upstream, November 1999

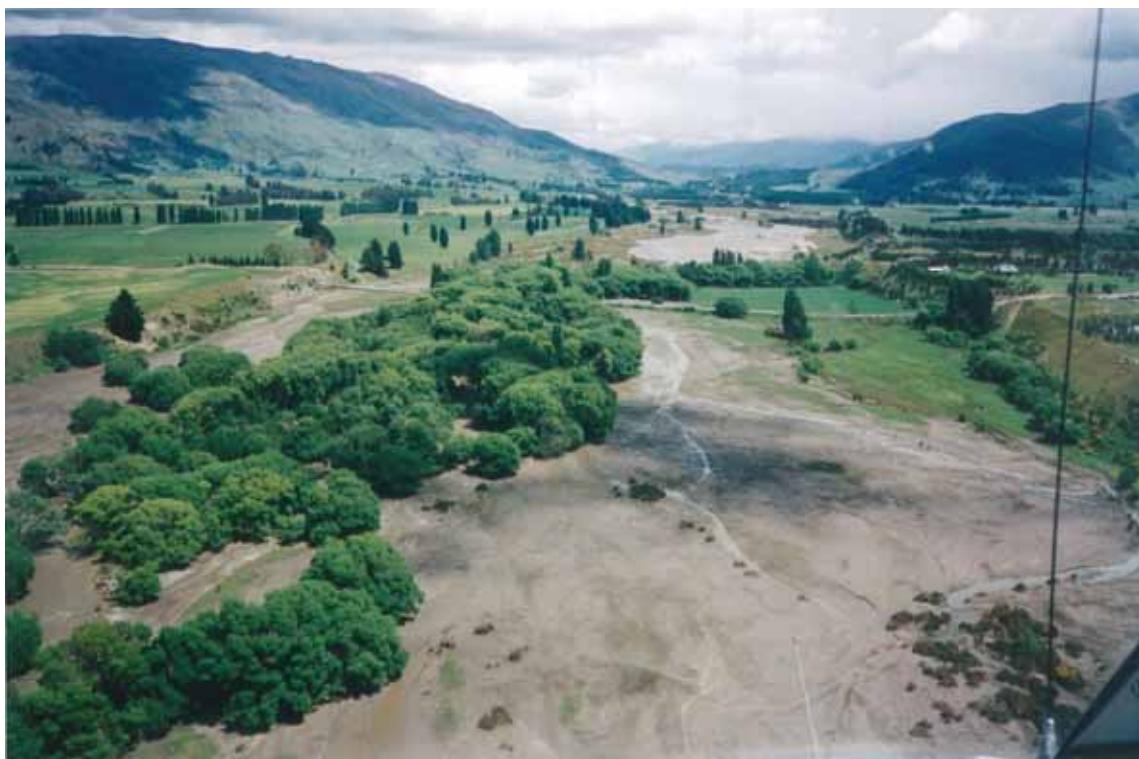
Figure B.15 Flood sedimentation below the State Highway 6 Bridge looking upstream, November 1999

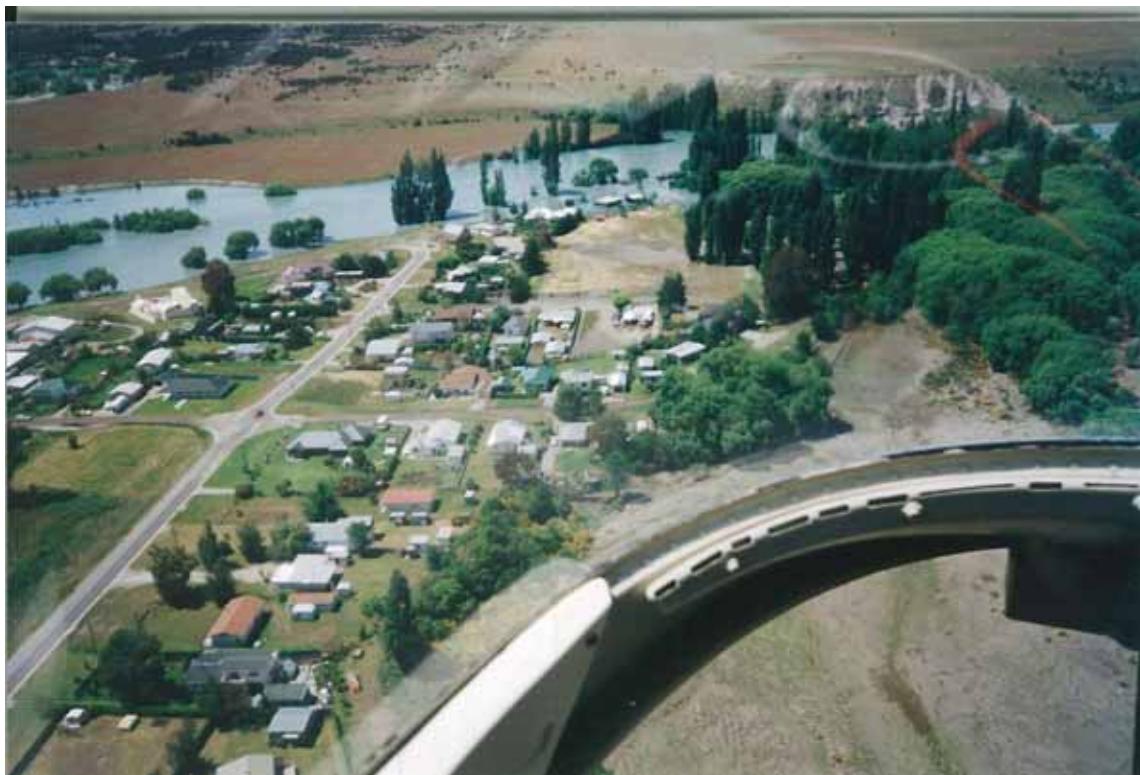
Figure B.16 Flood sedimentation near Albert Town looking downstream, November 1999
