Ref: **6786**

**OCEANA GOLD (NZ) LTD  
MACRAES GOLD PROJECT  
MINING OF ROUND HILL – SOUTHERN PIT  
MTI, SP10 & SP11A TAILING STORAGE  
FACILITIES AND RECLAIMED TAILINGS STACK  
TECHNICAL REPORT**

**28 April 2011**

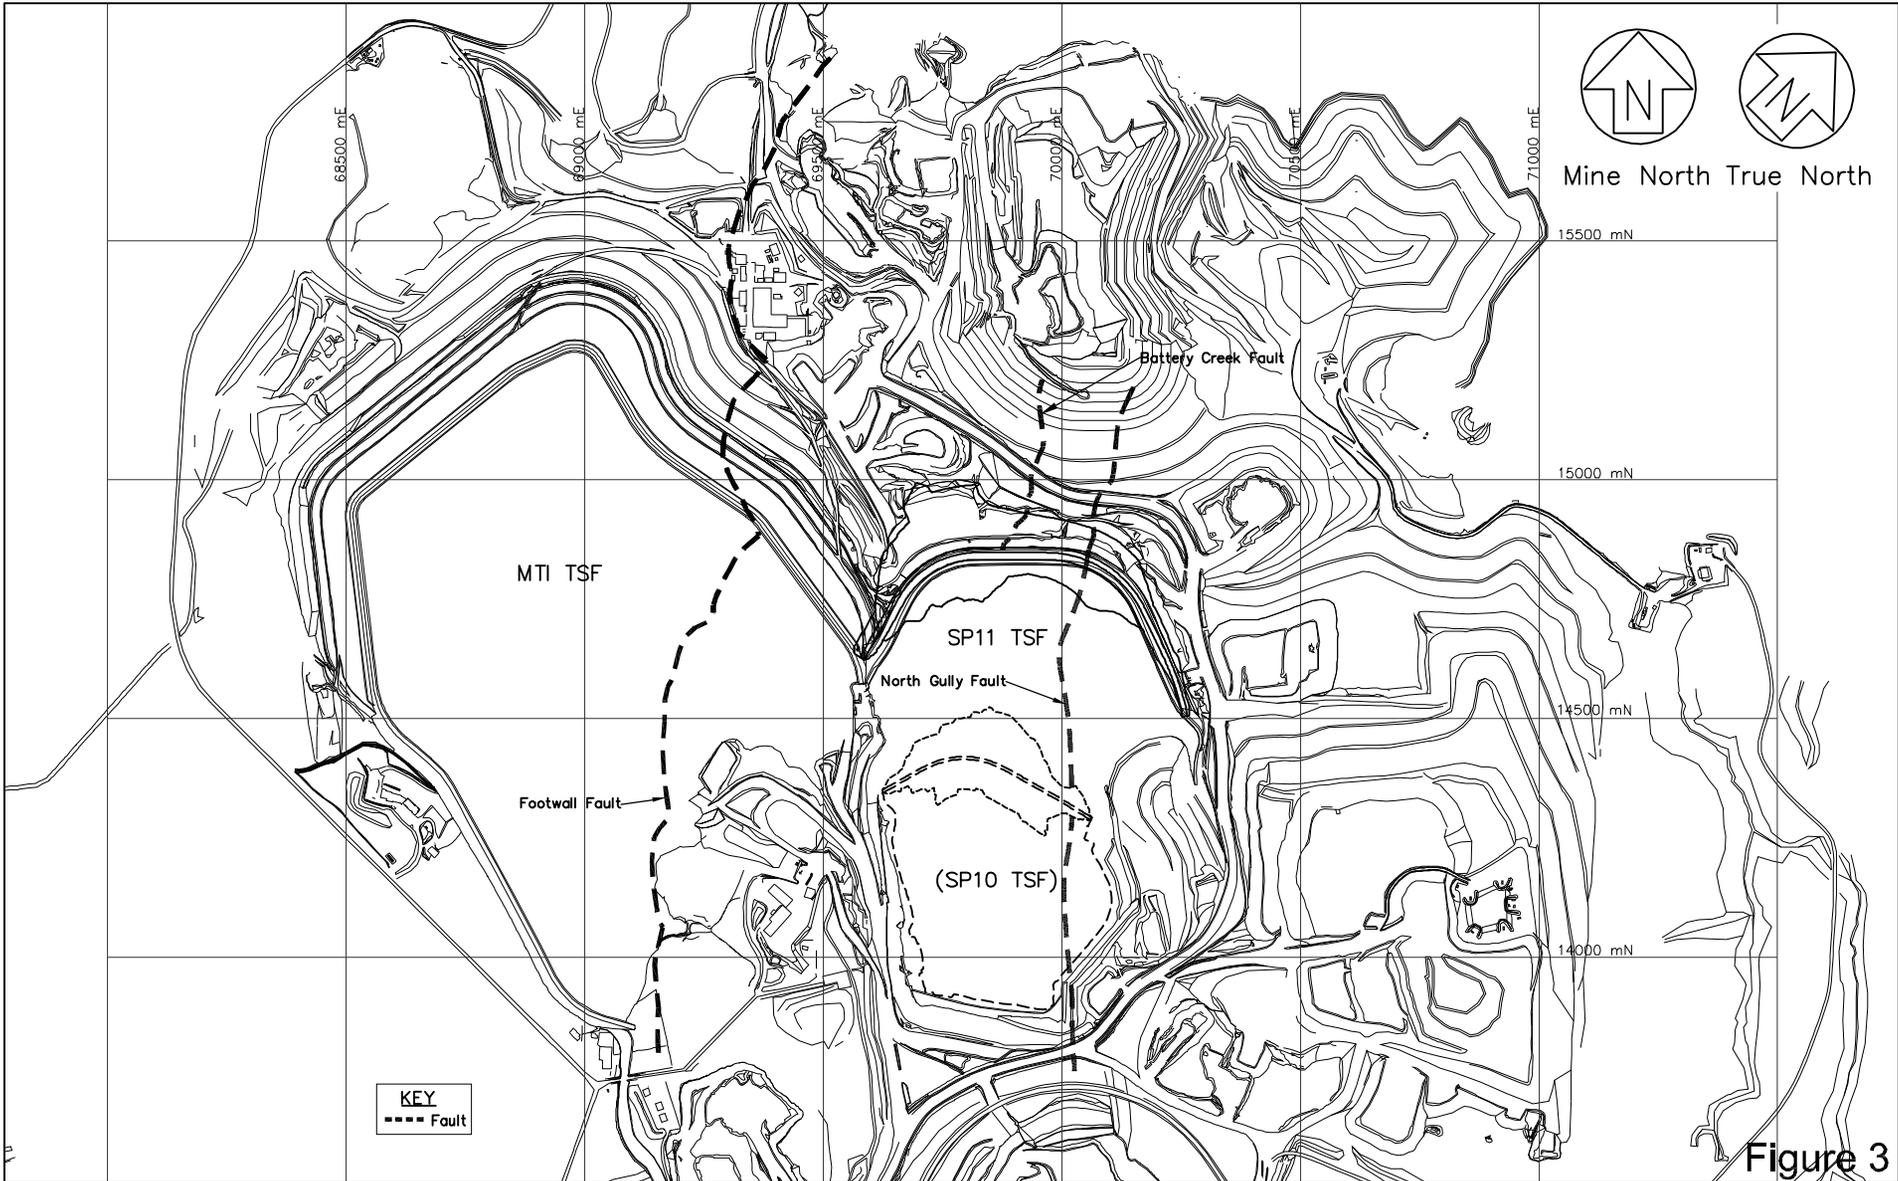
Figure 3

**OCEANA GOLD (NZ) LTD, MACRAES GOLD PROJECT**  
**Round Hill - Southern Pit**  
*Fault Locality Plan*

The Footwall Fault daylights beneath the MTI TSF (refer Figure 3) and dips to the east. Proposed mining of the Round Hill – Southern Pit is expected to reactivate movement on the Footwall Fault which will in turn result in movement over the eastern portion of the MTI TSF. The SP11A TSF will have been deconstructed when the mining works commence and the SP10 TSF is not expected to be significantly affected by the deformation. Therefore only the MTI TSF will be significantly affected by movement on the Footwall Fault due to the mining operation. The Process Plant, to the north east of the MTI TSF (refer Figure 2), will also be affected by the movement but the consequences of the deformation on it is outside the scope of this report.

are shown in Figure G1, in Appendix G, and on the cross section in Figure 5. The seepage from the drain outlets is regularly measured. During resting of the MTI TSF the average flow from the drains over the eastern area of the TSF (i.e. from about where the Footwall Fault daylights - refer Figure 3) is about 5 l/sec. This is not all the seepage that could potentially be collected as some drains were lost during the previous movement on the Footwall Fault and no longer flow. If these drains were still flowing then the total seepage collection could be about 8 l/sec.

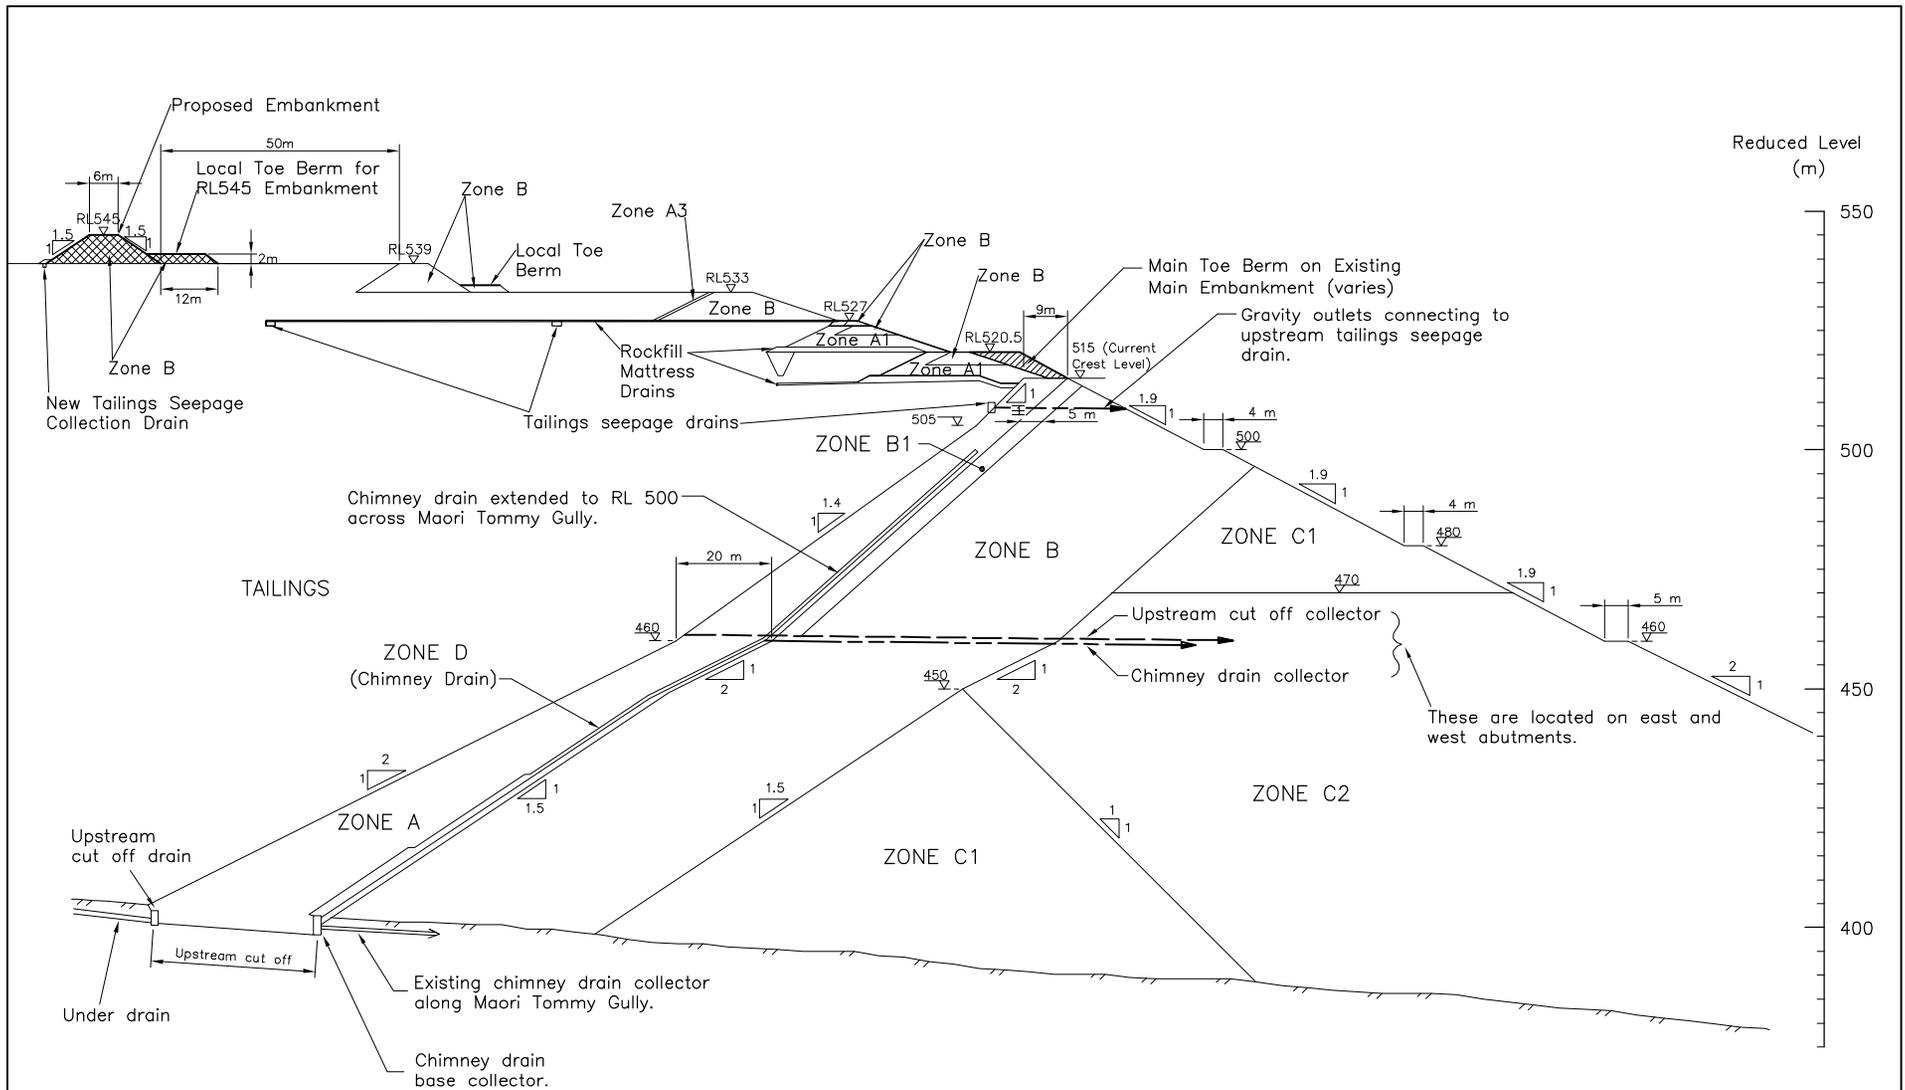
**Figure 5**

OCEANA GOLD LIMITED  
 Macraes Gold Operation  
 Mixed Tailings Embankment  
*Typical Cross Section through Embankment*

- (iii) The embankment includes a chimney drain (refer Figure 5 & 11). Although the chimney drain is not continuous along the entire embankment, it was initially located where differential settlement is more likely to occur then extended over the eastern abutment after the deformation on the Footwall Fault was observed (refer Figure F7). On the eastern abutment the chimney drain is 2.5m wide over the lower section.

The MTI Embankment is essentially a zoned earth/rockfill structure as shown in Figure 5 with the bulk of the downstream embankment to RL515 comprising rockfill (Zone B and C). The low permeability (Zone A) is generally formed from well compacted weathered rock of low plasticity. Deformation of the embankment is unlikely to significantly affect the strength of the Zone B and C material which

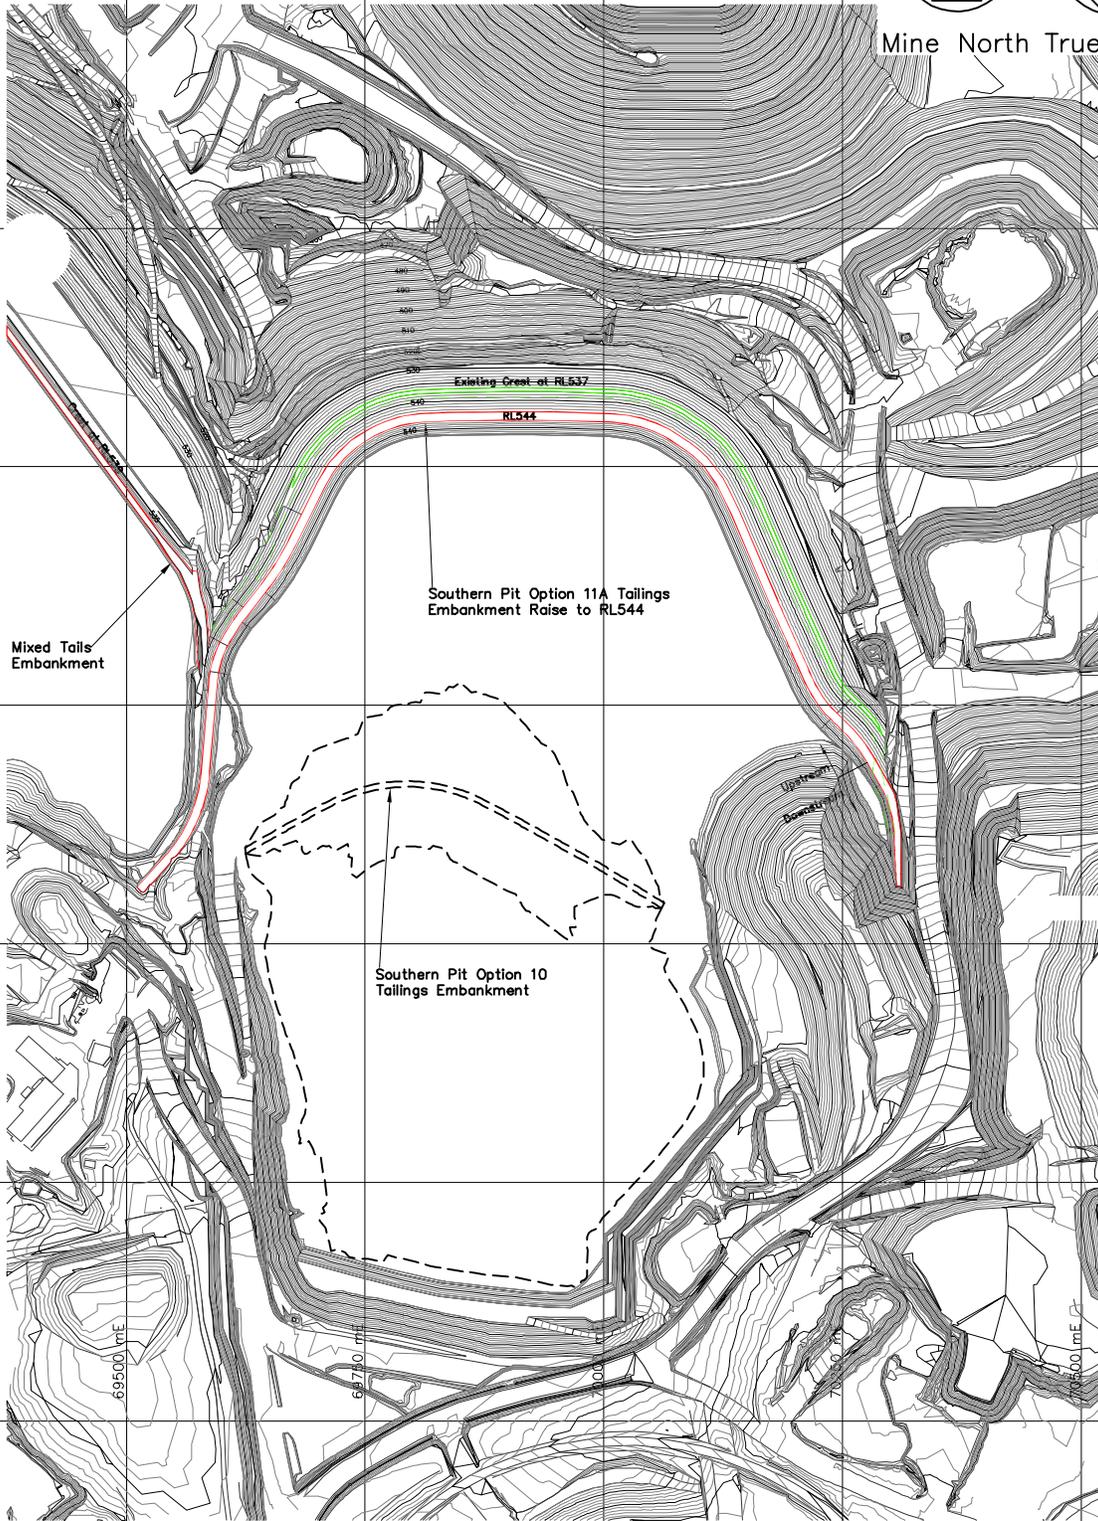
Figure 8

OCEANA GOLD (NZ) LTD, MACRAES GOLD PROJECT  
 Round Hill - Southern Pit  
 SP11 Raised to RL544 Proposed Layout

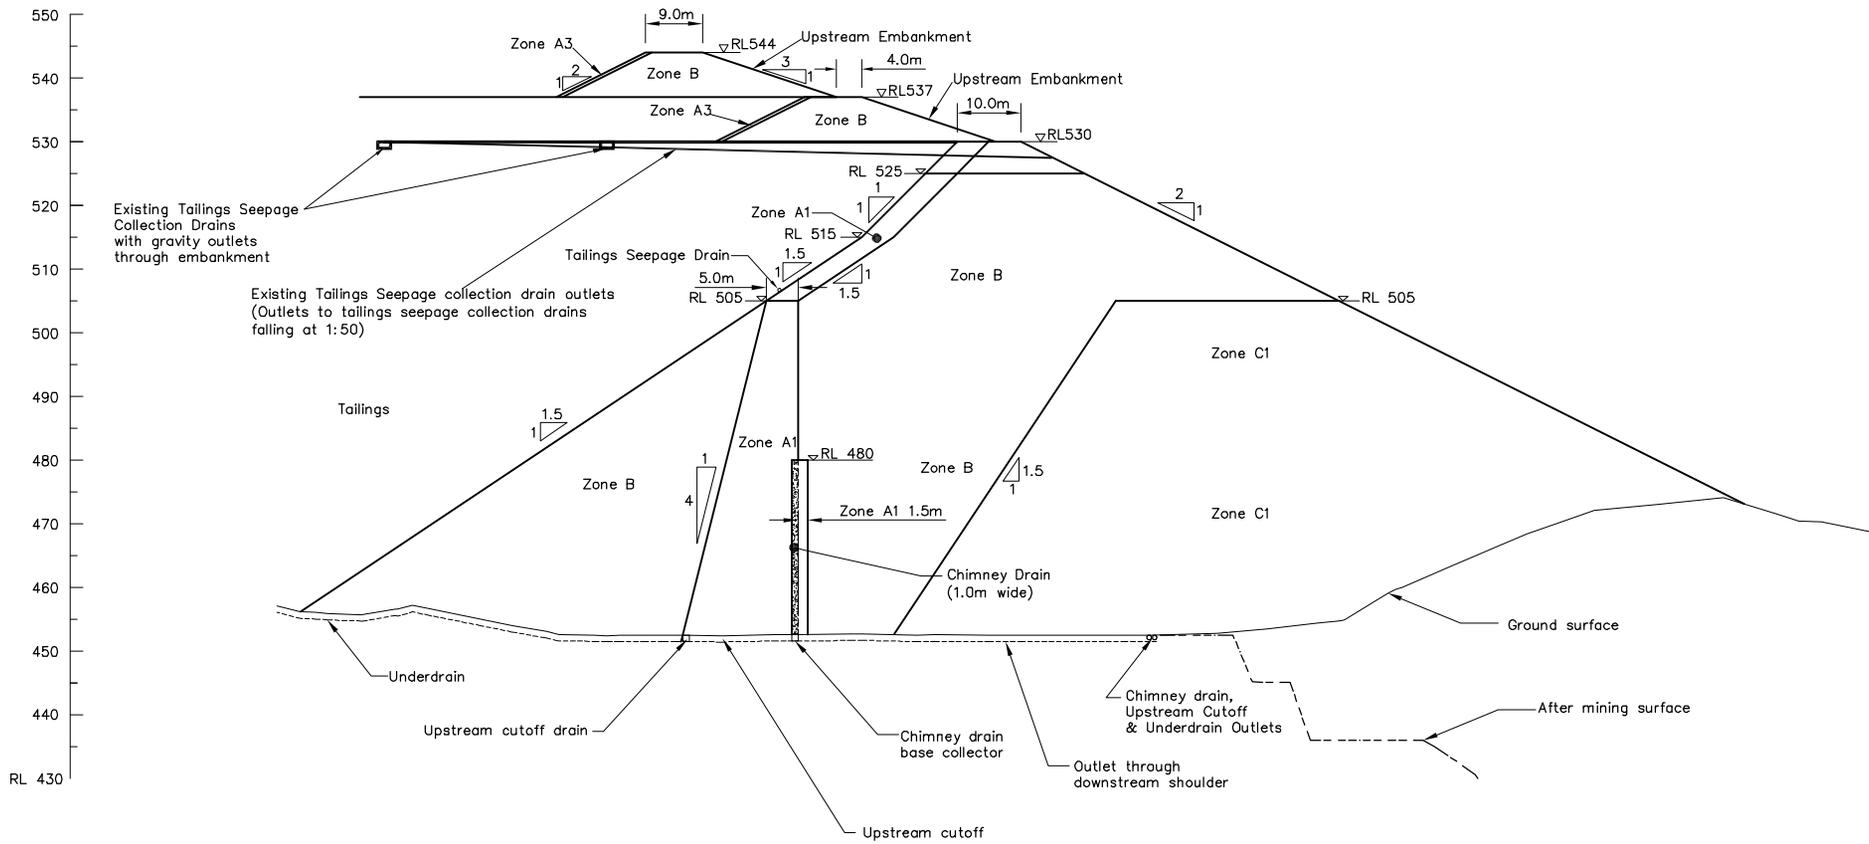
Figure 9

Southern Pit Option 11A Typical Section

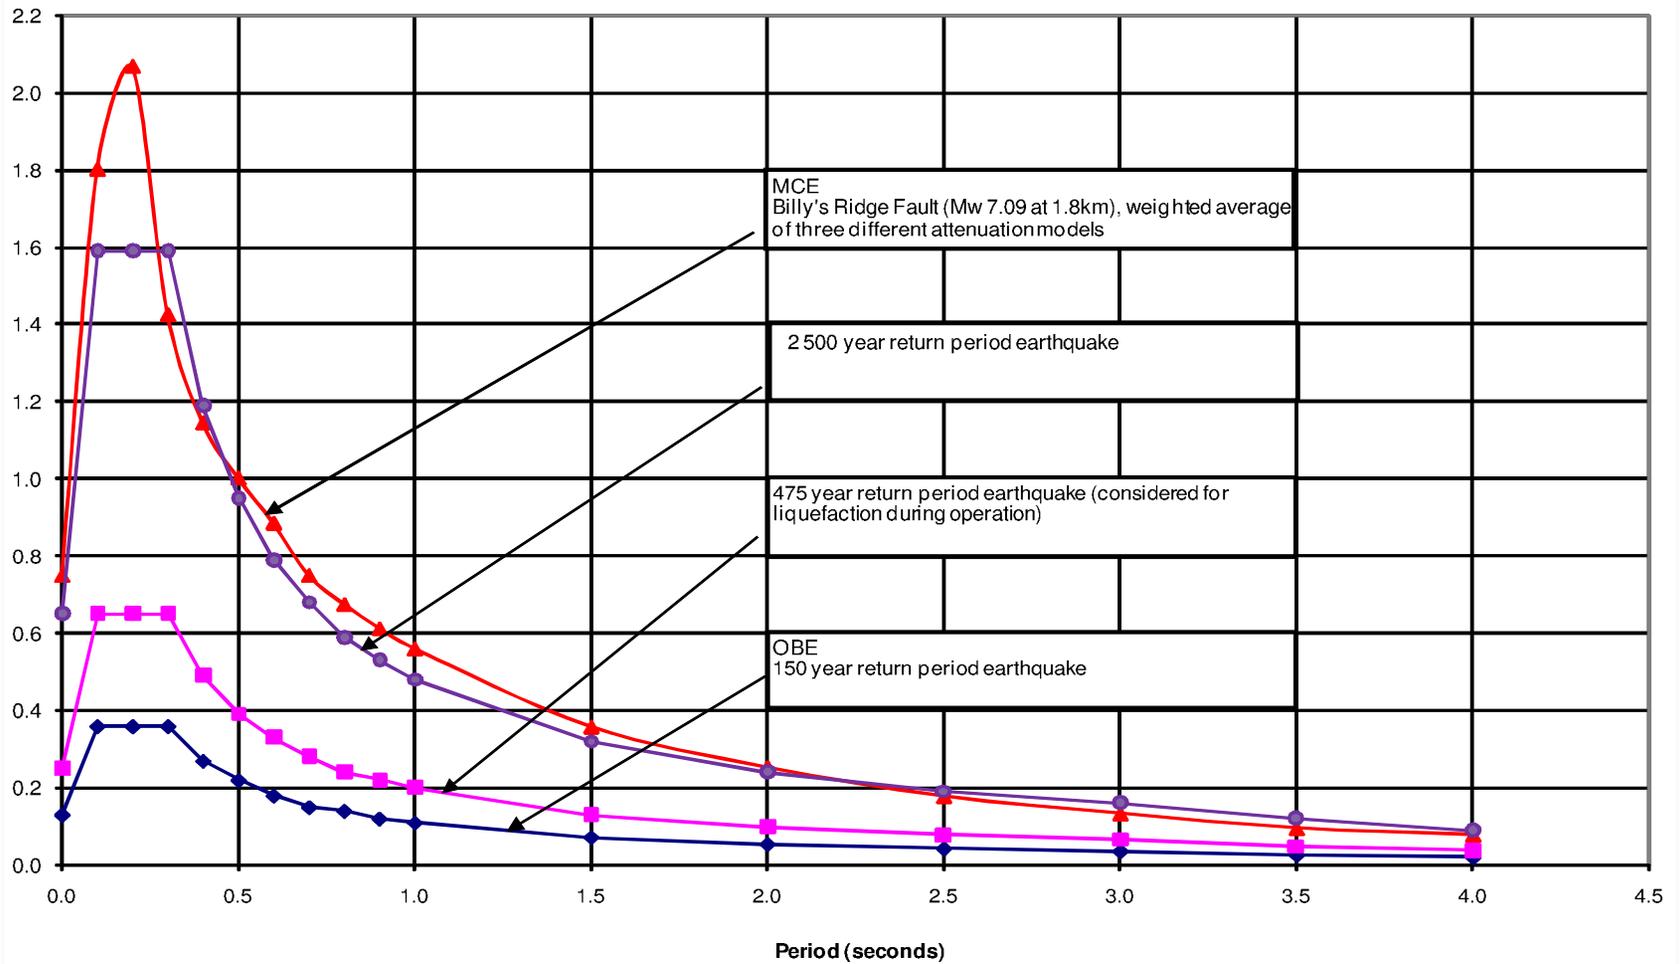
Figure 10

OCEANA GOLD LIMITED  
 MACRAES GOLD PROJECT  
*Acceleration Response Spectra (5% Damping)*

In 2005 Geological and Nuclear Sciences (GNS) was engaged to undertake a seismic hazard study for the site (Ref.12). Probabilistic estimates of seismic hazard in terms of acceleration response spectra were estimated for use in the design of the tailings embankments. Spectra were provided for return periods of 150, 475, 1,000, 2,500 and 10,000 years as well as for earthquakes associated with the closest active faults to the site (Billy's Ridge and Taieri Ridge). Spectra for return periods of 150, 475 and 2,500 years, and for a possible earthquake associated with the Billy's Ridge Fault ( $M_w = 7.09$  at 1.8km), are shown in Figure 10.

The deformation of the embankment is checked during earthquake shaking using a pseudostatic stability analysis together with a simplified deformation analysis (Newmark sliding block approach). The analysis is carried out for the 475 return period earthquake and MDE using the peak ground accelerations given in Figure 10. A pseudostatic factor of safety (FOS) of less than 1.0 indicates that permanent deformations are likely during the ground motion and in these cases the deformation is estimated using Jibson (Ref.18).

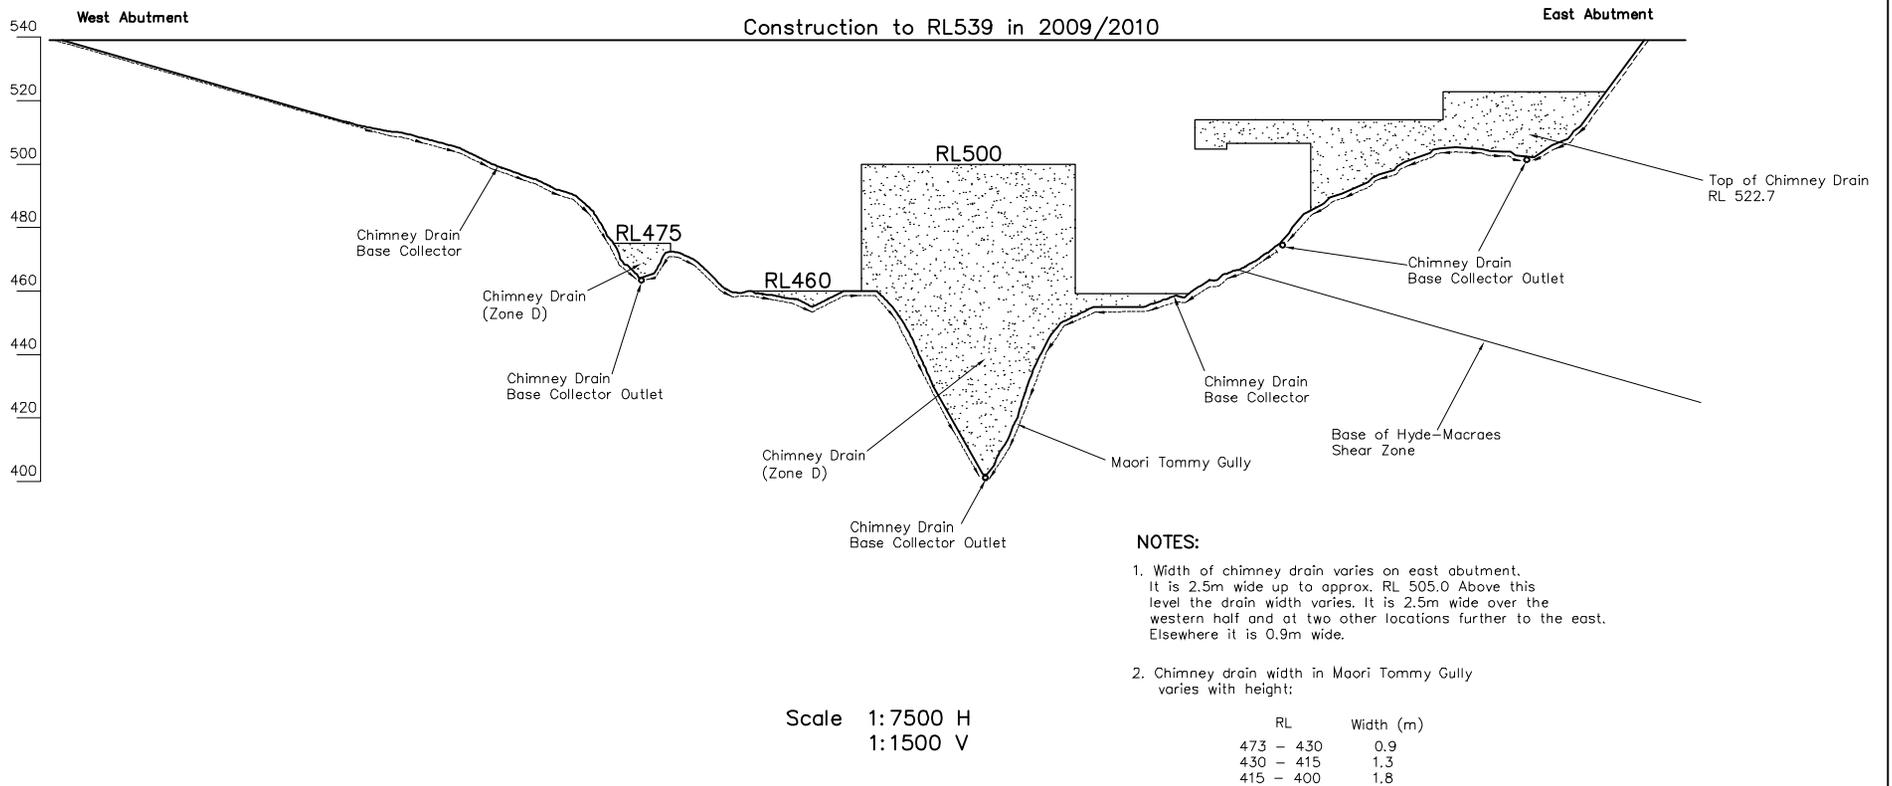
Figure 11

OCEANA GOLD LIMITED  
Macraes Gold Operation  
Mixed Tailings Embankment  
*Long Section Showing Chimney Drain and Base Collector*

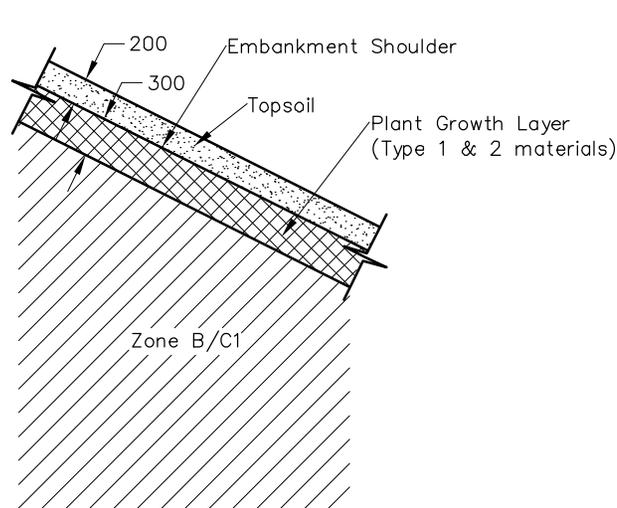
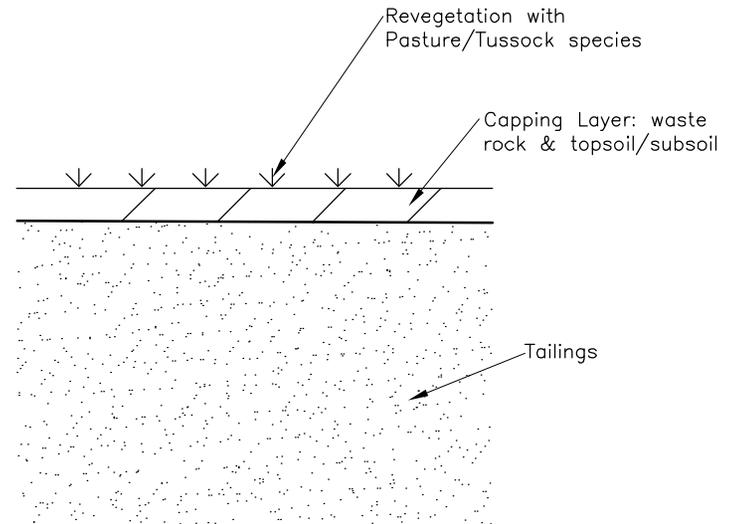
**Figure 12**

Rehabilitation Details for Sloping Surface on Embankments

Rehabilitation Details for Horizontal Surface and Tailings

The downstream batter of the TSF embankments will be rehabilitated as will the RTS side slopes as the RTS is developed. This will involve the direct placement of a plant growth layer, consisting of loess, colluvium or weathered schist. The surface will be re-vegetated with pasture/tussock species (refer Figure 12).

Following closure of the MTI TSF, reshaping of the SP10 TSF and RTS the tailings will be covered and rehabilitated to the final planned landform (refer Figure 12). The objectives of this cover are to:

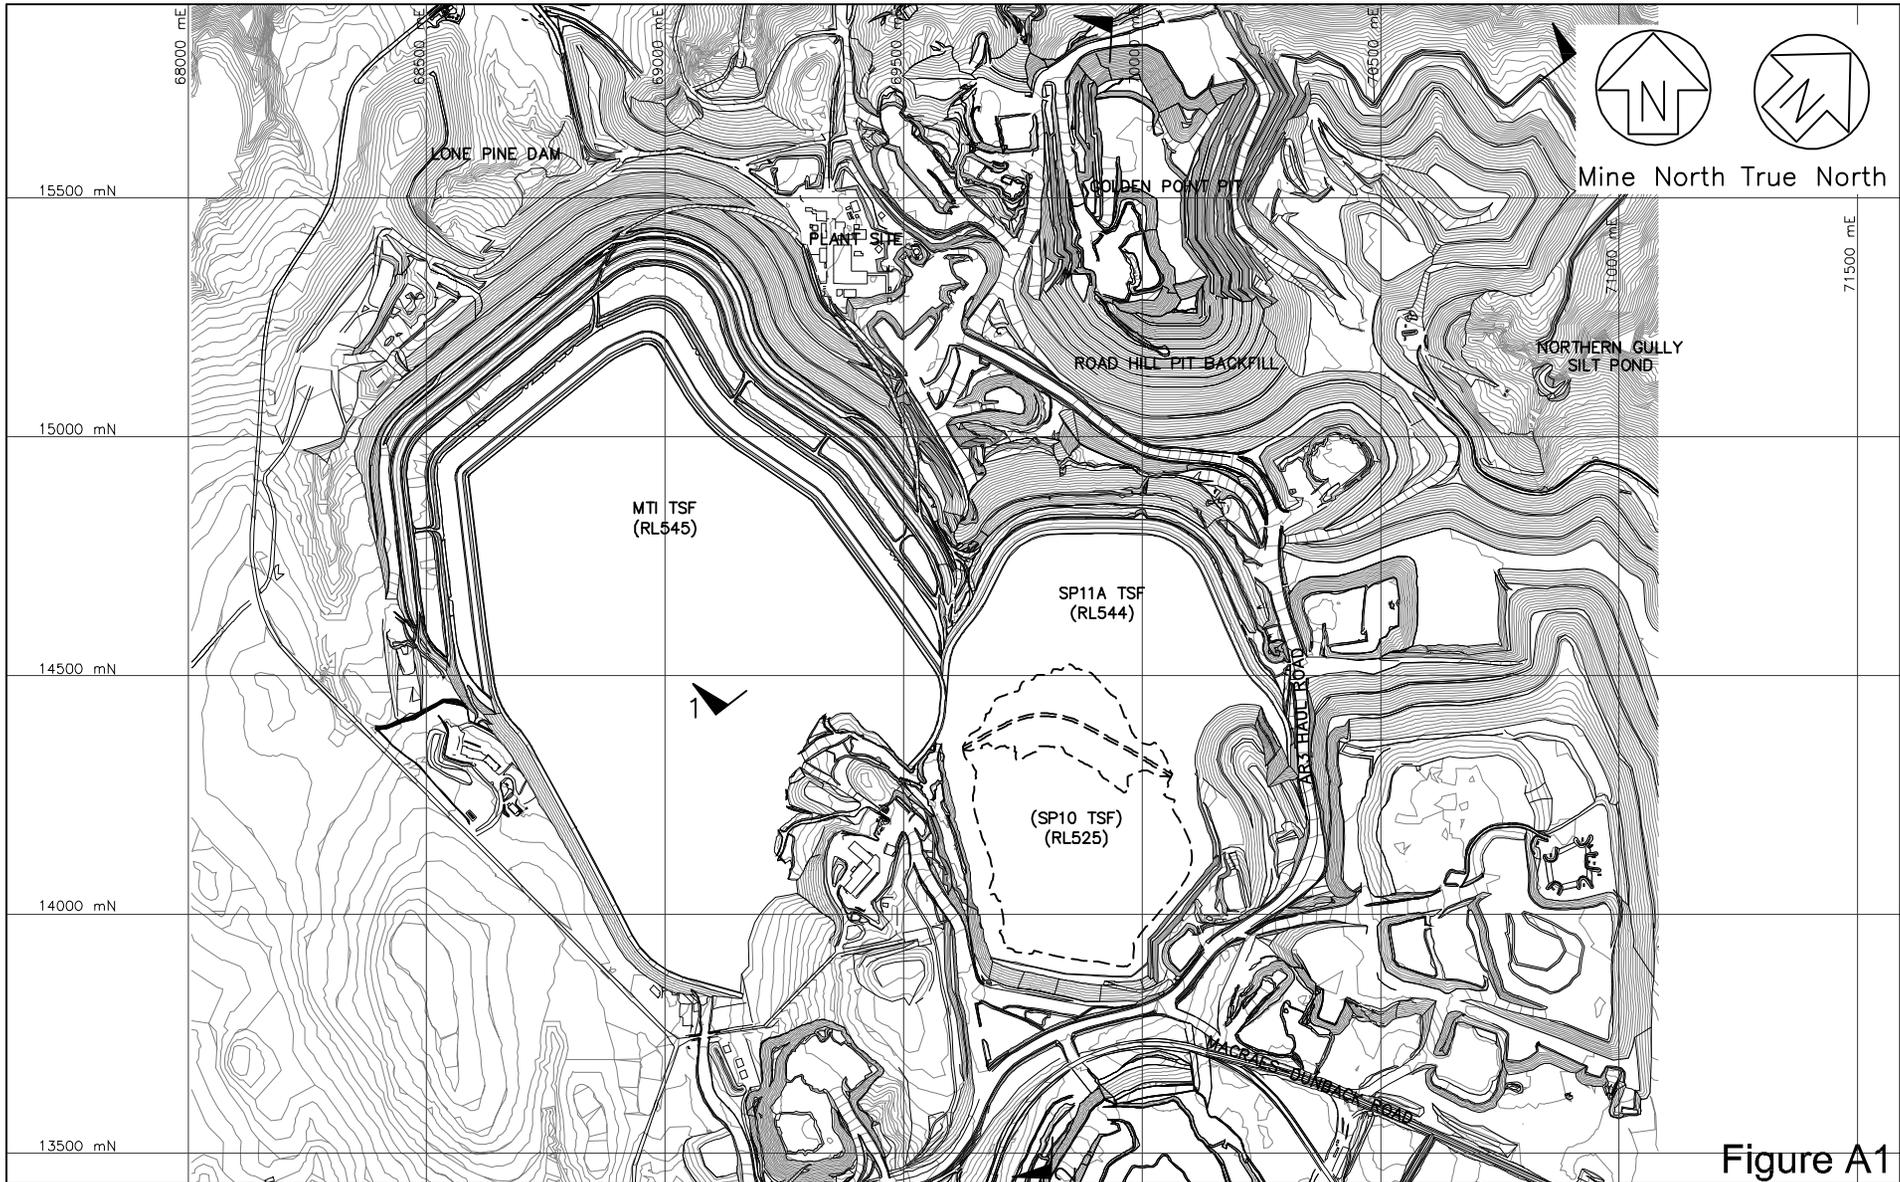
Figure A1

**OCEANA GOLD (NZ) LTD, MACRAES GOLD PROJECT**  
 Round Hill-Southern Pit  
*Initial Site Conditions (Mid to End of 2012)*

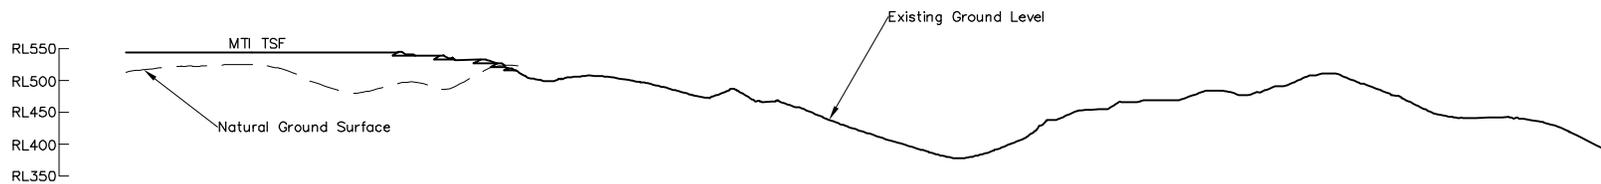
SECTION 1

**OCEANA GOLD (NZ) LTD, MACRAES GOLD PROJECT**  
**Round Hill-Southern Pit**  
*Typical Sections (Mid to End of 2012)*

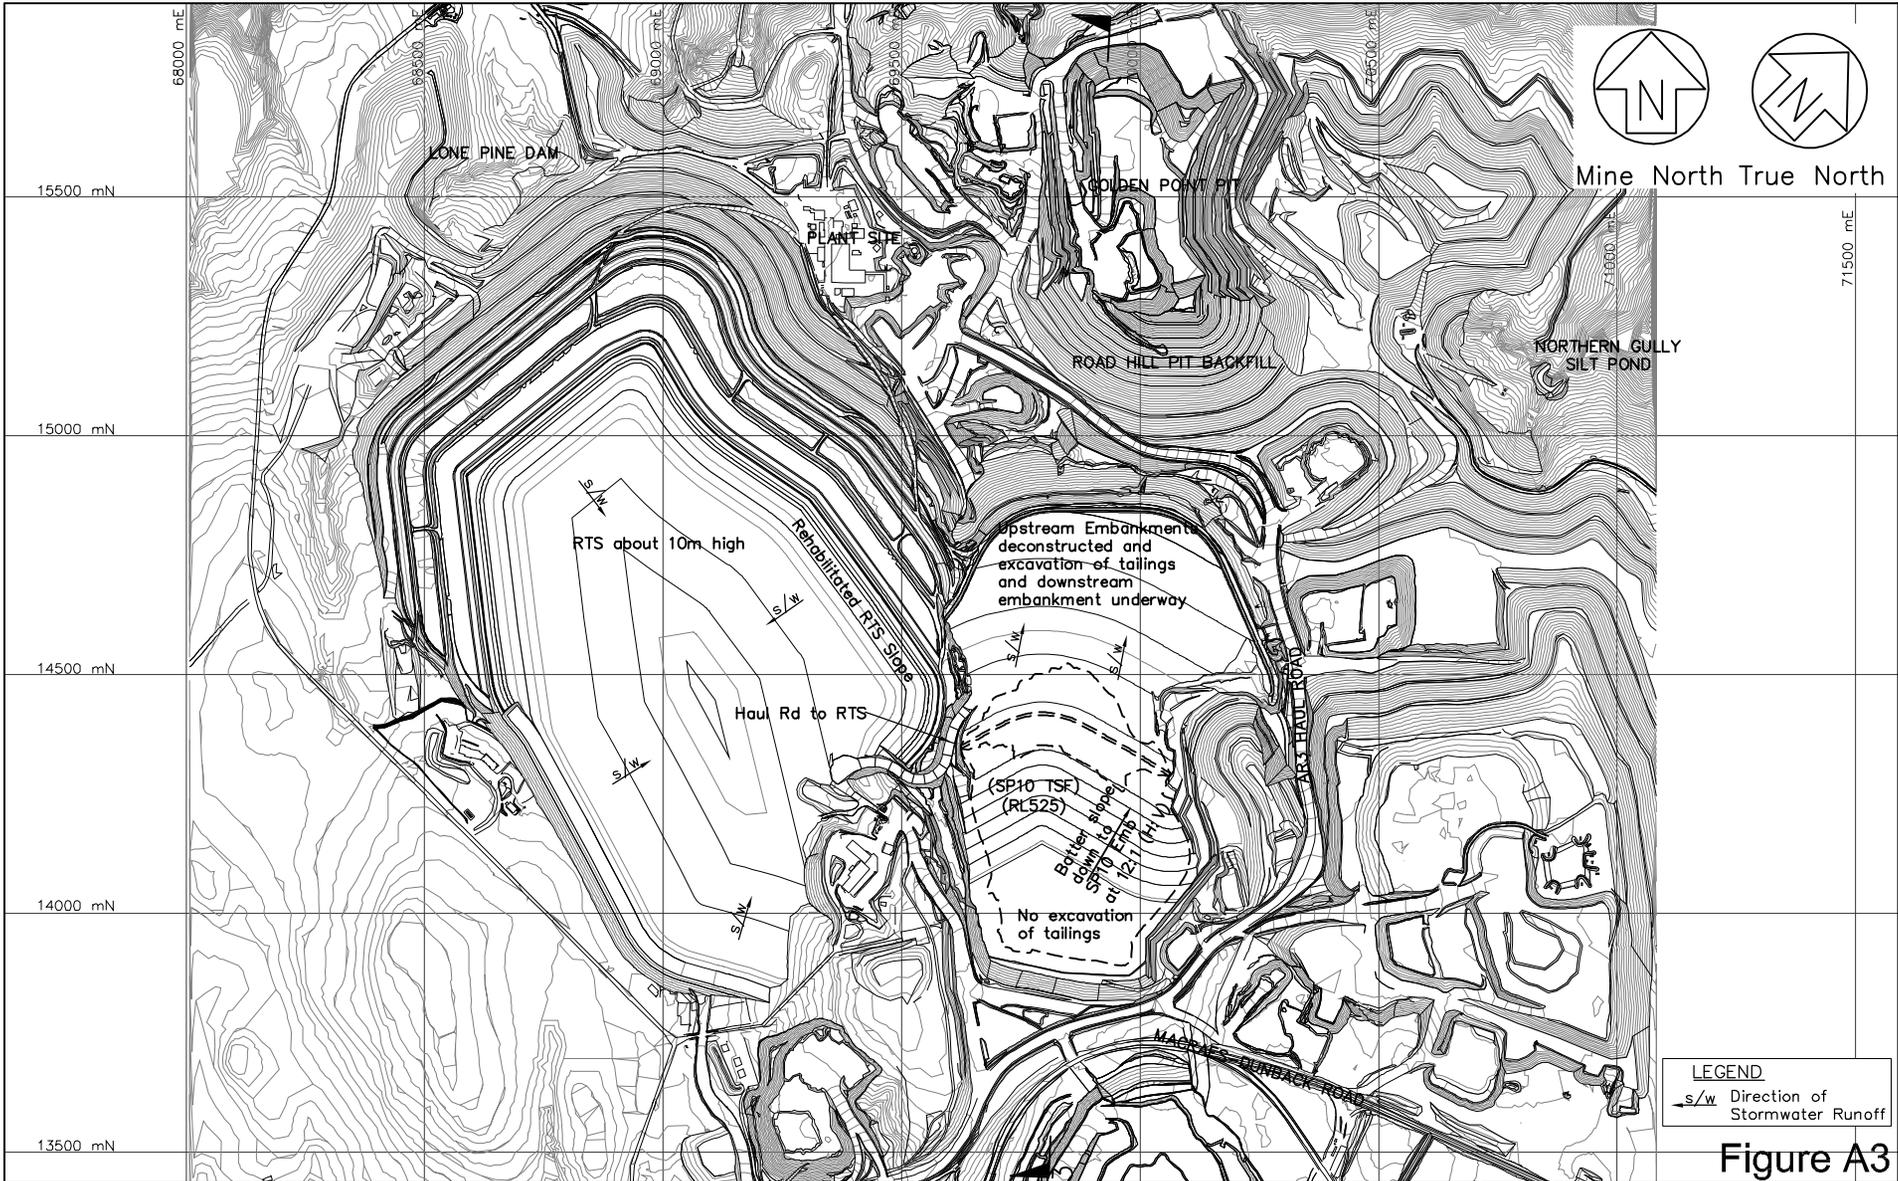
**Figure A3**

**OCEANA GOLD (NZ) LTD, MACRAES GOLD PROJECT**  
 Round Hill-Southern Pit  
*Interim Site Conditions (Mid 2013)*

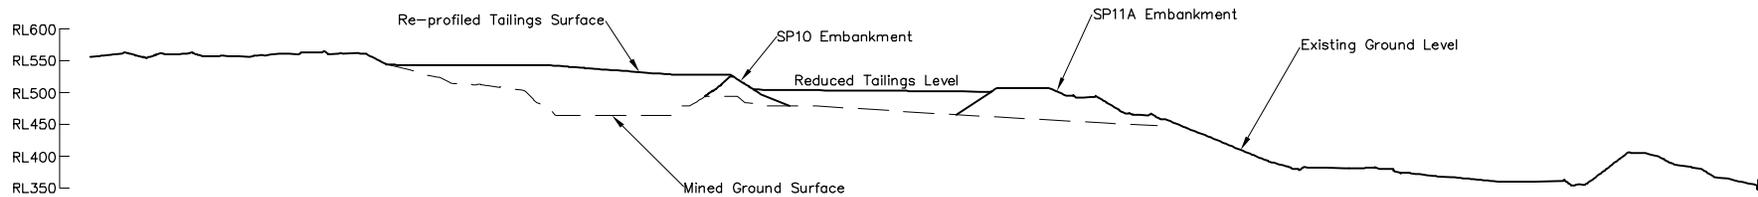
Figure A6

OCEANA GOLD (NZ) LTD, MACRAES GOLD PROJECT  
 Round Hill-Southern Pit  
*Typical Section (Early 2014)*

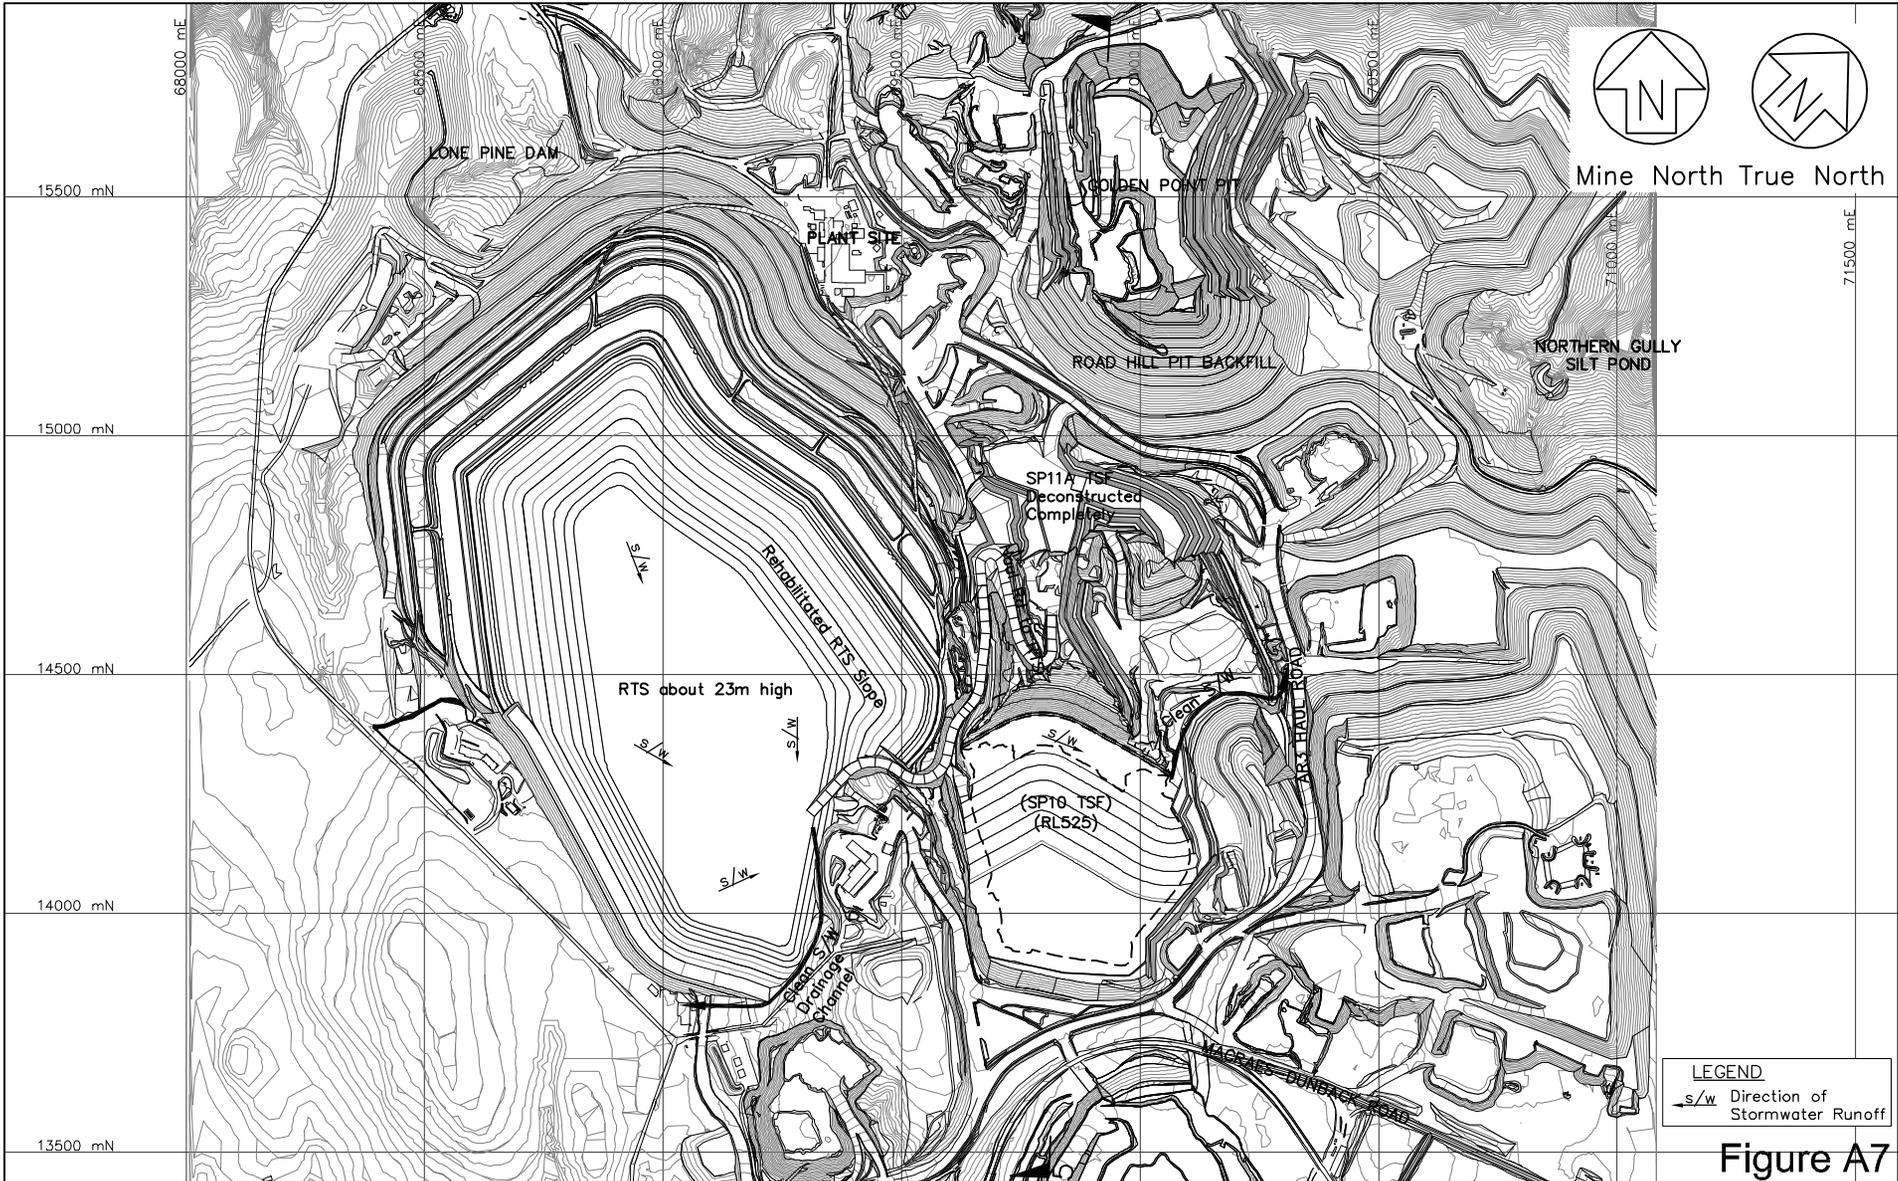
**Figure A7**

**OCEANA GOLD (NZ) LTD, MACRAES GOLD PROJECT**  
 Round Hill-Southern Pit  
*Interim Site Conditions (Mid 2014)*

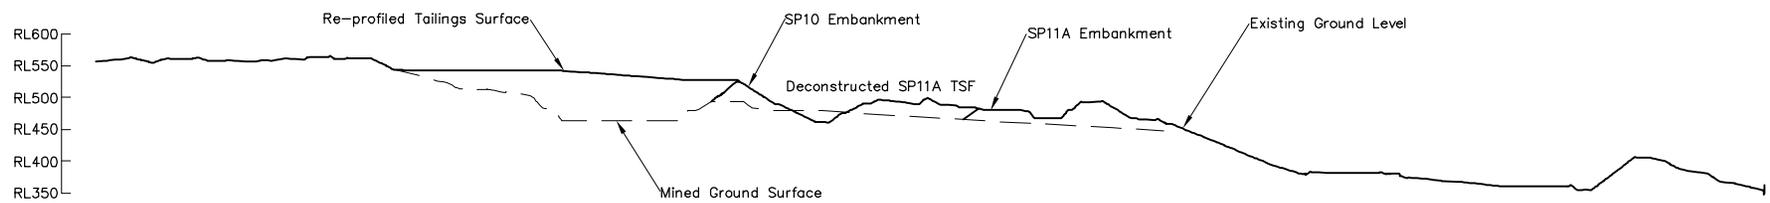
Figure A8

**OCEANA GOLD (NZ) LTD, MACRAES GOLD PROJECT**  
**Round Hill-Southern Pit**  
*Typical Section (Mid 2014)*

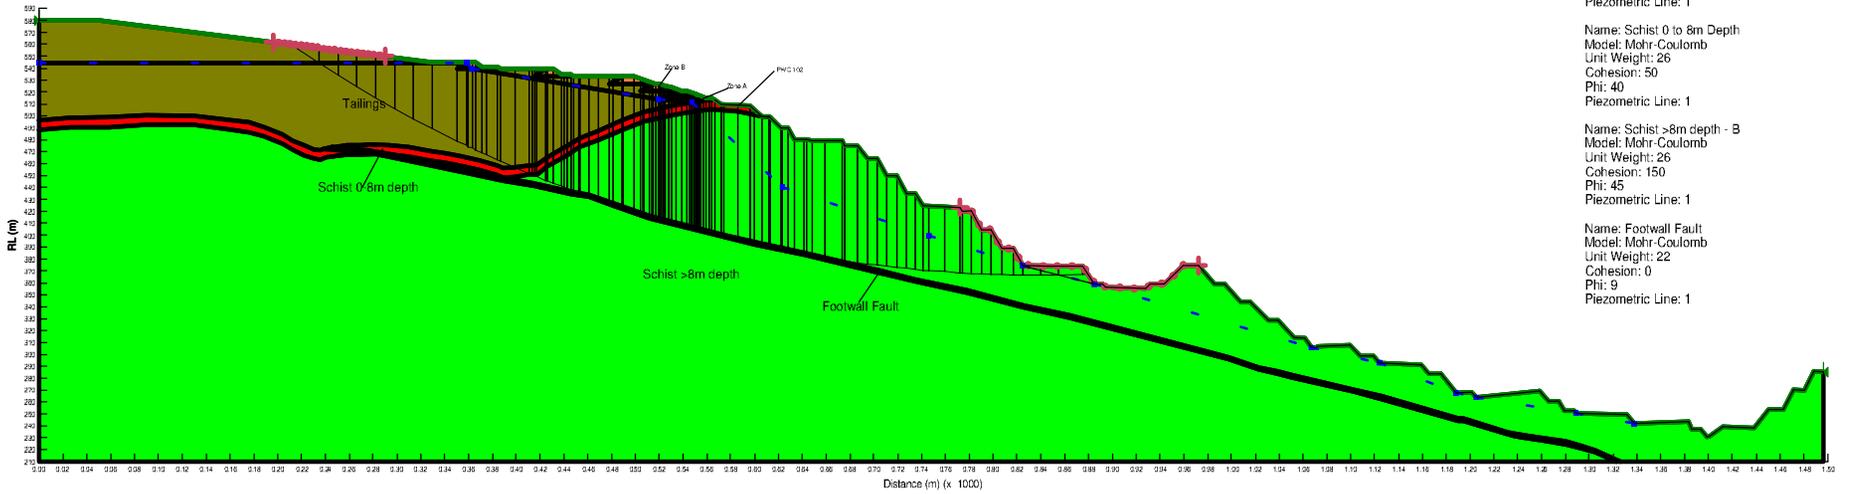
Figure B3

Factor of Safety: 1.58  
Method: Spencer

Name: Zone A  
Model: Shear/Normal Fr.  
Unit Weight: 22.5  
Strength Function: Function 1 -  $2.43 \times \text{Sigma}^{0.83}$   
Piezometric Line: 1

Name: Zone B  
Model: Shear/Normal Fr.  
Unit Weight: 22.5  
Strength Function: Function 1 -  $2.43 \times \text{Sigma}^{0.83}$   
Piezometric Line: 1

MTI TSF with mined Round Hill - Southern Pit  
Static Analysis  
Local Stability

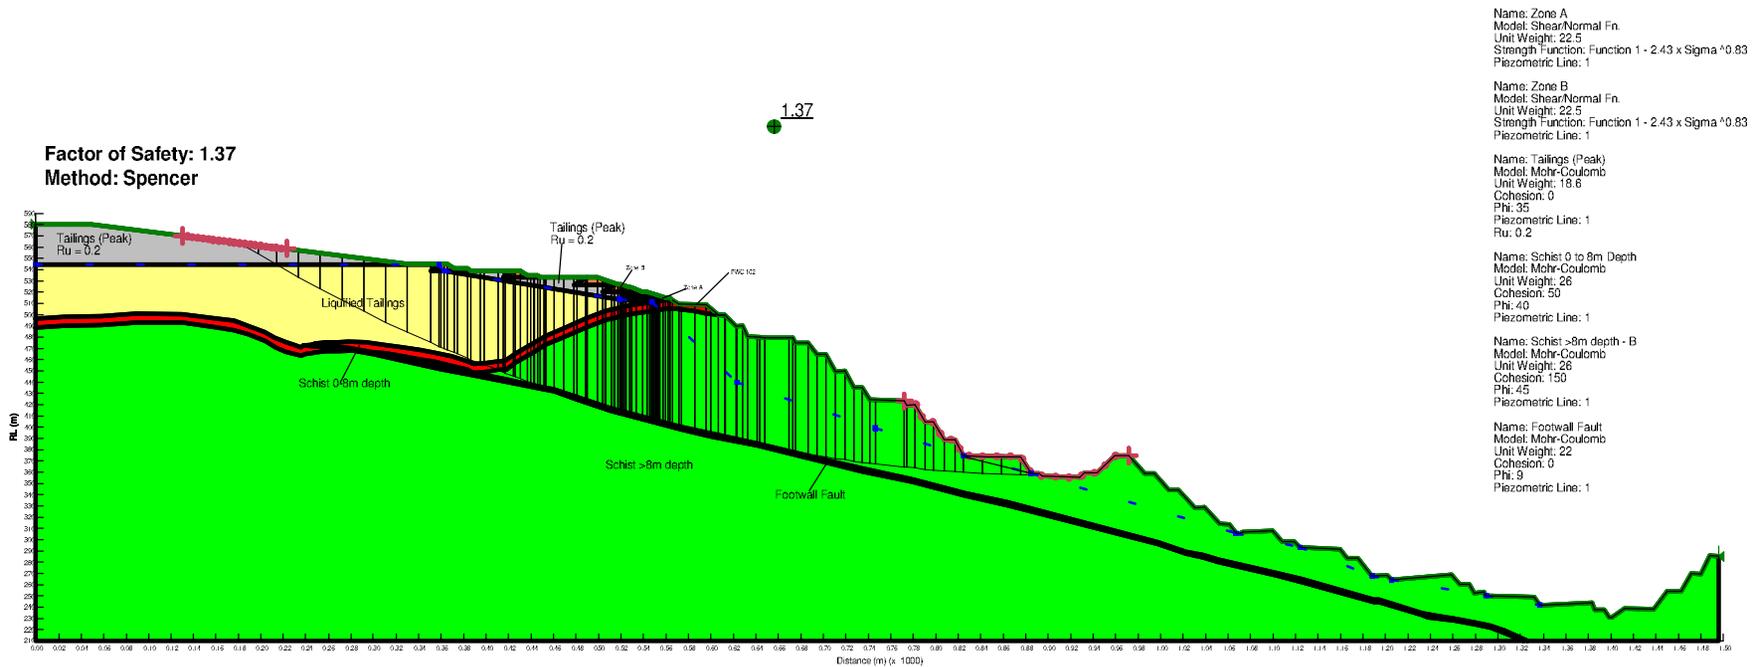
Figure B4

MTI TSF with mined Round Hill - Southern Pit  
 Post Earthquake Analysis  
 475 year return period Analysis  
 Local Stability

Longer term the re-routed Macraes-Dunback Road and new site access/haul road will be built over the southern extremity of the TSF. Post earthquake stability analyses have been carried out to check the feasibility of building the embankment and this shows that the phreatic surface will have to have dropped significantly to achieve a FOS of at least 1.2 (refer Figure 8D). If the phreatic surface has not dropped significantly by the time that the embankment is constructed then some stabilisation options will have to be considered. These may comprise one or a combination of dewatering to lower the phreatic surface, increasing the size of the toe berm on the tailings slope or 'ground' improvement such as stone or soil mix columns.
