Ref: **6786**

**OCEANA GOLD (NZ) LTD  
MACRAES GOLD PROJECT  
MINING OF ROUND HILL – SOUTHERN PIT  
MTI, SP10 & SP11A TAILING STORAGE  
FACILITIES AND RECLAIMED TAILINGS STACK  
TECHNICAL REPORT**

**28 April 2011**

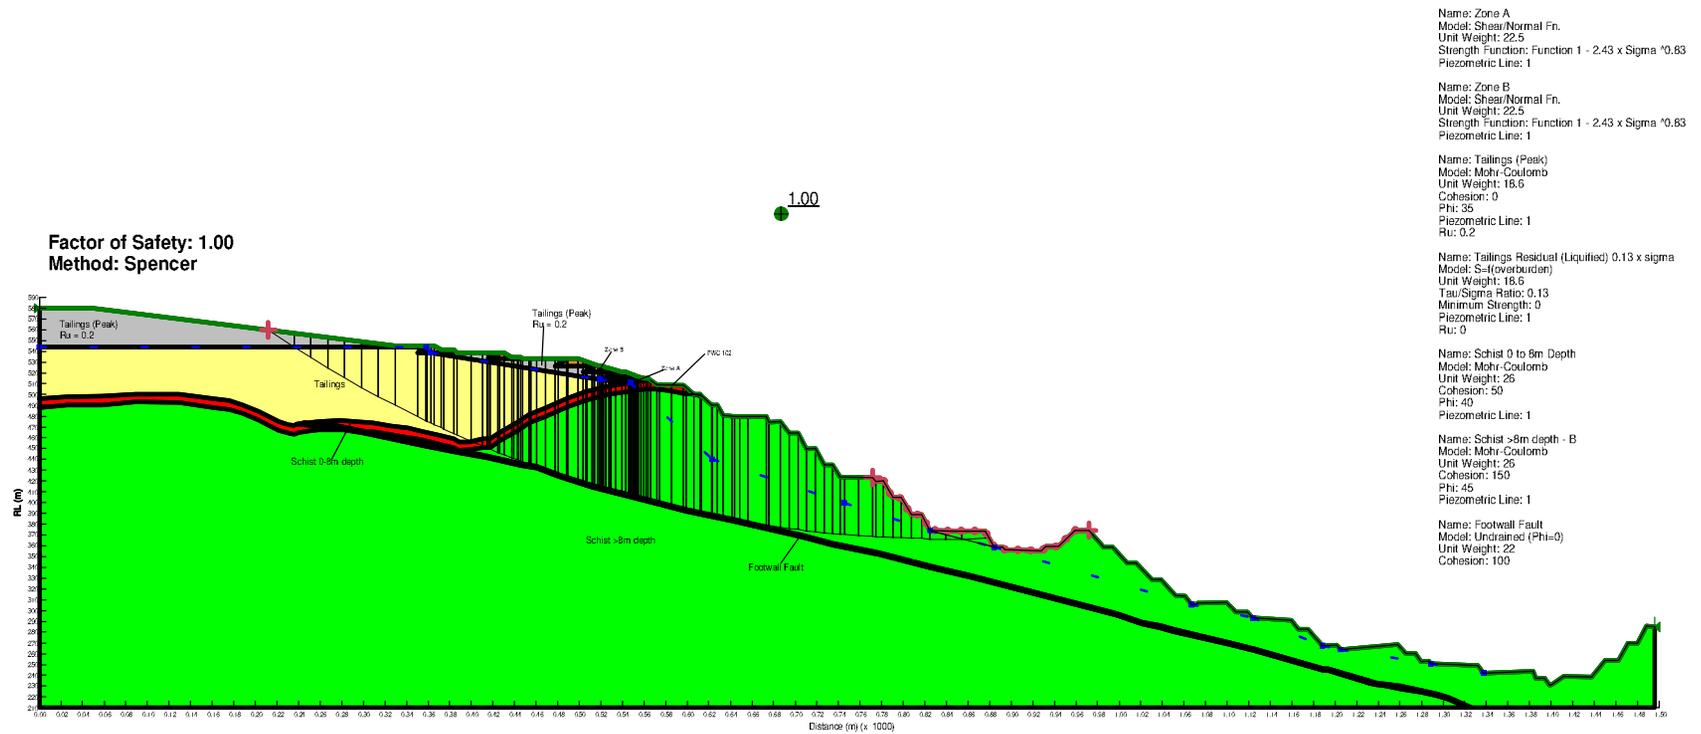
MTI TSF with mined Round Hill - Southern Pit  
Pseudostatic Seismic Analysis  
475 year return period earthquake  
Determined Yield Acceleration = 0.144g

A simplified deformation analysis has been carried out to assess the permanent deformation that could occur during a 475 year return period earthquake and the MDE. The ground acceleration adopted for the pseudostatic stability analysis has been taken as the peak ground acceleration (PGA) determined by GNS (Ref.12), and shown in Figure 10. This should be conservative as any amplification due to the ground geometry will be more than compensated by the out of phase shaking of the large ground mass within the failure block assumed for the analysis. For detailed design more sophisticated analyses should be carried out to determine the ground acceleration using QUAKE/W, or similar. The pseudostatic stability analysis carried out on the basis of the above results in a FOS less than 1.0. This indicates that some permanent deformation can be anticipated during the earthquake shaking. Further analysis has therefore been carried out to determine the yield acceleration of 0.14g and 0.22g for the critical failure mass through the insitu rock for the 475 year return period earthquake and MDE respectively (refer Figure B5 and B6). For a 10 percent probability of exceedance the calculated permanent displacement using Jibson (Ref.18) is 0.01m and 0.26m for the 475 year return period earthquake and MDE respectively. It is considered unlikely that this permanent deformation will result in any significant increase in seepage loss from the MTI TSF.

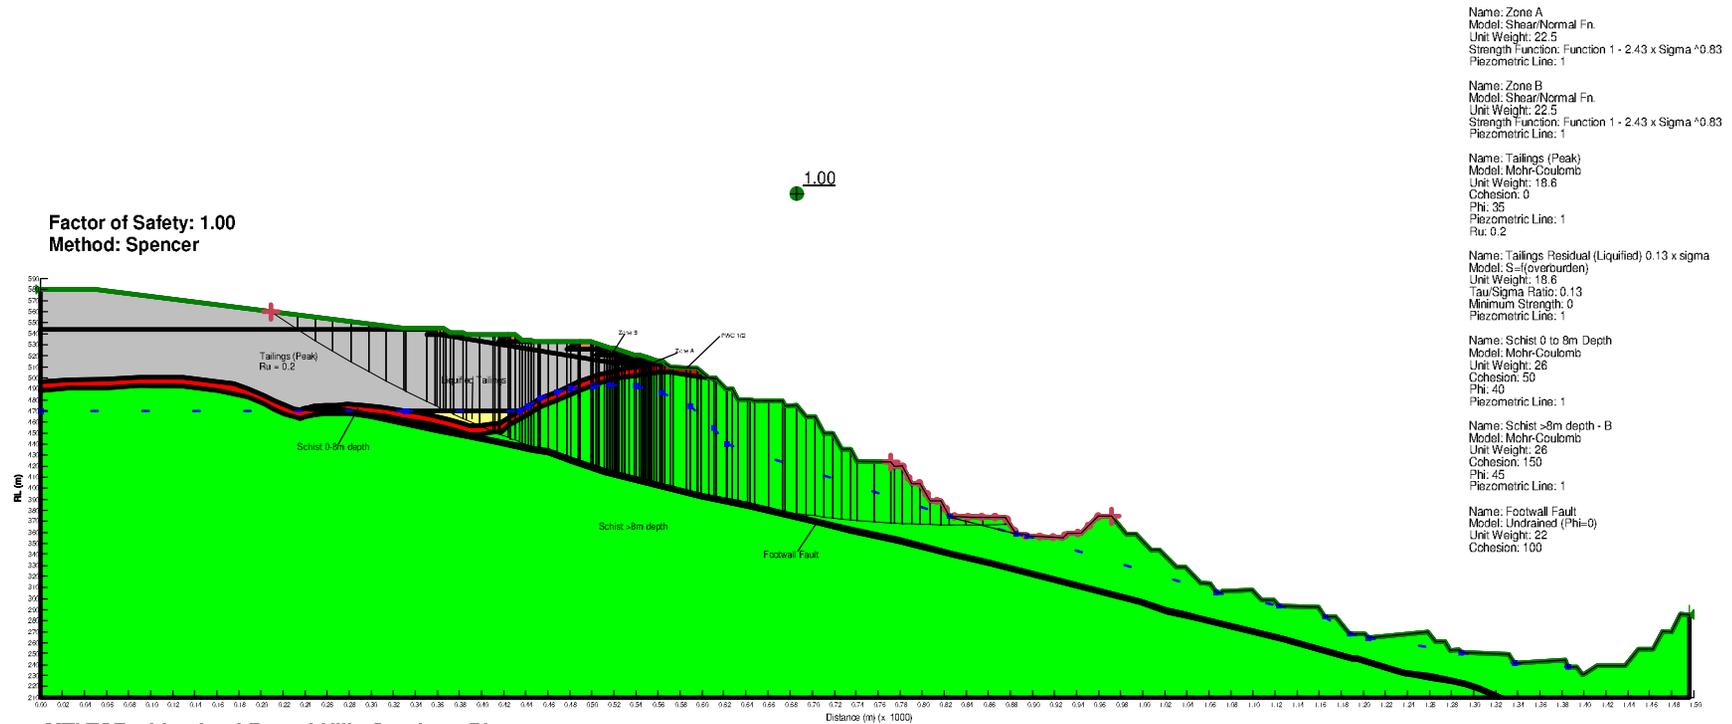
**Figure B6**

**MTI TSF with mined Round Hill - Southern Pit**  
**Pseudostatic Seismic Analysis**  
**MDE return period earthquake**  
**Determined Yield Acceleration = 0.222g**

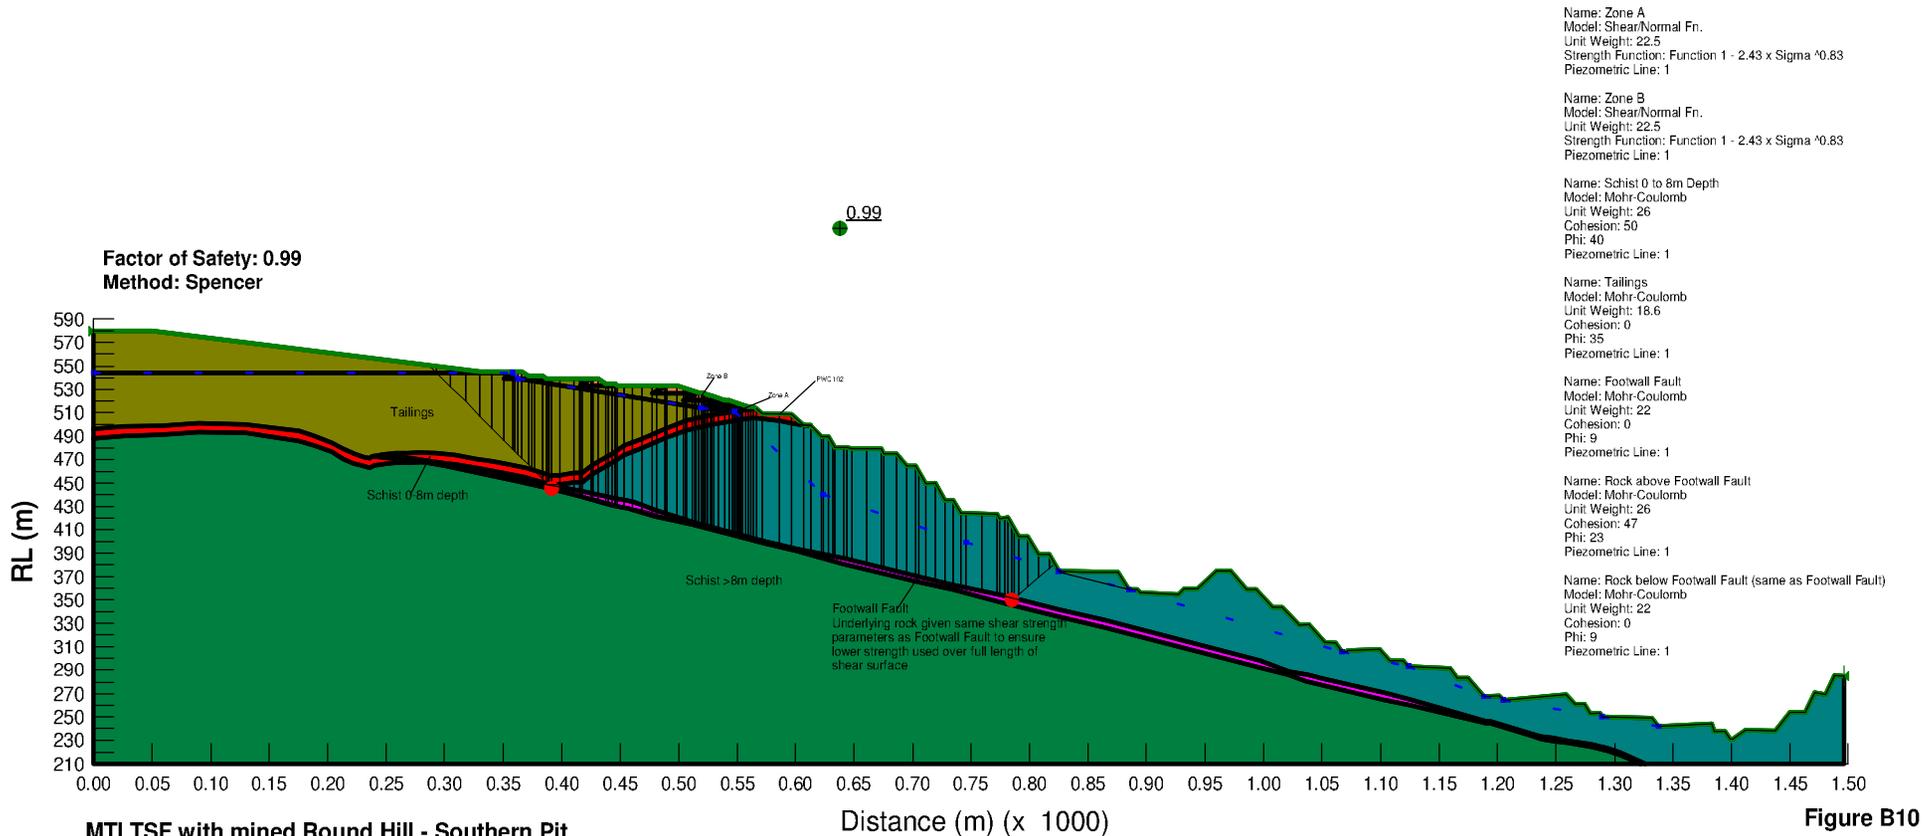
Figure B10

MTI TSF with mined Round Hill - Southern Pit  
 Static Analysis  
 Reduced Rock Strength  
 Footwall Fault

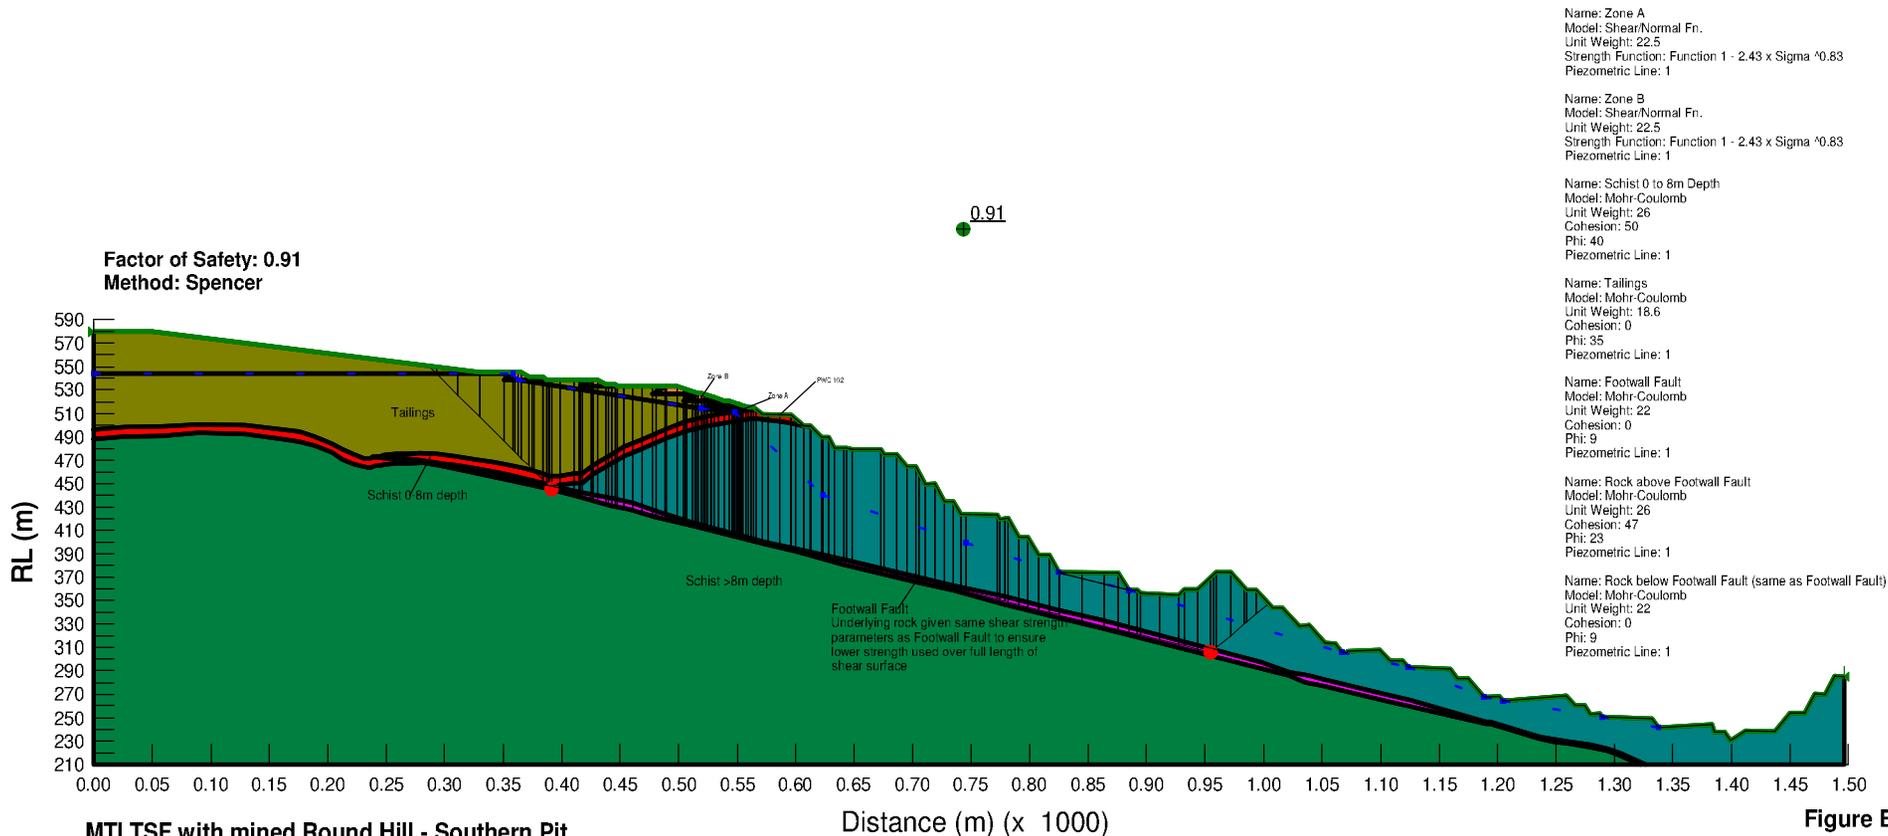
Figure B12

MTI TSF with mined Round Hill - Southern Pit  
 Static Analysis  
 Reduced Rock Strength  
 Footwall Fault

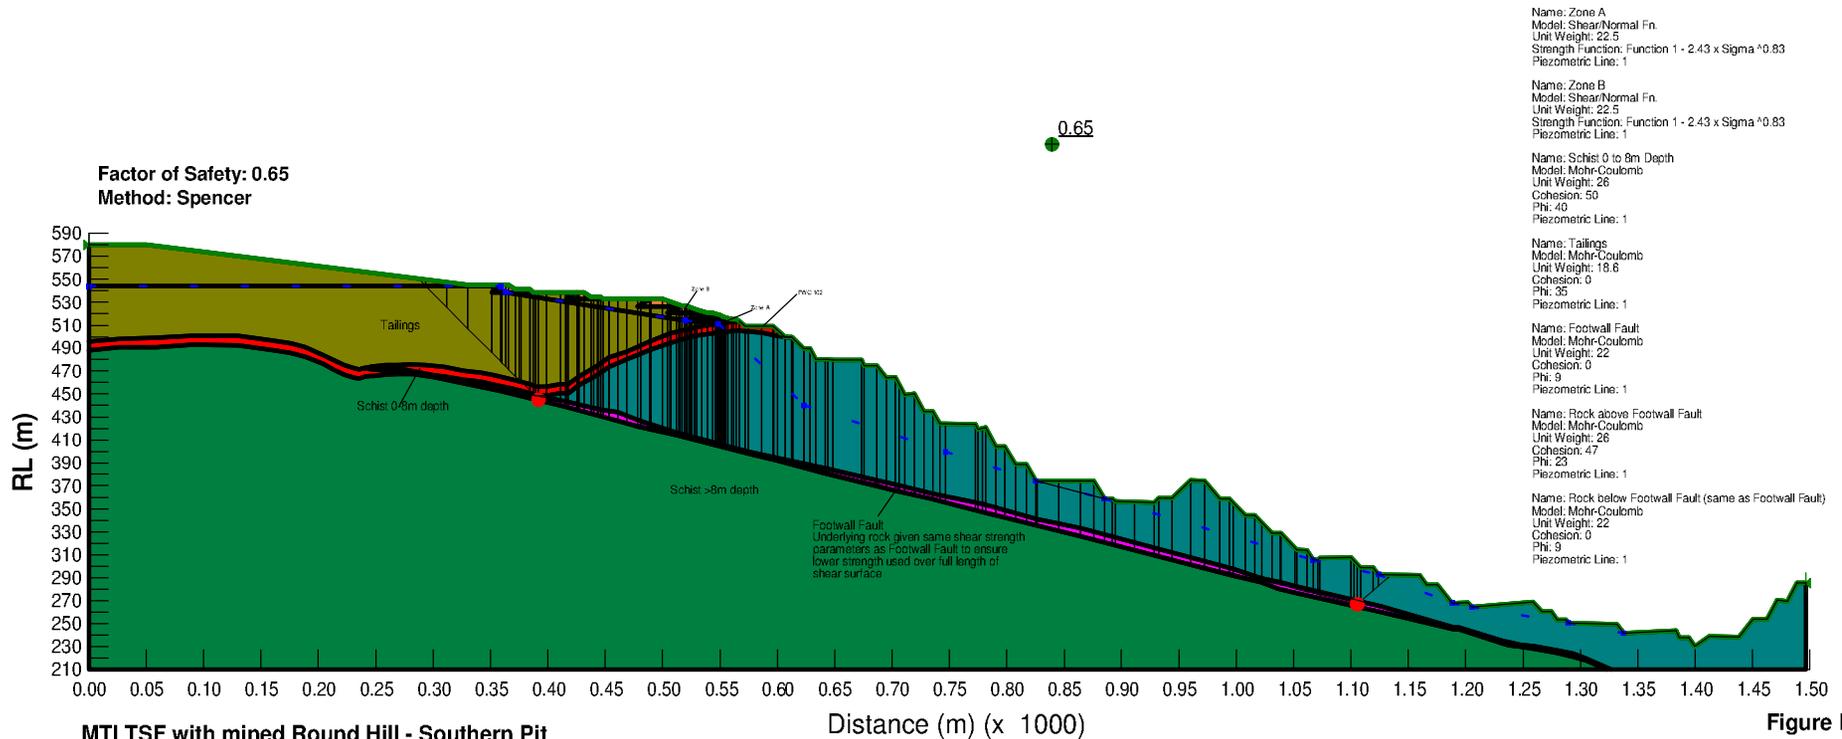
Figure B14

MTI TSF with mined Round Hill - Southern Pit  
 Static Analysis  
 Reduced Rock Strength  
 Footwall Fault

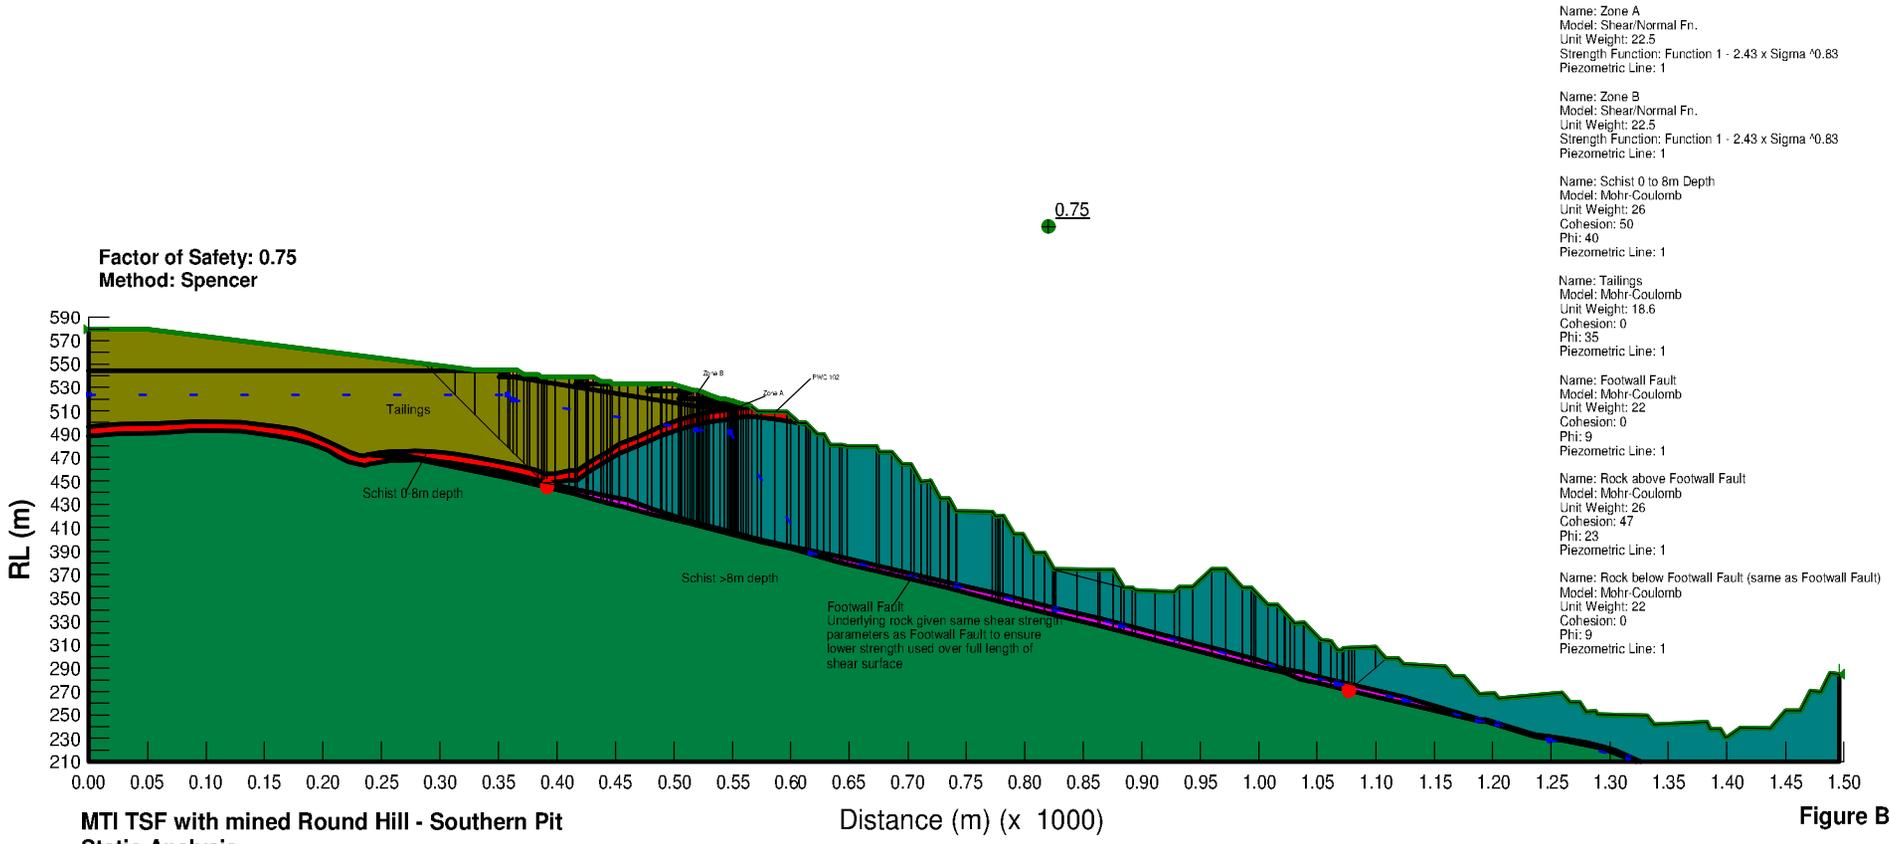
Figure B15

MTI TSF with mined Round Hill - Southern Pit  
 Static Analysis  
 Reduced Rock Strength  
 Footwall Fault  
 Dry

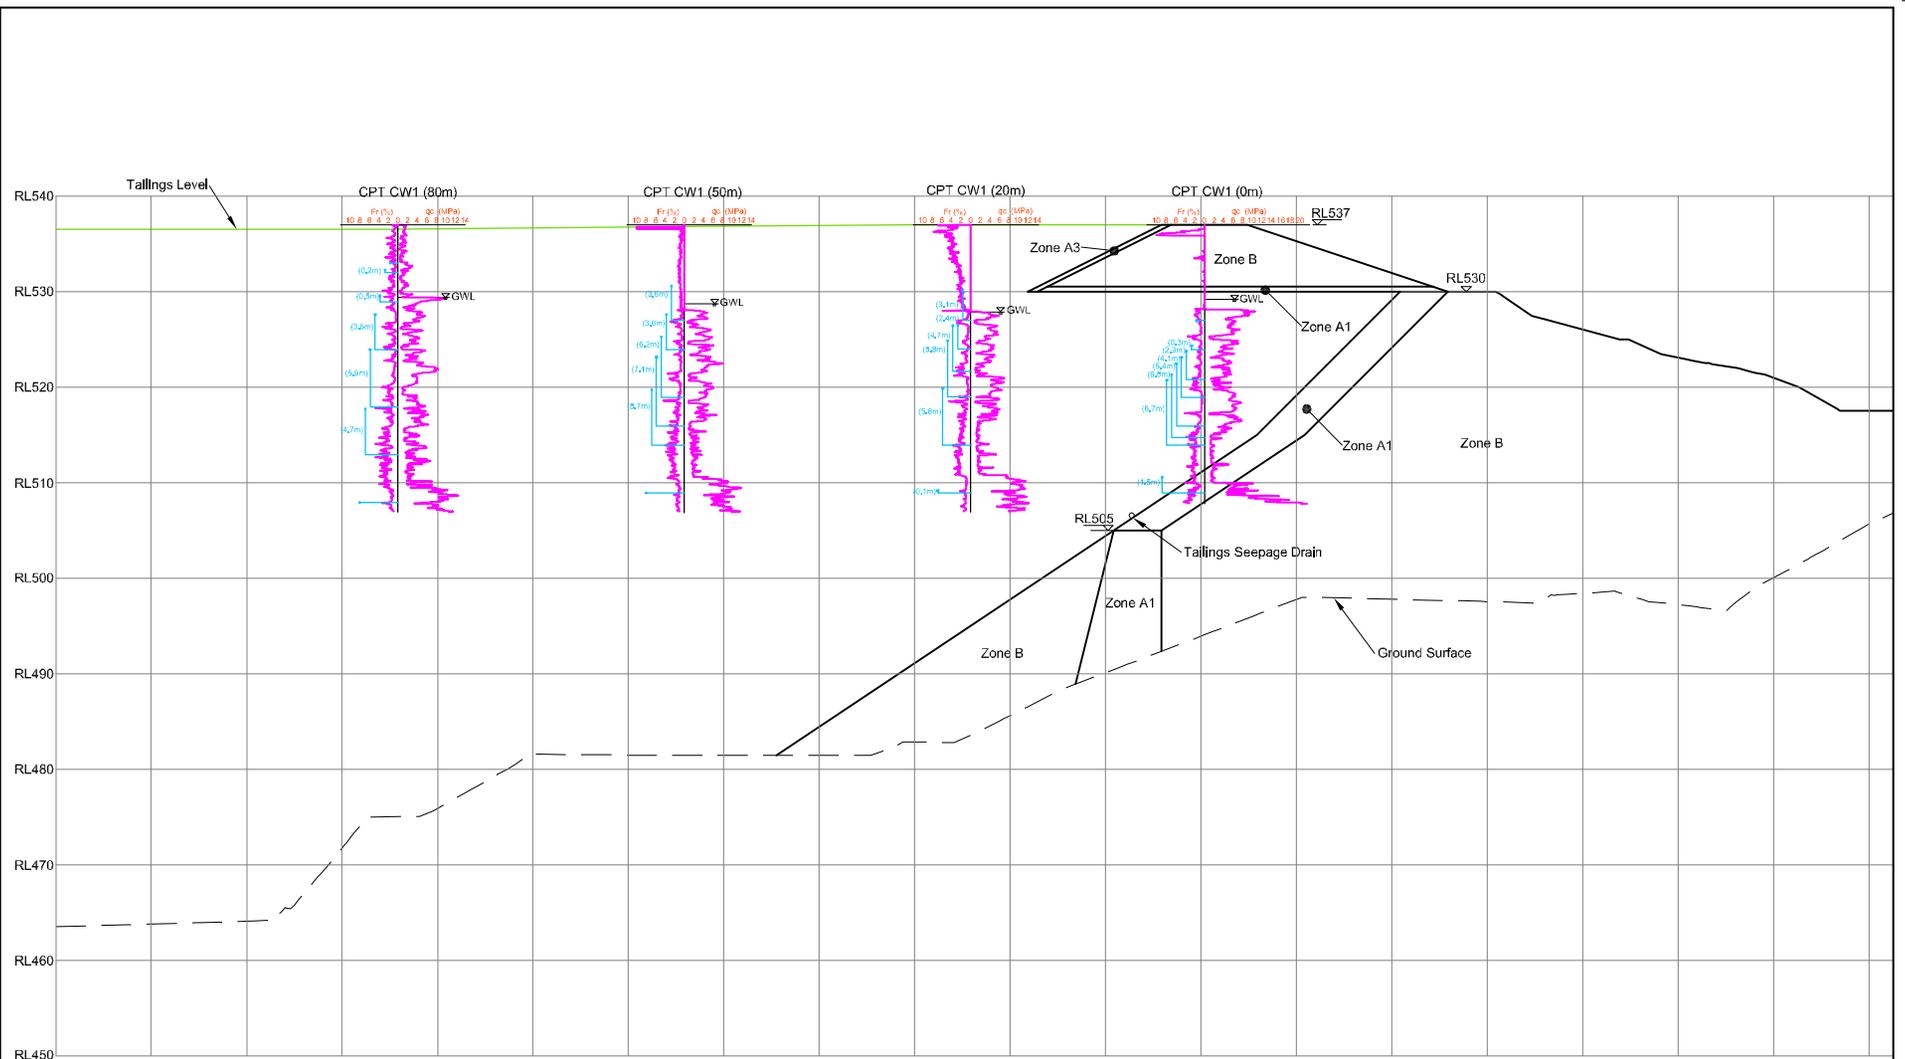
CPT 1 - 0m to 80m along Causeway 1

Note:  
CPTs carried out in April 2010

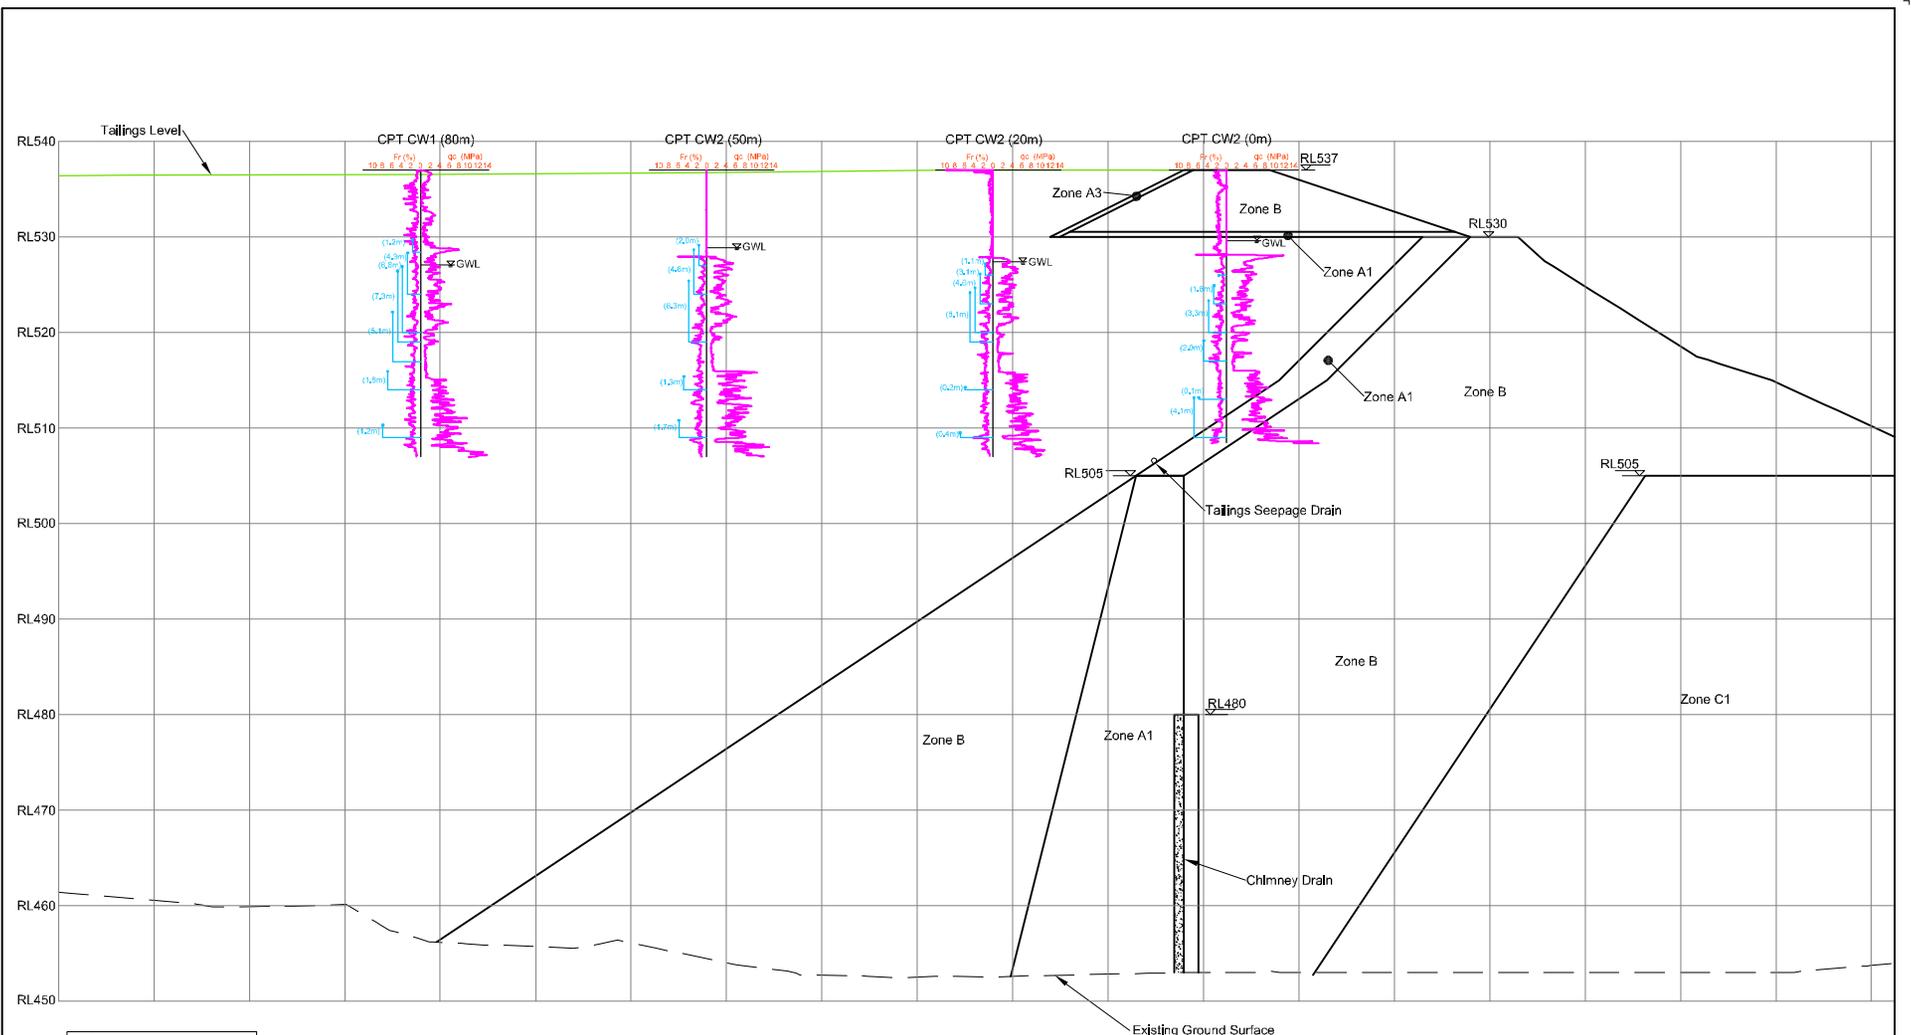
TITLE	REV. No.
<b>Southern Pit Option 11A - Causeway 1</b>	
DRAWING No.	
<b>6793-CPT-02</b>

Note:  
CPTs carried out in April 2010

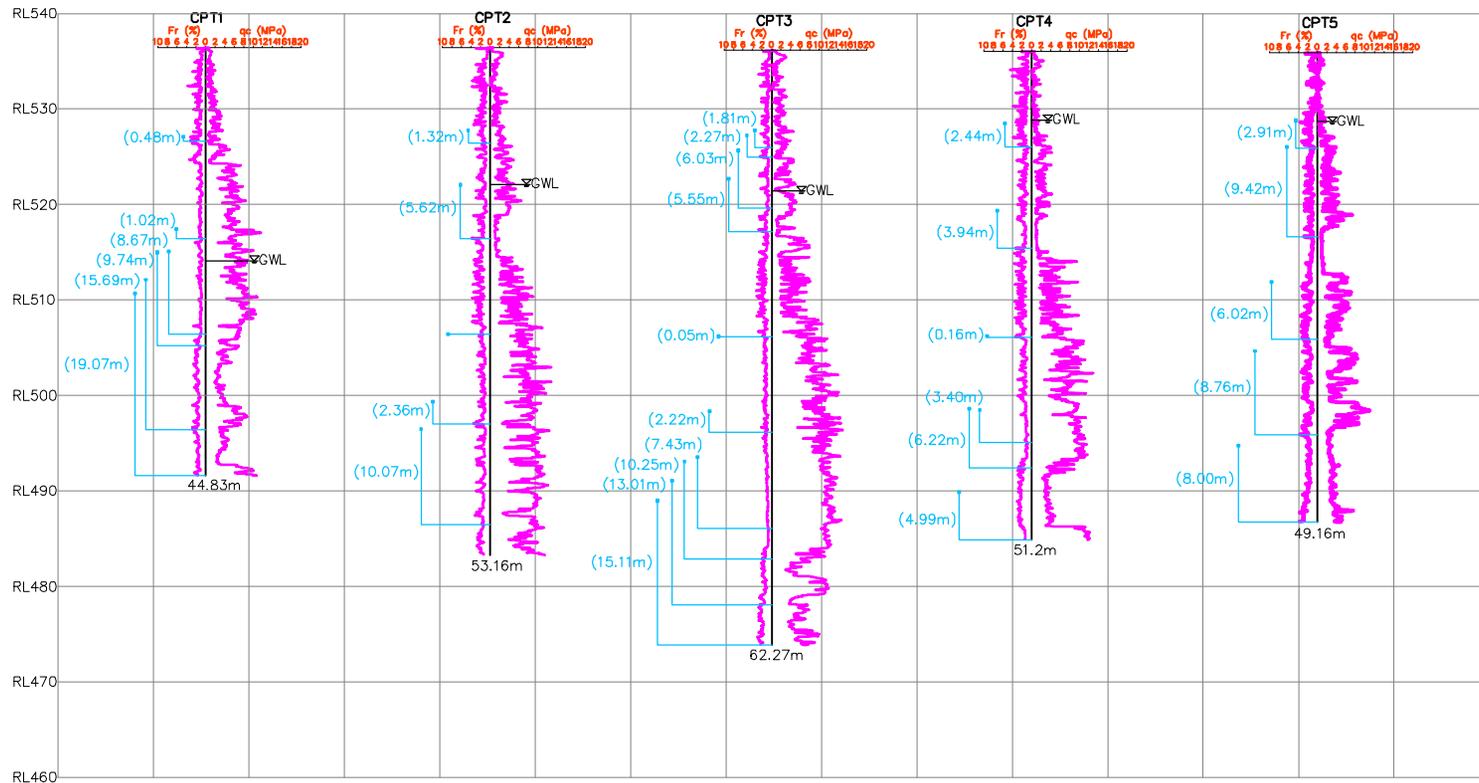
Note:  
CPTs carried out in Nov 2010

KEY  
 PWP Dissipation Test Result

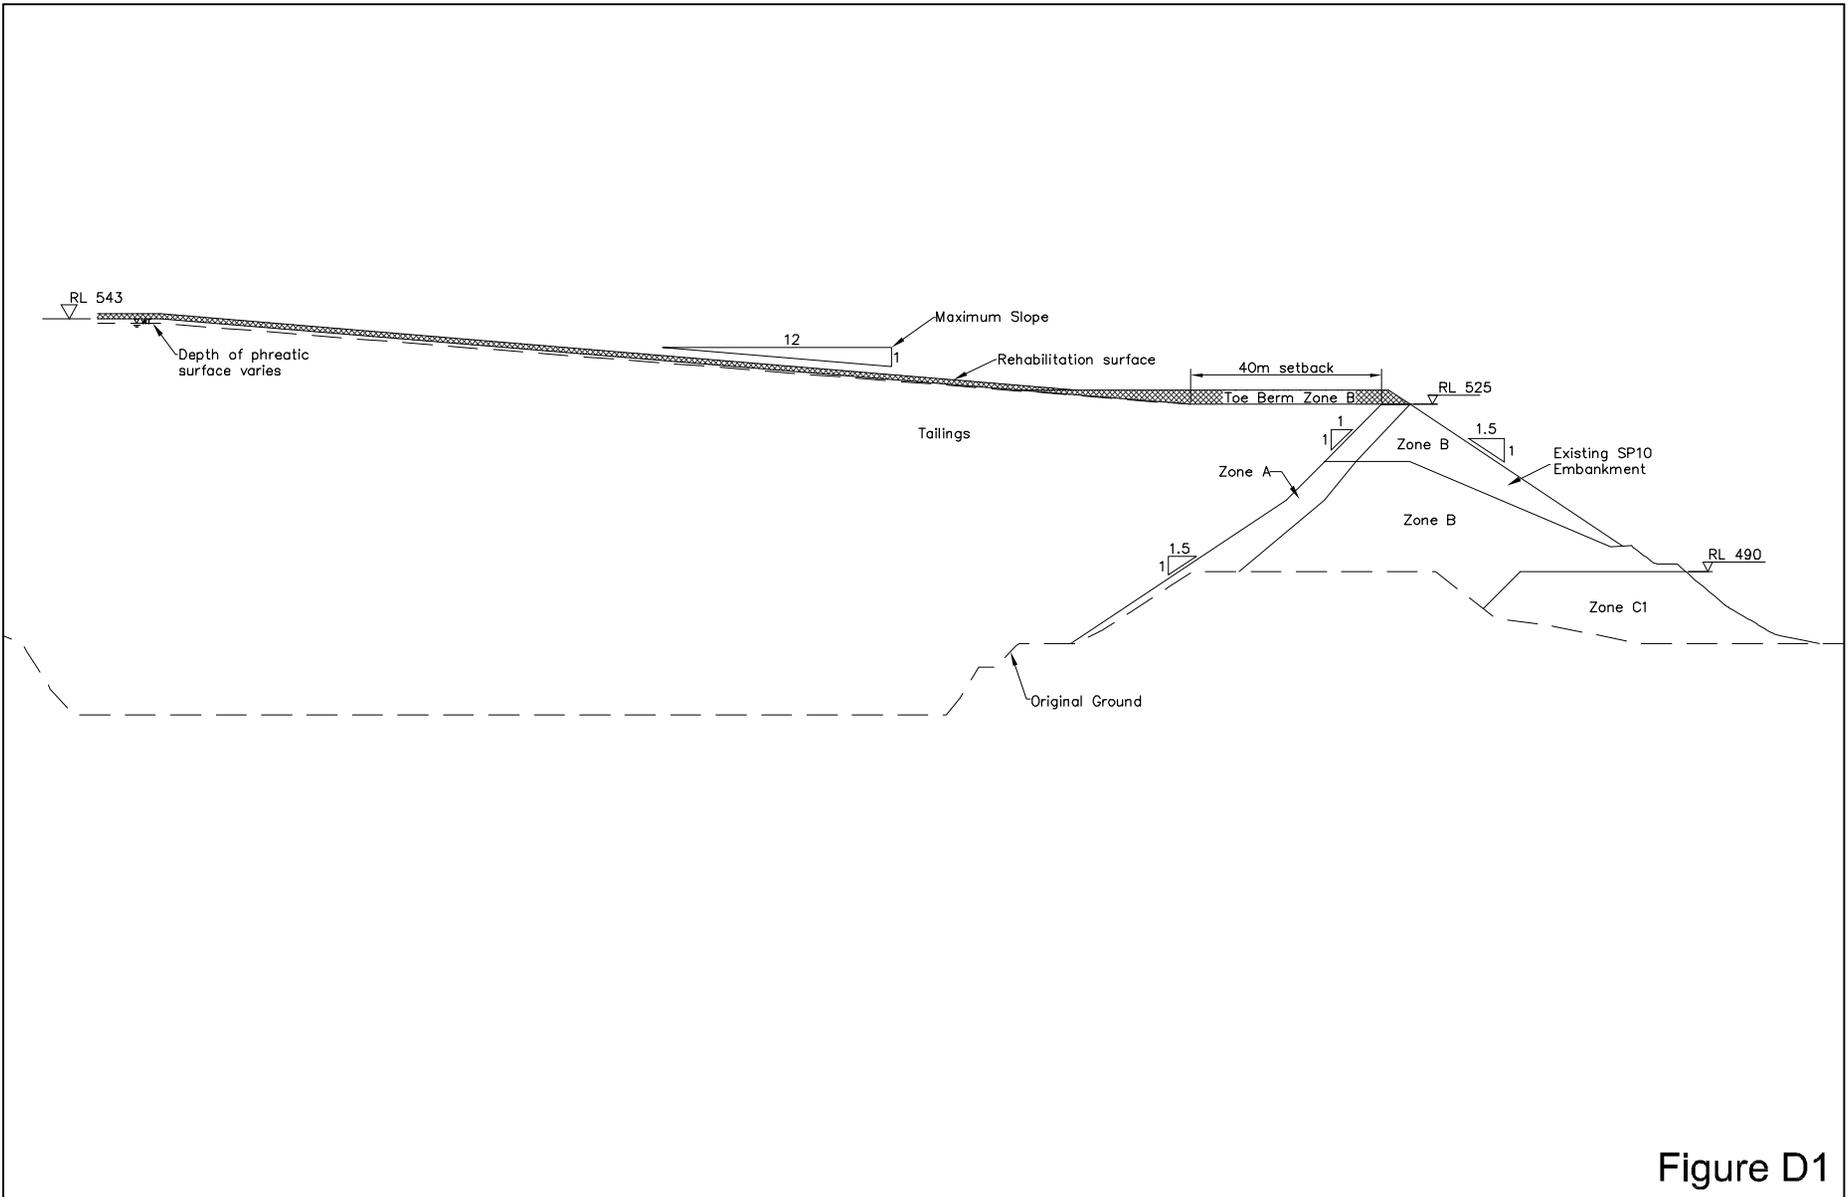
**Figure D1**

**OCEANA GOLD (NZ) LTD, MACRAES GOLD PROJECT**  
**Round Hill-Southern Pit**  
*SP10 Embankment and Tailings Surface Profile*

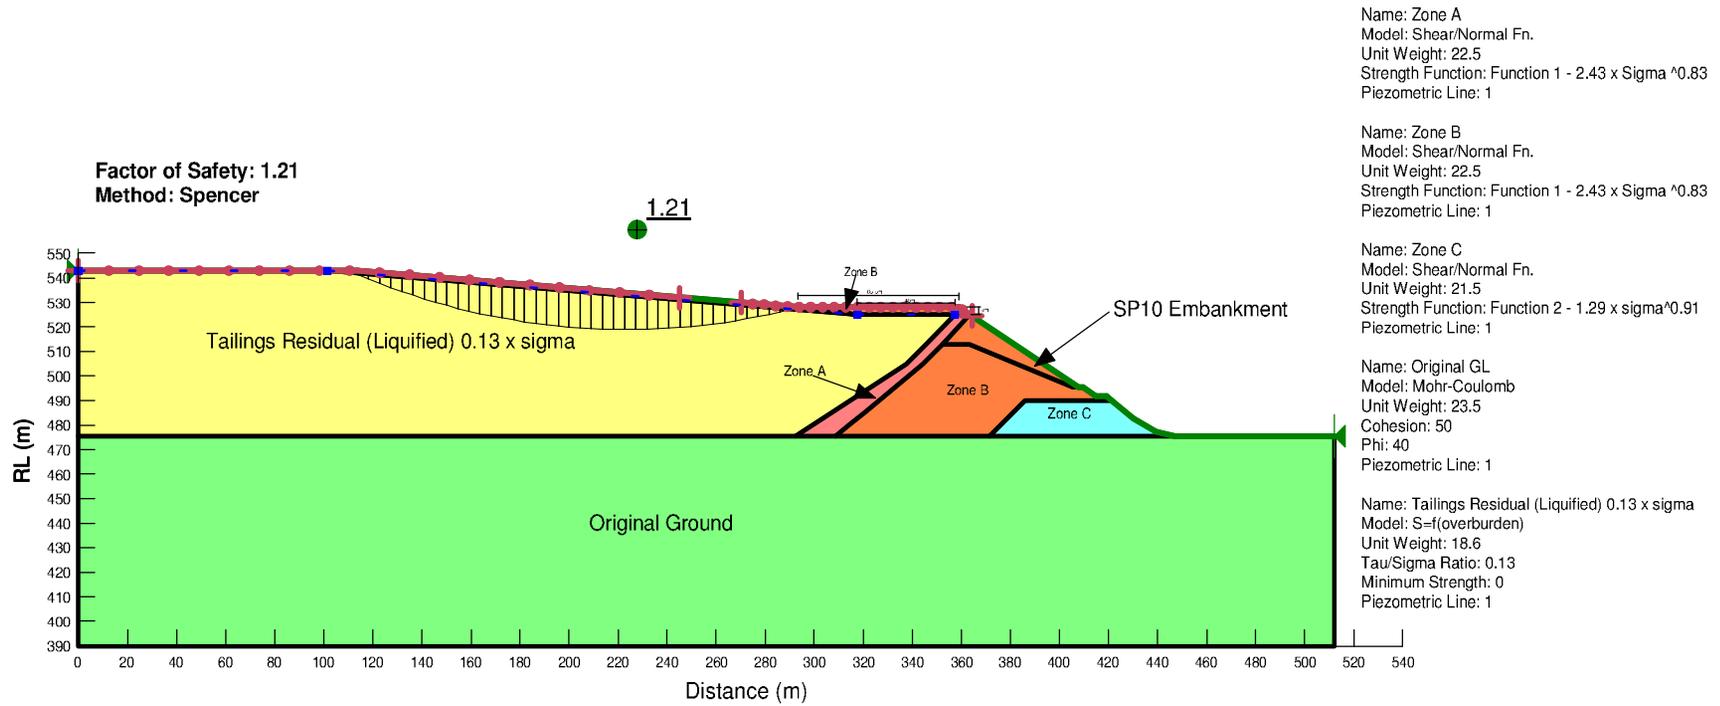
**Figure D2**

**SP10 TSF Reprofiled Tailings Surface**  
**Post Earthquake Analysis**  
**475 year return period**  
**WL at tailings surface**  
**3m deep toe berm**  
**1(v) in 12(h) trimmed slope**

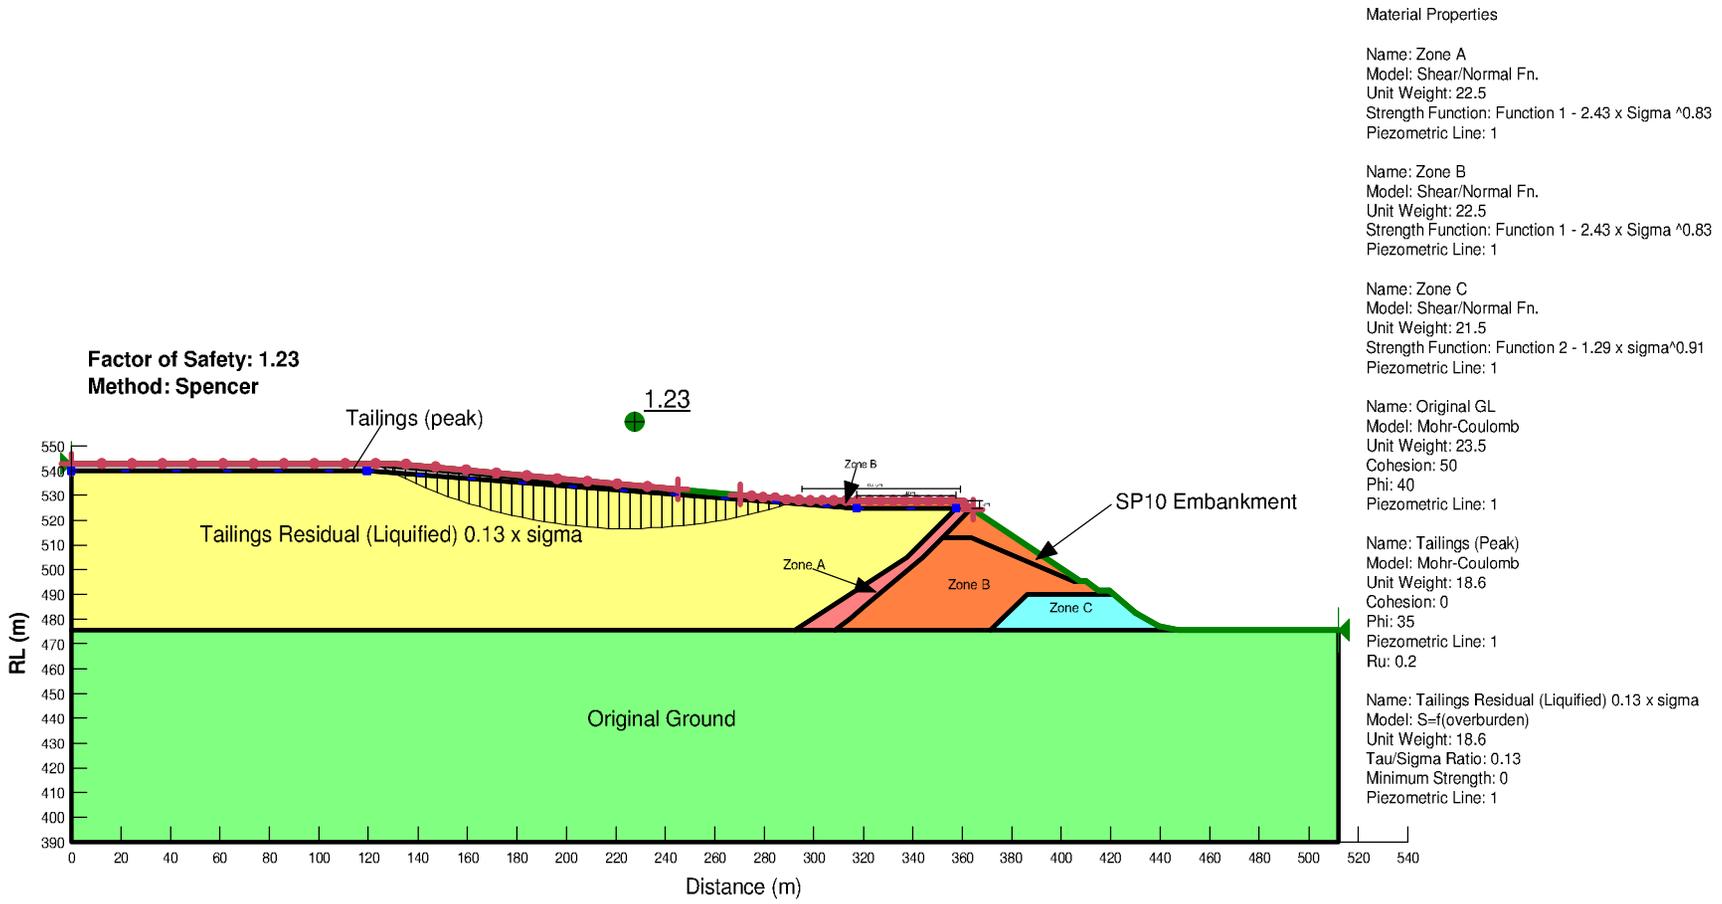
**Figure D3**

**SP10 TSF Reprofiled Tailings Surface**  
**Post Earthquake Analysis**  
**475 year return period**  
**WL at RL 540 at top of slope**  
**3m deep toe berm**  
**1(v) in 11(h) trimmed slope**

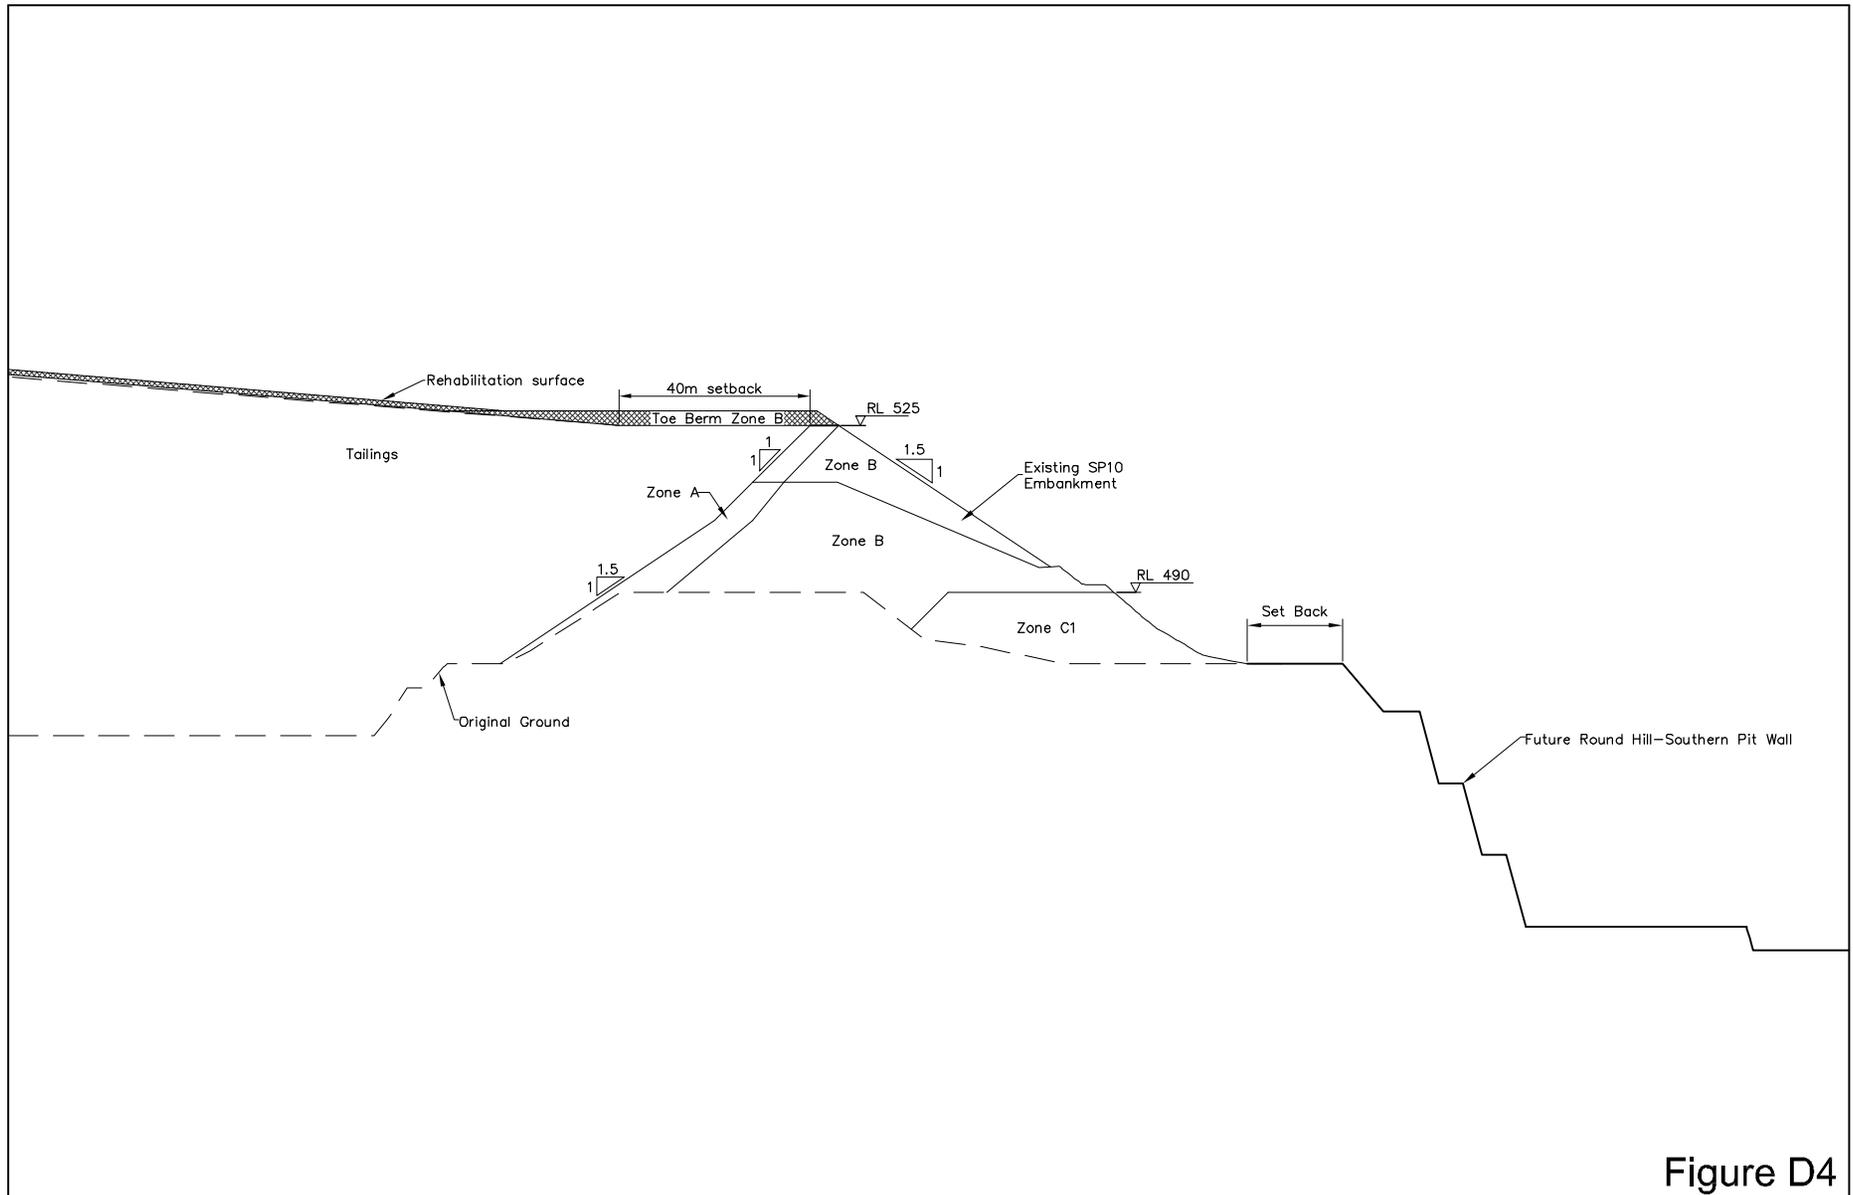
**Figure D4**

**OCEANA GOLD (NZ) LTD, MACRAES GOLD PROJECT**  
**Round Hill-Southern Pit**  
*SP10 Embankment and Pit Excavation*

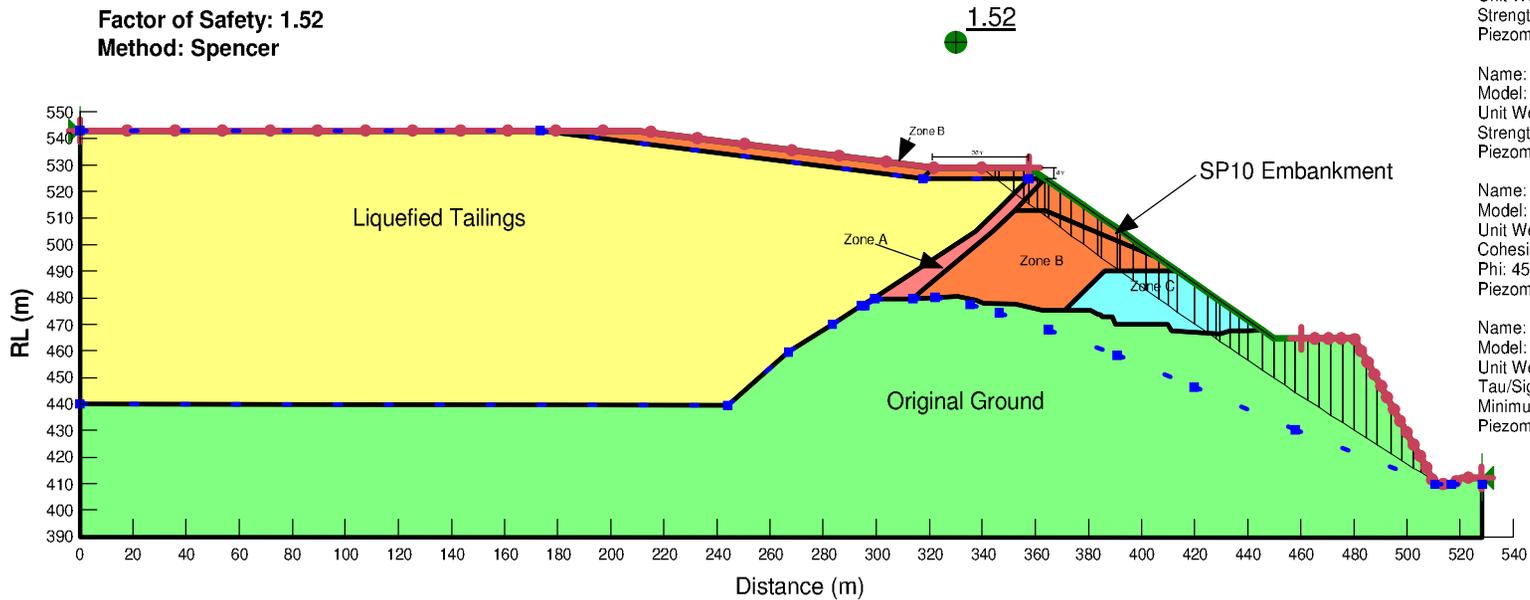
**Figure D5**

**SP10 TSF and Excavated Pit**  
**Static Analysis (& Post Earthquake)**  
 Insitu rock  $c' = 50\text{kPa}$ , 30m set back of pit  
 Local Stability
