Ref: **6786**

**OCEANA GOLD (NZ) LTD  
MACRAES GOLD PROJECT  
MINING OF ROUND HILL – SOUTHERN PIT  
MTI, SP10 & SP11A TAILING STORAGE  
FACILITIES AND RECLAIMED TAILINGS STACK  
TECHNICAL REPORT**

**28 April 2011**

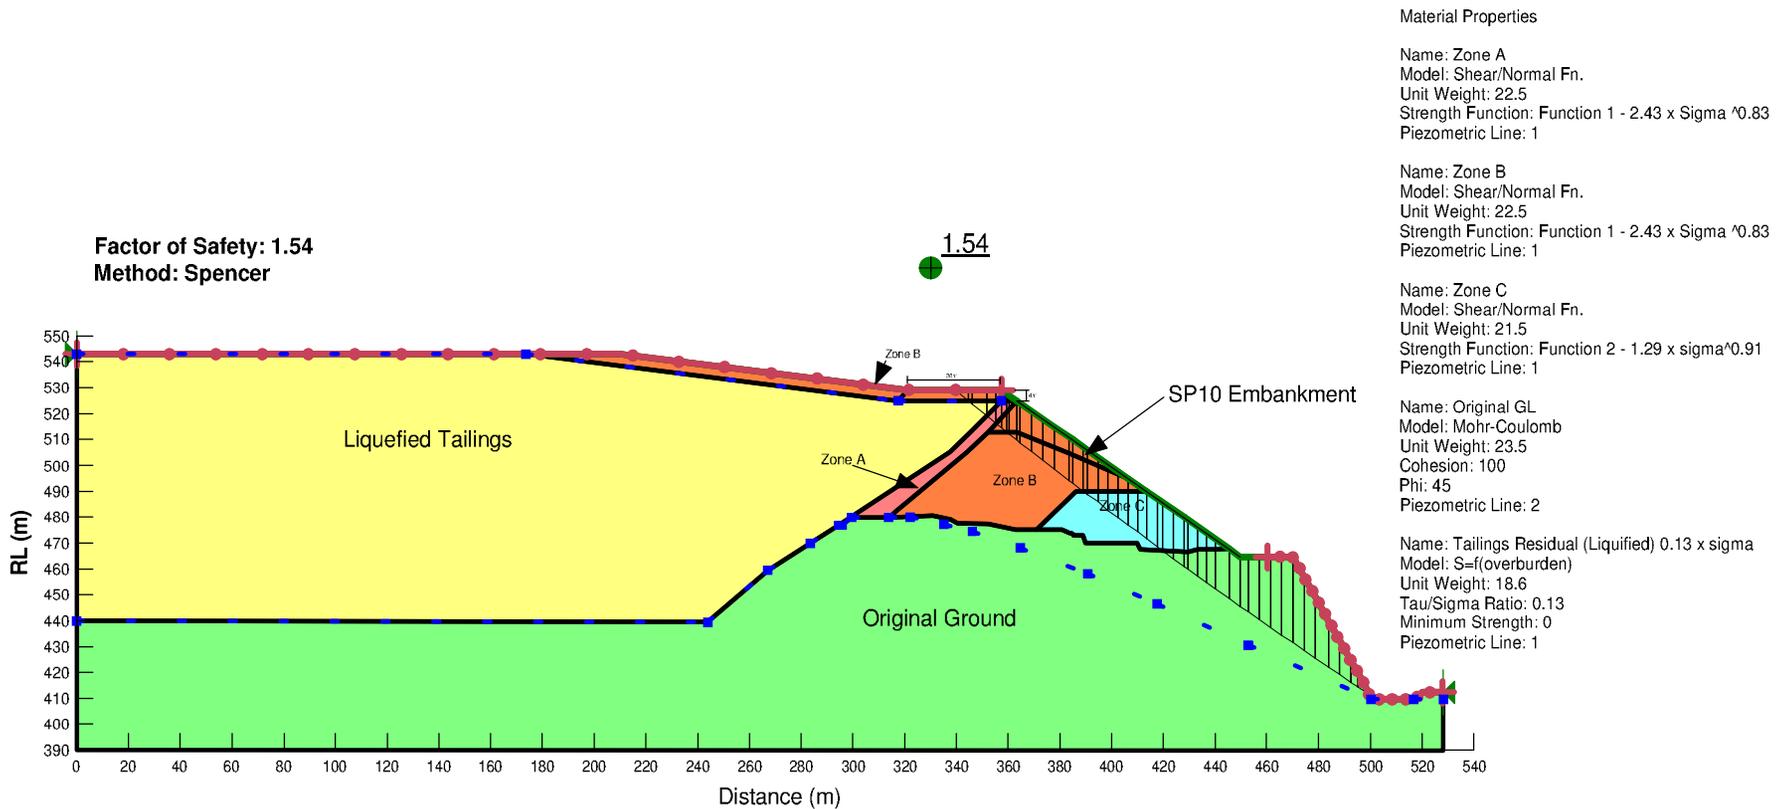
**Figure D6**

**SP10 TFS and Excavated Pit**  
**Static Analysis (& Post Earthquake)**  
**Insitu rock -  $c' = 100\text{kPa}$ , 20m set back of pit**  
**Local Stability**

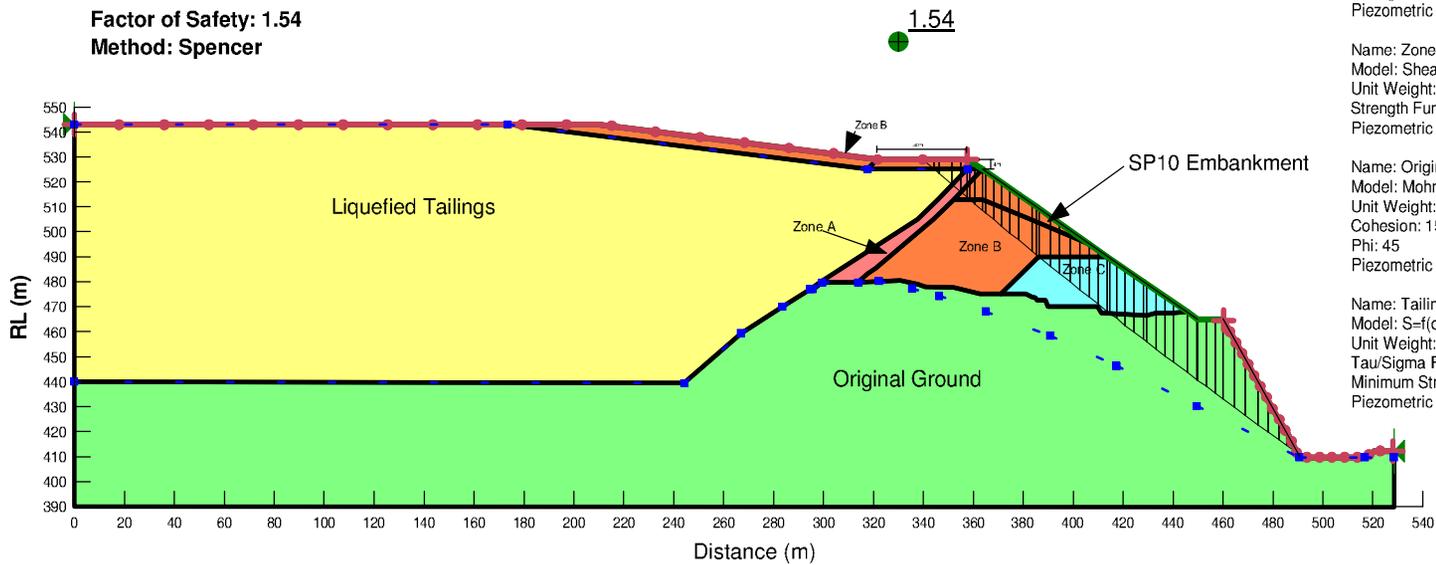
**Figure D7**

**SP10 TSF and Excavated Pit**  
**Static Analysis (& Post Earthquake)**  
 Insitu rock -  $c' = 150\text{kPa}$ , 10m set back of pit  
**Local Stability**

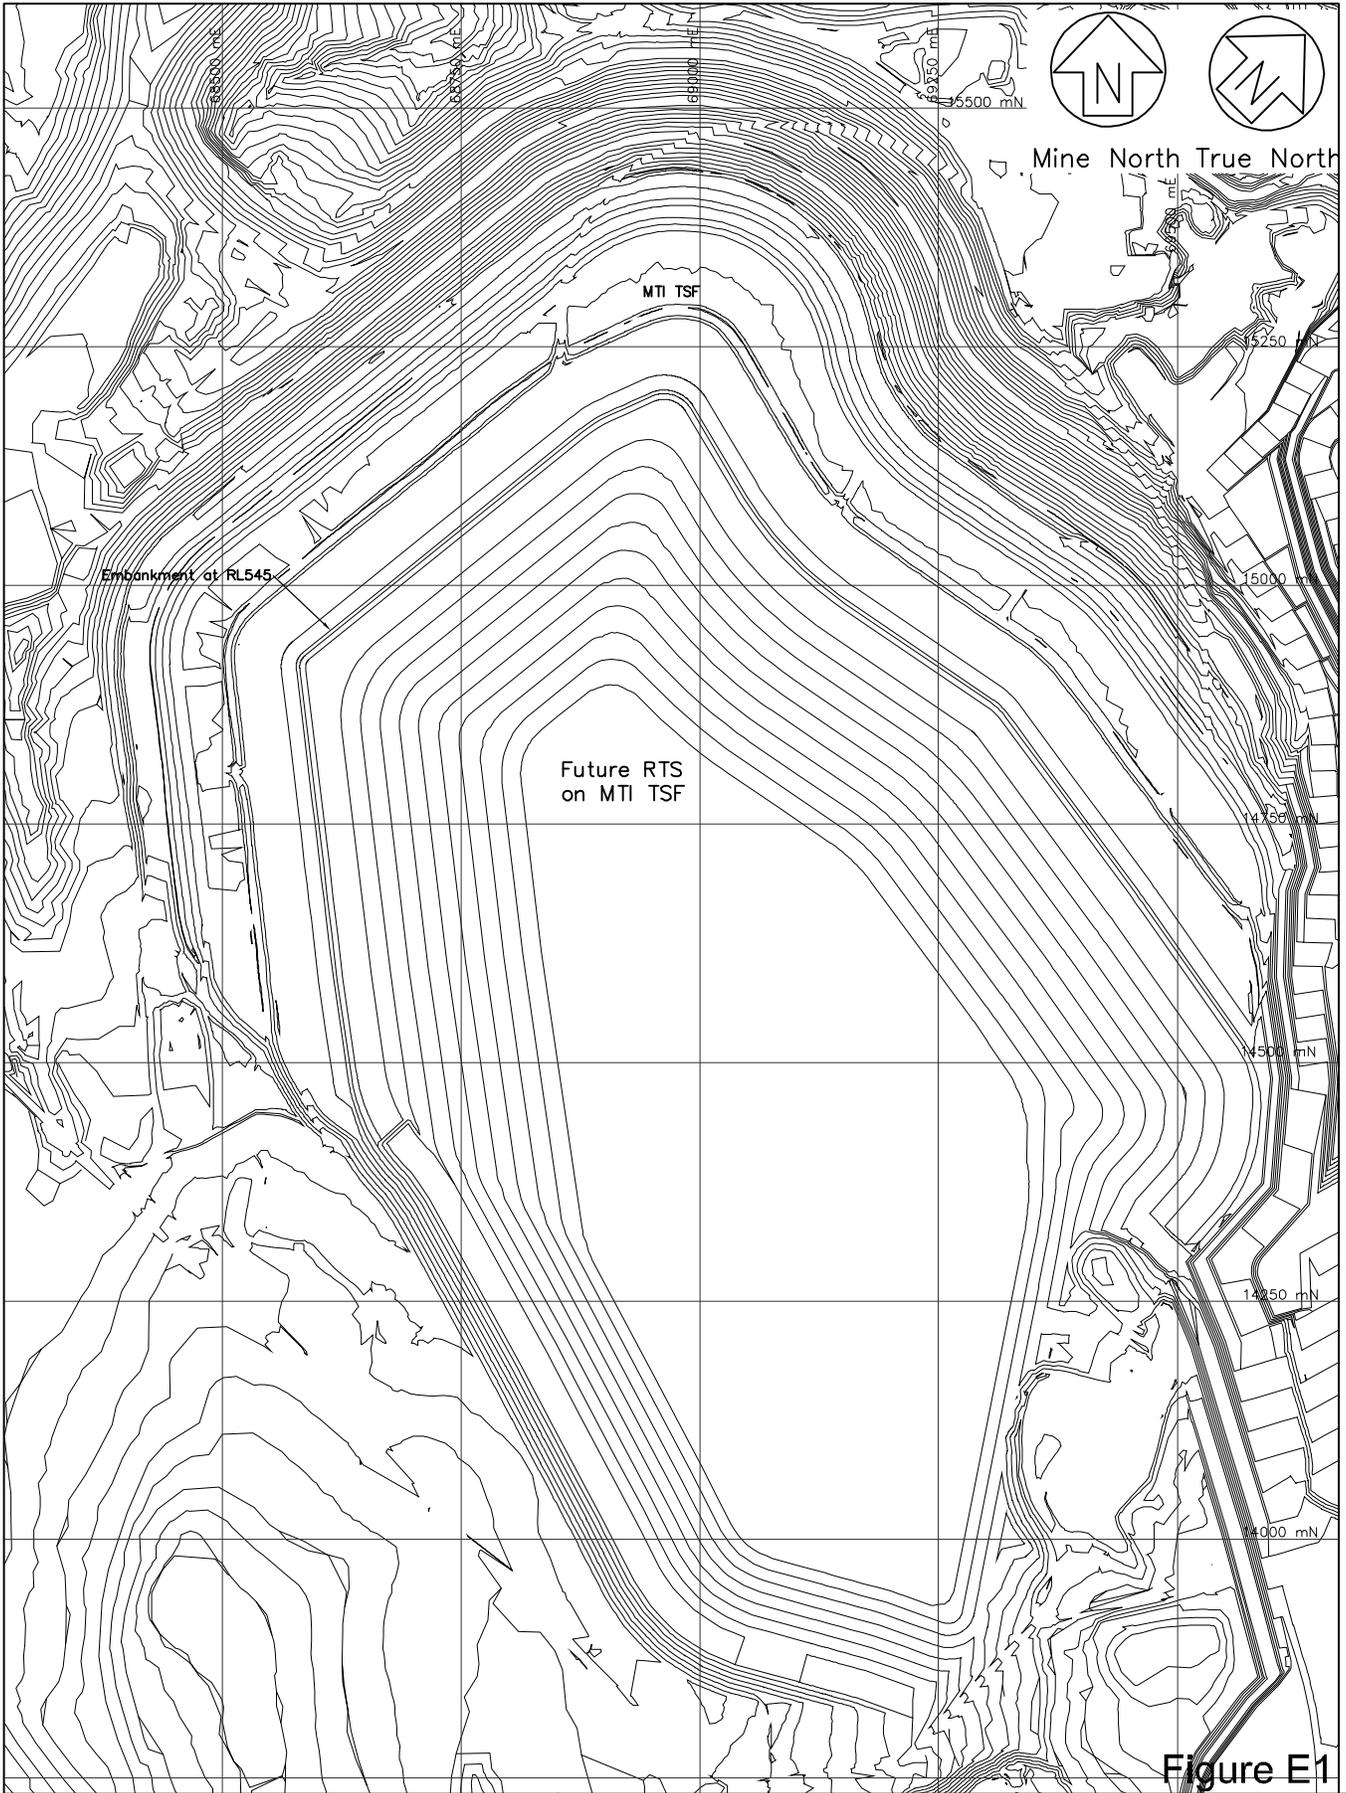
**Figure E1**

**OCEANA GOLD (NZ) LTD,  
 MACRAES GOLD PROJECT  
 MTI TSF and RTS  
 Plan**

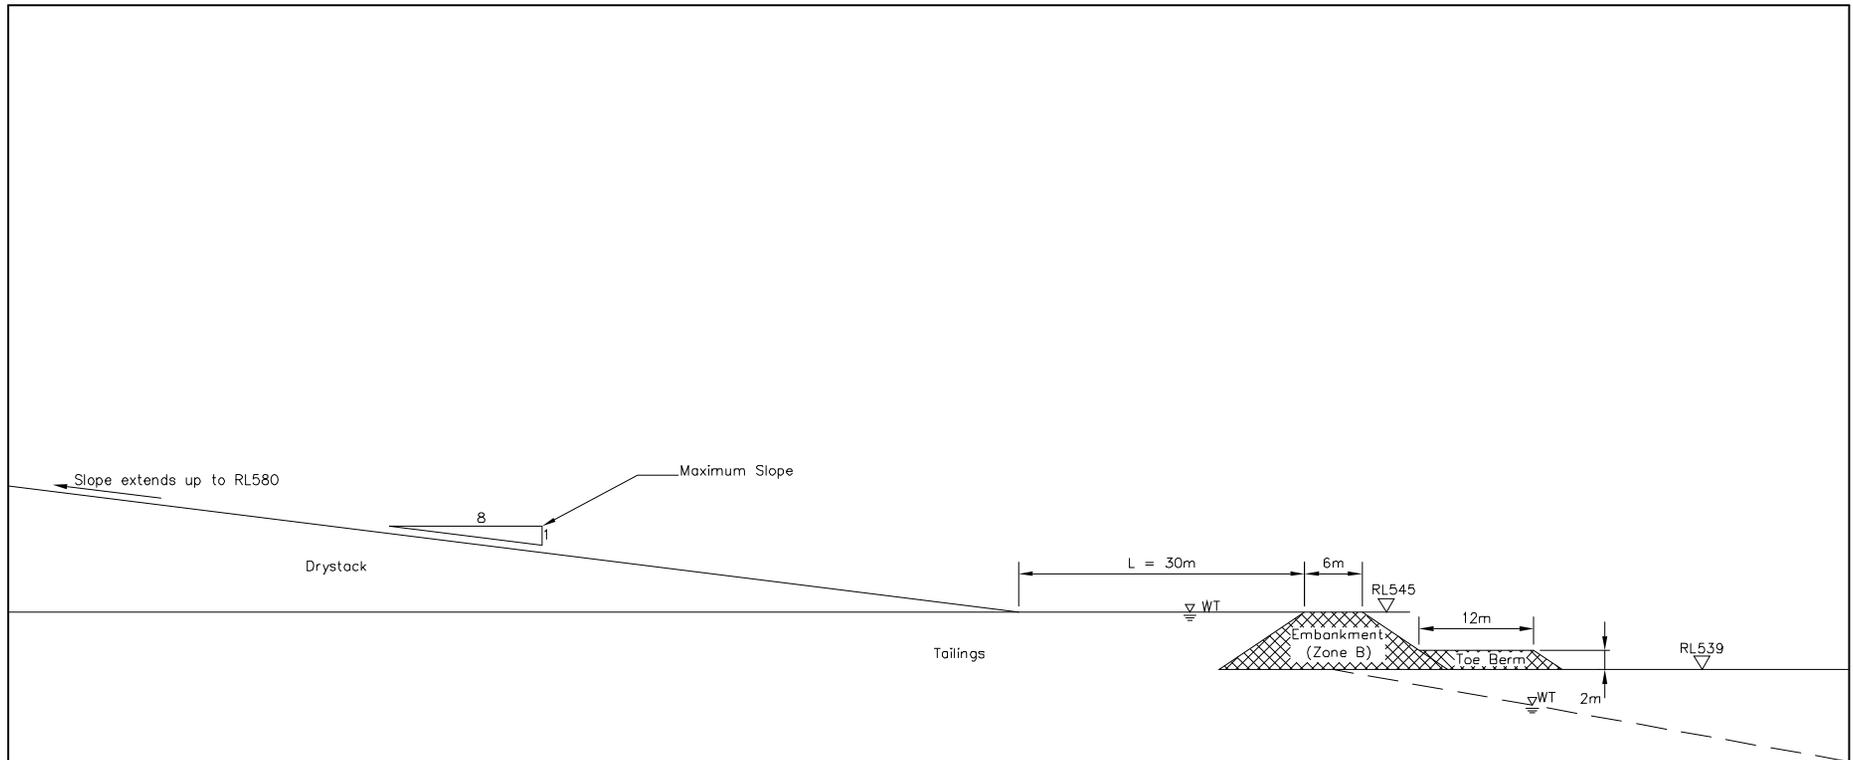
**Figure E2**

Upstream Embankment  
Preliminary MTI Drystack Profile

**OCEANA GOLD (NZ) LTD, MACRAES GOLD PROJECT**  
**Round Hill-Southern Pit**  
*Upstream MTI Embankment and RTS*

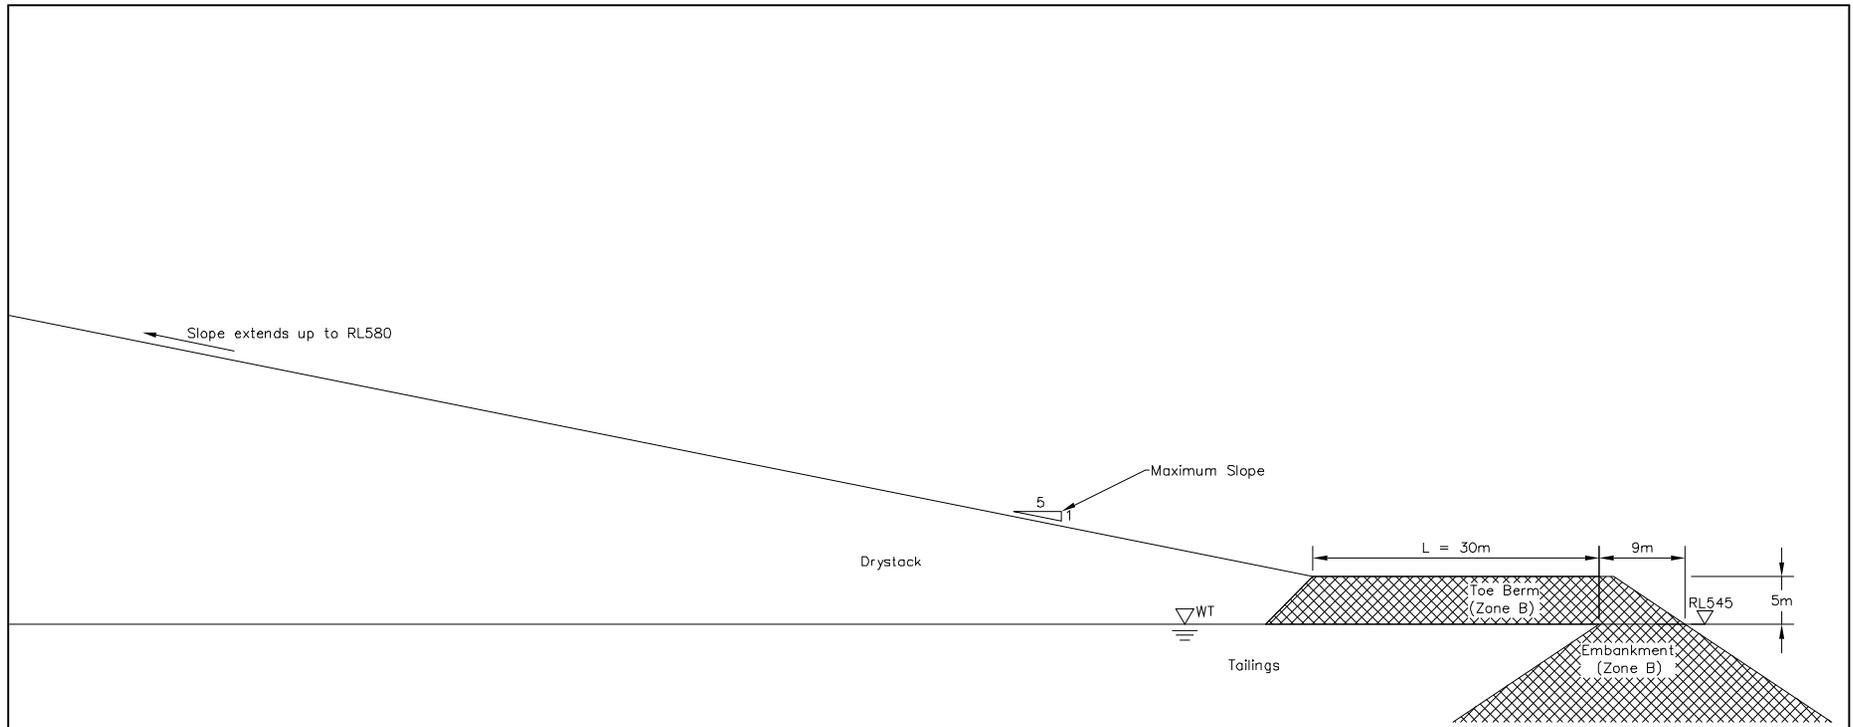
**Figure E3**

Downstream Embankment  
Preliminary MTI Drystack Profile

**OCEANA GOLD (NZ) LTD, MACRAES GOLD PROJECT**  
**Round Hill-Southern Pit**  
**Downstream MTI Embankment and RTS**

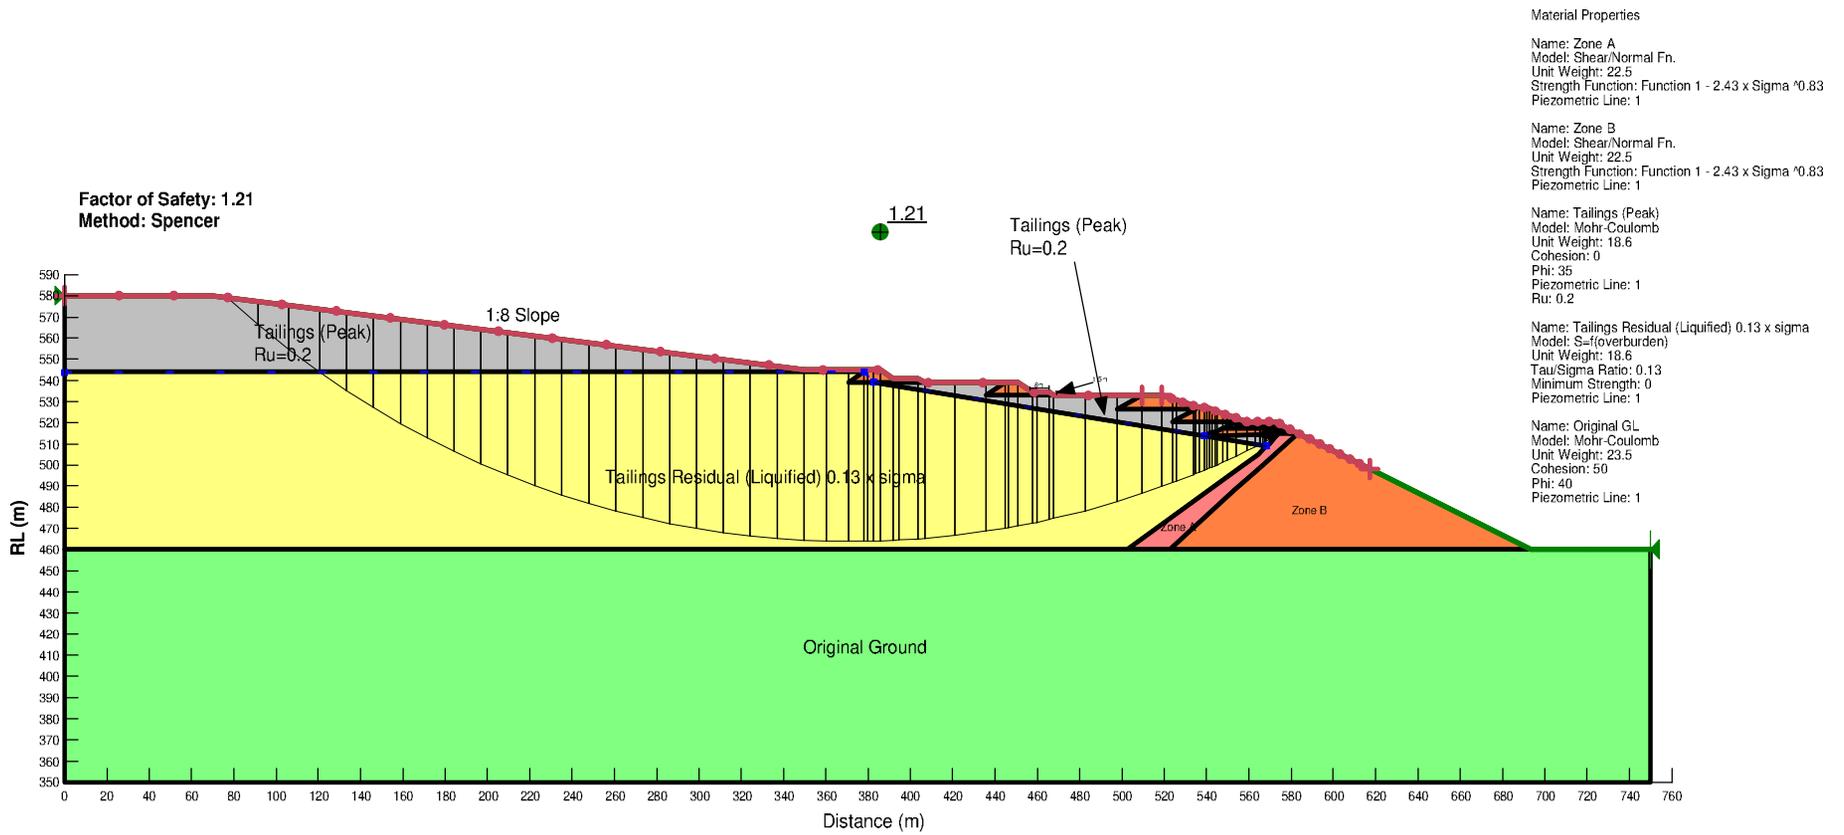
**Figure E4**

**MTI Upstream Embankment and RTS**  
**Post Earthquake Analysis**  
**475 year return period**  
**Main Toe Berm at RL520.5**  
**WL at downstream embankment - RL509**

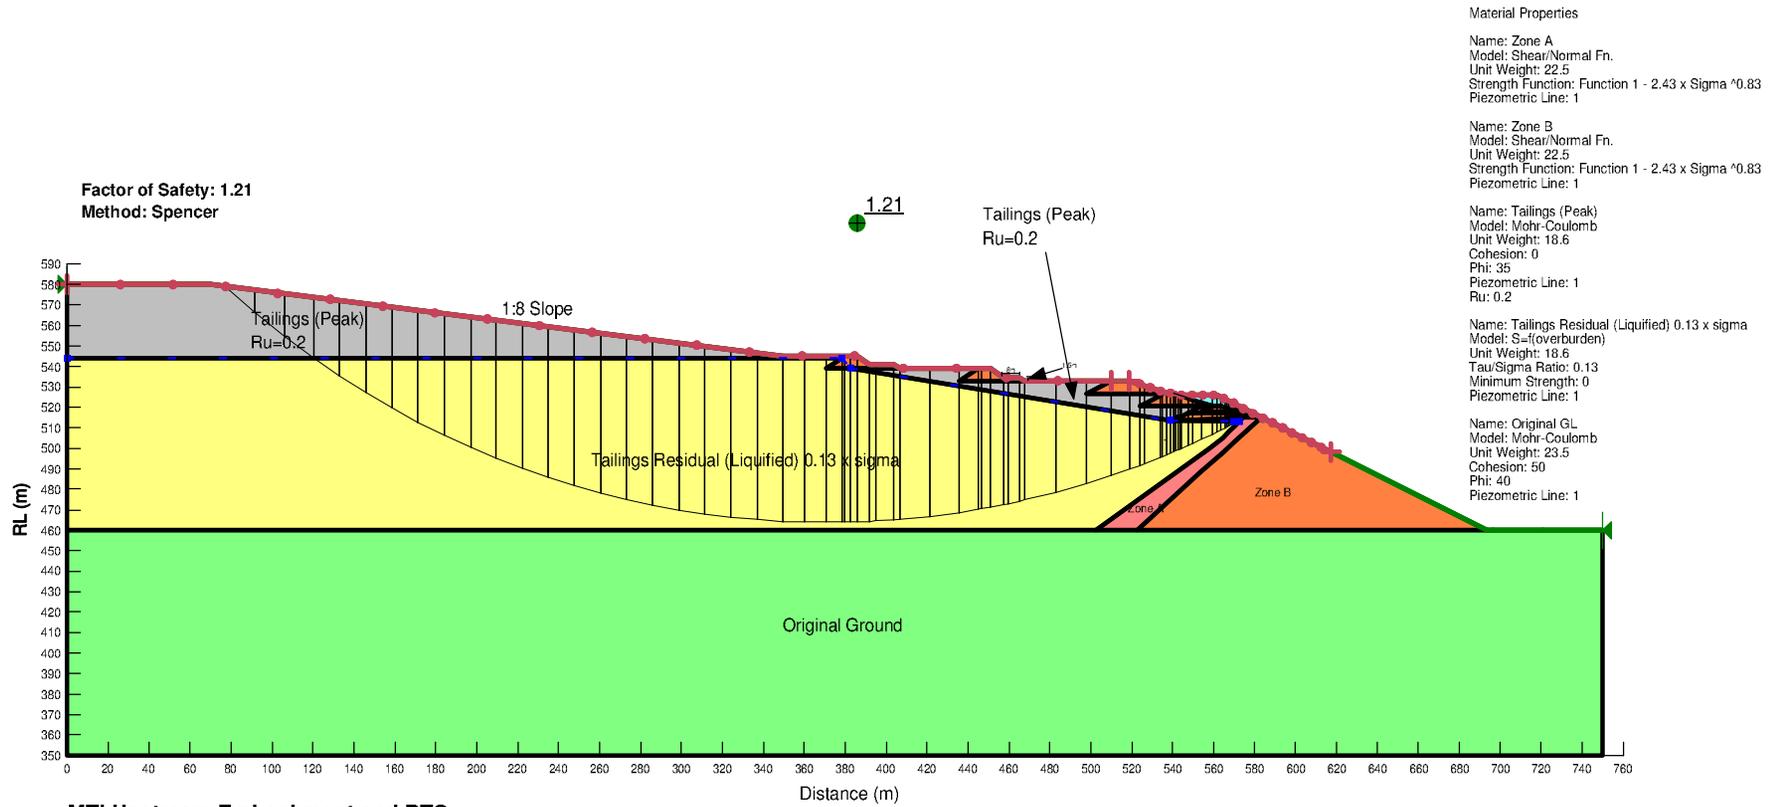
**Figure E5**

**MTI Upstream Embankment and RTS**  
**Post Earthquake Analysis**  
**475 year return period**  
**Main Toe Berm at RL526**  
**WL at downstream embankment - RL513**

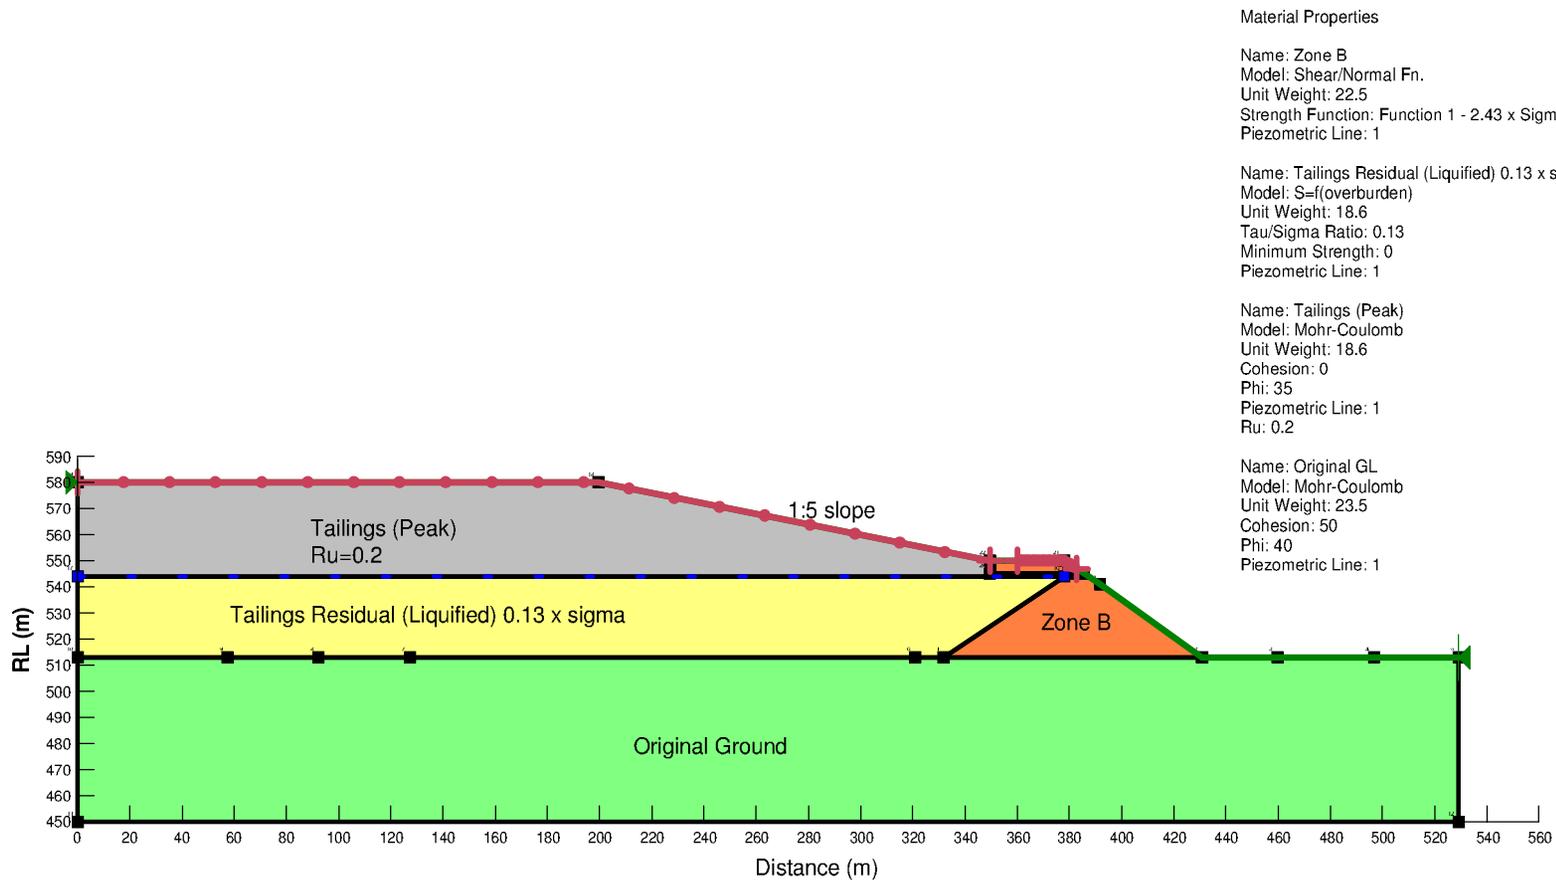
**Figure E6**

**MTI Downstream Embankment and RTS  
Post Earthquake Analysis  
475 year return period  
Toe Berm 5m depth  
WL at RL545**

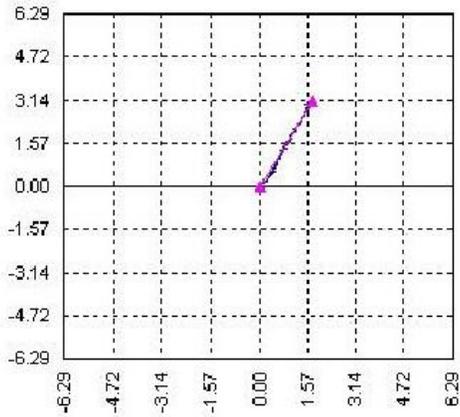
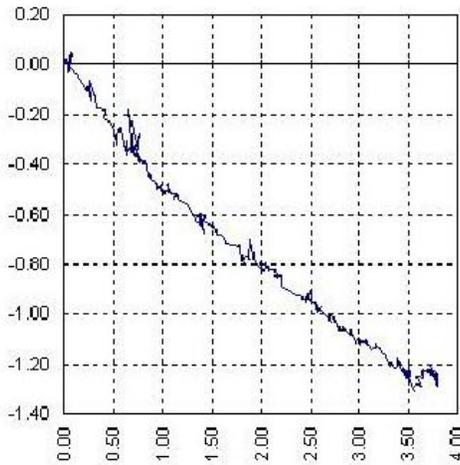
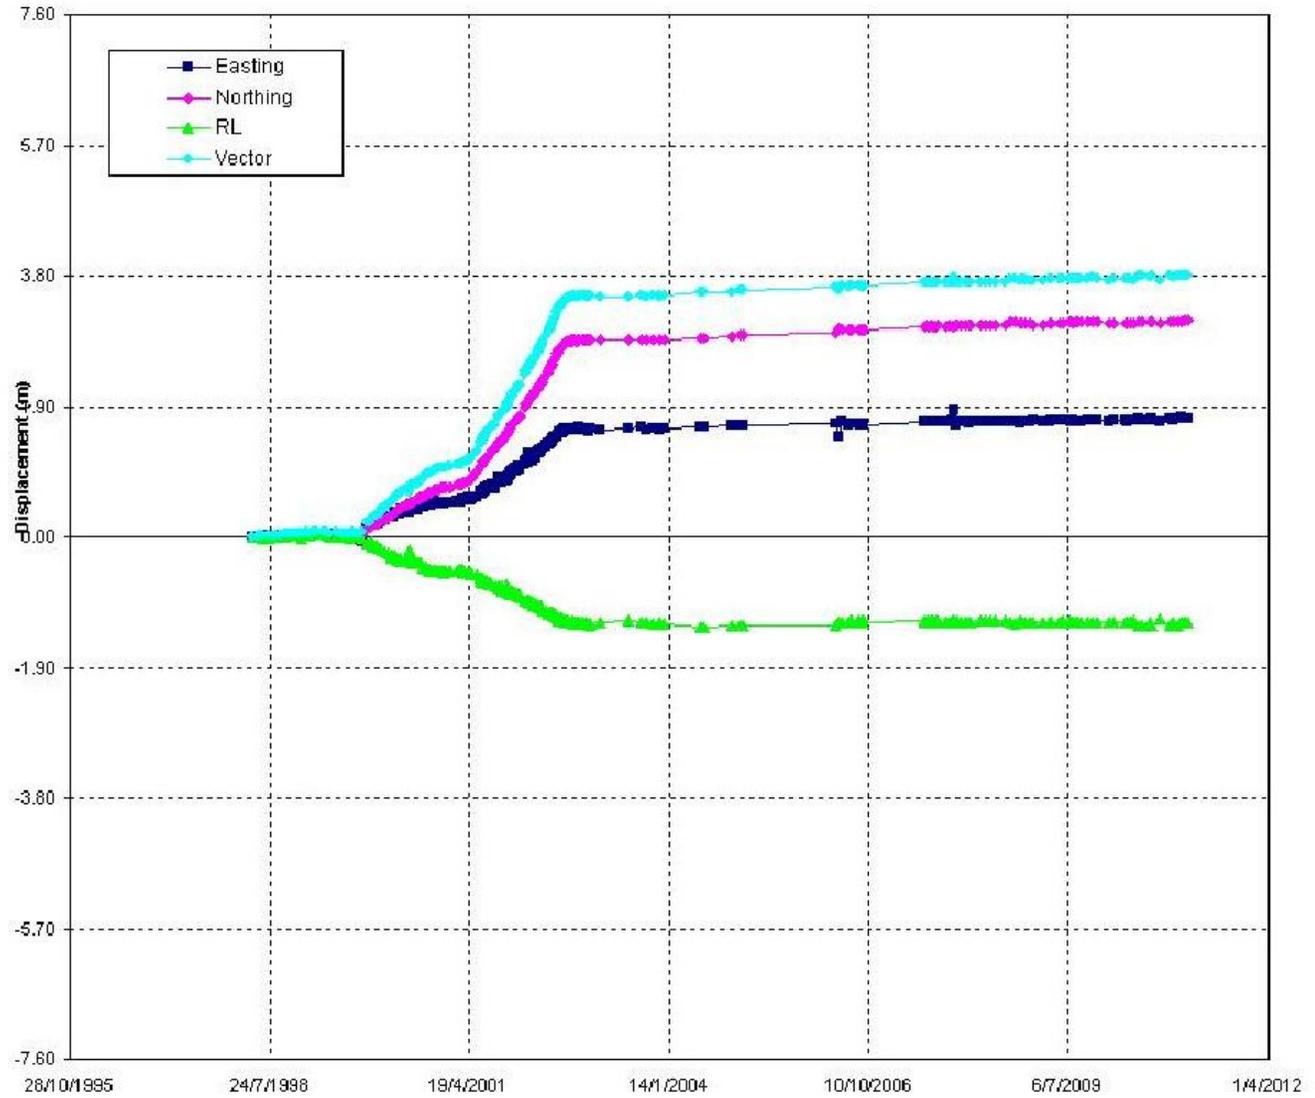
Figure F2

PLAN PLOT  
mN vs mE

RL vs Movement Vector

PRISM ID: FT19  
SLOPE: Round Hill

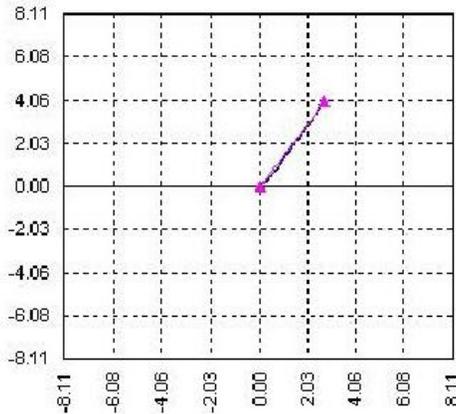
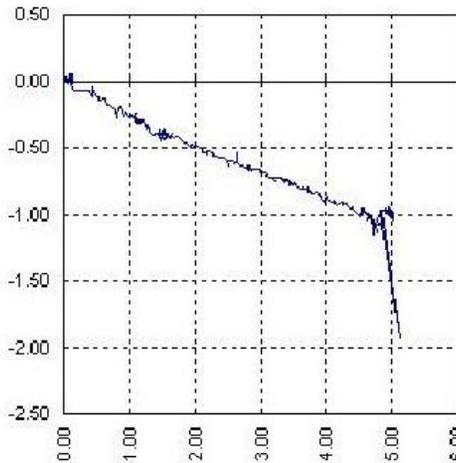
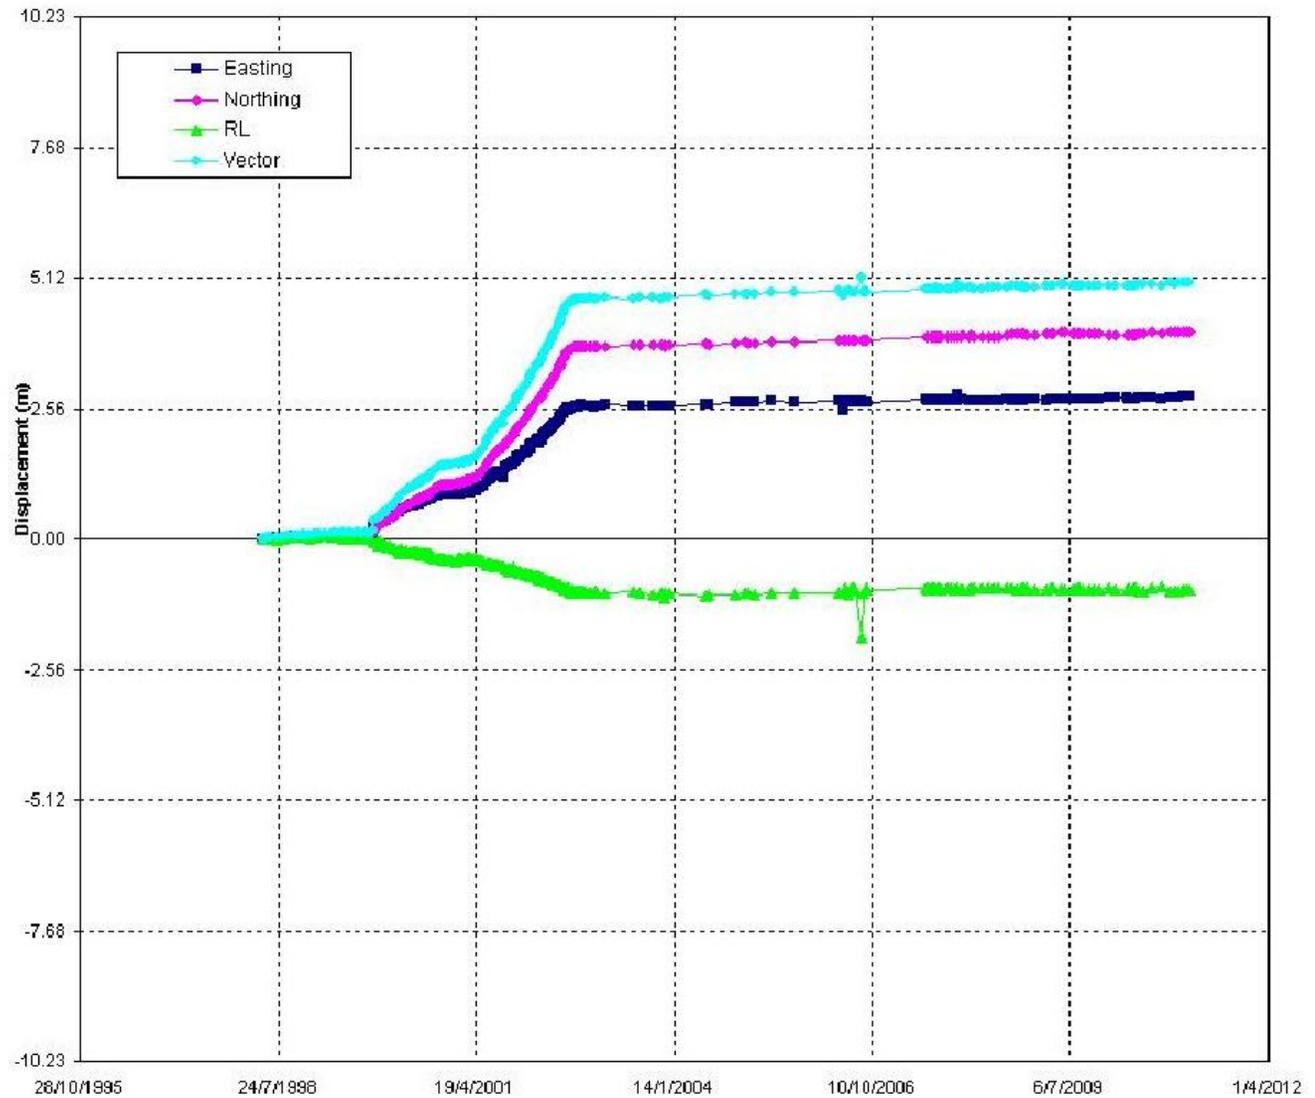
Figure F3

PLAN PLOT  
mN vs mE

RL vs Movement Vector

PRISM ID: FT20  
 SLOPE: Round Hill

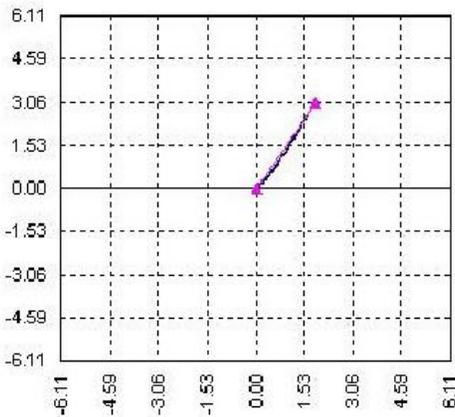
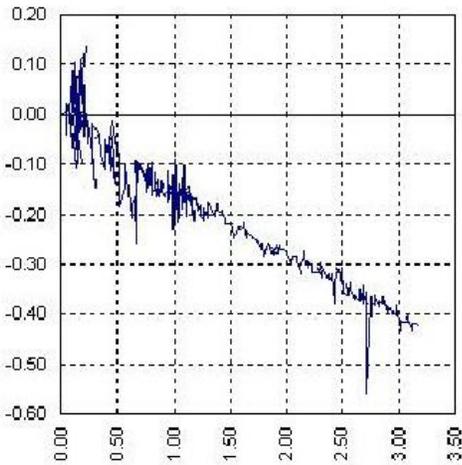
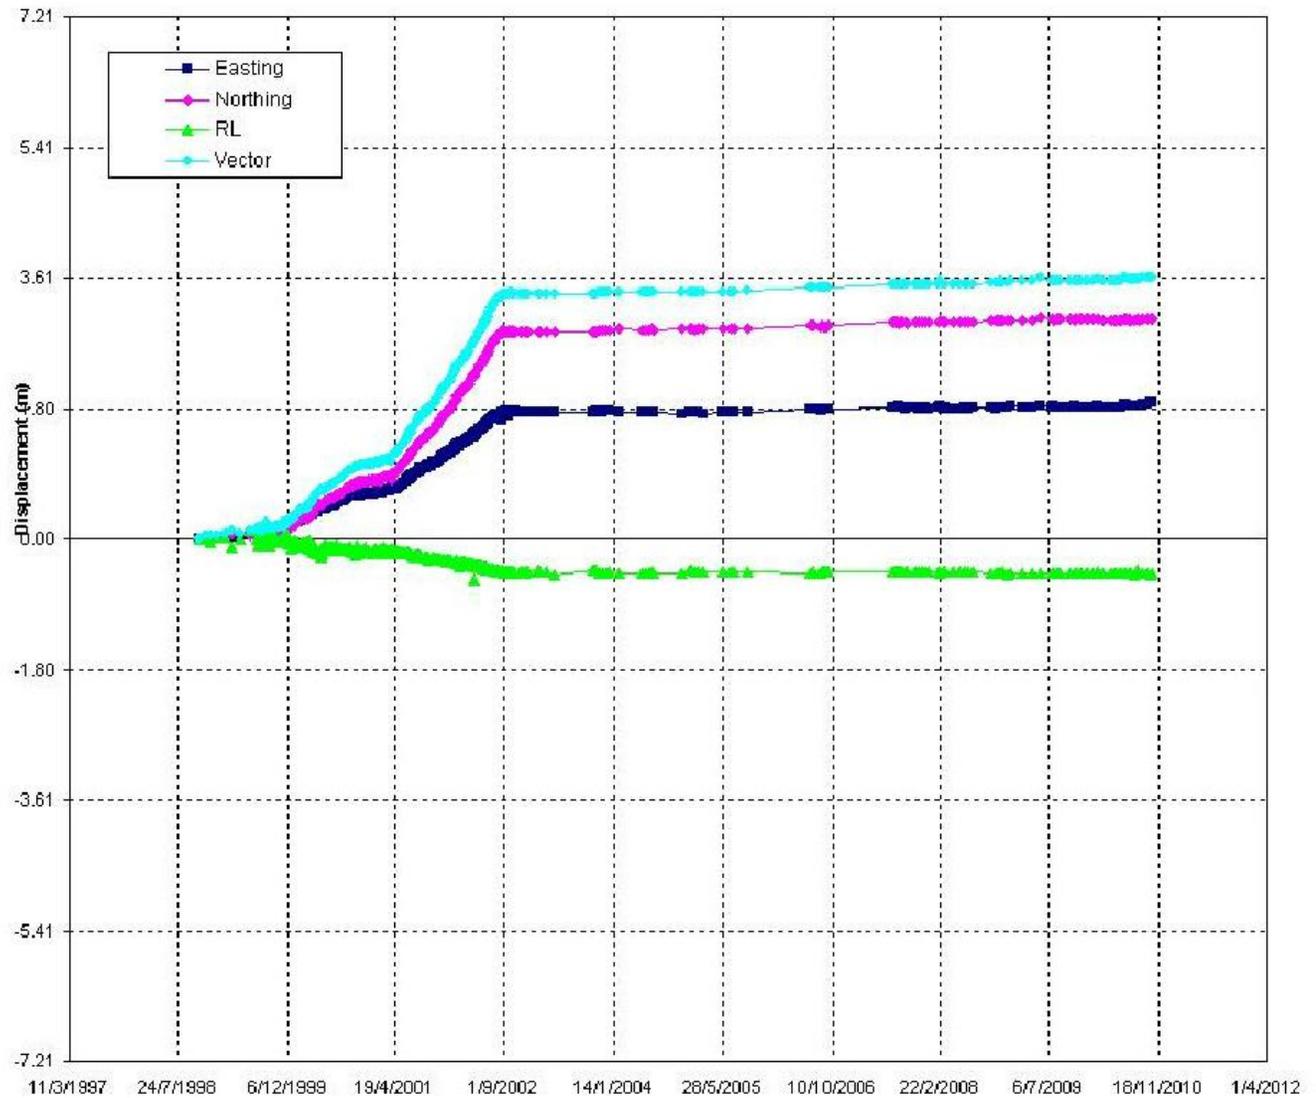
Figure F4

PLAN PLOT  
mN vs mE

RL vs Movement Vector

PRISM ID: 40  
 SLOPE: Round Hill

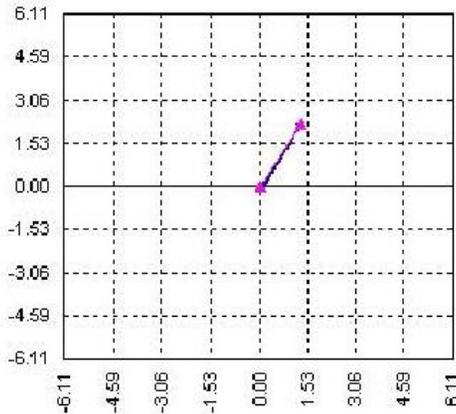
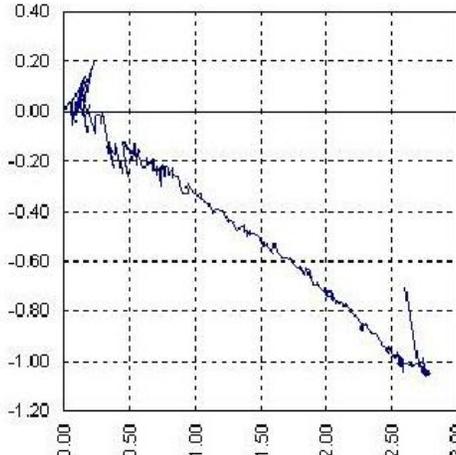
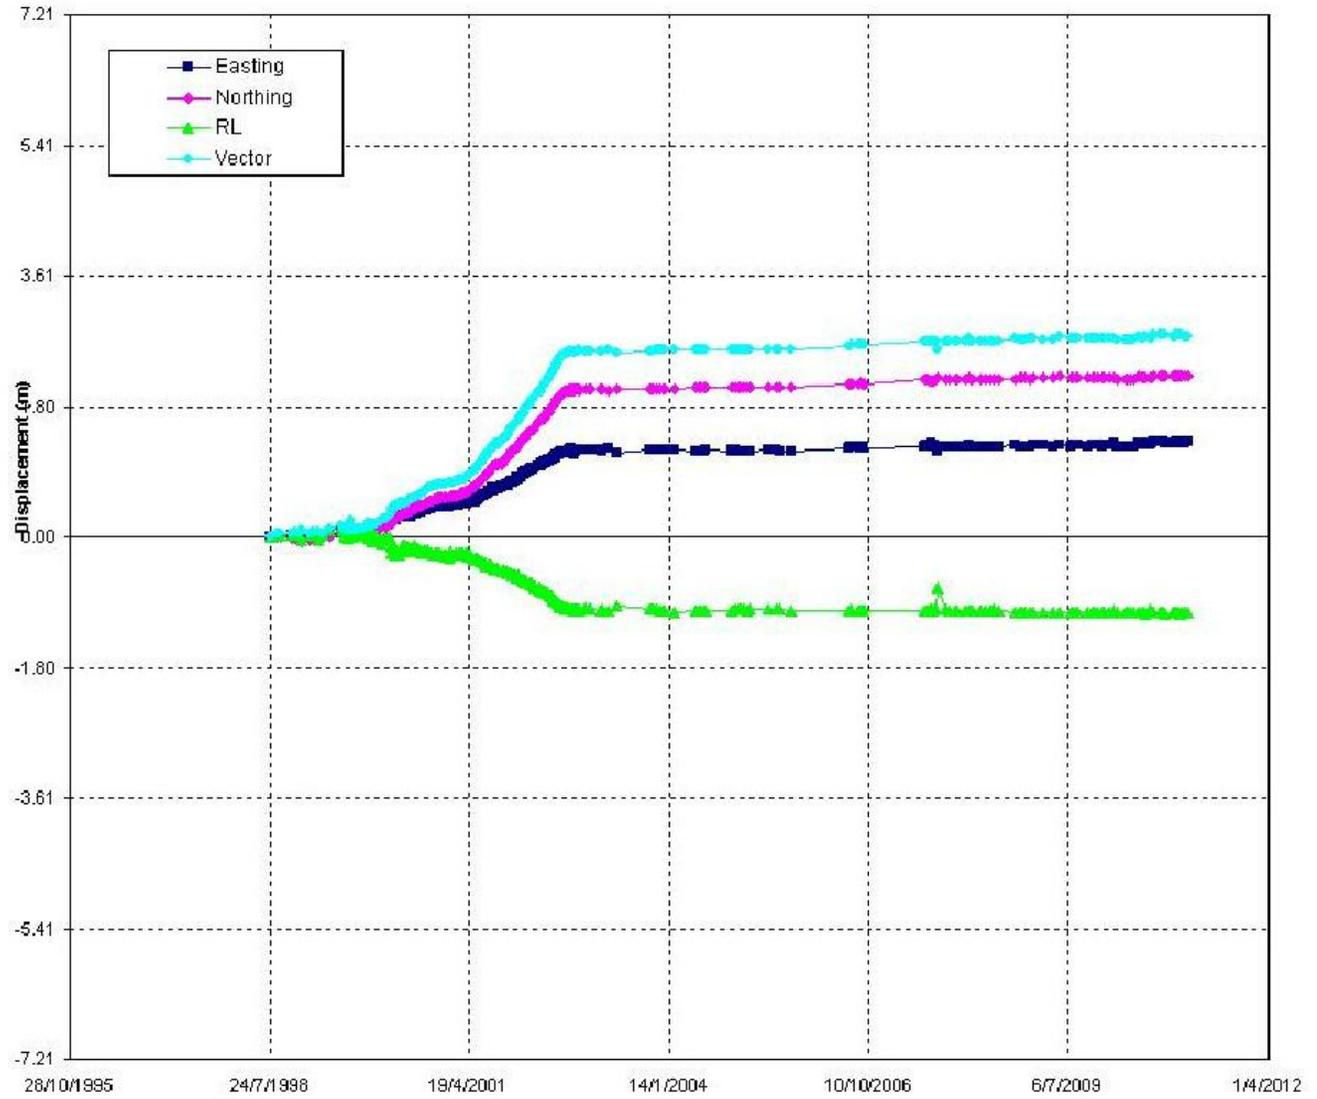
Figure F5

PRISM ID: **41**  
 SLOPE: Round Hill

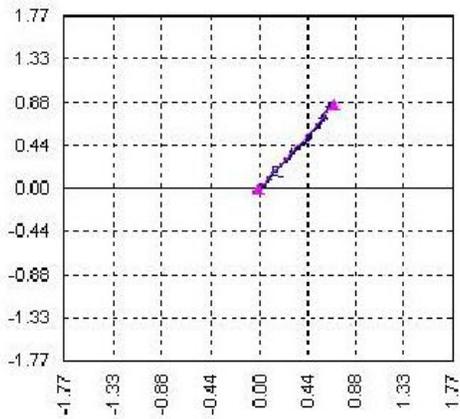
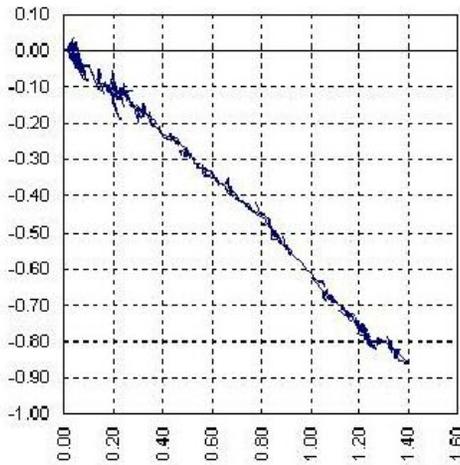
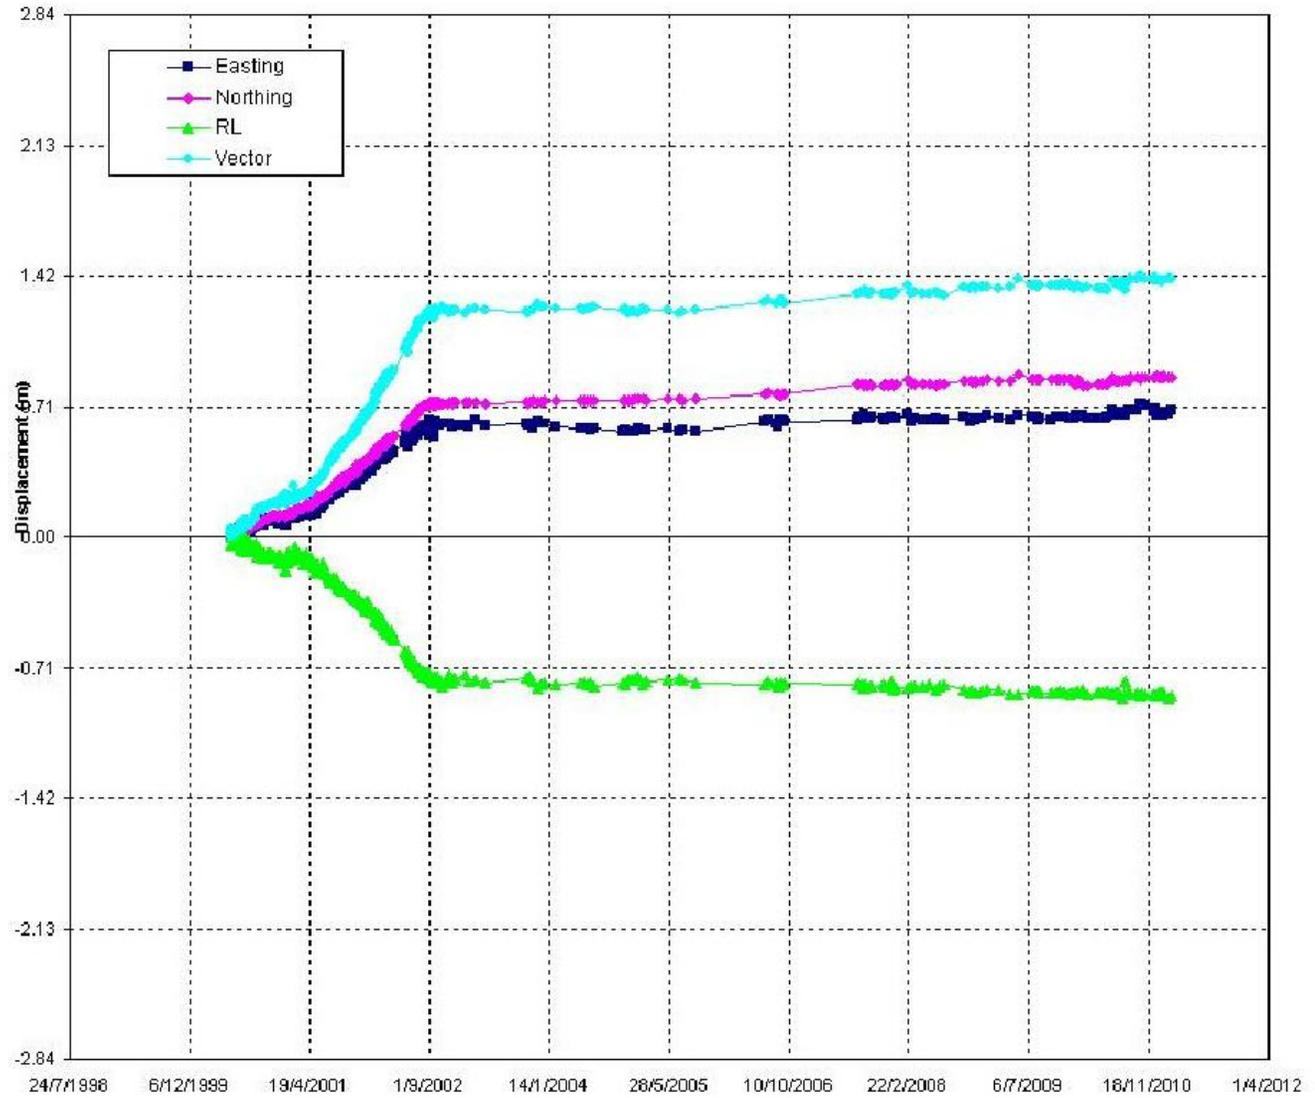
Figure F6

PLAN PLOT  
mN vs mE

PRISM ID: 42  
 SLOPE: Round Hill

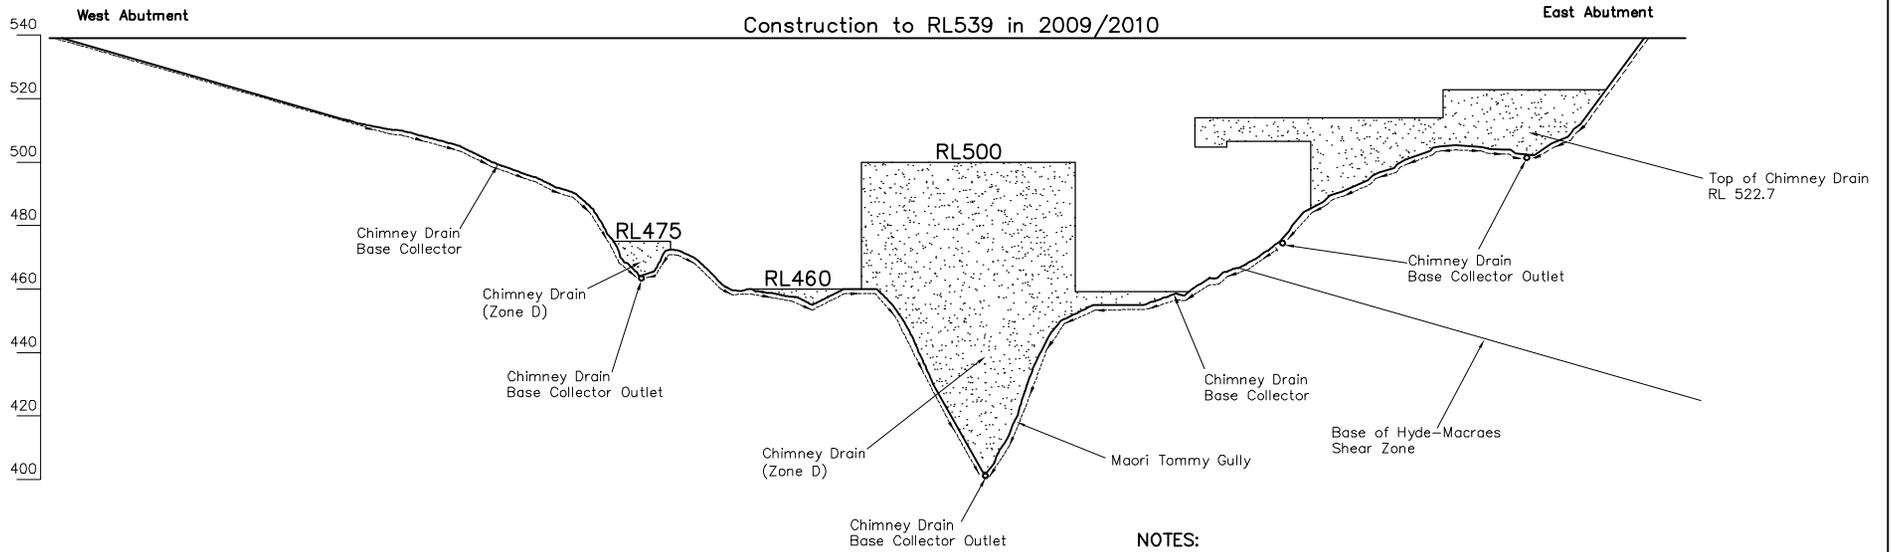
1. Width of chimney drain varies on east abutment. It is 2.5m wide up to approx. RL 505.0 Above this level the drain width varies. It is 2.5m wide over the western half and at two other locations further to the east. Elsewhere it is 0.9m wide.
2. Chimney drain width in Maori Tommy Gully varies with height:
