Ref: **6786**

**OCEANA GOLD (NZ) LTD  
MACRAES GOLD PROJECT  
MINING OF ROUND HILL – SOUTHERN PIT  
MTI, SP10 & SP11A TAILING STORAGE  
FACILITIES AND RECLAIMED TAILINGS STACK  
TECHNICAL REPORT**

**28 April 2011**

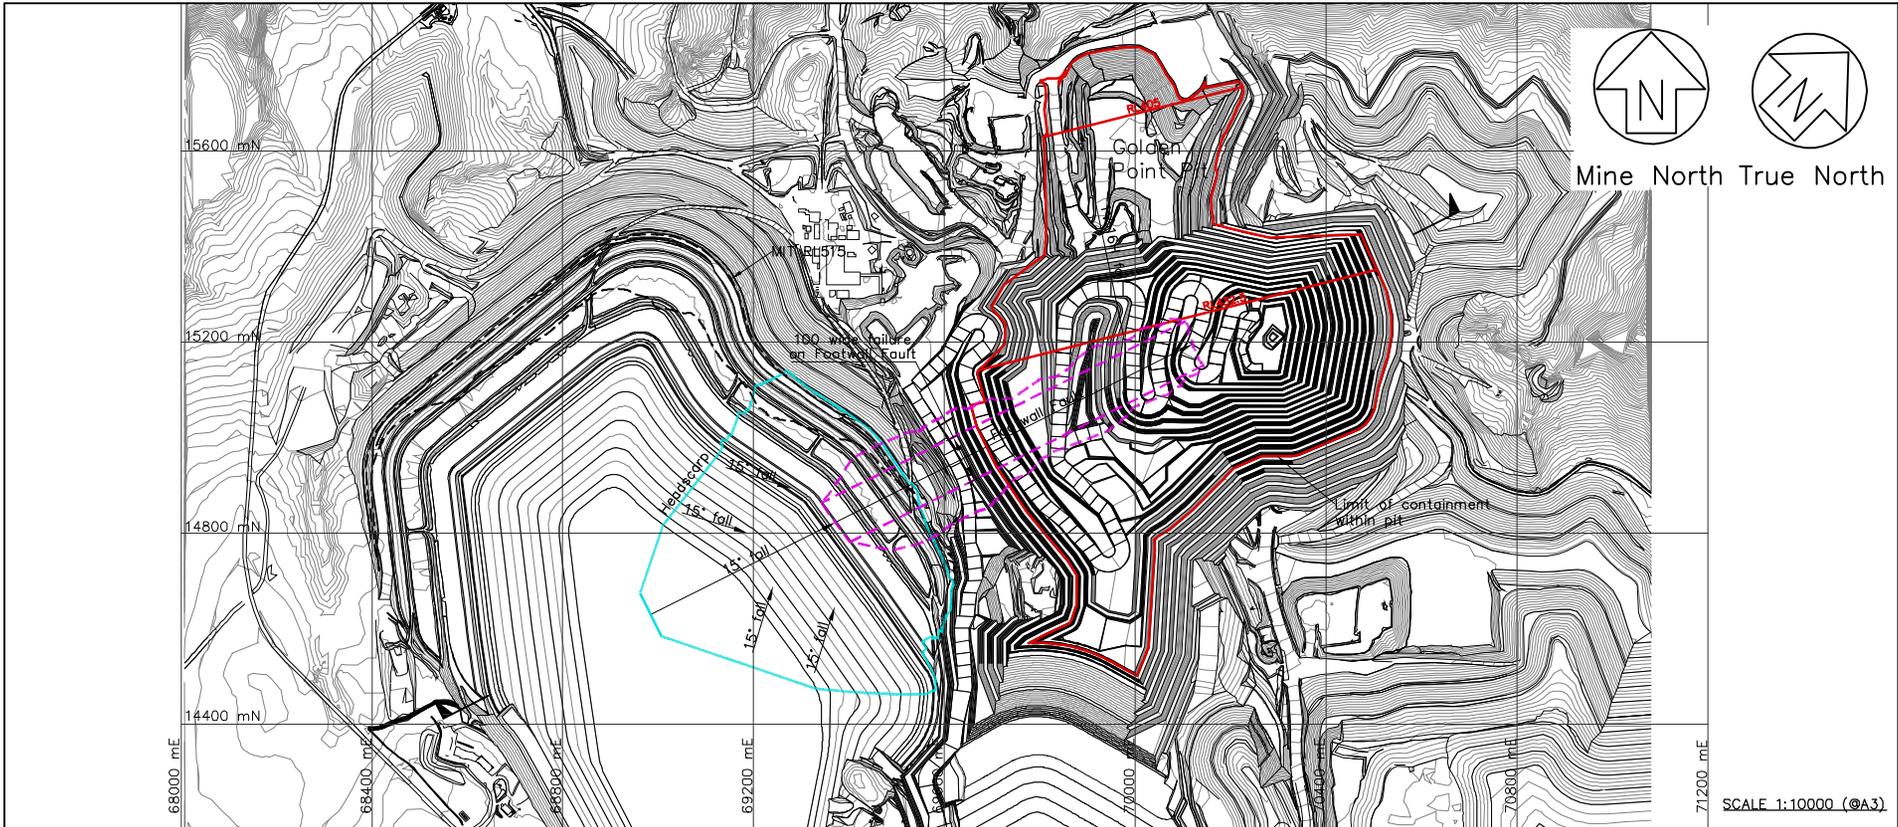
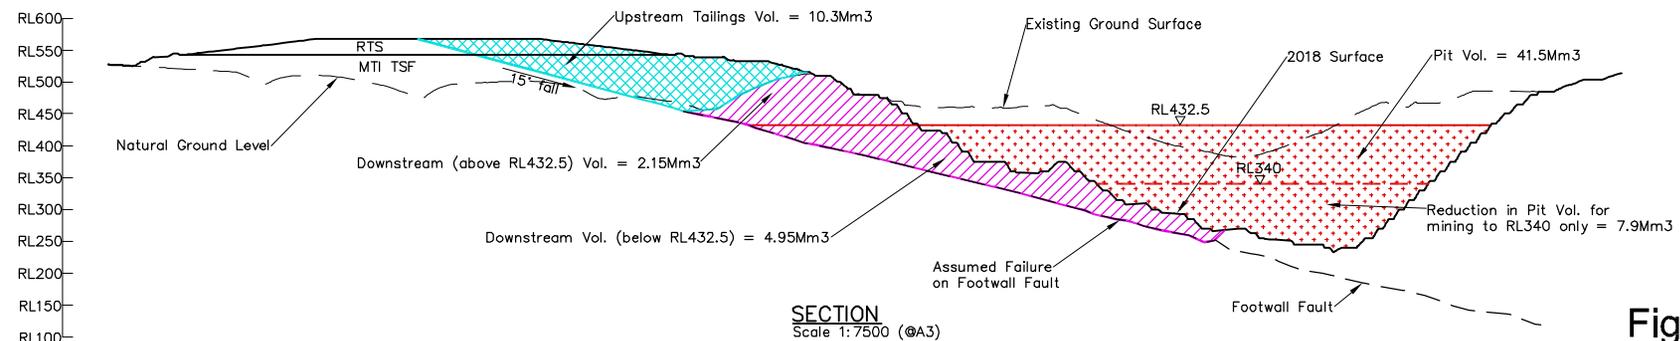
Drawing No. 6786-Figure H1  
Date: 21 April 2011  
Drawn: BL  
Scale: As shown  
Filename: 6786-Figure H1.dwg

SCALE 1:10000 (@A3)

SECTION  
Scale 1:7500 (@A3)

**OCEANA GOLD (NZ) LTD, MACRAES GOLD PROJECT**  
**Round Hill-Southern Pit**  
**Dry Breach of MTI TSF (15 deg Headscarp)**

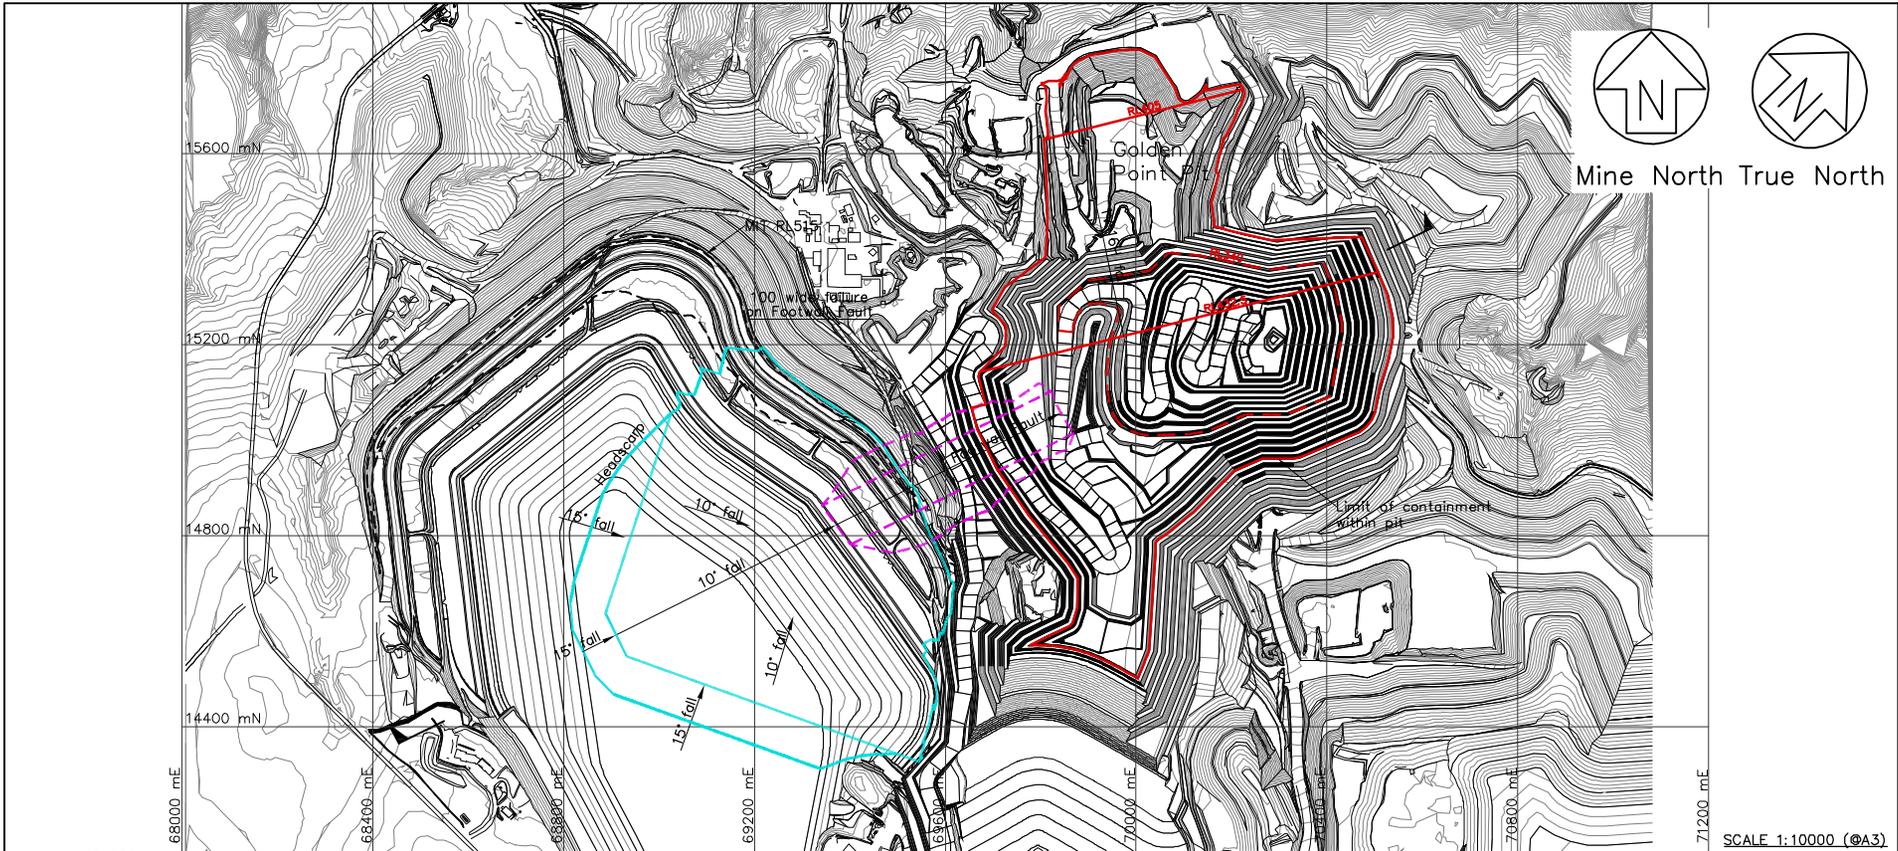
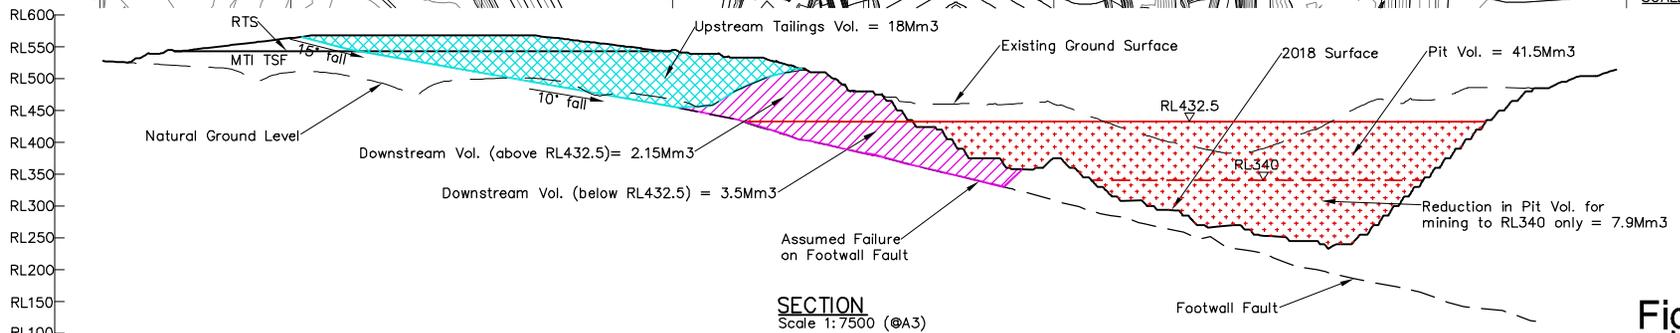
Figure H2

**OCEANA GOLD (NZ) LTD, MACRAES GOLD PROJECT**  
Round Hill-Southern Pit  
*Dry Breach of MTI TSF (10 deg Headscarp)*
