Clutha Delta Qualitative Risk Assessment (Seismic)

Prepared for
Otago Regional Council

Prepared by
Tonkin & Taylor Ltd

Date
August 2025

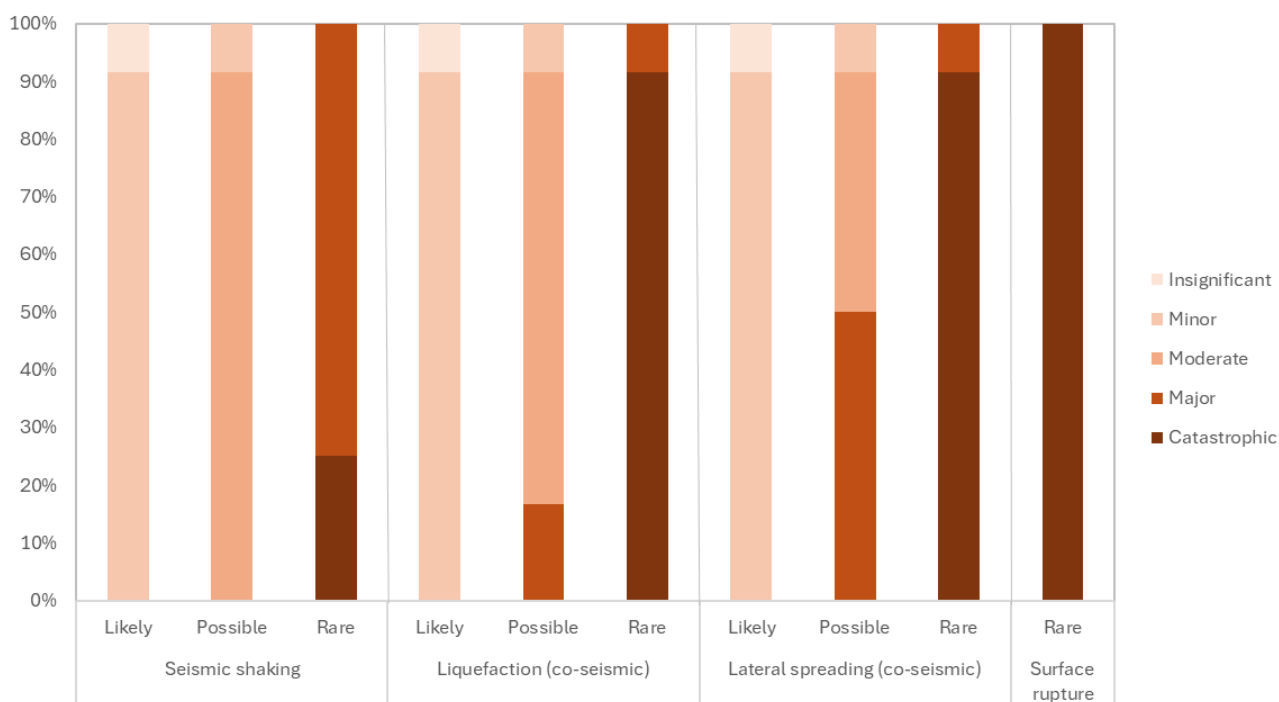
Figure 3.1: Distribution of consequence ratings across the different likelihood scenarios and hazards

The distribution of consequence ratings across the different hazards and likelihood scenarios is presented in Figure 3.1. It highlights the higher consequences associated with the Rare scenarios, and the lower consequences associated with the Likely scenarios. It also demonstrates the compounding effects of the co-seismic hazards considered i.e., the consequences for surface rupture are highest and the consequences for seismic shaking are lowest.
