# TAIERI LIAISON GROUP AGENDA

## 1. MEETING DETAILS

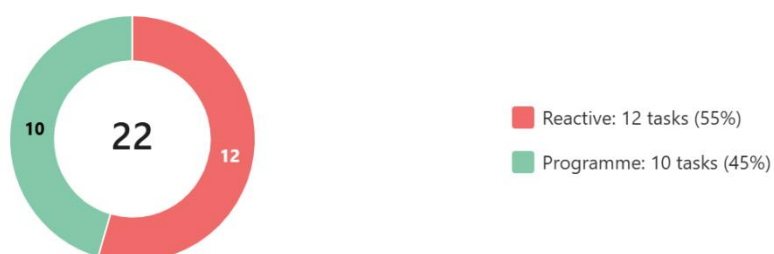
Complete contract works by planning type - Q1

**Figure 2** Contract works completed up to the end of Quarter 1 including programmed and reactive works.

Figure 2 below shows contract works completed to date as well as reactive works that have been undertaken in addition to programmed works. Figure 3 shows inspections completed up to the end of Quarter 1.

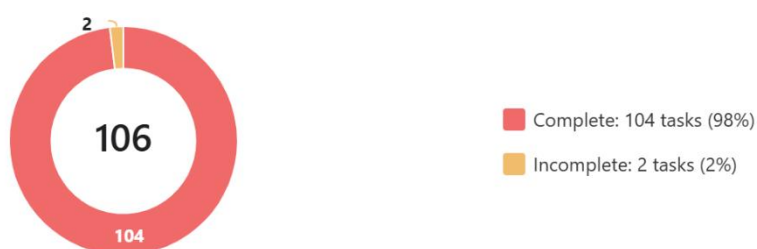
Q1 Inspection Completion Status

**Figure 3** Progress of planned inspections up to the end of Q1.

To the end of Quarter 1 a total of 114 jobs (22%) have been completed out of 522 Two routine river inspections were not completed in Quarter 1.

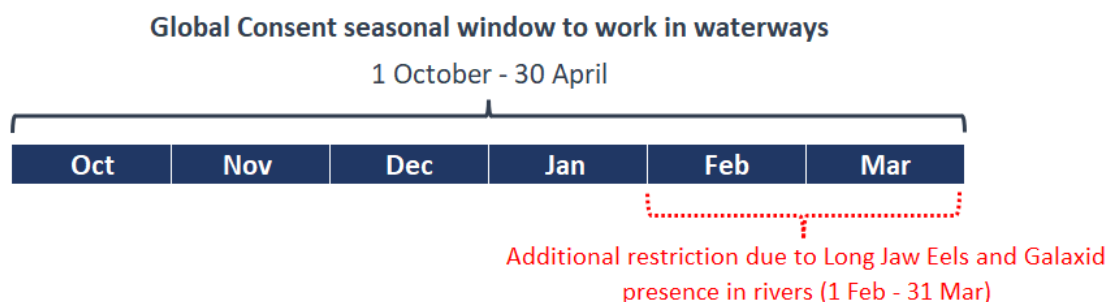
*Figure 5 Global Consent summary of when working in waterways can occur annually.*

Engineering performs its activities under a Global Consent which applies across Otago's waterways, as per the summary in Figure 9. Activities cannot be performed within waterways from May through to September annually, unless express approval and/or emergency works are required in accordance with the RMA.

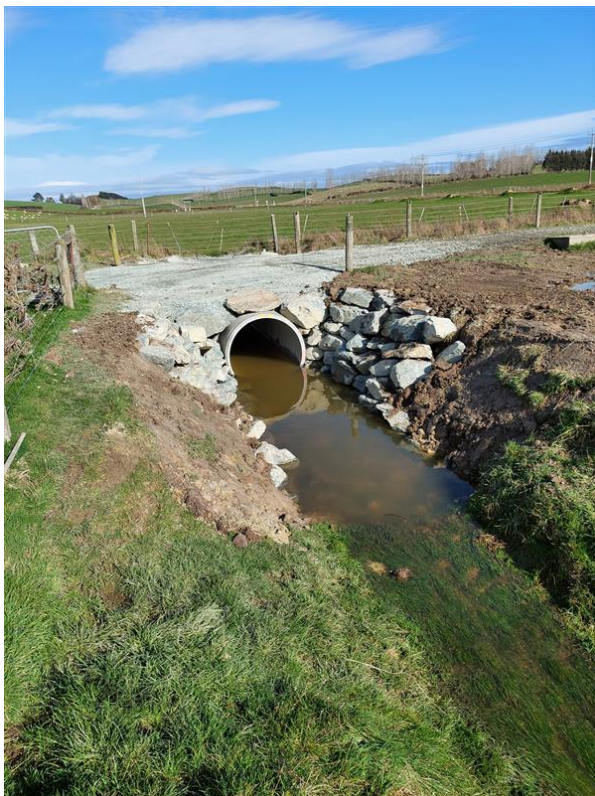
*Figure 6 Toko Bridge 3 replaced with new culvert*

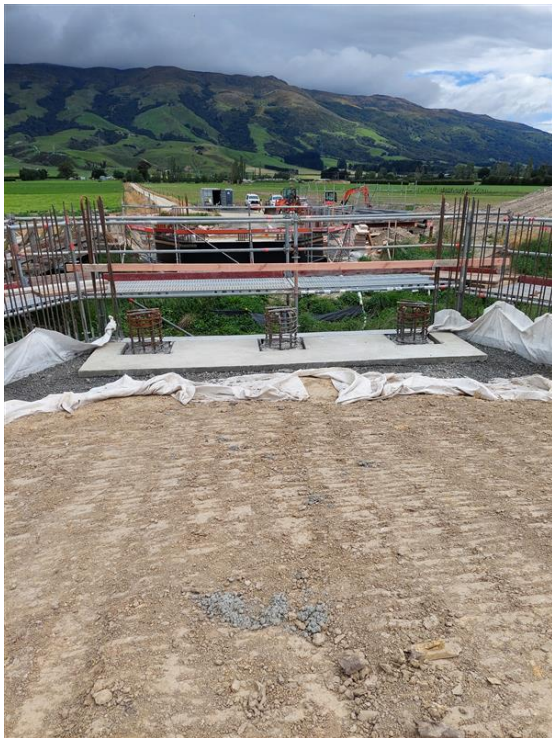
*Figure 7 December 2024 Bridge 14 Headwalls almost complete*

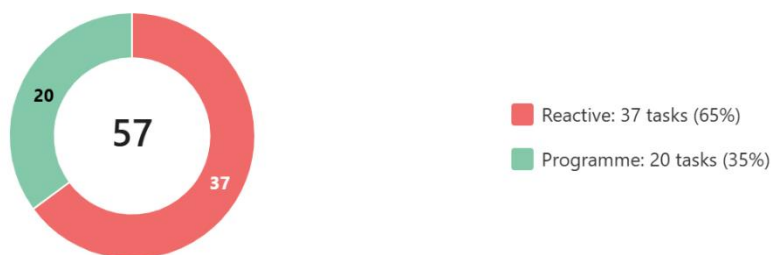
Complete contract works by planning type - Q2

**Figure 2** Contract works completed up to the end of Quarter 2 including programmed and reactive works.

Figure 2 below shows contract works completed to date as well as reactive works that have been undertaken in addition to programmed works. Figure 3 shows inspections completed up to the end of Quarter 2.

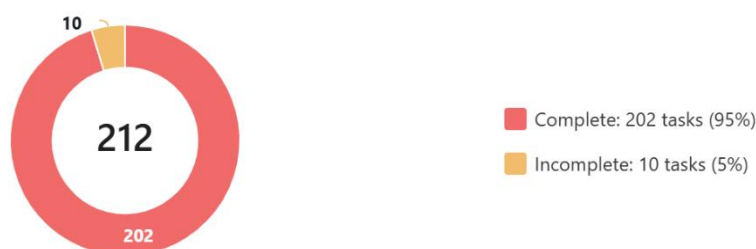
Q2 Inspection Completion Status

**Figure 3** Progress of planned inspections up to the end of Q2.

To the end of Quarter 2 a total of 222 jobs (42%) have been completed out of 522. The river management programme is on track to achieving the 85% target of this performance measure as at the end of Quarter 2.

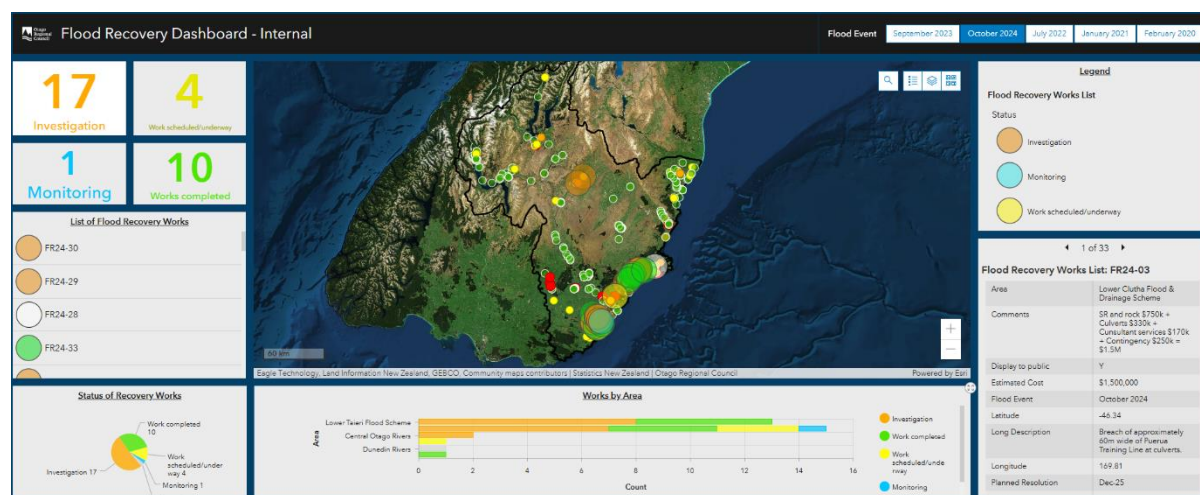
Figure 5 Flood recovery dashboard following October 24 weather event.

A flood repair and recovery programme is being established for this event. The programme will be established within the 3 month requirement and will be available to the public online as an interactive map showing repair sites, their programmed completion, and their status. The programme and map will be updated monthly as work progresses. The live repair programme can be viewed by visiting the following ORC webpage and clicking the link to the dashboard near the bottom of the page – [Flood Repair Programme | Otago Regional Council \(orc.govt.nz\)](https://orc.govt.nz/flood-repair-programme).

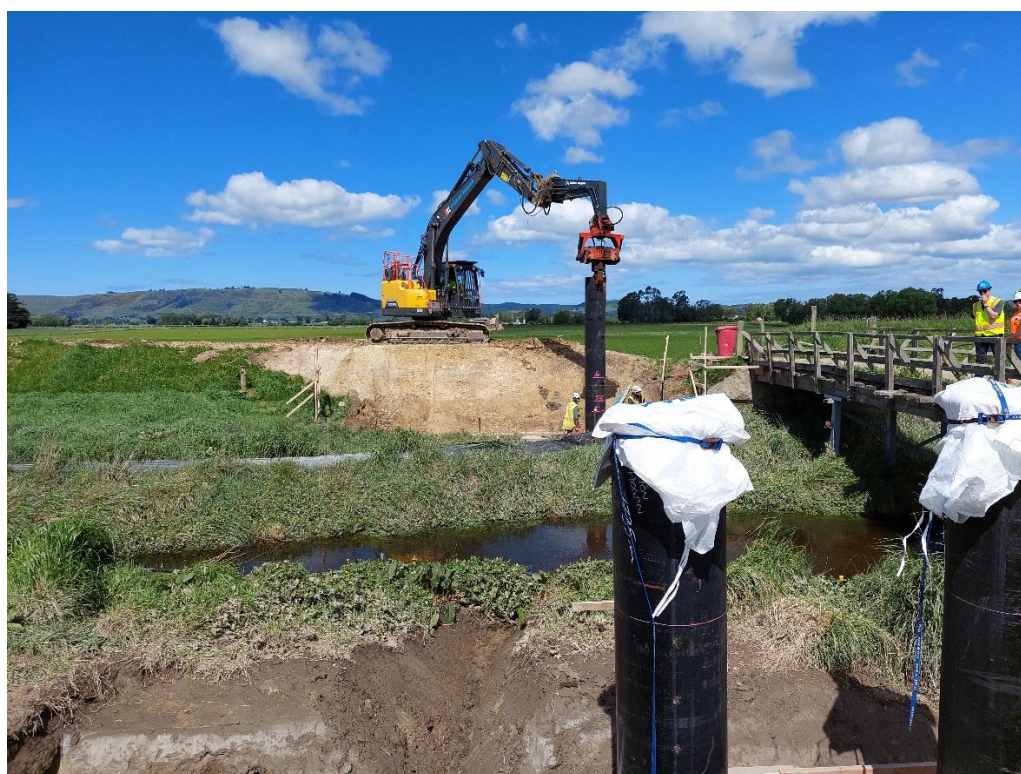
*Figure 7 Bridge 14 site works underway*

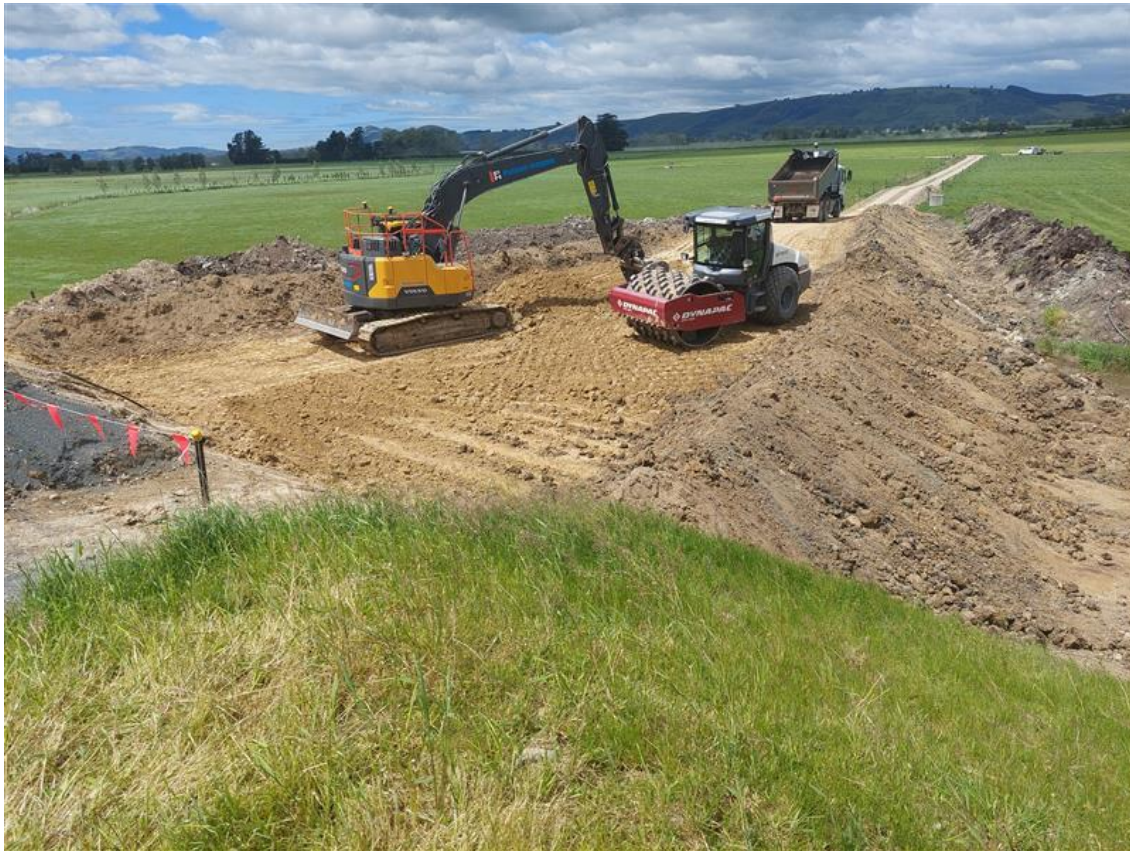
*Figure 8 Bridge 14 approach road in construction*

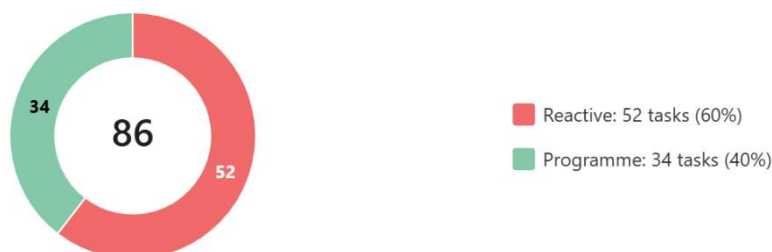
Complete contract works by planning type - Q3

Figure 2 Contract works completed up to the end of Quarter 3 including programmed and reactive

Figure 2 below shows contract works completed to date as well as reactive works that have been undertaken in addition to programmed works. Figure 3 shows inspections completed up to the end of Quarter 3.

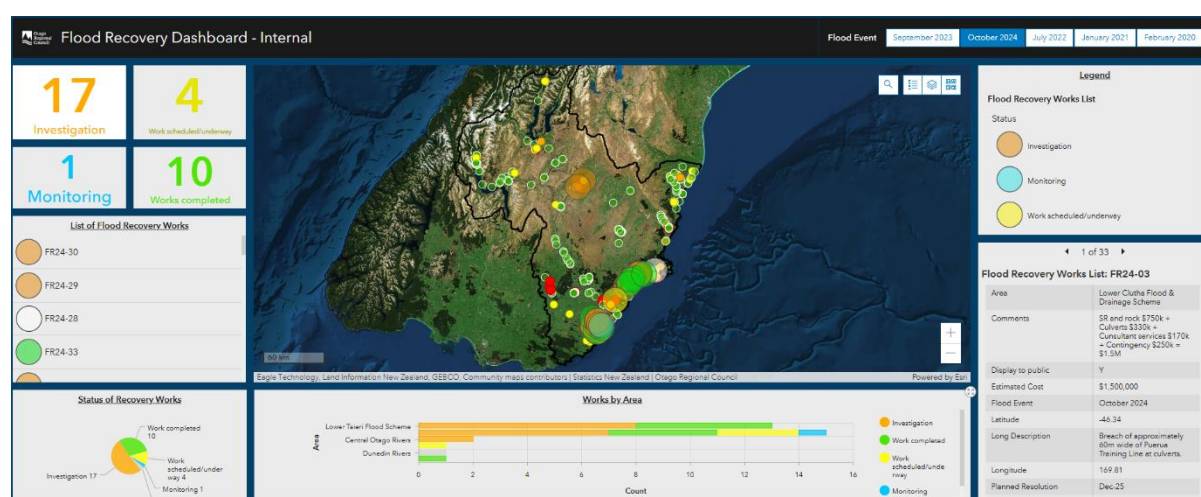
Figure 6: Flood recovery Work Dashboard - September 2023 weather event.

A flood repair and recovery programme is being established for this event. The programme will be established within the 3 month requirement and will be available to the public online as an interactive map showing repair sites, their programmed completion, and their status. The programme and map will be updated monthly as work progresses. The live repair programme can be viewed by visiting the following ORC webpage and clicking the link to the dashboard near the bottom of the page – [Flood Repair Programme | Otago Regional Council \(orc.govt.nz\)](https://orc.govt.nz/flood-repair-programme).

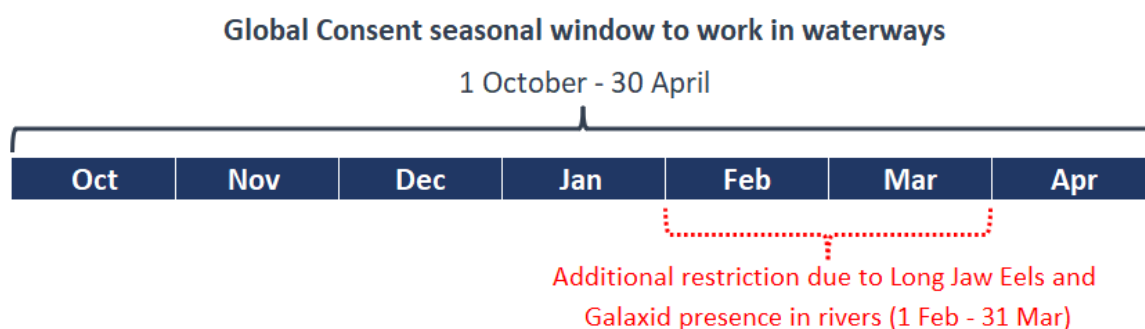
*Figure 7 Global Consent summary of when working in waterways can occur annually.*

Engineering performs its activities under a Global Consent which applies across Otago's waterways, as per the summary in Figure 9. Activities cannot be performed within waterways from May through to September annually, unless express approval and/or emergency works are required in accordance with the RMA.

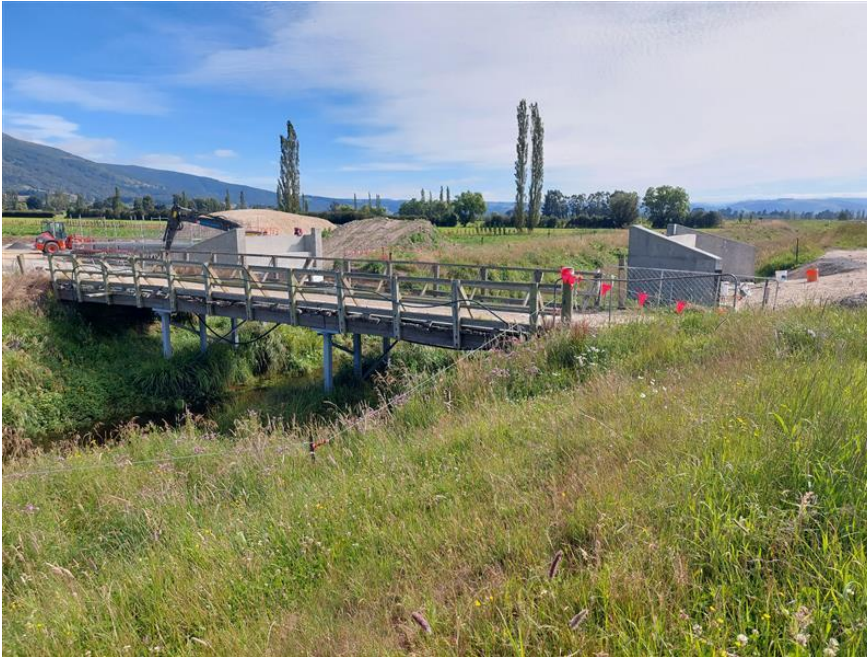
*Figure 8 December 2024 Bridge 14 old versus new*

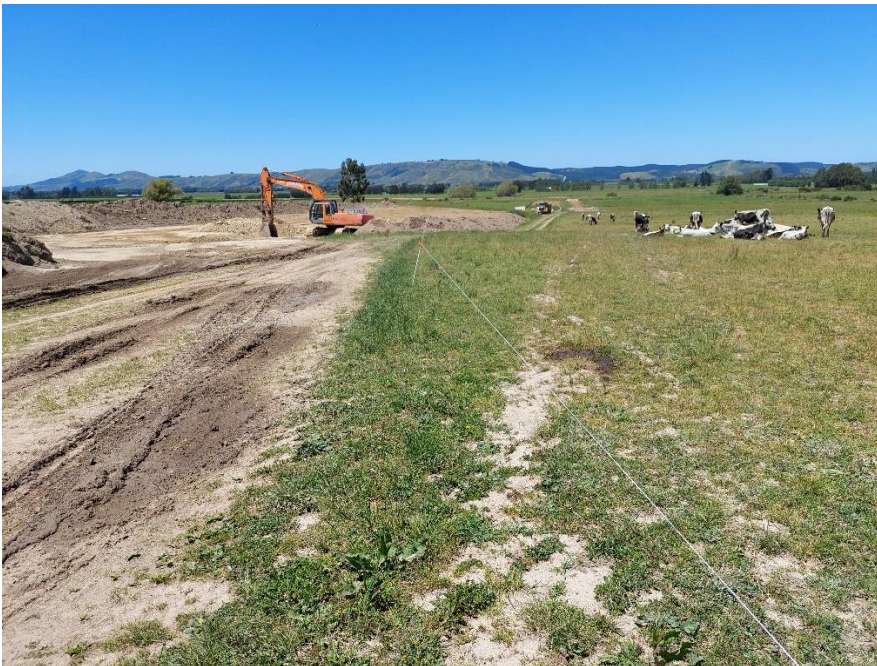
*Figure 9 December 2024 Contour Borrow Pit reinstatement*

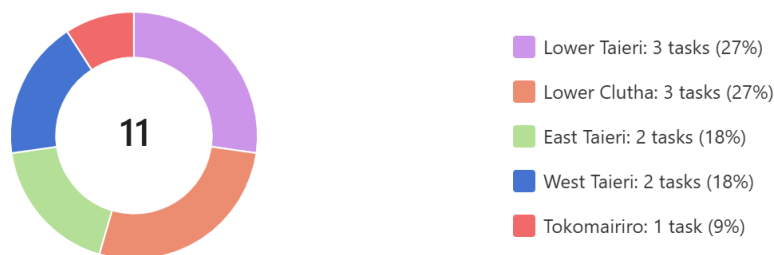
Completed tasks by Location

Figure 1. Completed tasks by location

11/113 scheduled jobs have been completed in Quarter 1. This equates to approximately 10% of the programme being completed so far. See Section 2 of this report for further commentary on the Operations work programme and this performance measure.

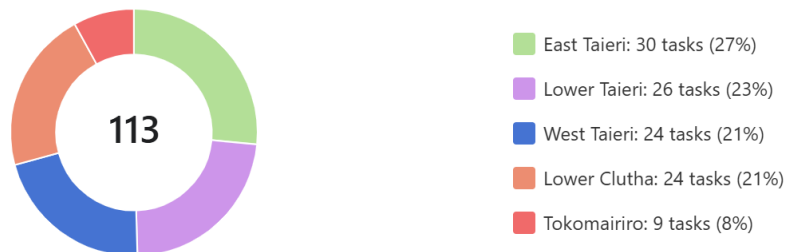
Total tasks by Location

Figure 2. Scheduled Maintenance tasks by location

Operations staff have identified the scheduled maintenance tasks required for the 24-25 year in line with the budget. Q1 involved planning across all schemes with work scopes being written and sent to suppliers to provide pricing for the work. The majority of Operations and Maintenance works is planned to be completed in Q3/Q4 as shown in the below graph.

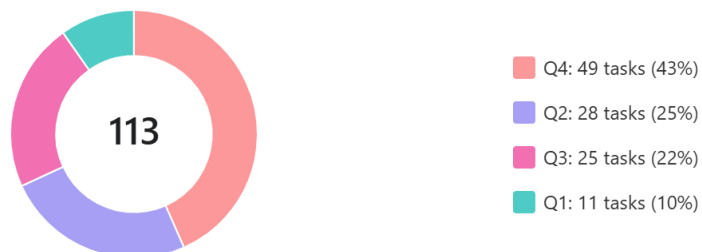
Total tasks by Quarter Planned

Figure 3. Scheduled Maintenance tasks by planned completion quarter

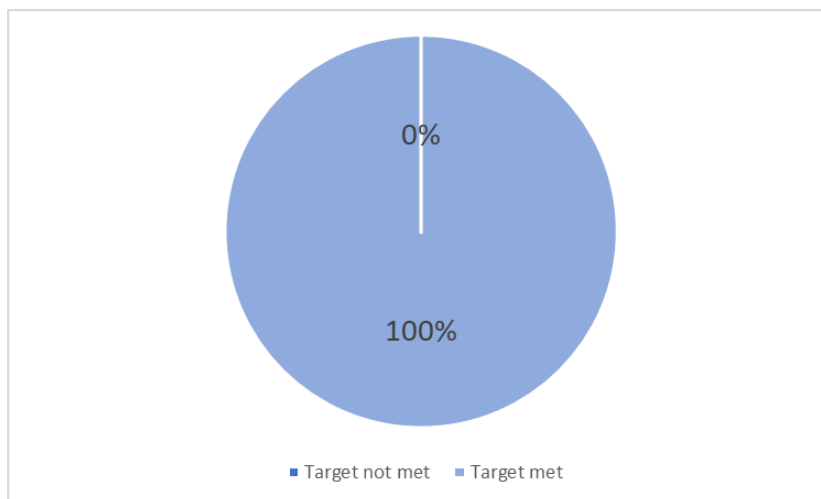
**Figure 4** Quarter 1 Project Status Update.

For the 2024/2 financial ORC has 7 renewals projects that fall within the renewals programme KPI performance measure. All projects are currently on track to meet that planned milestone by year end (Figure 4).

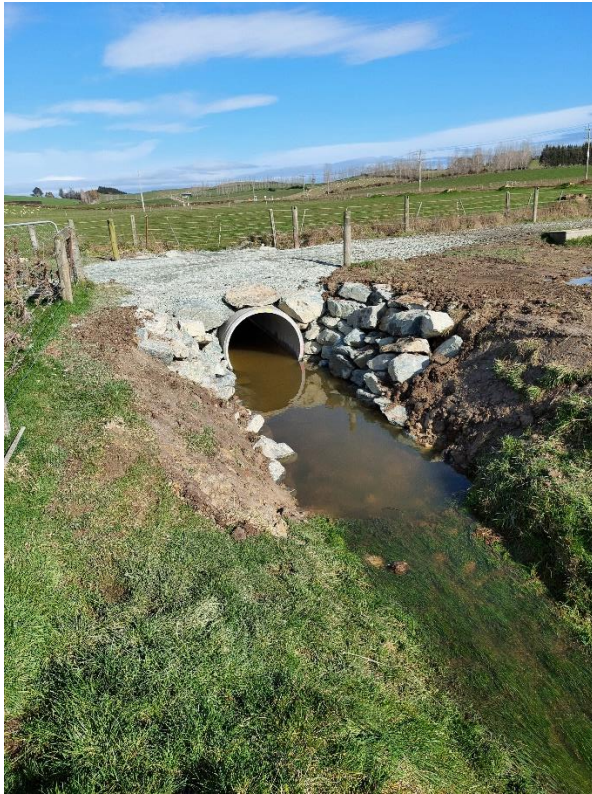
**Figure 7** Climate Resilience Project: Toko Bridge, replaced with new culvert

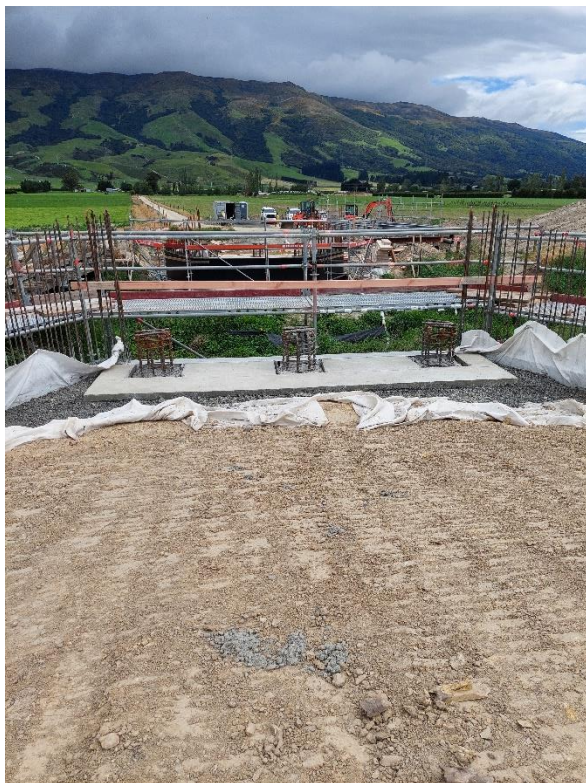
**Figure 8** Climate Resilience Project: Bridge 14 headwalls almost complete.

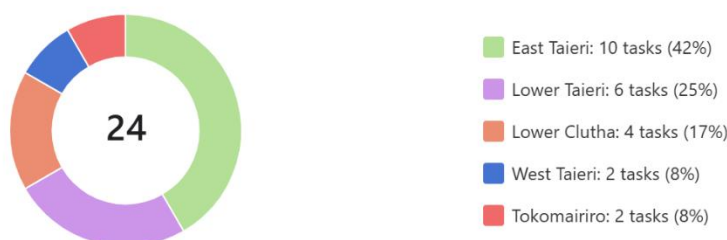
Completed tasks by Location

Figure 1. Completed tasks by location (Q2)

24/113 of the scheduled jobs have been completed in Quarter 2. This equates to approximately 21% of the work programme, with approximately 30% of the total work programme complete. The mulch mowing, vegetation control for the Taieri has started. See Section 2 of this report for further commentary on the Operations work programme and this performance measure.

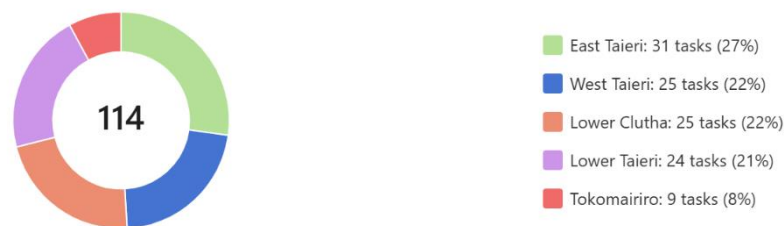
Operations staff have identified the scheduled maintenance tasks required for the 24-25 year in line with the budget. Q1 involved planning across all schemes, with work getting under way in Q2. The majority of Operations and Maintenance works is planned to be completed in Q3/Q4 as shown in the below graph.

Figure 2. Scheduled Maintenance tasks by location

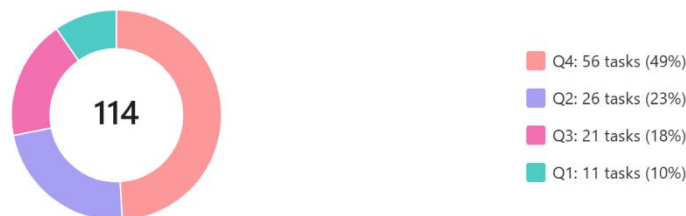
Figure 3. Scheduled Maintenance tasks by planned completion quarter

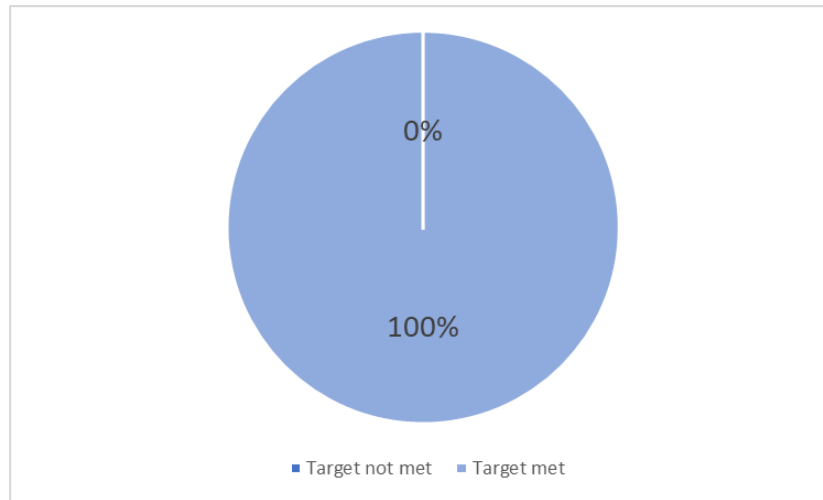
**Figure 4** Quarter 2 Project Status Update.

For the 2024/2 financial ORC has 7 renewals projects that fall within the renewals programme KPI performance measure. All projects are currently on track to meet that planned milestone by year end (Figure 4).

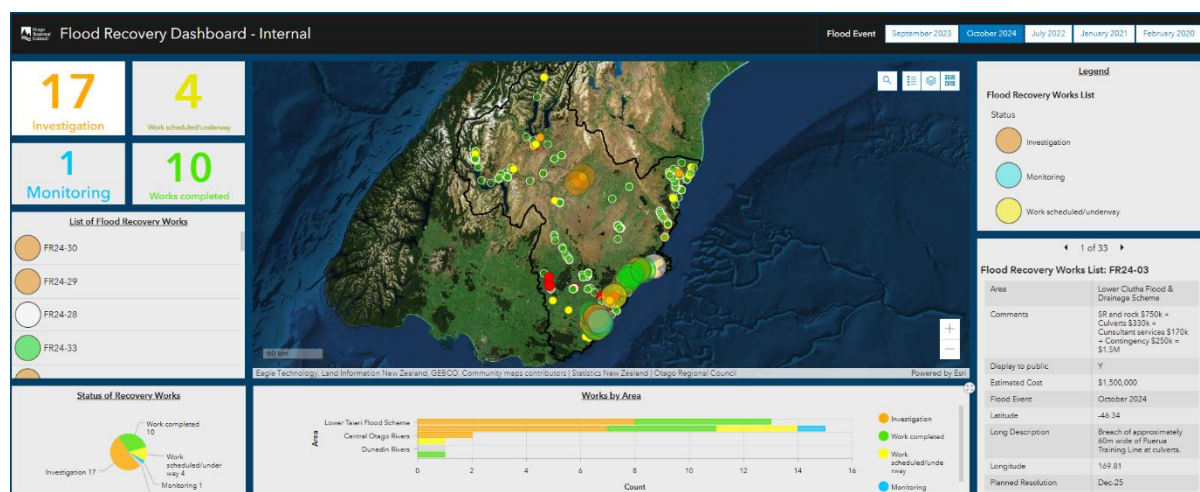
A flood repair and recovery programme is being established for this event. The programme will be established within the 3 month requirement and will be available to the public online as an interactive map showing repair sites, their programmed completion, and their status. The programme and map will be updated monthly as work progresses. The live repair programme can be viewed by visiting the following ORC webpage and clicking the link to the dashboard near the bottom of the page – [Flood Repair Programme | Otago Regional Council \(orc.govt.nz\)](https://orc.govt.nz/flood-repair-programme).

Figure 5: Flood recovery dashboard following October 24 weather event.

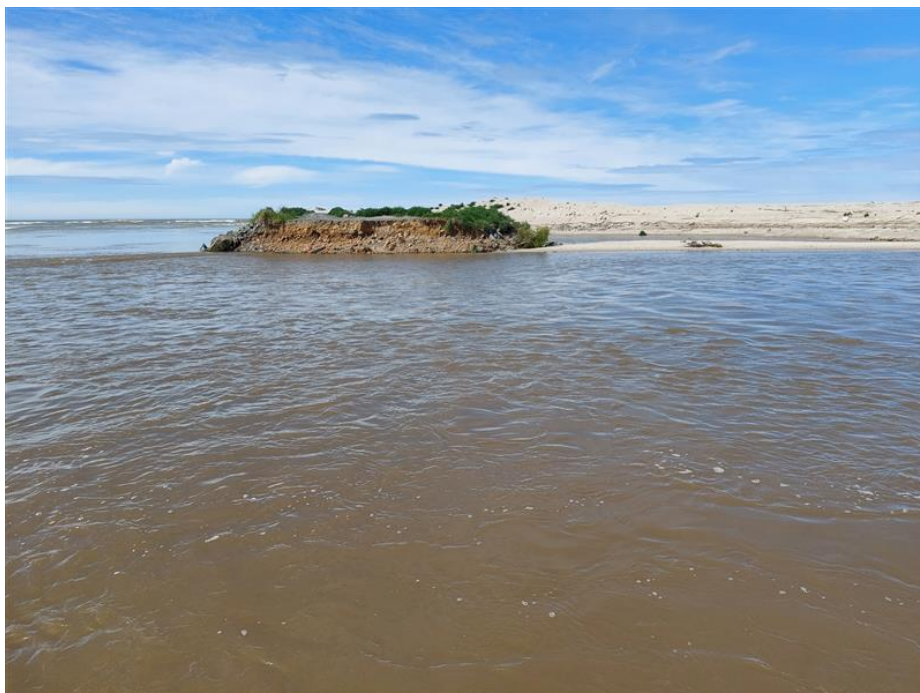
**Figure 8** October 2024 Puerua Outfall damage visit after October rain event.

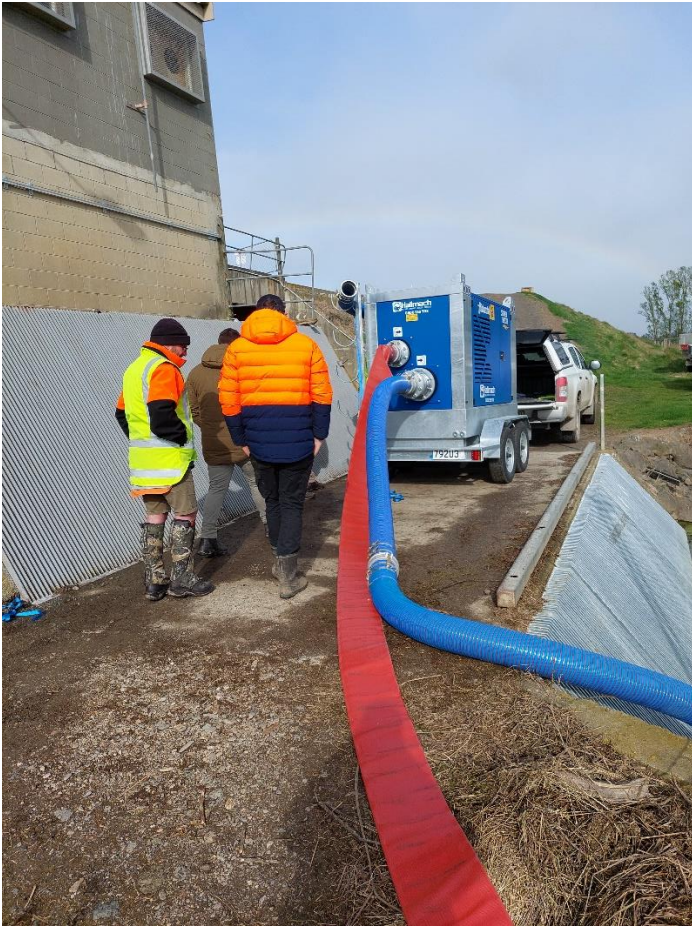
*Figure 9 October 2024 New pump being tested at Silverstream*

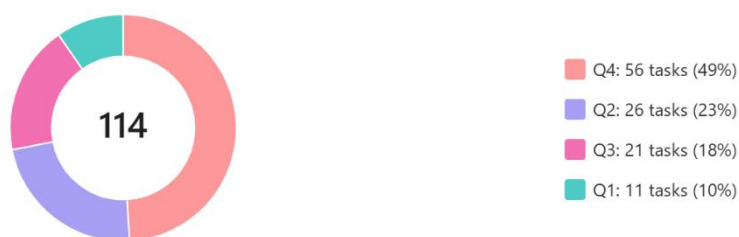
Figure 1. Scheduled Maintenance tasks by planned completion quarter

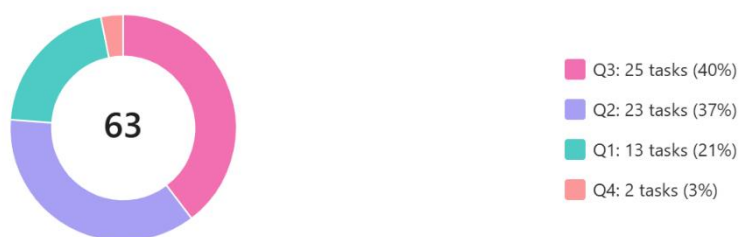
Figure 2. Scheduled Maintenance tasks by completion quarter

63 jobs completed out of the 114 of the scheduled jobs have been completed at the end of Quarter 3, the remaining tasks will be completed by 30 June 2025. This equates to 55% of the programme being completed to the end of Quarter 3. See Section 2 of this report for further commentary on the Operations work programme and this performance measure.

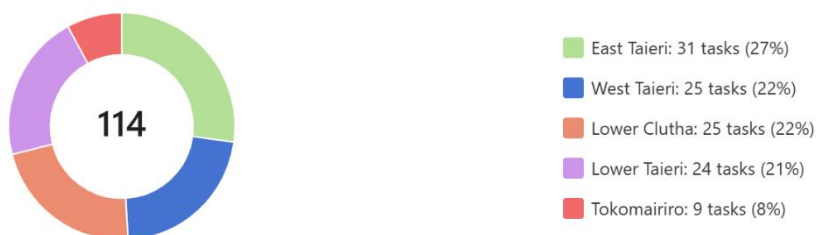
Figure 3. Scheduled Maintenance tasks by location

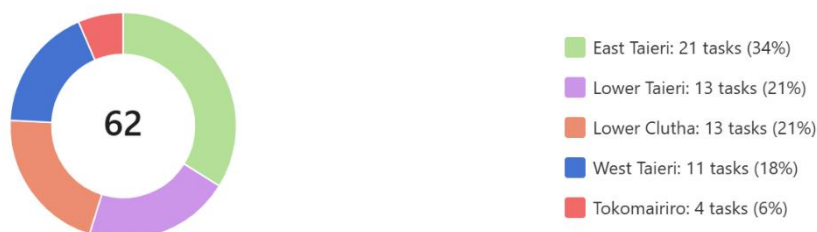
Figure 4. Scheduled Maintenance tasks completed in by location.

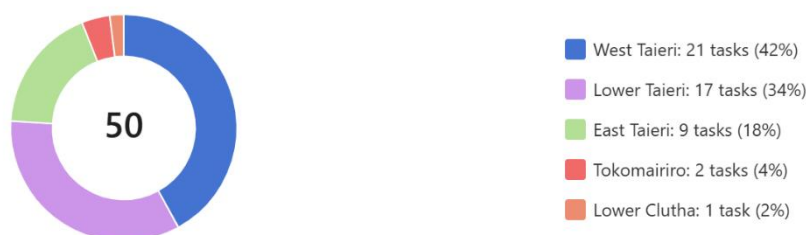
Figure 5. Reactive Maintenance tasks completed in by location

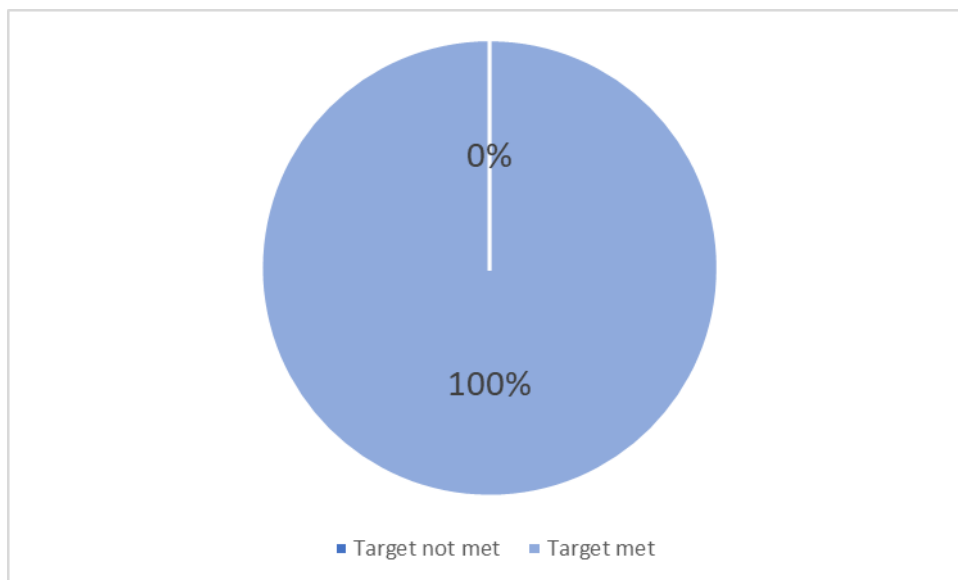
*Figure 6 Quarter 3 Project Status Update.*

For the 2024/5 financial ORC has 7 renewals projects that fall within the renewals programme KPI performance measure. All projects are currently on track to meet that planned milestone by year end.

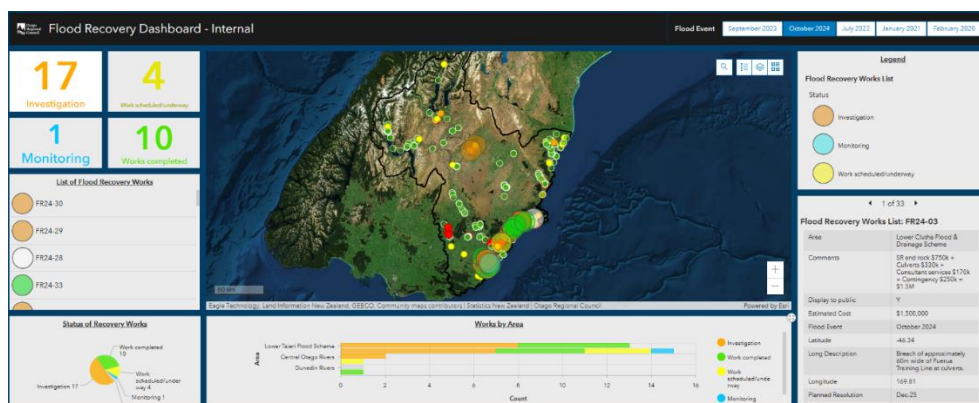
A flood repair and recovery programme is being established for this event. The programme will be established within the 3 month requirement and will be available to the public online as an interactive map showing repair sites, their programmed completion, and their status. The programme and map will be updated monthly as work progresses. The live repair programme can be viewed by visiting the following ORC webpage and clicking the link to the dashboard near the bottom of the page – [Flood Repair Programme | Otago Regional Council \(orc.govt.nz\)](https://orc.govt.nz/flood-repair-programme).

**Figure 7:** Flood recovery Work Dashboard - September 2023 weather event.

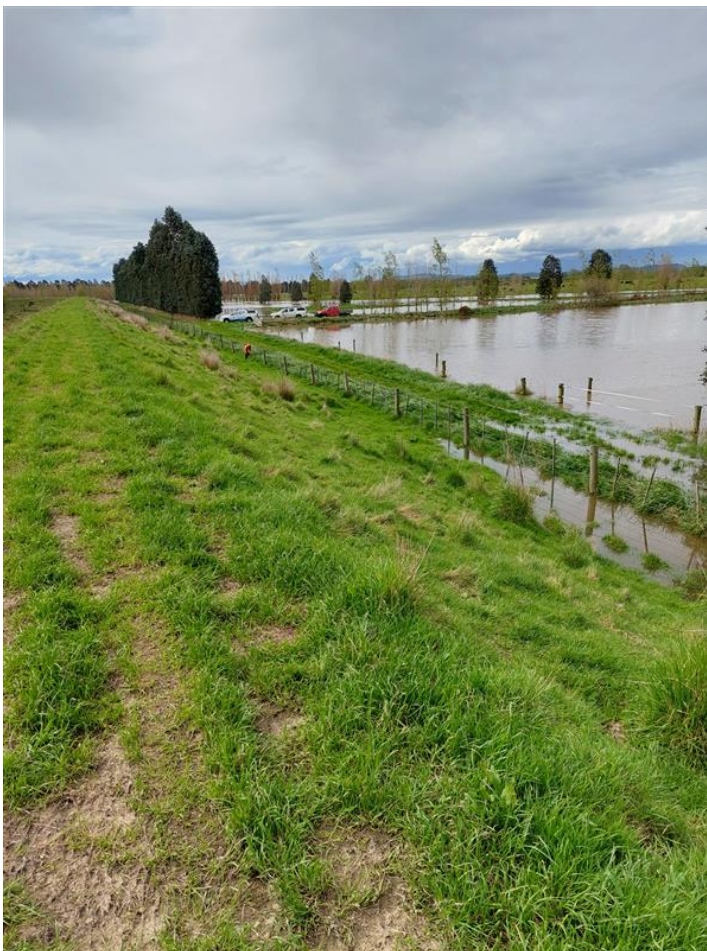
*Figure 9 October 24 Clutha visit after rain event*

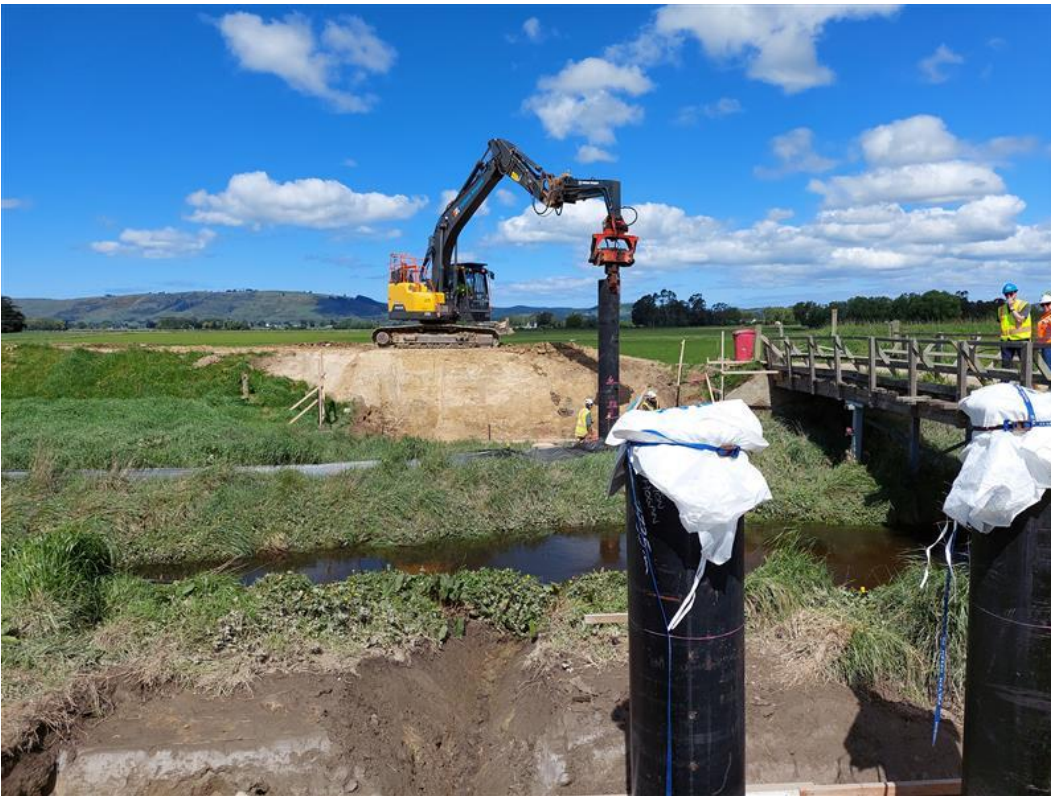
*Figure 10 Bridge 14 site works underway*

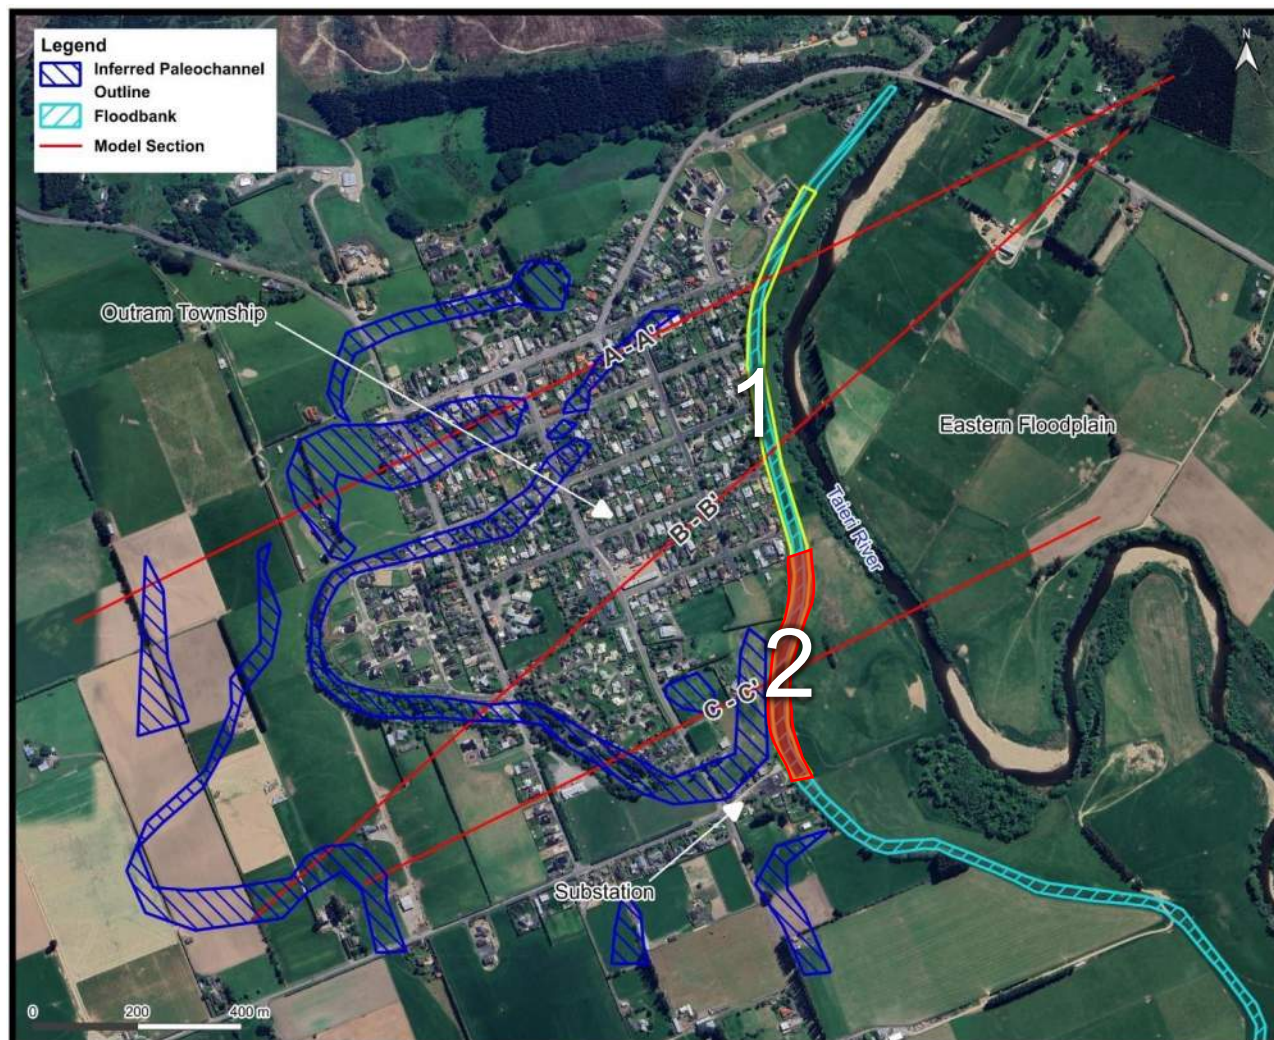
Figure 1-1. Overview Map of Outram Showing the Floodbank, Taieri River, Paleochannels, and 2D model Sections. The floodbank assessed in this report is outlined in yellow (Zone 1) and red (Zone 2). Paleochannels are inferred from Taieri Flood Hazard maps and LiDAR. (Image source: Google Earth)

An assessment of the floodbank was undertaken to determine the level of risk and potential type of floodbank failure, to provide high level remedial options for the floodbank, and to feed into a review of the Outram Flood Response protocols (to be carried out by others). An overview map of the site is shown in Figure 1-1.

The Taieri Flood Hazard map on the ORC Natural Hazards Database shows the paleochannels through Outram, which act as seepage pathways beneath the floodbank, and are particularly noticeable near the northern section at Holyhead Street and in the southern section at Bell Street (Figure 1-1). The open paleochannels are predominantly in the western half of the town and are currently utilised as natural storage / soakage areas within the town, with rainwater and manmade culverts diverting surface water into them. There appears to be no remaining surface outlet from the paleochannels.

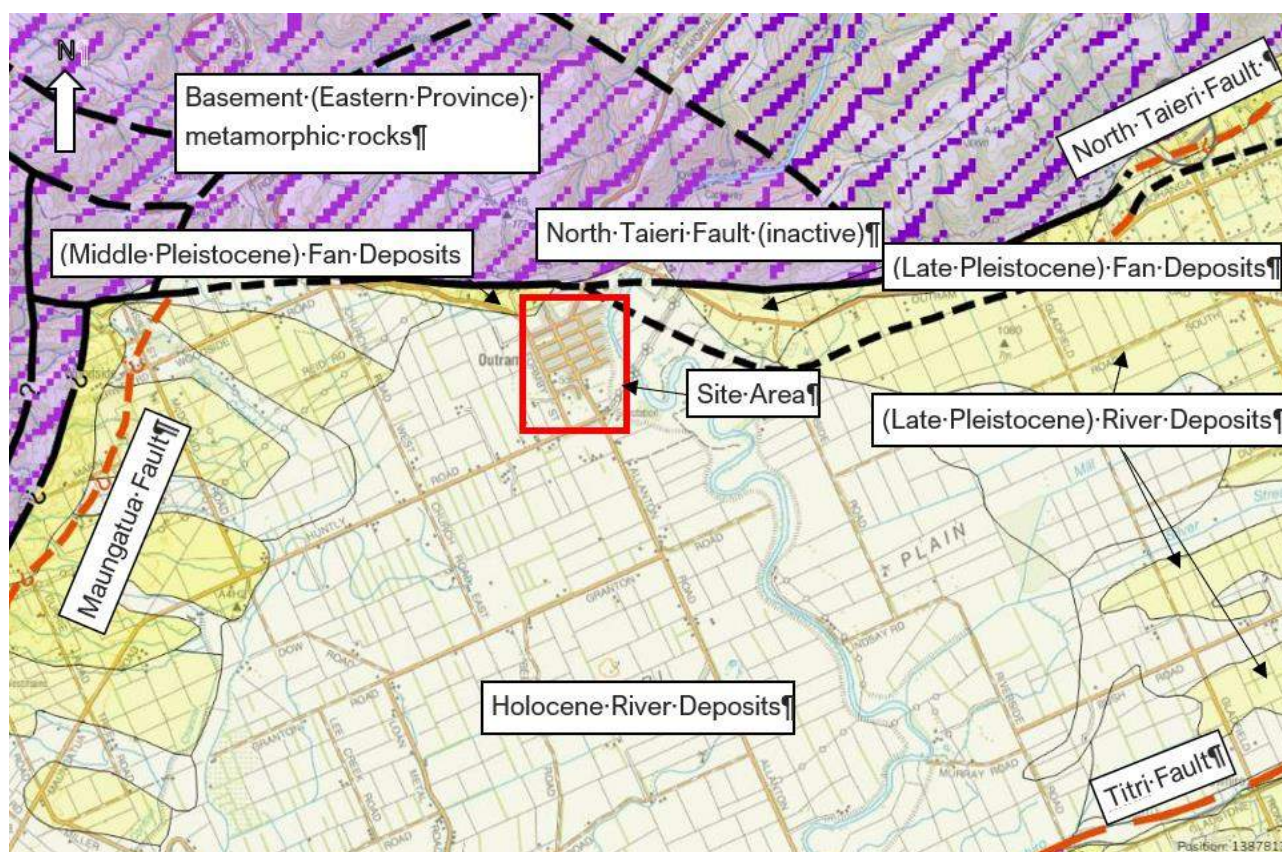
The main geological units in the Outram area are shown in Figure 3-1.

Figure 3-1. Annotated geological map of the area (Image source: GNS Webmap 250,000, not to scale).

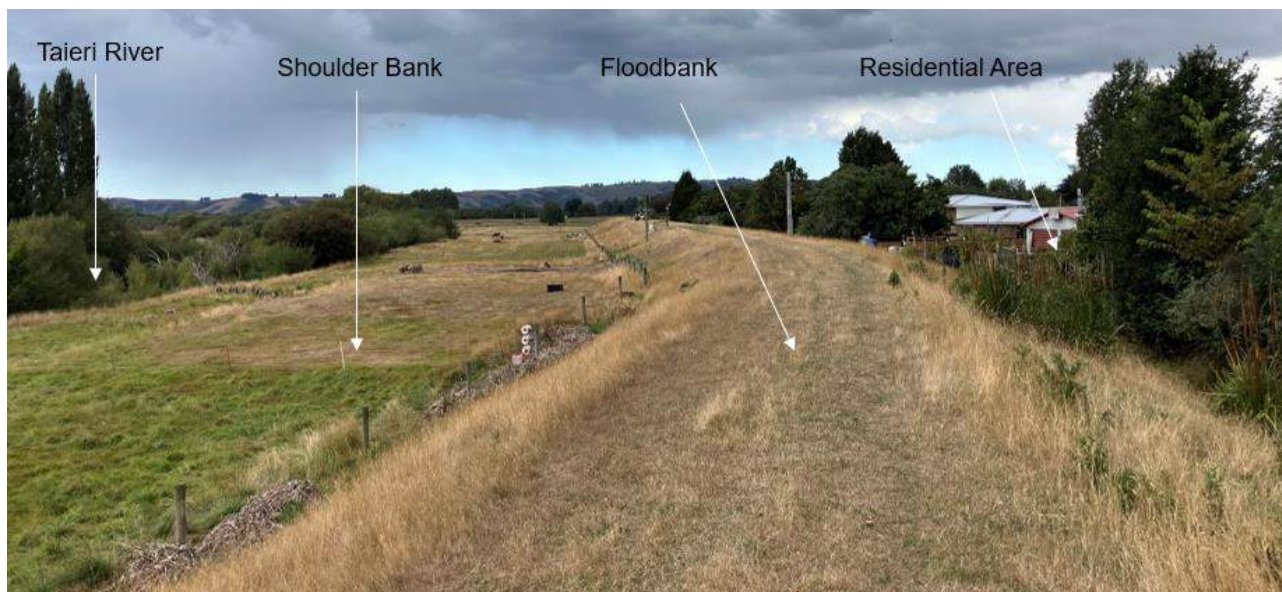
The elevation throughout the text is referenced to New Zealand Vertical Datum 2016 (NZVD2016) as meters reduced level (m RL). A photograph showing the floodbank, shoulder bank, Taieri River, and residential area is shown in Figure 3-2.

Figure 3-2. Photo of Floodbank, Shoulder Bank, Taieri River, and Residential Area (looking south, not to scale, Image source: Beca, 2024).

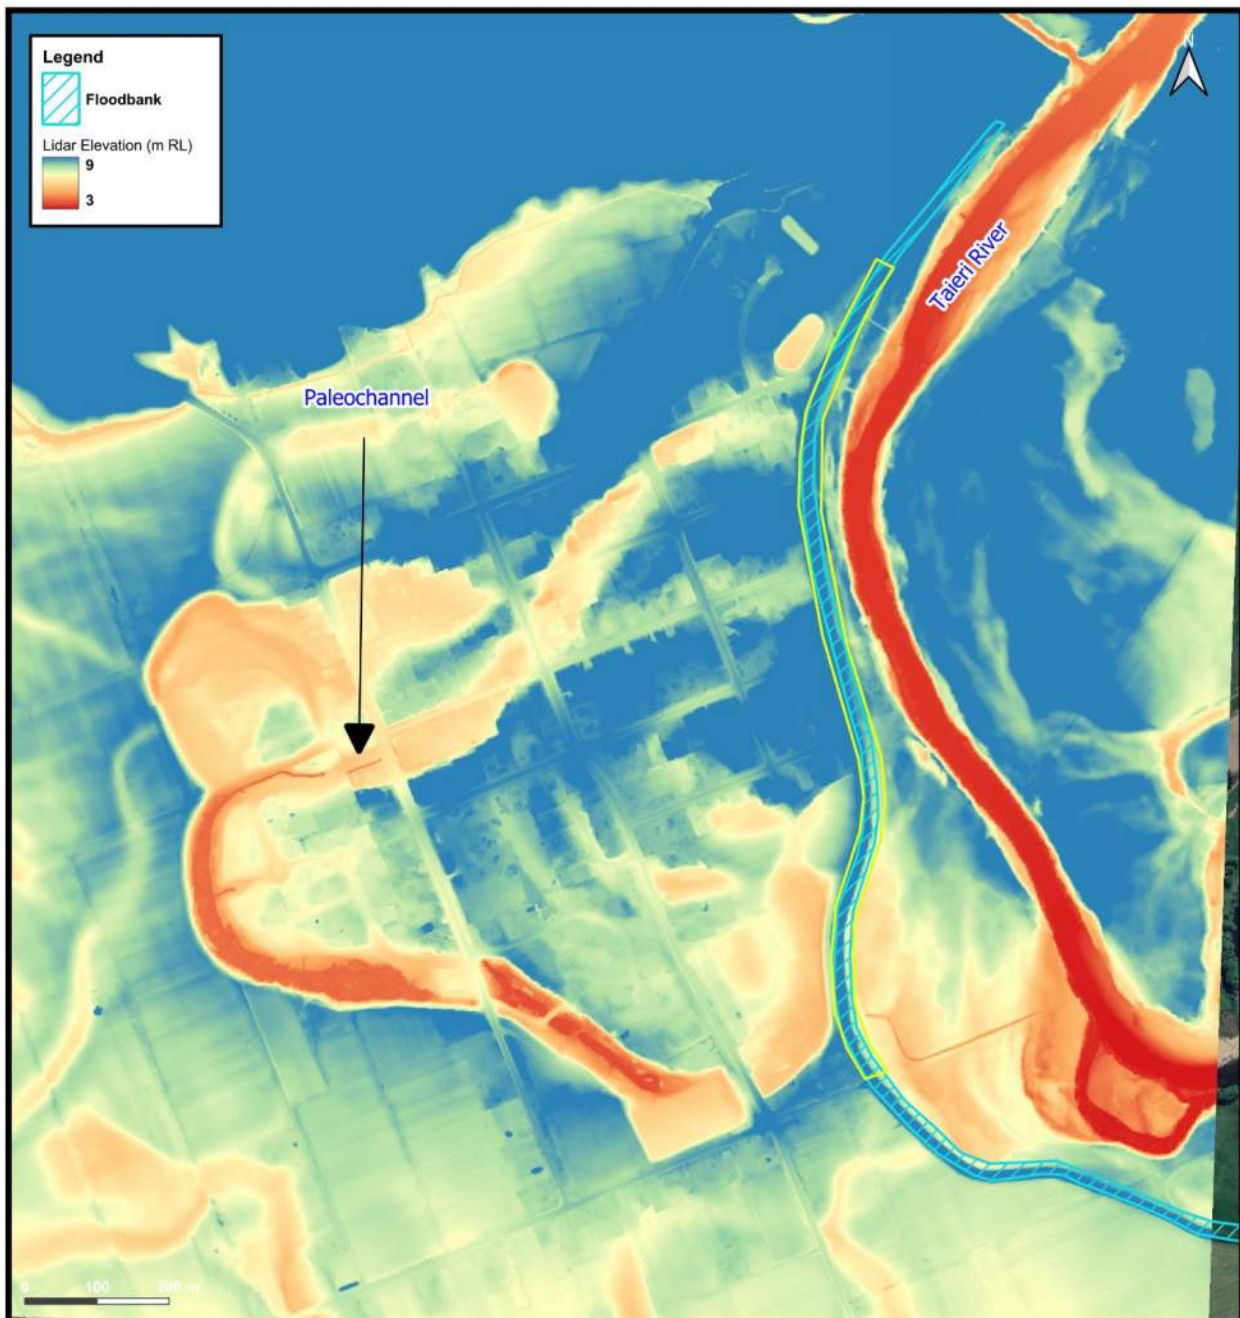
The paleochannels discussed in Section 1.3 once formed part of the Taieri River system but are no longer directly linked to the main river channel and have no discharge point. Some portions of the paleochannel network have been infilled during the development of the township, and others were in their natural state with some holding water year-round. The open channels are utilised to capture surface water runoff, with an open meandering stream in the western portion of the town, near the Taieri Rugby Club, which has no clear outlet to the river or drainage system. The paleochannels are the first places to intercept rising groundwater levels, and will hold some surface runoff, hence play an important part in runoff conveyance and storage. The paleochannels can be observed in Figure 3-3 as red areas to the left (west) of the floodbank.

Figure 3-3. Map of LIDAR (2021) ground topography of the Outram area (created in QGIS), with the paleochannels and Taieri River channel indicated in red having the lowest elevation. The assessed floodbank is shown in yellow.

Paleochannels once formed part of the Taieri River system but are no longer directly linked to the main river channel and have no discharge point. The paleochannels are discussed in Section 3.1.2 and shown in Figure 3-3. ORC's overland flow path and paleochannel map is shown in Appendix F.
