# TAIERI LIAISON GROUP AGENDA

## 1. MEETING DETAILS

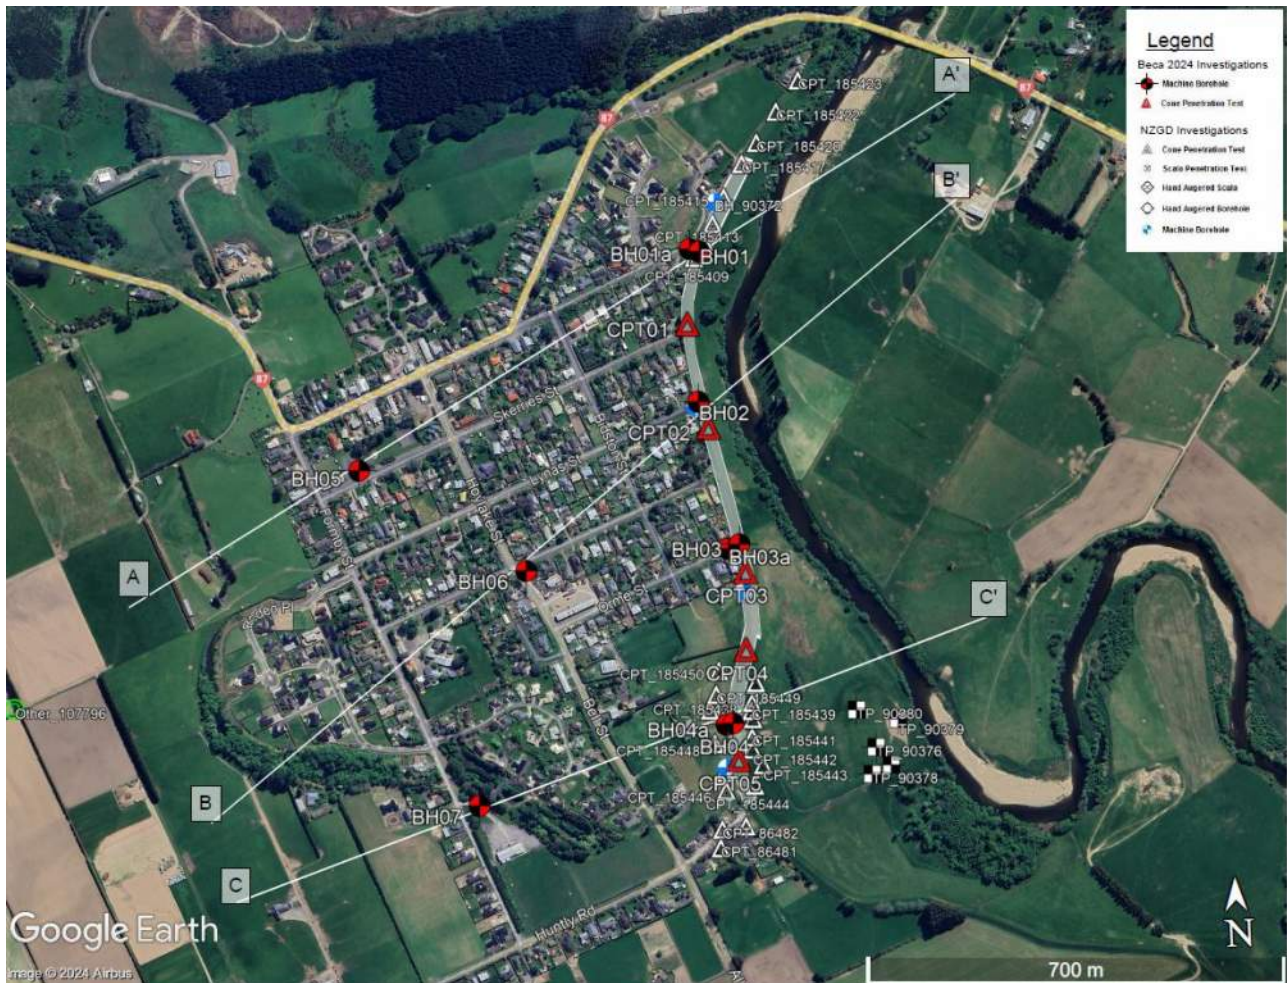
Existing geotechnical information reviewed as part of this assessment included bore logs from water bores available from the ORC database, investigation data from the New Zealand Geotechnical Database (NZGD), and limited data from previous assessment reports by others in the area. The existing investigations are shown in Figure 4-2, along with testing undertaken as part of this scope of works and associated cross-section locations are presented in Figure 4-1.

Figure 4-1. Beca 2024 and NZGD investigation locations, and corresponding cross sections used for analysis. (Image source: Google Earth)

A representative ground profile is summarised in Table 5-1. Cross sections are presented in Appendix C with cross section locations shown on Figure 4-1. Note that this ground profile is representative only, and actual conditions across the site are variable.

Three cross sections were cut through the floodbank and into the wider Outram township on the 3D geological model. These profiles have been selected based on the proximity to ground investigation testing, locations of the paleochannels, and seepage observed during previous flooding. These cross-section locations are shown on Figure 4-1.

The floodbank geometry (presented in Section 6.1.1) was generally consistent throughout the site, and the profile locations and associated zones are shown on Figure 4-1 and Figure 4-2. Zones 1 and 2 indicate similar levels of anticipated performance. The models have been run assuming the following:

The floodbank locations used for the breach modelling were mostly consistent with the cross-section locations used for the slope stability and seepage analyses discussed in Sections 8 and 10, respectively. Figure 4-1 shows these cross-section locations. Although these other analyses have used three cross sections, the breach modelling has only been undertaken for breaching of the floodbank at sections A-A and C-C, as agreed with ORC. This is because an additional set of model results for a breach at section B-B is unlikely to provide any additional understanding to the project.

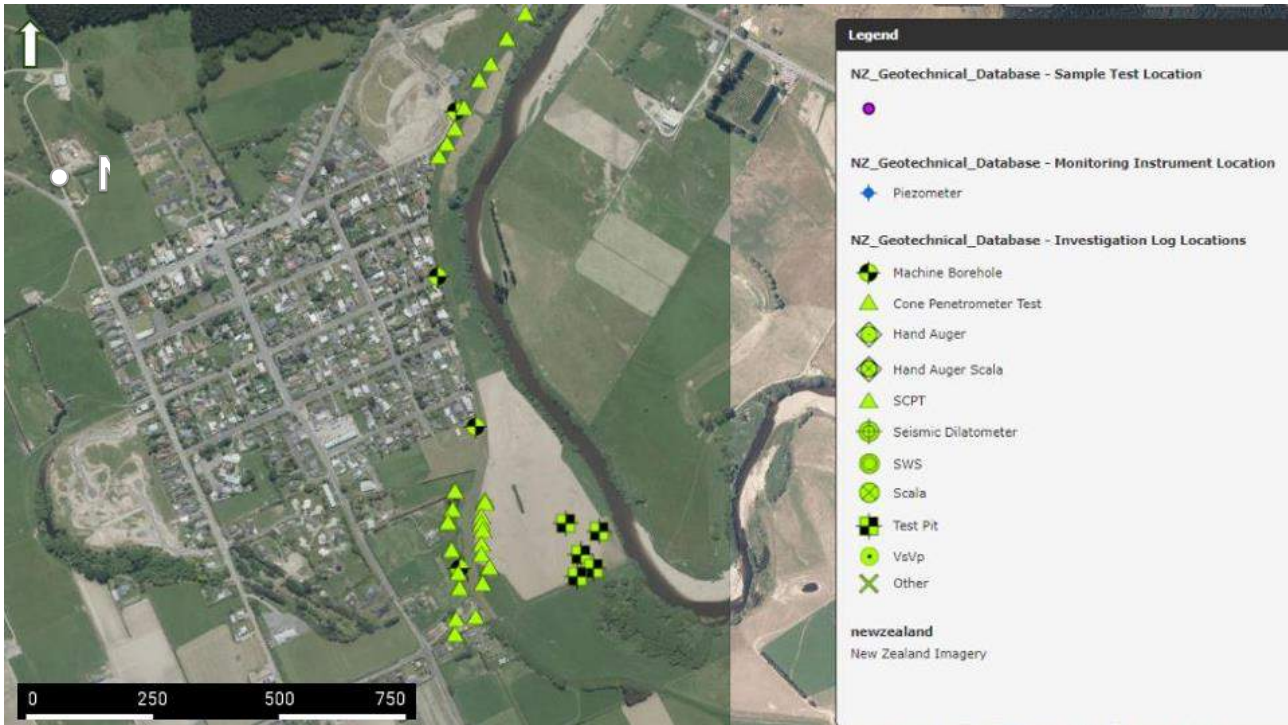
A review of publicly available data on the NZGD (presented on Figure 4-2) shows the nearest available existing data consisted of:

- 5 test pits, terminated between 2.3 m and 4.1 m bgl, approximately 120 m east of the floodbank.
- 8 CPT tests, terminated from 12 and 15 m bgl along the northern part of the floodbank (BH01 to SH87).
- 18 CPT tests, terminated between 8.1 m and 15.2 m bgl along the southern part of the floodbank between the substation and 48 Bell Street.
- 4 boreholes, terminated between 6.0 and 6.3 m bgl along the landside toe of the floodbank.

Figure 4-2. Geotechnical data near the site (Image source: New Zealand Geotechnical Database, not to scale).

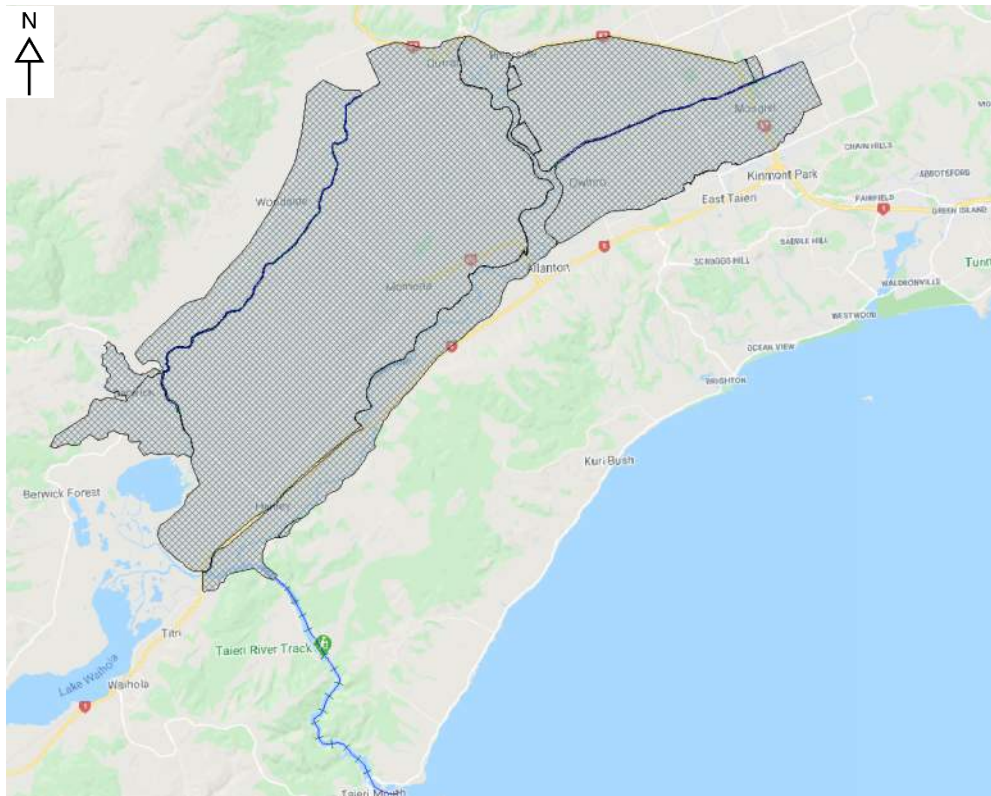
Due to covering most of the Lower Taieri floodplain, the HEC-RAS model was large and complex. Figure 9-1 has been copied from 20210121 Taieri Model Development Report DRAFT and shows the model extent.

Figure 9-1. Extent of HEC-RAS model provided by ORC. Figure taken from 20210121 Taieri Model Development Report DRAFT (not to scale).

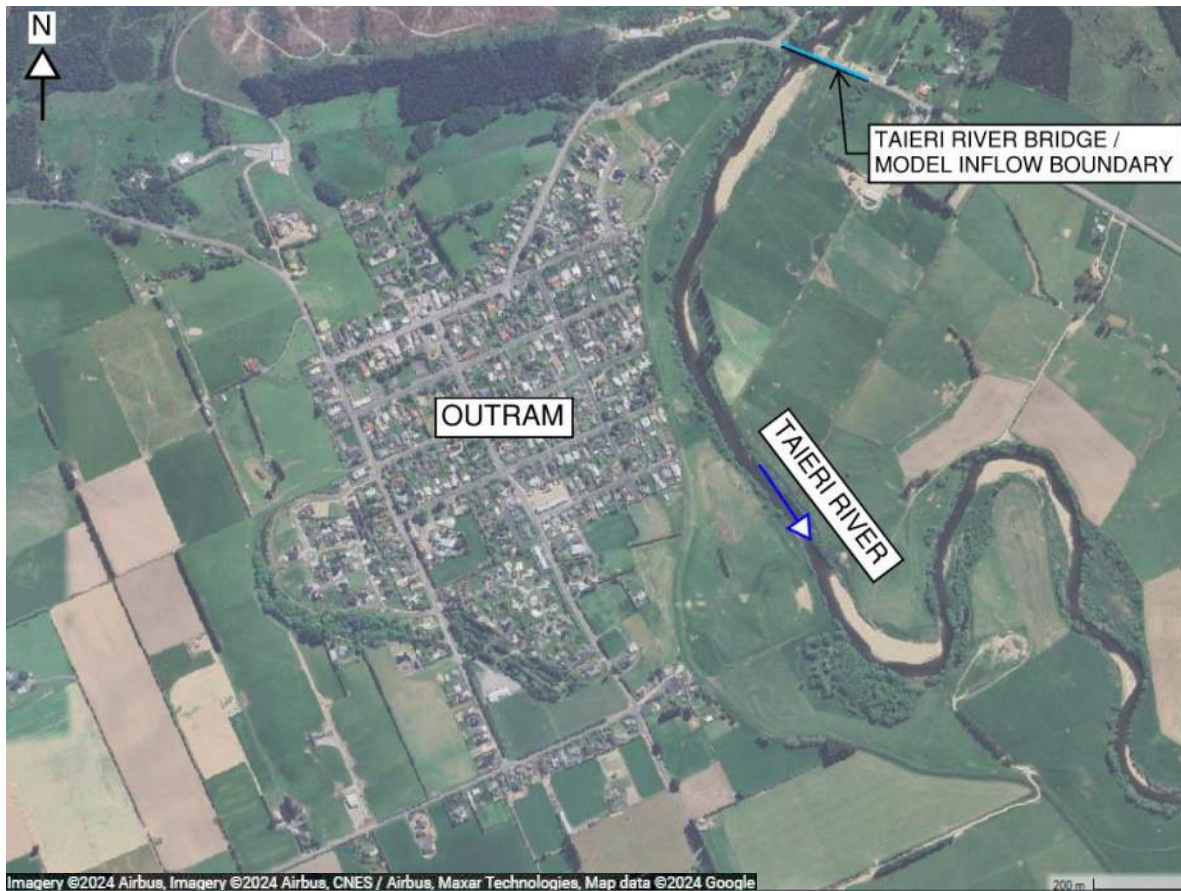
Outram is located at the northern extent of the model, immediately downstream of the Taieri River inflow boundary. Figure 9-2 shows Outram, the adjacent reach of the Taieri River, and the model inflow location for the Taieri River.

Figure 9-2. Locality plan of area of Outram and Taieri River. Changes to the HEC-RAS model provided by ORC have been limited to this area (Image source: Google Earth).

The following sections of this report focus on the details of the HEC-RAS model for the extents shown in Figure 9-2. The details of the model outside of these extents have not been changed as part of this project and can be found in *20210121 Taieri Model Development Report DRAFT*.

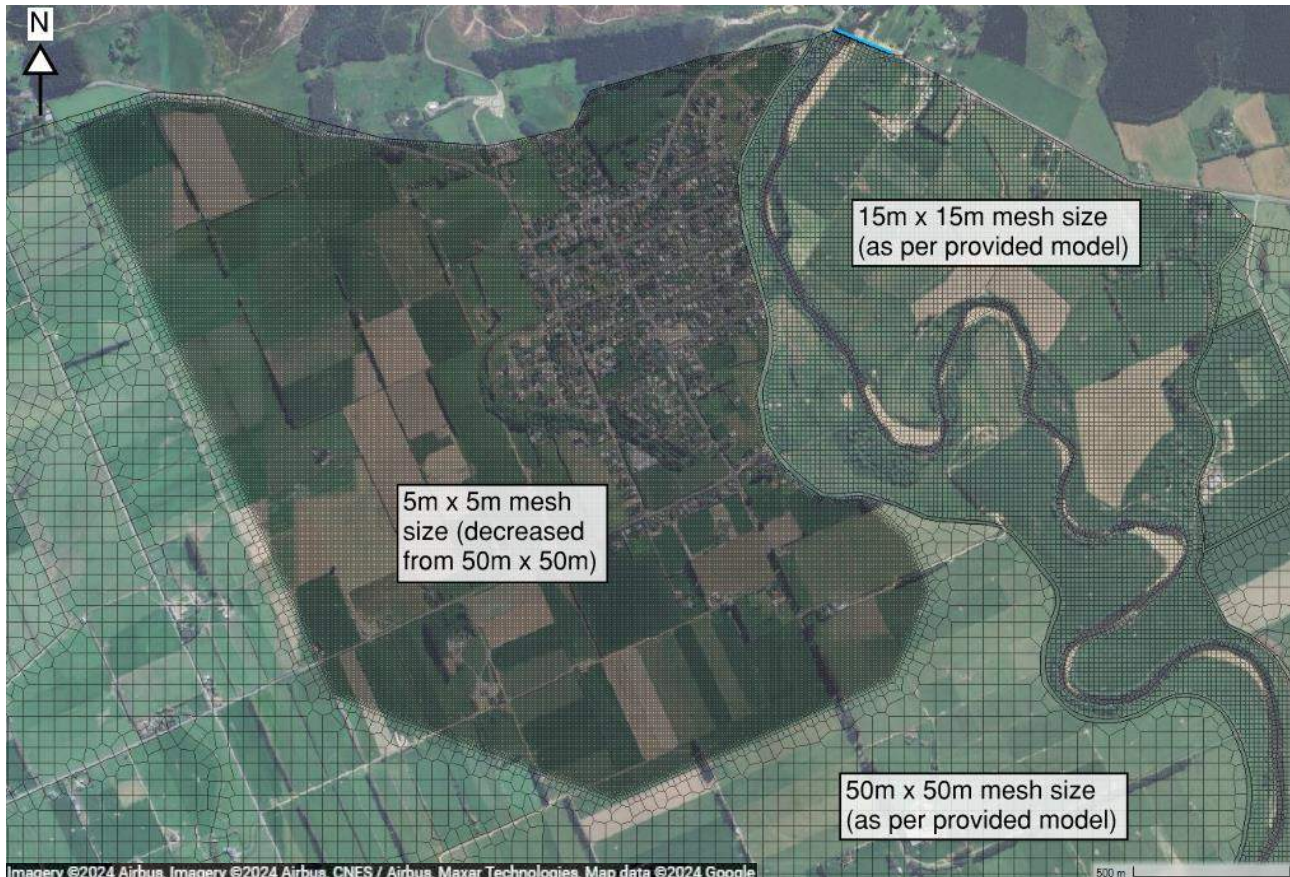
The ORC provided model has a mesh resolution of 50 m x 50 m for Outram and its surrounds. As ORC want to understand the flood risk to different properties and roads, particularly roads that provide escape routes out of the town. A mesh size of 50 m x 50 m is relatively coarse and is unlikely to provide results that are appropriate for this level of detail, so we have added a refinement region to reduce the mesh size to 5 m x 5 m for the area shown in Figure 9-3.

Figure 9-3. HEC-RAS model mesh resolutions within area of interest (Image source – Google Earth).

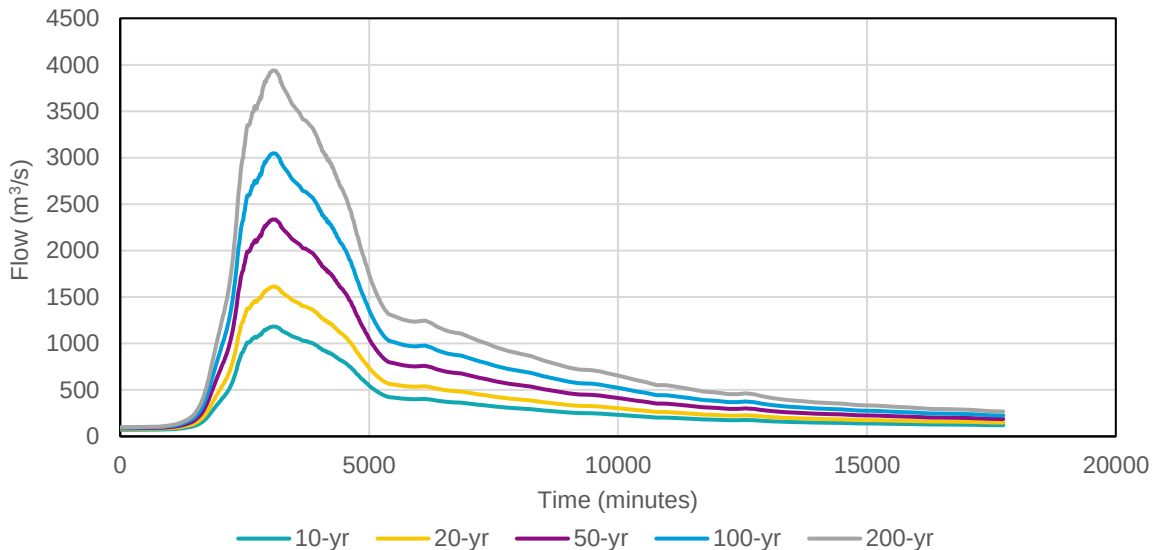
Figure 9-4. Design hydrographs for Taieri River at Outram. Copied from Figure 19 of '*20210121 Taieri Model Development Report DRAFT*'.

The report *20210121 Taieri Model Development Report DRAFT* provided by ORC discusses how 50 years of historic flow data have been used to estimate design flows and hydrograph shapes for the Taieri River at Outram. Figure 9-4 has been copied from the report and shows these design hydrographs.

The provided HEC-RAS model contained hydrology files setup for the hydrographs shown in Figure 9-4, other than the 200-year. We created an inflow hydrograph for the 200-year design event for use in the breach modelling by plotting the hydrograph for the 100-year event and scaling it to the 200-year peak design flow of 3,939 m<sup>3</sup>/s (taken from Table 12 of *20210121 Taieri Model Development Report DRAFT*).

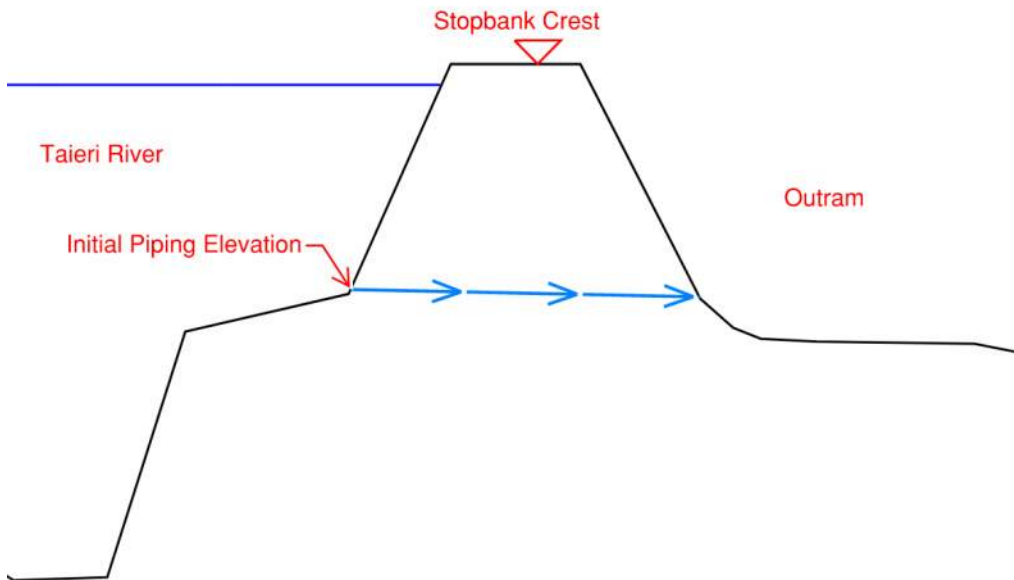
Figure 9-5. Cross section sketch of the Taieri River floodbank showing the initial stage of piping failure.

HEC-RAS requires a range of inputs to model floodbank breaching caused by piping failure. These inputs are summarised in Table 9-1. Refer to Figure 9-5 and Figure 9-6 for diagrams showing what these inputs represent.

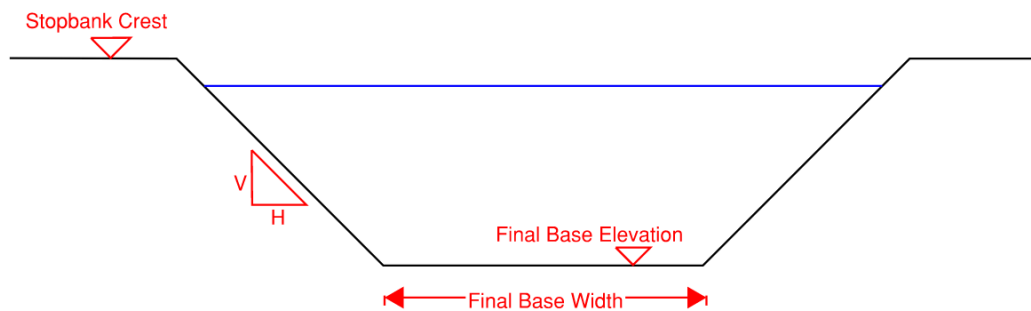
Figure 9-6. Long section sketch of fully developed breach profile.

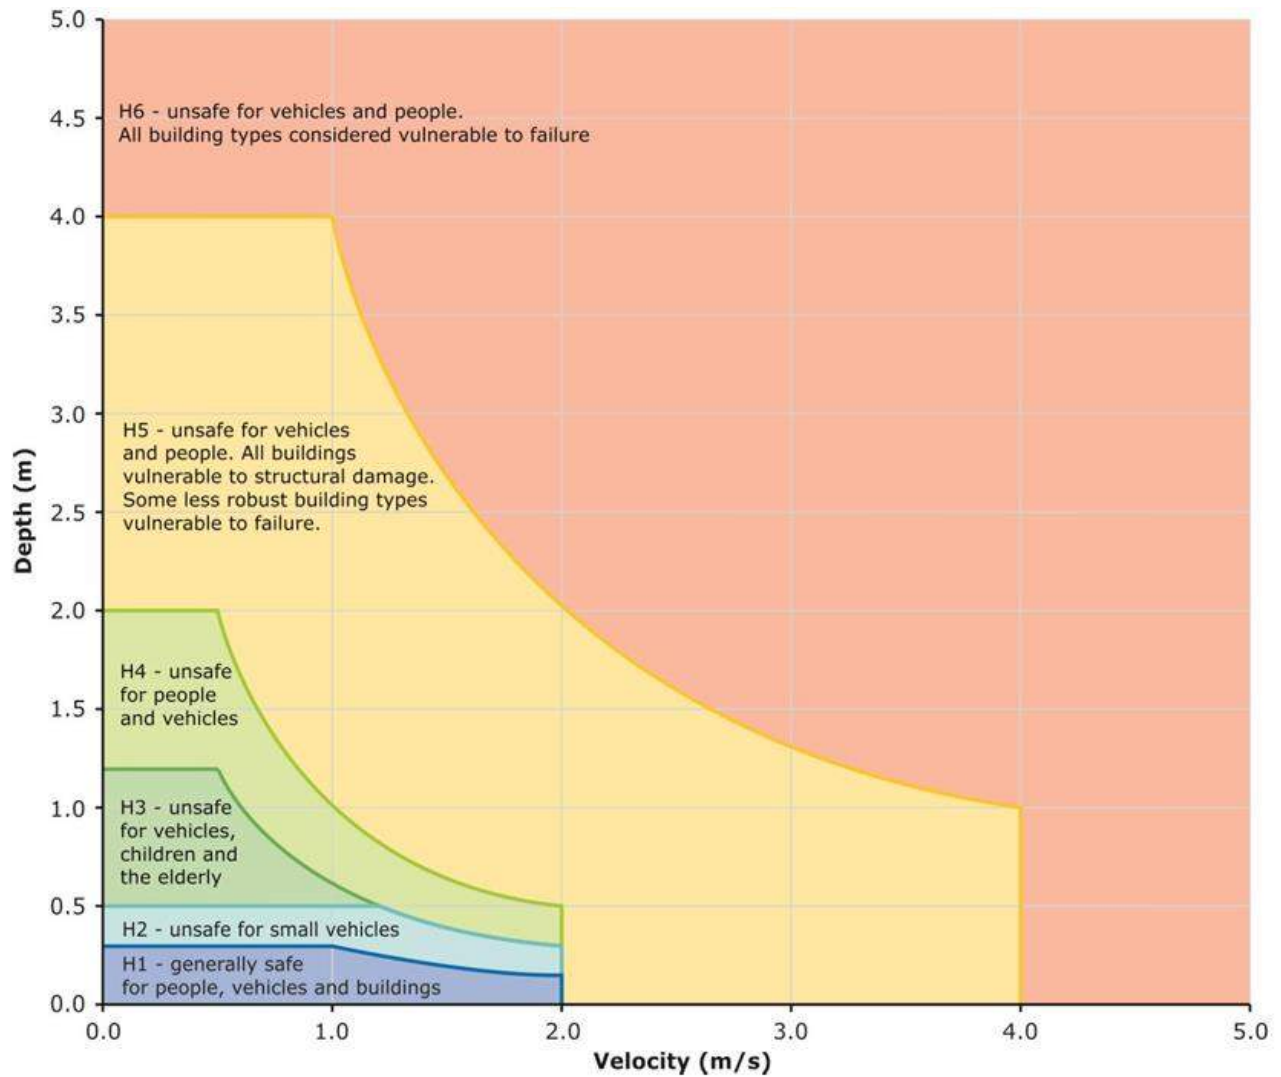
Figure 9-7. General flood hazard vulnerability curve.

For assessing flood hazard as part of this project, we have adopted the combined flood hazard curves produced by Smith et al. (2014) and reported in Australian Rainfall and Runoff (2019). Figure 9-7 presents these flood hazard curves, which reflect the vulnerability of people and assets when interacting with floodwater, as a combined function of water depth and velocity.

The number of buildings in the higher hazard categories (H3-H6) are relatively similar, while there is more variance in the lower hazard categories (H0-H2). Figure 9-7 shows that buildings are susceptible to structural failure in H5 and H6. There are a reasonably high number of buildings (roughly 25% of Outram's buildings) located within these hazard categories for each of the breach locations.

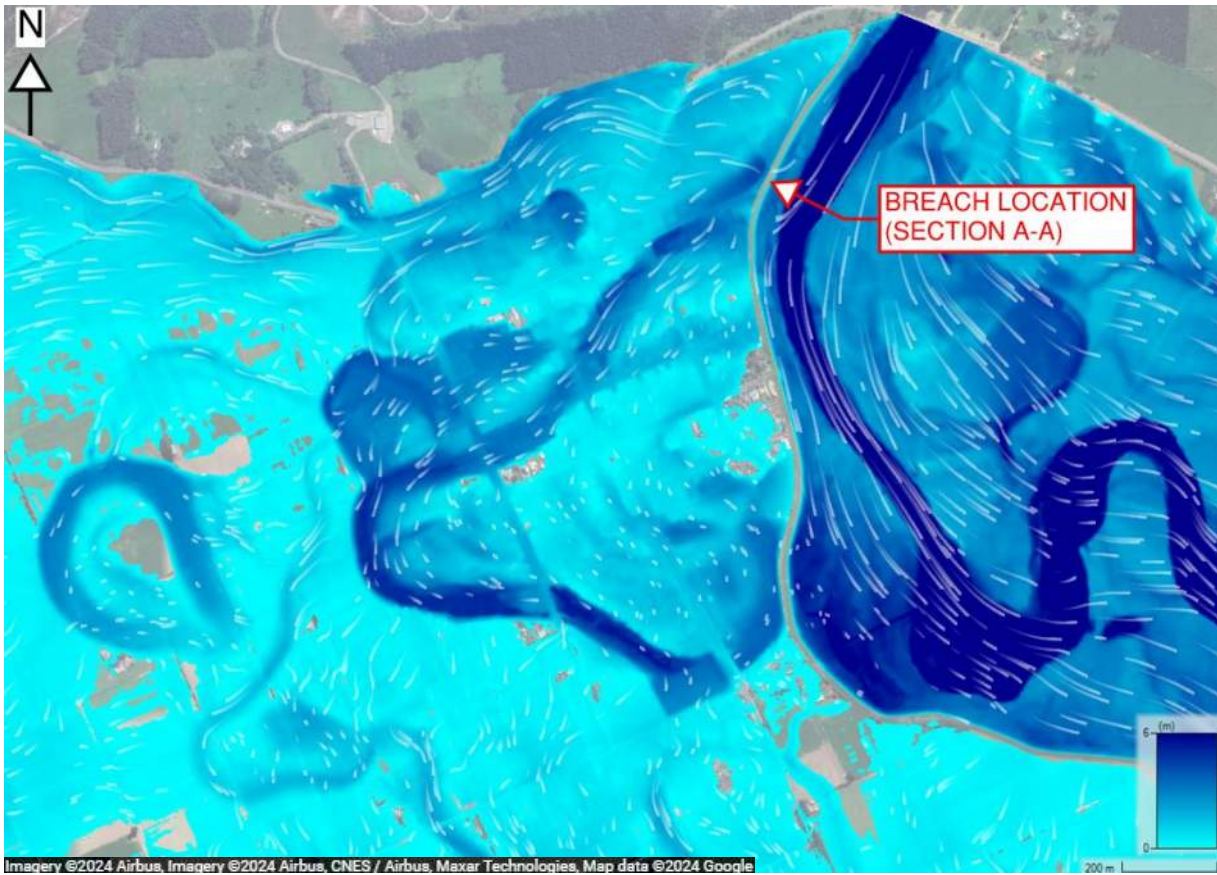
Figure 9-8. Maximum water depth model results for floodbank breach at Section A-A (Image source: Google Earth).

Results maps showing the maximum water depths for each of the breach model simulations are shown in Figure 9-8 and Figure 9-9.

These results show significant inundation of Outram for both breach locations. The paleochannels (discussed in Section 3.1.2) appear to initially act as natural overland flow paths for floodwater and represent the deepest areas of inundation (up to almost 6 m water depth).

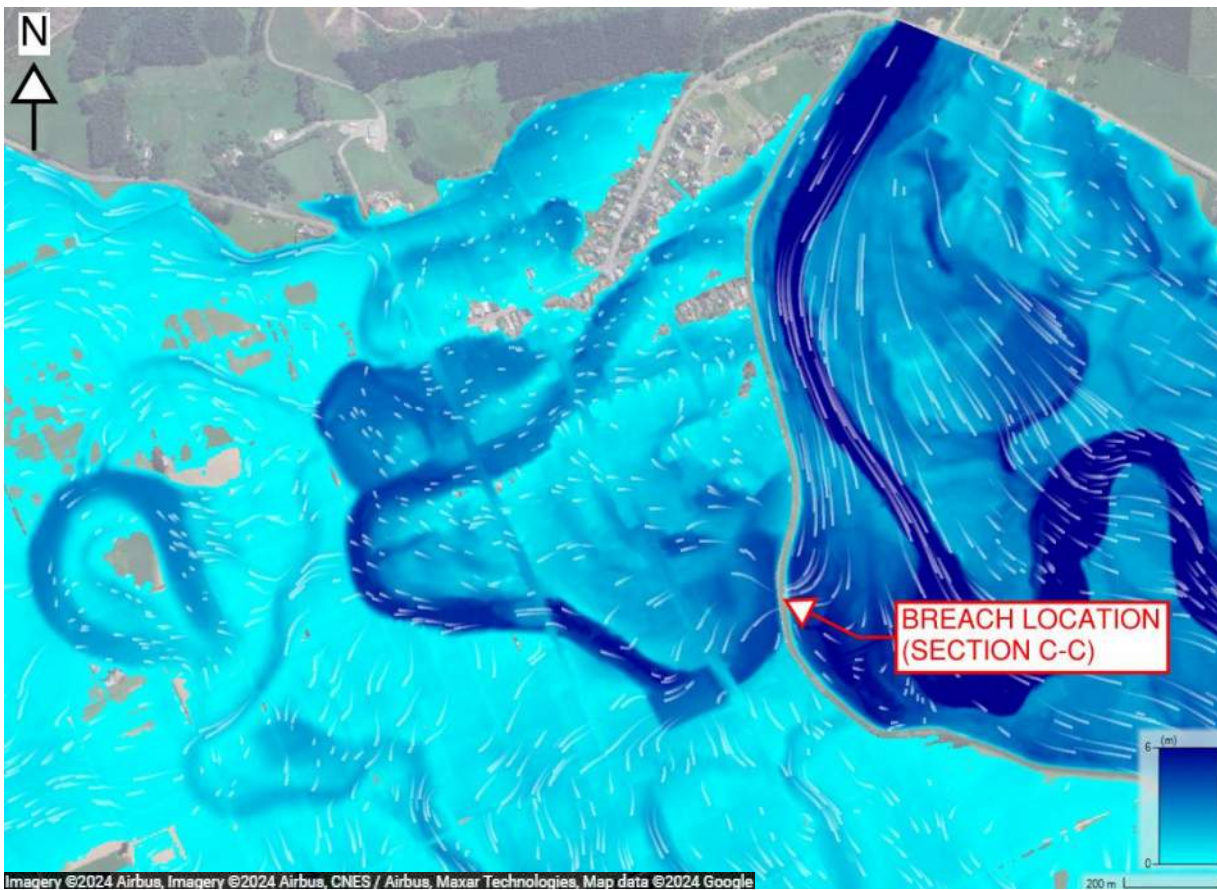
Figure 9-9. Maximum water depth model results for floodbank breach at Section C-C (Image source: Google Earth).

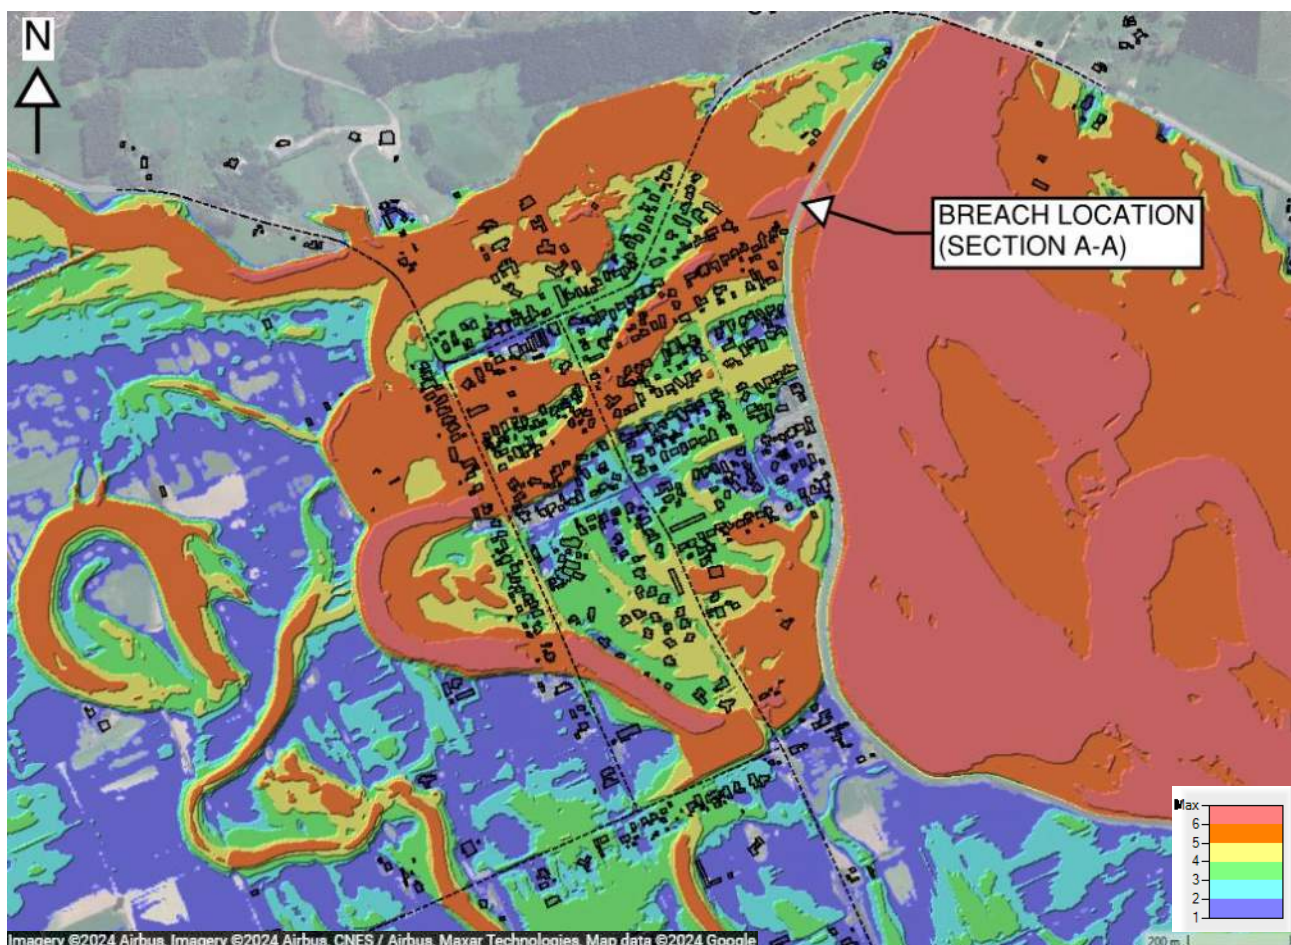
Figure 9-10. Flood hazard map for floodbank breach at Section A-A (Image source: Google Earth).

Figure 9-10 and Figure 9-11 show the flood hazard maps for each of the breach locations. We have included the NZ *Building Outlines* layer from LINZ to show what individual buildings sit within the different hazard categories. We have also included the centrelines of the public roads providing access in and out of Outram to show the viability of residents using these roads to escape flooding.

The flood hazard maps are similar for the two breach locations. In both cases the paleochannels (and areas adjacent to the channels) show a combination of mostly H5 and H6, representing areas of significant flood hazard. The flood hazard in other areas throughout Outram varies between no hazard and H4. The results are discussed in more detail in the following sections.

The roads shown as black dashed lines in Figure 9-10 and Figure 9-11 are the only public roads that provide access out of Outram. The hazard maps (and other results included in Appendix G) show that a breach at both locations has a significant impact on these access routes.

Figure 9-10 shows that the breach at section A-A causes all access routes to be cut off by areas of H5, meaning that most people located within Outram would have no way of evacuating the town once a breach has developed. Figure 9-11 shows that the breach at section C-C would have similar impacts, except State Highway 87 appears to provide a safe exit route from buildings located in the northern part of the town. It's important to note that the model inflow boundary for the Taieri River is located on the downstream side of the bridge, meaning that the impact of the flood event on the bridge has not been investigated as part of this project. This would need to be done to confirm whether State Highway 87 does in fact provide a safe access route from some of the town in the event of a floodbank breach at section C-C.

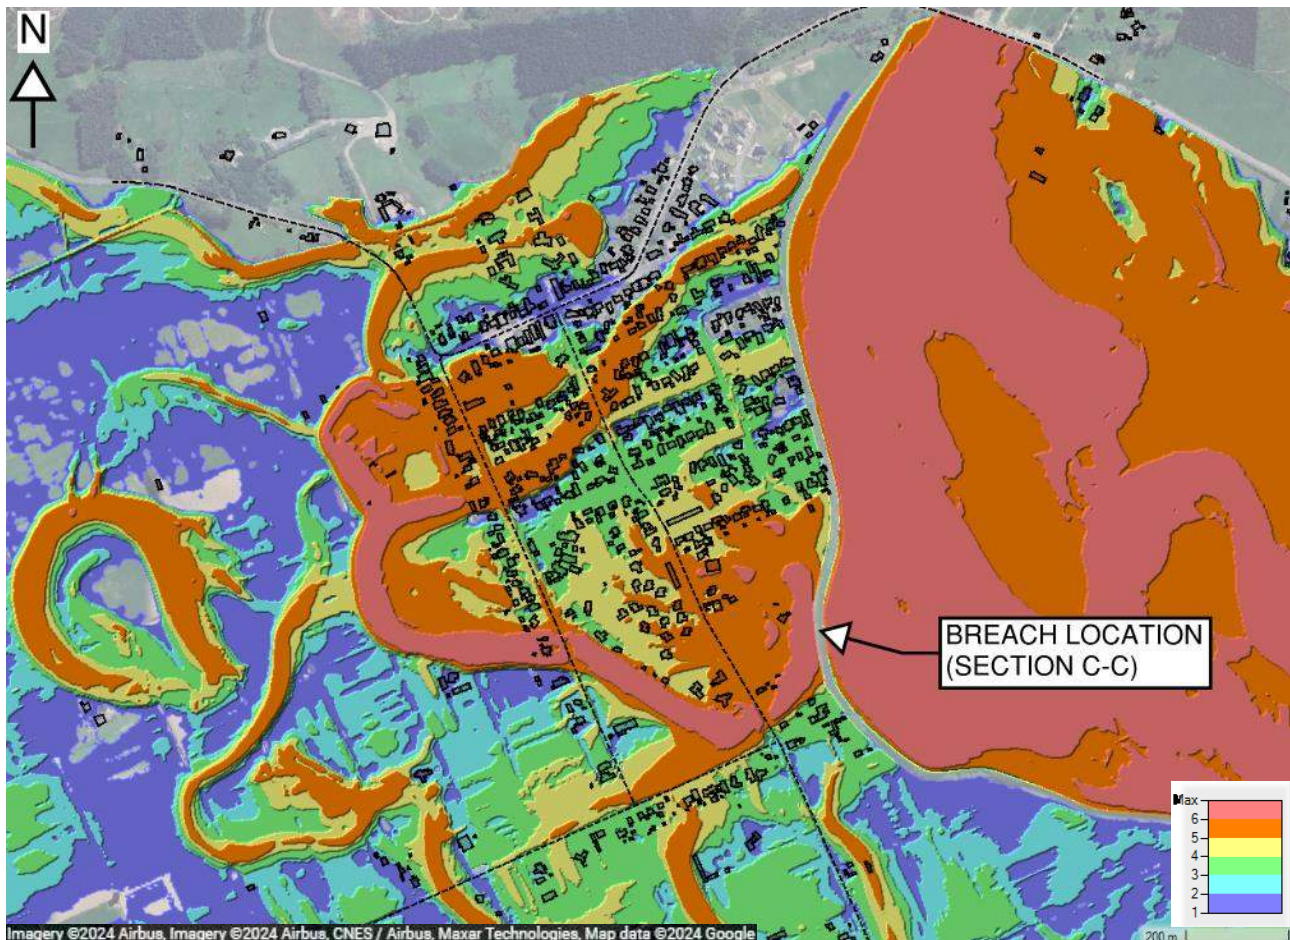
Figure 9-11. Flood hazard map for floodbank breach at Section C-C (Image source: Google Earth).

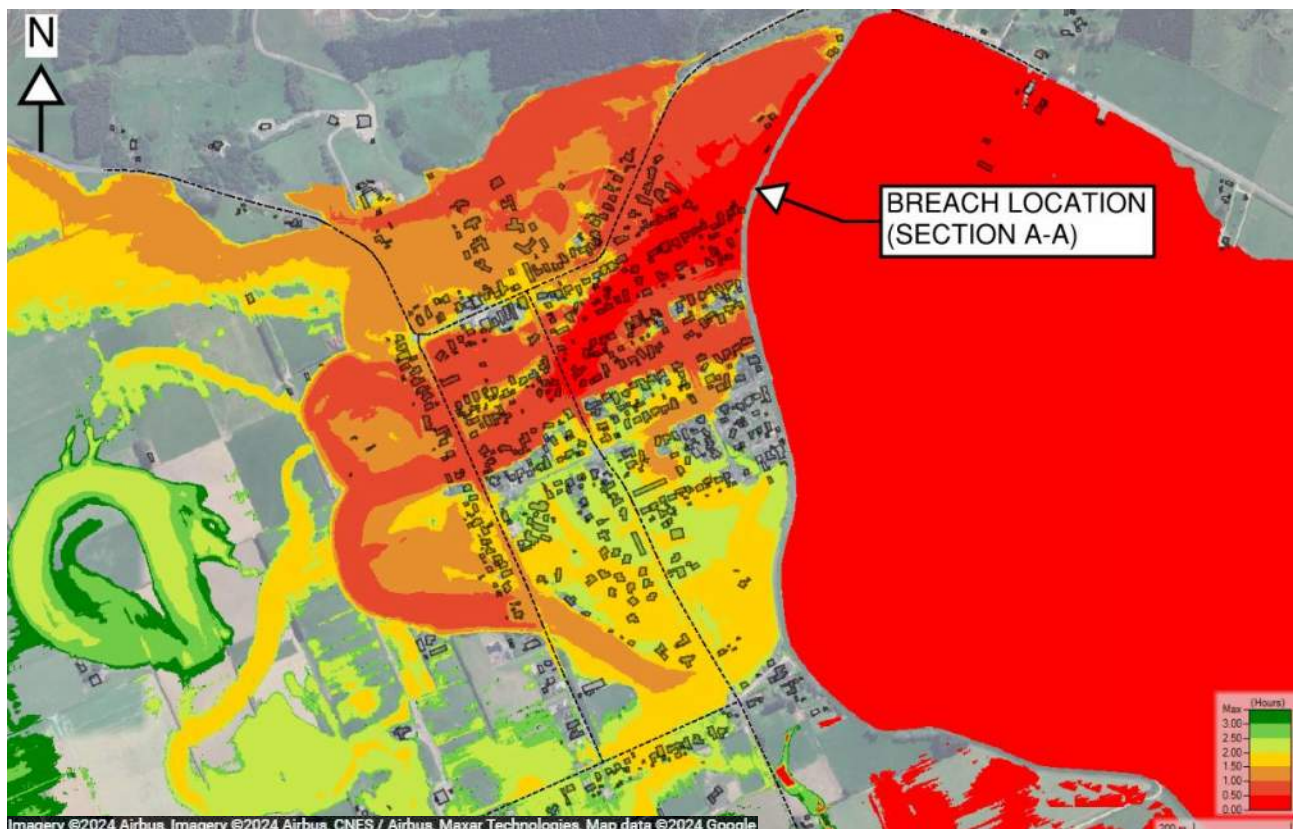
Figure 9-12. Arrival time results map for breach at section A-A. Colours represent time taken since beginning of breach formation for water depth to reach 0.30 m (Image source: Google Earth).

The results generally indicate that people will have a longer time window to evacuate the further they are from the breach site, as would be expected. For a breach at section A-A the roads on the south side of Outram would likely provide the most suitable means of leaving the town, while the roads on the north side of town would be most suitable for a breach at section C-C.

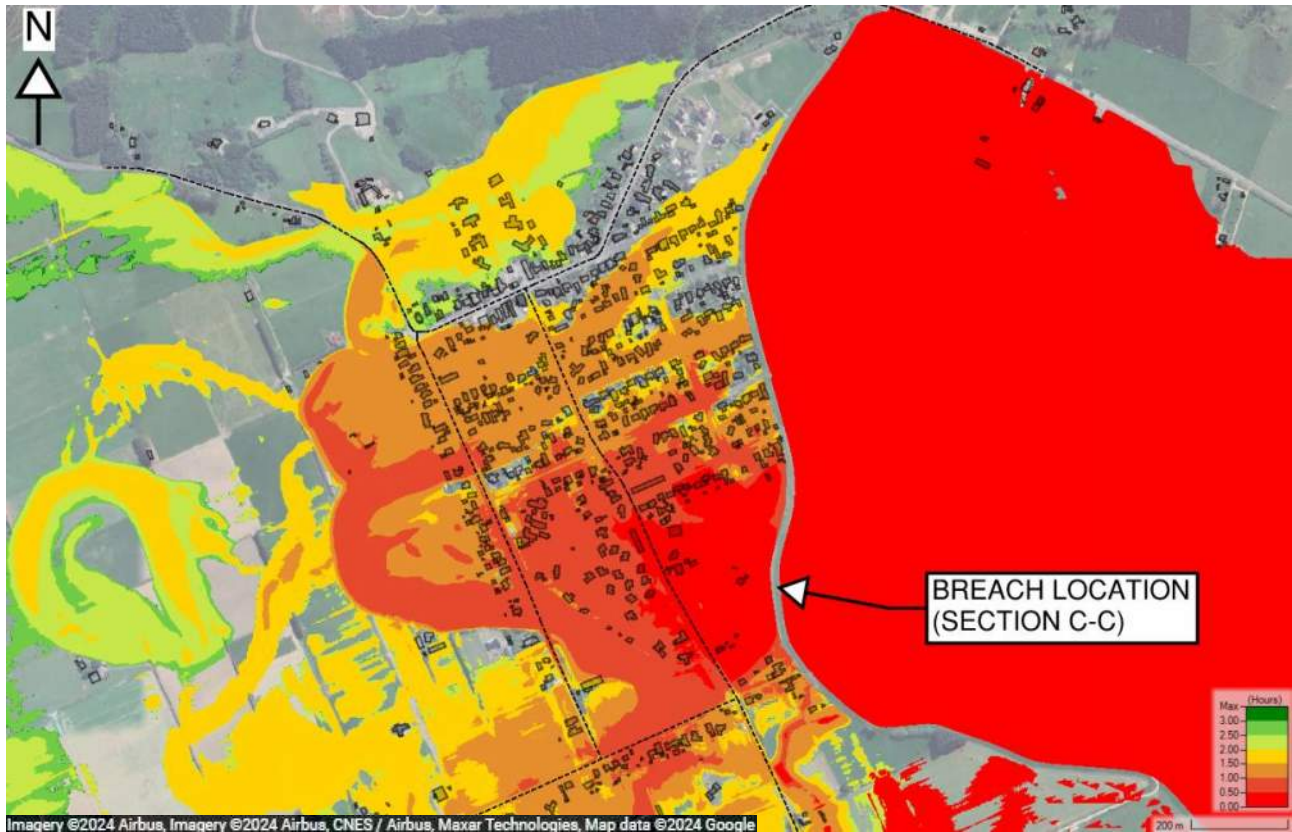
Figure 9-13. Arrival time results map for breach at section C-C. Colours represent time taken since beginning of breach formation for water depth to reach 0.30 m (Image source: Google Earth).

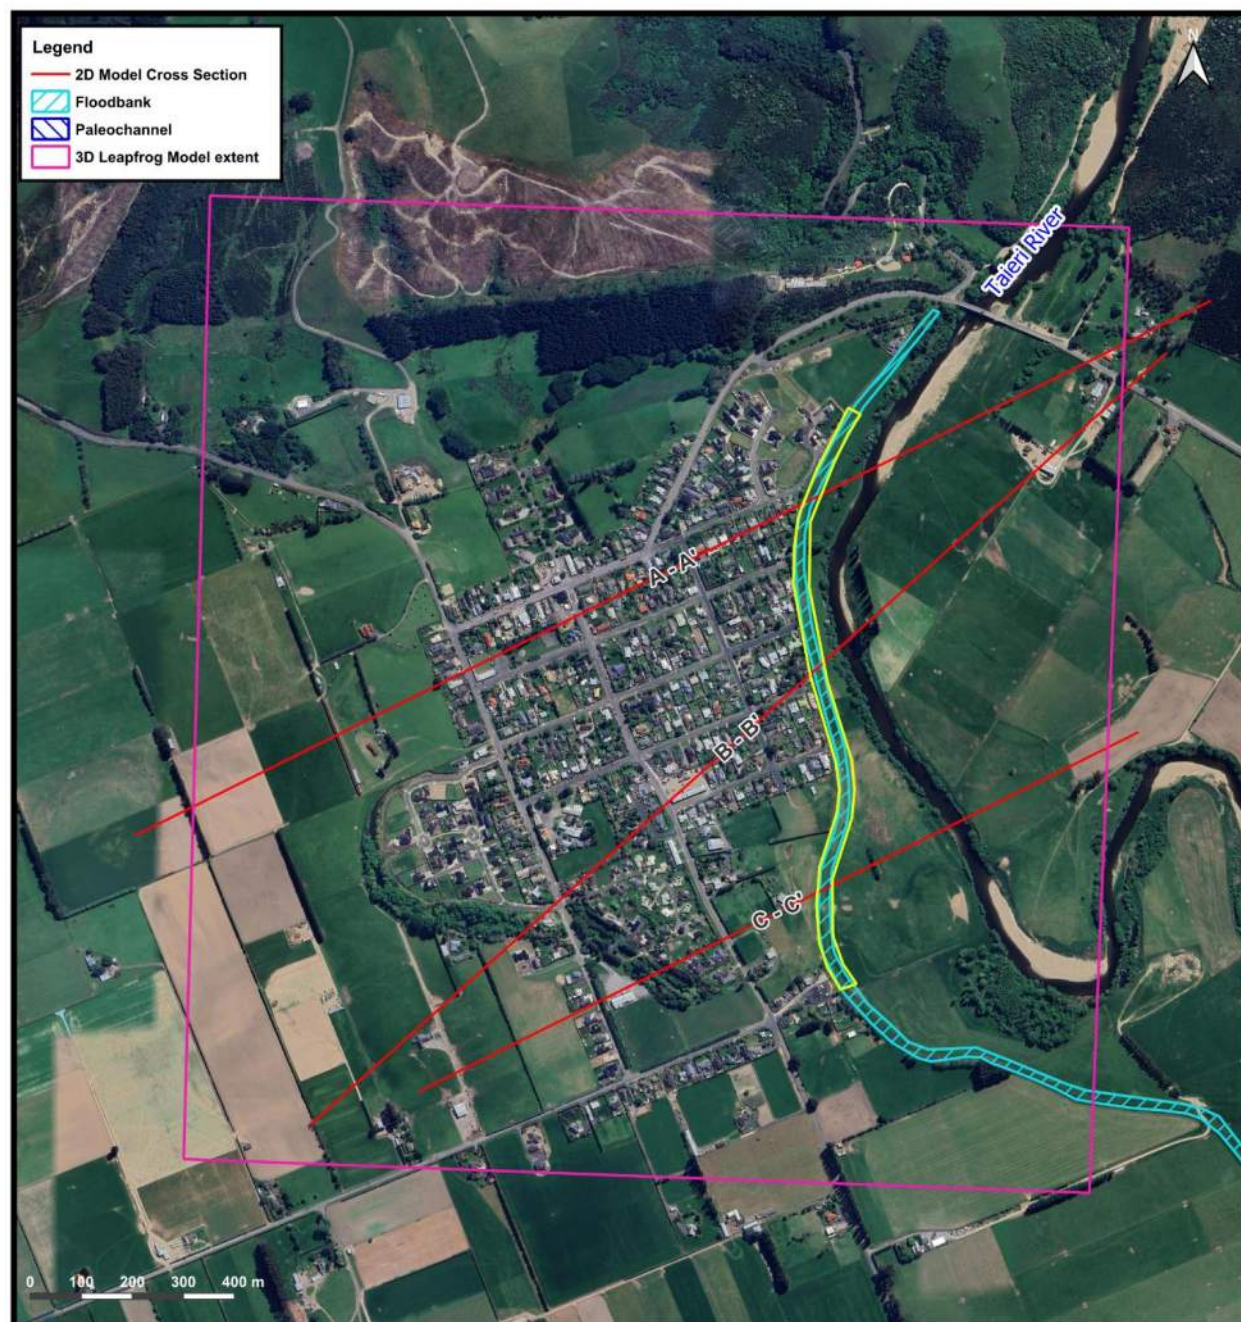
Figure 10-1. Overview map of Outram, its key features, and the Leapfrog and SEEP/W Model Extents. (Image source: Google Earth)

Each 2D groundwater model is centred through the Outram Township and the floodbank, extending beyond the Township extent to the west, and beyond the floodbank and Taieri River in the east. The cross-section locations are shown in 2D in Figure 10-1.

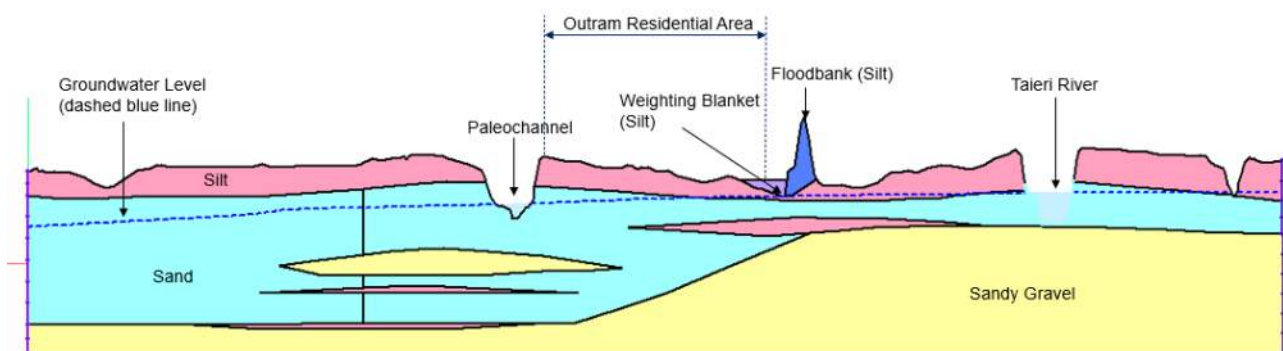
Figure 10-2. C – C' Cross Section Showing the Distribution and Thickness of Hydraulic Units (Note: 15x vertical exaggeration).

While the hydraulic properties of each unit were kept the same in each section, their depths and extents vary in each model, which was based on available borehole data. The silt provides increased hydraulic separation between the gravelly sand and sandy gravel and the floodbank and can be seen in Figure 10-2 (note that the figure has 15 times vertical exaggeration).

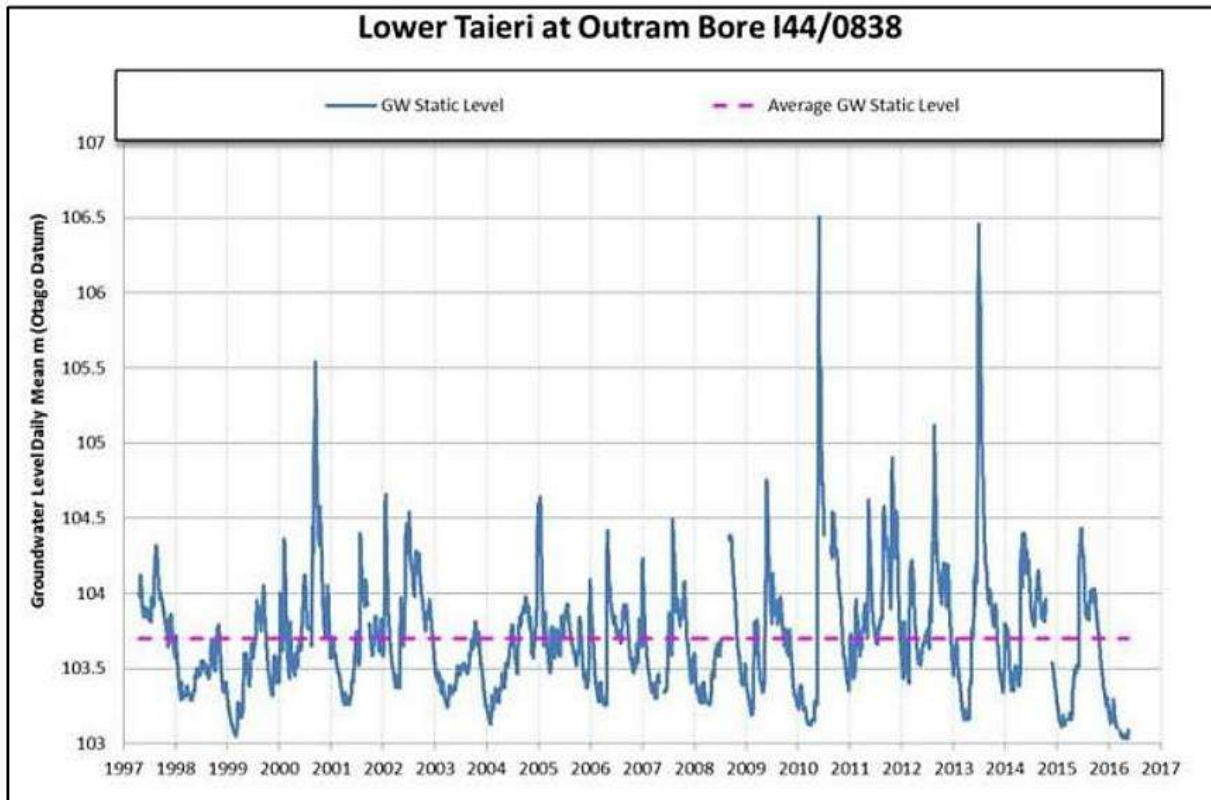
Figure 10-3. Groundwater Levels at Bore I44/0838 on Orme Street in Outram from 1997 to 2016.

To derive an approximate seasonal range in groundwater levels, historic groundwater levels in bore I44/0838 on Orme Street were found, beginning in April 1997, shown in Figure 10-3 (note that the data references the Otago Datum). The important point to take away from this data is the seasonal range, which is about 1.5 m, with some short periods of significantly higher groundwater level in 2000, 2010, and 2013.

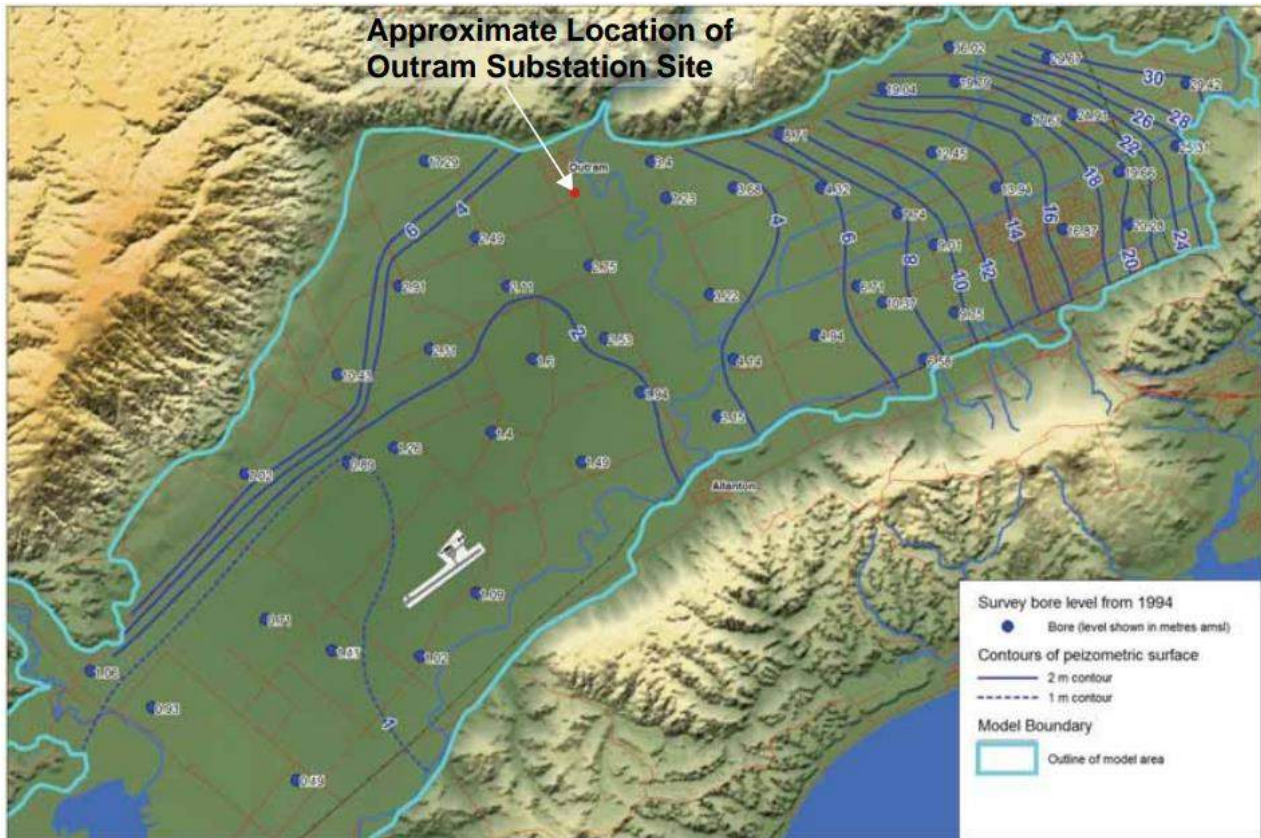
Figure 10-4. Contours / potentiometric surface from the 1994 survey of Groundwater Levels. Source: ORC, 2010. Lower Taieri Groundwater Allocation Study Report.

The direction of regional groundwater flow is broadly from the northeast to the southwest. Regionally, groundwater moves perpendicular to the contour lines as shown in Figure 10-4.

- The groundwater gradient is from east to west (right to left on Figure 10-9) with higher head near the river and lower head on the western side of Outram. This reflects the trend of regional piezometric head shown in Figure 10-4.
