# TAIERI LIAISON GROUP AGENDA

## 1. MEETING DETAILS

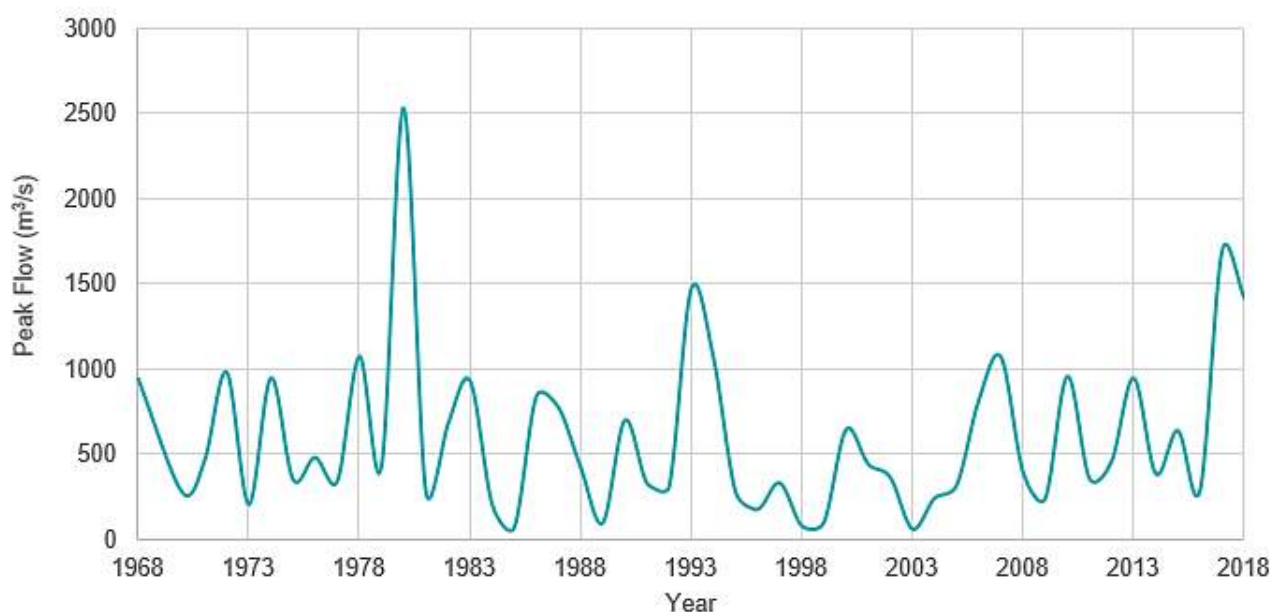
Figure 10-5. Taieri at Outram Annual Maxima Series. (Source: ORC, 2021)

The peak river flows recorded in the Taieri River in Outram each year over 50 years from 1968 to 2018 are shown in Figure 10-5. Note the large spike in 1980 which corresponds with a large flood event which resulted in significant damage in the local area.

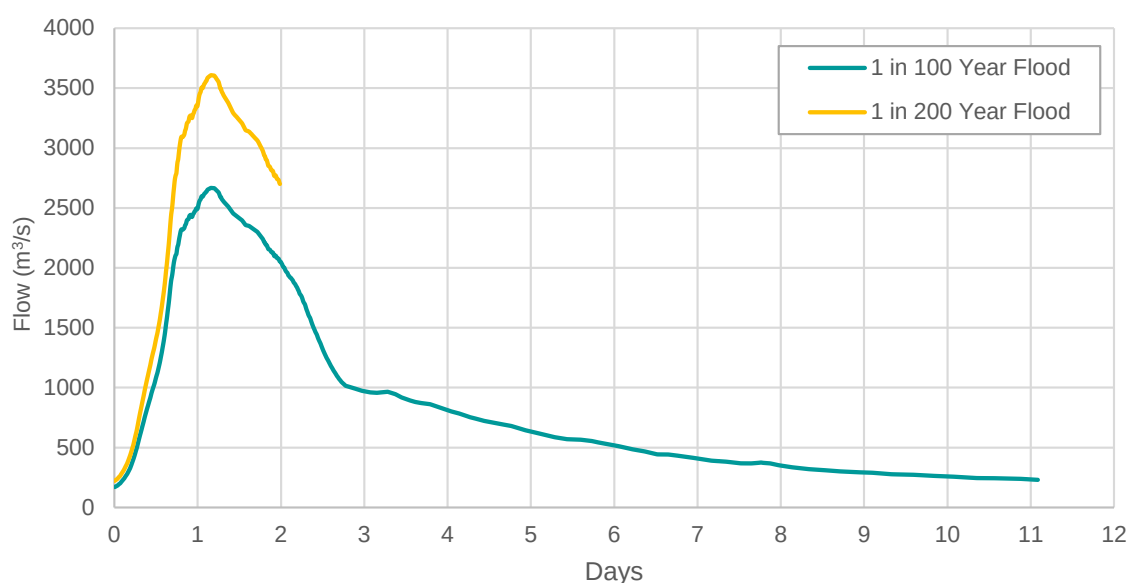
Figure 10-6. Hydraulic Model Flood Flow Outputs for 1 in 1—and 1 in 200-year Flood Events. (Source: ORC Hydraulic Model)

A hydraulic model was provided to Beca from ORC which was used to derive the average or 'starting' river levels and to export both 1 in 100 and 1 in 200-year flood flows as shown in Figure 10-6. The flood responses are typical of most rivers with a sharp rise in river level followed by a gradual decline in flow after the peak. In the 1 in 200-year event, the model fails and crashes after the peak flow. This instability could not be resolved. Hence there is no data for most of the flow recession in the 200-year event. This does not impact our ability to assess the effects of flood flows on the floodbanks.

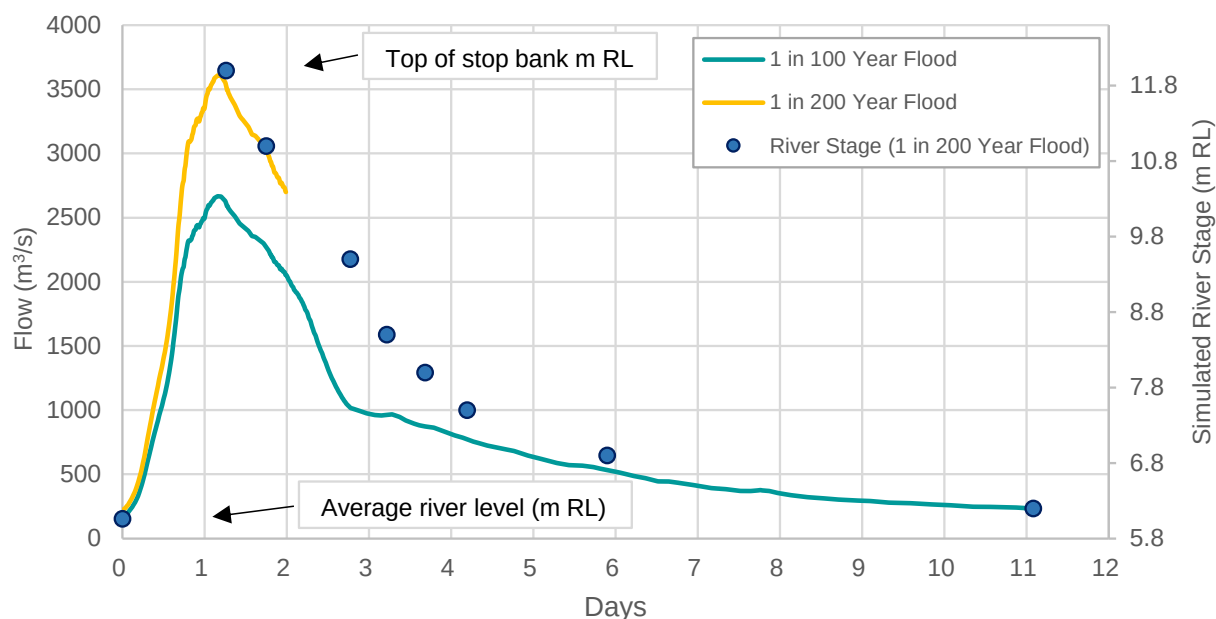
Figure 10-7. Plot Showing Flood Discharge Against Simulated Stage/ Level.

The river levels used in the A – A' groundwater model are shown as blue dots in Figure 10-7.

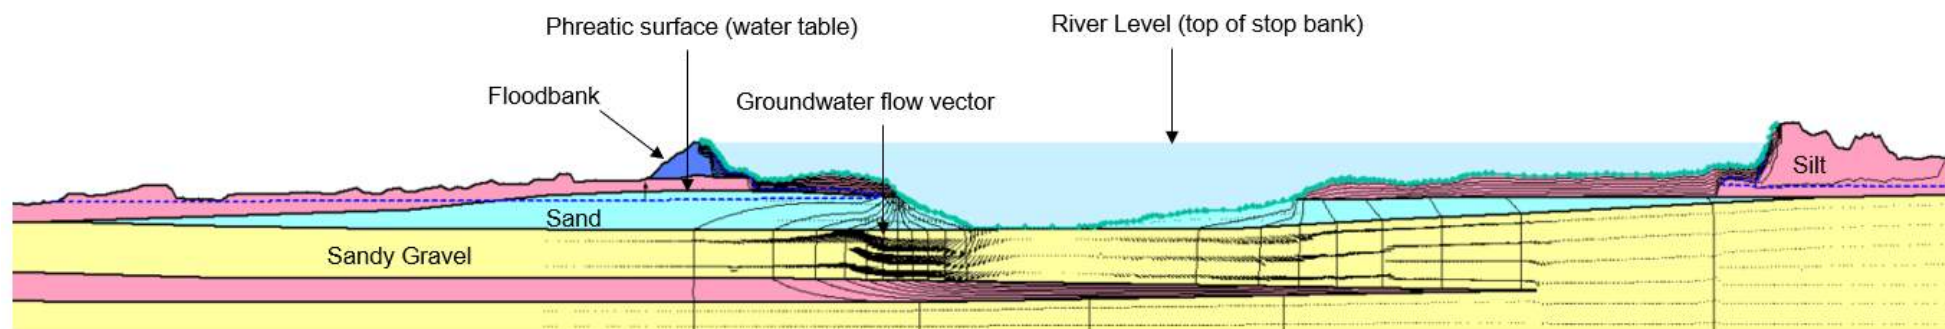
Figure 10-8. Peak Flood Scenario with River Level at the Top of Floodbank in Model A – A'.

A screenshot of the top of the floodbank flood level for cross-section A – A' is shown in Figure 10-8 to indicate how the river stage is input into the groundwater model. Note the high-pressure head areas in red in the riverbed and extending out to the floodbank to the west and along the floodplain to the east. The phreatic surface or water table is shown by the dotted blue line. The model shown in the figure has five times vertical exaggeration.

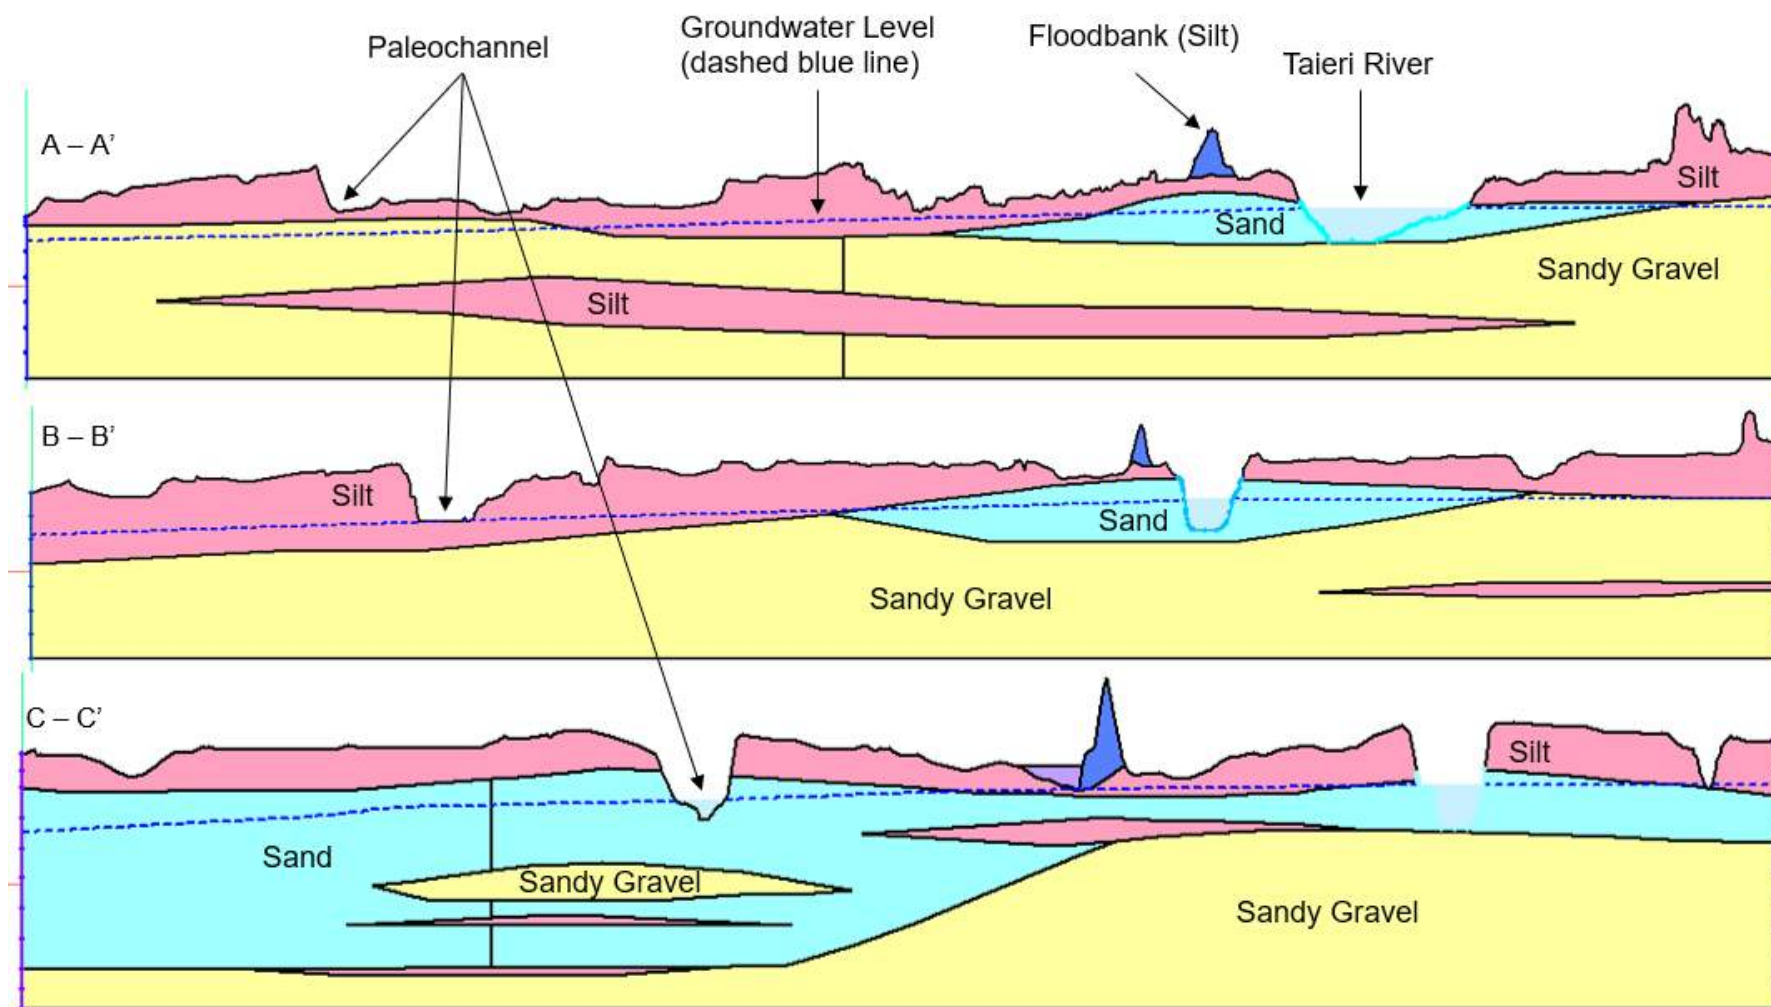
Figure 10-9. Simulated Model Head in Average Water Table Conditions: A – A' at the Top, B – B' in the Centre and C – C' at the Bottom

- The groundwater gradient is from east to west (right to left on Figure 10-9) with higher head near the river and lower head on the western side of Outram. This reflects the trend of regional piezometric head shown in Figure 10-4.

- There is surface water in some parts of the paleochannel which can be seen in C – C' cross sections in Figure 10-9. Note that in the cross-sections below the vertical exaggeration is set to 15 to allow the main features to be visible.

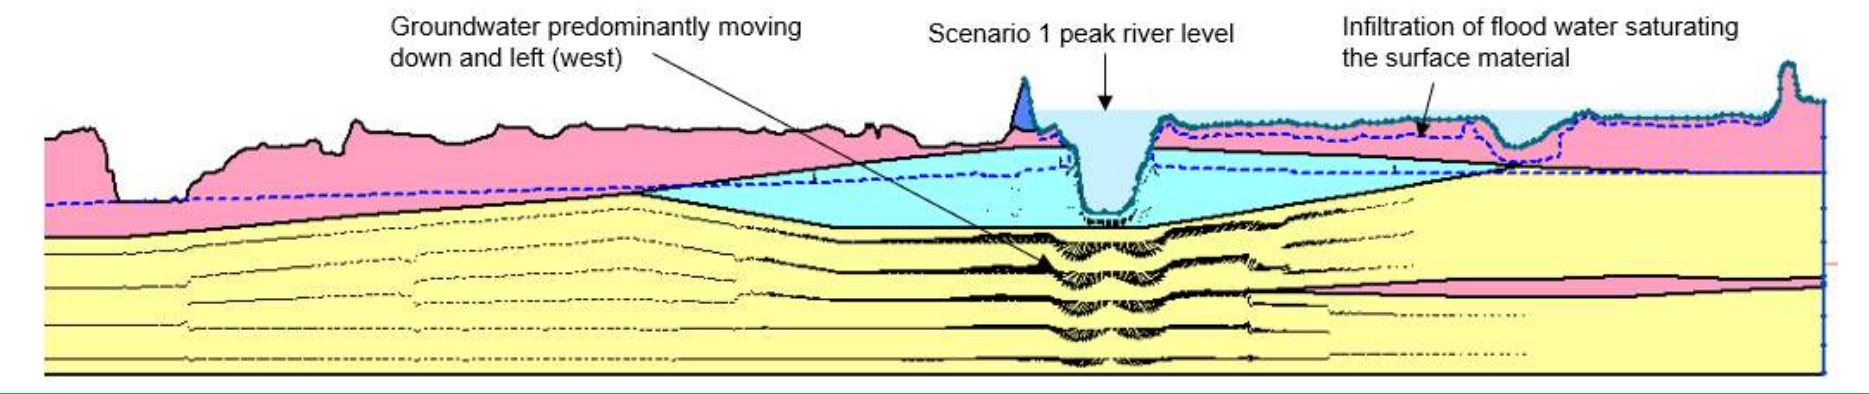
| Scenario | Description | Results |
|---|---|---|
| 1 | 1 in 100-year river stage and average starting groundwater levels | <ul style="list-style-type: none"><li>• In the model, the seepage face moved a small way through the floodbank during high river levels, but as the river level resided, the seepage face did not move through the entire floodbank. The permeability and storage properties of the floodbank material retards shorter duration groundwater flow.</li><li>• In the model, surface flooding in Outram did not occur from groundwater breaching the surface. This is likely because the flood event was too short-lived, the river level was not high enough, and the antecedent groundwater levels did not have time to rise to the surface.</li><li>• The flood scenario induced minor groundwater level rise underneath Outram and its floodbank, as well as increasing the water level in the paleochannels. In the model, this took about 3 days for peak groundwater/ paleochannel levels to occur after the peak river level occurred, i.e., there is a delay in the response.</li><li>• The peak river level is shown in the row directly below.</li></ul> |

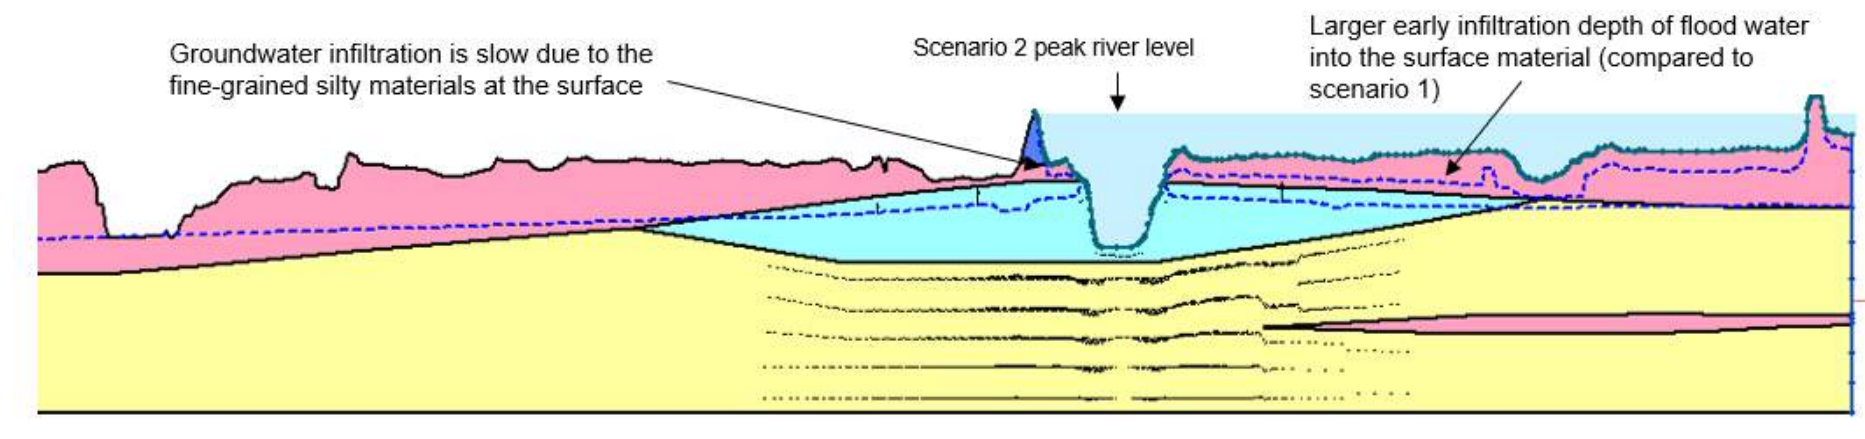
| Scenario | Description | Results |
|---|---|---|
| 2 | Top of floodbank stage and average starting groundwater levels | <ul style="list-style-type: none"><li>• In the model, the seepage face moved part way through the floodbank during high river event, but with the river level receding, the seepage face did not move through the entire floodbank for the same reasons described in Scenario 1 above.</li><li>• There was some surface flooding in the lowest lying parts of Outram driven by groundwater pushing up through the surface strata. The groundwater reached the surface approximately 3 days after the peak of the flood but did not continue to rise significantly above the surface before it began to subside. This was a subdued and delayed response to the flood, as it took much longer for water to move through the ground than flowing over the surface as it would in a rainfall-runoff induced flood.</li><li>• The levels in the main paleochannel increased by approximately 300 mm, about 3 days after the flood peak. For reference, the paleochannel in cross-section C – C’ is about 200 m from the floodbank.</li><li>• A screenshot of the top of floodbank river level is shown in the row directly below.</li></ul> |

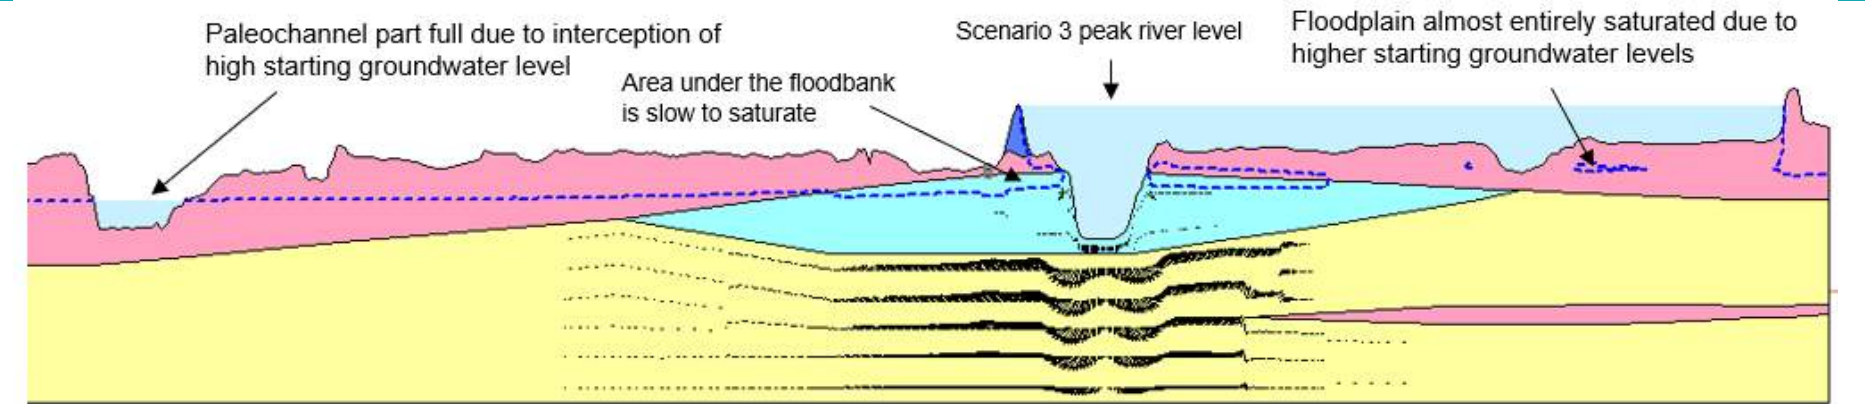
| Scenario | Description | Results |
|---|---|---|
| 3 | Top of floodbank stage and high starting groundwater levels | <ul style="list-style-type: none"><li>• In the model, the seepage face did not migrate through the floodbank for the same reasons explained in Scenario 1 and 2.</li><li>• Surface flooding in the low-lying parts of Outram was modelled to occur about 3 days after the peak river level. The flooding occurred as a result of groundwater pushing up through the upper sand and silt layers driven by the high head in the river.</li><li>• The water level in the C – C' paleochannel increased by about 600 mm, peaking about 3 days after the peak river level.</li><li>• Once the river level subsided, and groundwater levels were higher than the river level, the groundwater strata started to release water from storage and recharge the river until the original equilibrium was reached.</li><li>• A screenshot of the top of floodbank river level is shown in the row directly below.</li></ul> |

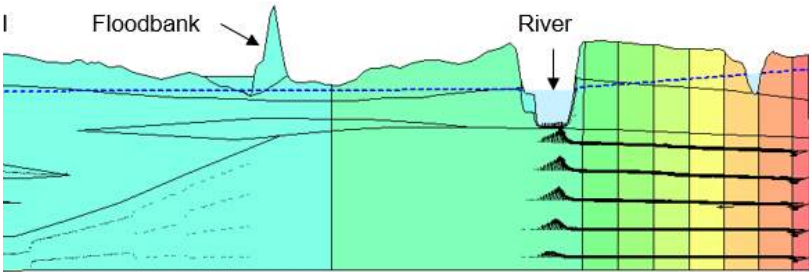
| Step | Hours after Peak River Level | Description of Result | Model Image |
|---|---|---|---|
| 1 | 0 | <p>The top screenshot is at initial conditions before the river level rise. Note the high starting groundwater levels.</p> <p>The colours on each screenshot represent the total water head in metres. The legend showing water total head to the right applies to all screenshots in this table, with high head in red and low head in blue colours.</p> | <div><div><p>Water Total Head</p><ul style="list-style-type: none"><li>≤ 5.5 - 6 m</li><li>6 - 6.5 m</li><li>6.5 - 7 m</li><li>7 - 7.5 m</li><li>7.5 - 8 m</li><li>8 - 8.5 m</li><li>8.5 - 9 m</li><li>9 - 9.5 m</li><li>9.5 - 10 m</li><li>10 - 10.5 m</li><li>10.5 - 11 m</li><li>11 - 11.5 m</li><li>≥ 11.5 m</li></ul></div></div> |

Table 10-7. Model C – C’ – Scenario 3 groundwater flow model outputs indicating the change in groundwater head across various river stages

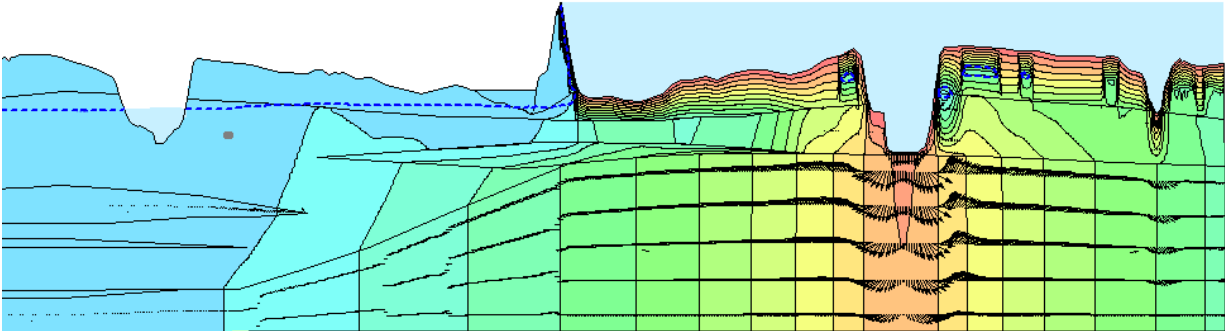
| Step | Hours after Peak River Level | Description of Result | Model Image |
|---|---|---|---|
| 2 | 1 | <p>Then second screenshot is when the river reaches the top of the floodbank. This increases the pressure (head) on the bed of the river and on the floodbank as represented by the red/orange/yellow colours. The arrows show that water in the flood channel is infiltrating to ground and moving both left and right through the ground.</p> | |

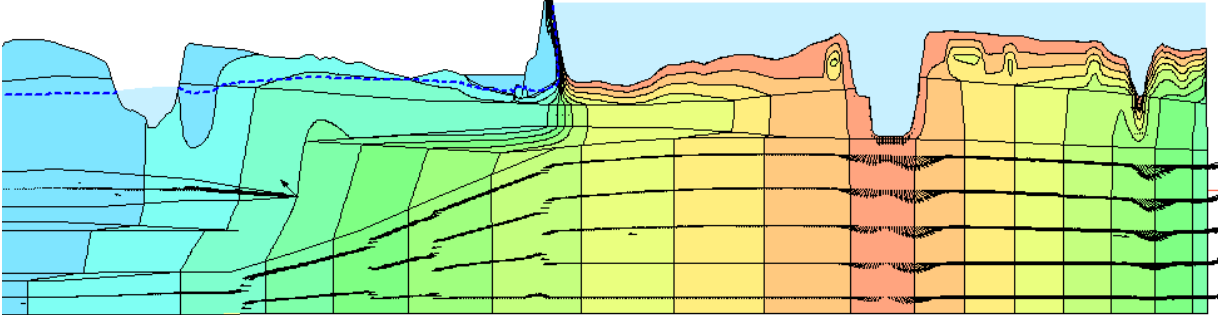
| Step | Hours after Peak River Level | Description of Result | Model Image |
|---|---|---|---|
| 3 | 23 | The third screenshot shows river levels beginning to decline, about 1-day (23 hours) days since the peak. Now the areas of high head are migrating outwards, and the phreatic surface is moving upwards. Groundwater levels and paleochannel water levels increase. | |

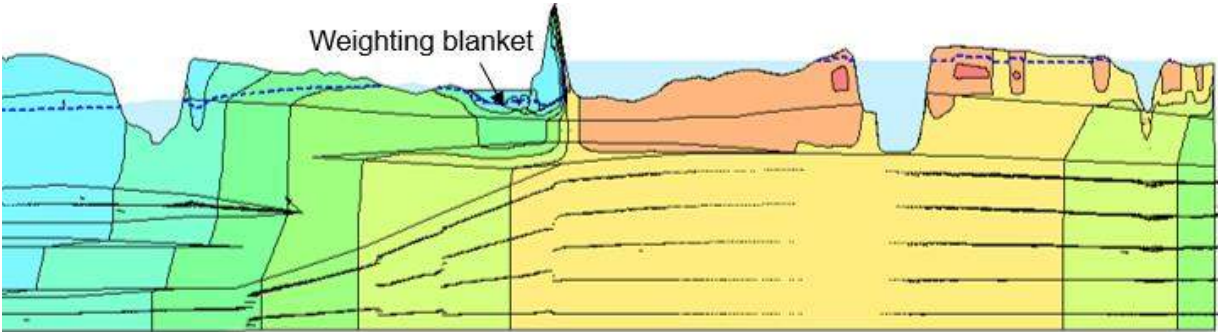
| Step | Hours after Peak River Level | Description of Result | Model Image |
|---|---|---|---|
| 4 | 54 | The fourth screenshot shows the river level declining 2.25 days (54 hours) after the peak. The groundwater levels have now breached the surface on the township side of the floodbank, causing surface flooding. Groundwater levels are still increasing, and groundwater is moving west under Outram. Note that the weighting blanket reduces daylighting at the toe of the floodbank. | |

Finally, the modelling suggests that the weighting blanket (only present in model section C – C') may reduce the rate of groundwater rising to the surface at the inside toe of the floodbank. In effect it acts like a confining layer. With regards to surface flooding, this material retards surface water infiltrating to ground, hence surface water build up will not drain as easily on this material. ORC indicate there is the ability to drain surface water under gravity and pump it out during weather events.

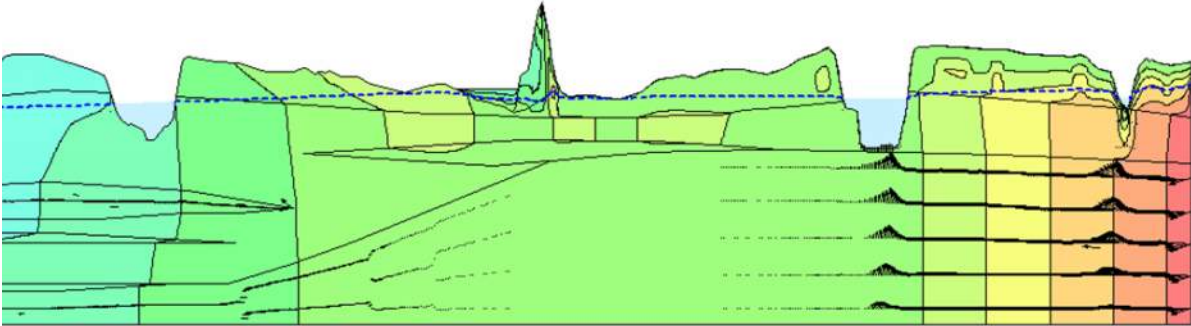
| Step | Hours after Peak River Level | Description of Result | Model Image |
|---|---|---|---|
| 7 | 11 days | <p>This image shows the river return to approximately an average level, about 11 days after the peak river level. The groundwater levels are now higher than the river level, hence groundwater flow direction under the floodbank has reversed and is now recharging the river. As groundwater levels gradually drop, the system returns to the conditions shown in the top screenshot.</p> | |

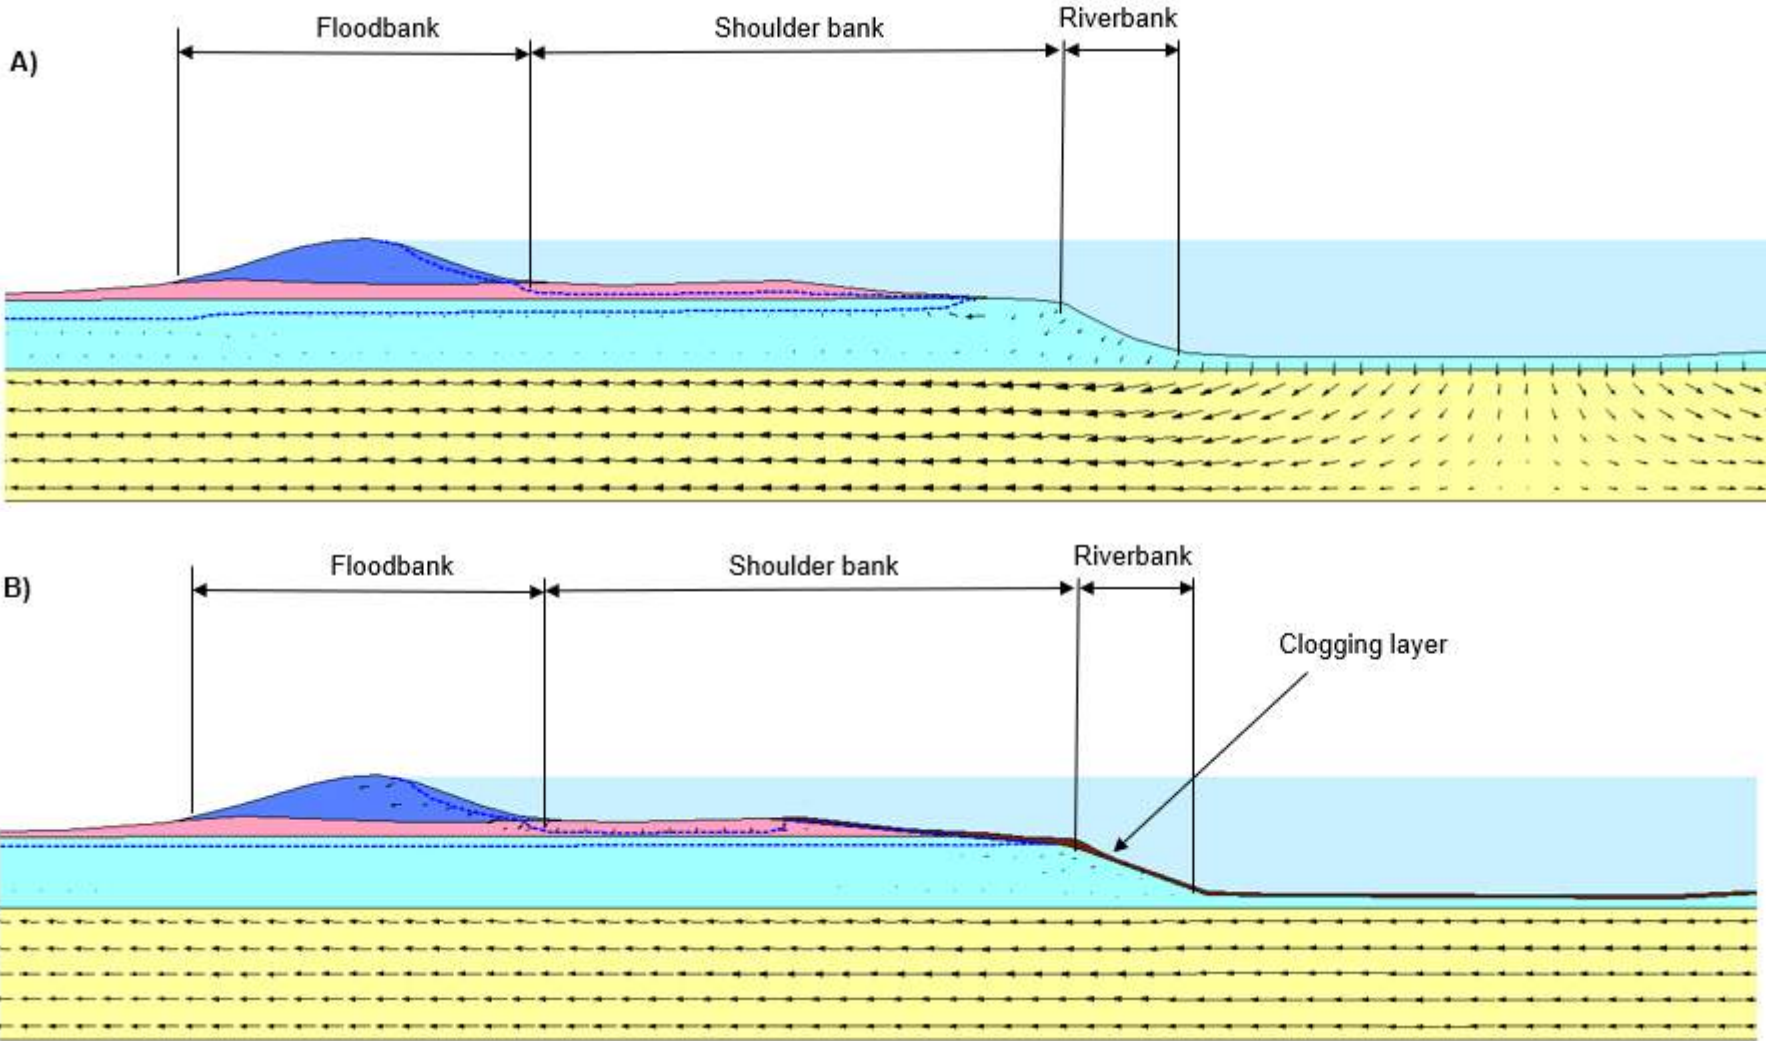
Figure 10-10. Figure Showing the 'Shoulder Bank,' in Cross Section A – A.' The top image (A) is from 3 hours after the river reached the top of floodbank (Scenario 3) without a clogging layer, and the bottom image (B) is the same but with the clogging layer in place.

It is possible that infiltration into the ground would be slower through the riverbed due to the presence of a clogging layer, hence potentially placing more pressure on the floodbank. To test this, a low permeability layer of about 0.25 m thickness with a hydraulic conductivity of  $1\text{E-}7$  m/s was added near the bed of the river. The result was that infiltration to ground was slower, and that there was less groundwater induced flooding in Outram indicated by the model.

The rate of movement and depth of penetration of the seepage face into the floodbank did not change appreciably with the presence of the clogging layer, though there was a small increase in the size of the hydraulic gradient in the model with the clogging layer as seen by the comparison in Figure 10-10. Note that the hydraulic gradient as above are represented by arrows, with the groundwater flow direction matching the arrow direction, and the size of the arrow reflecting the magnitude of the hydraulic gradient.

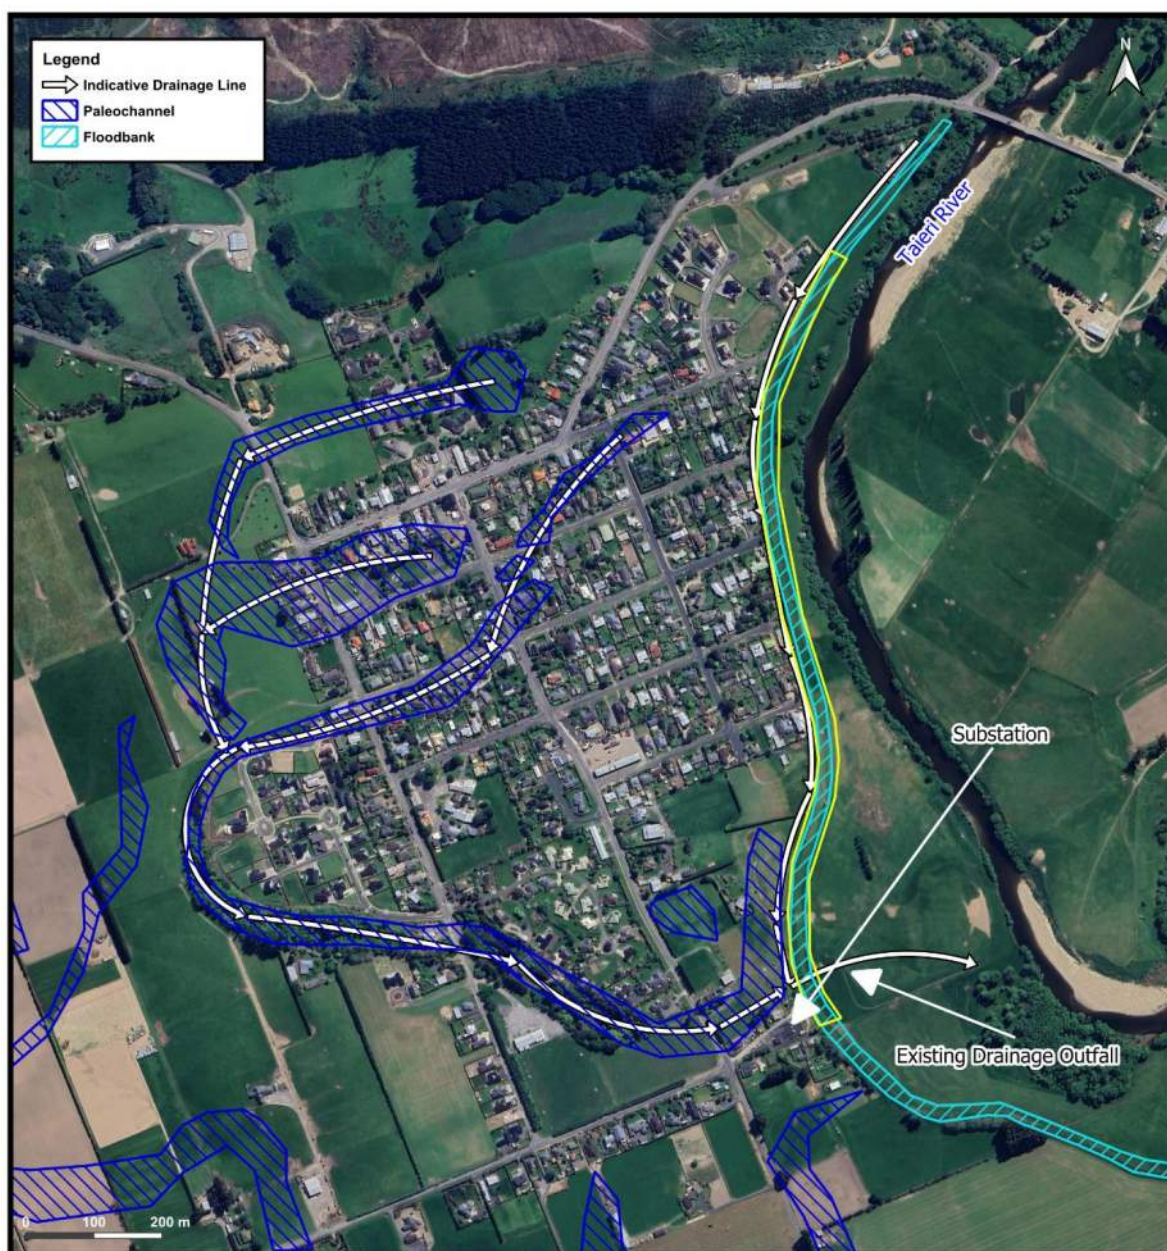
Figure 10-11. Sketch of possible future drainage option connecting the paleochannels and relief drain in the toe area to the existing gravity outlet near the substation. (Image source: Google Earth).

The major and remaining paleochannels are located across the western and southern areas of the township. These have been infilled on the eastern side of town nearer the floodbank. A subsoil relief drain in the toe area on the Outram side of the floodbank would provide additional groundwater and seepage protection locally to the floodbank. A drain in the toe area would help to reduce uplift pressures developing within the floodbank and assist in reducing seepage related failure as well as helping to remove excess flood water.

The paleochannels and relief drain in the toe area could be connected to the main river channel via the existing gravity outlet near the substation. A pump station could also be considered for high flow events. An indicative map of this system is shown in Figure 10-11.

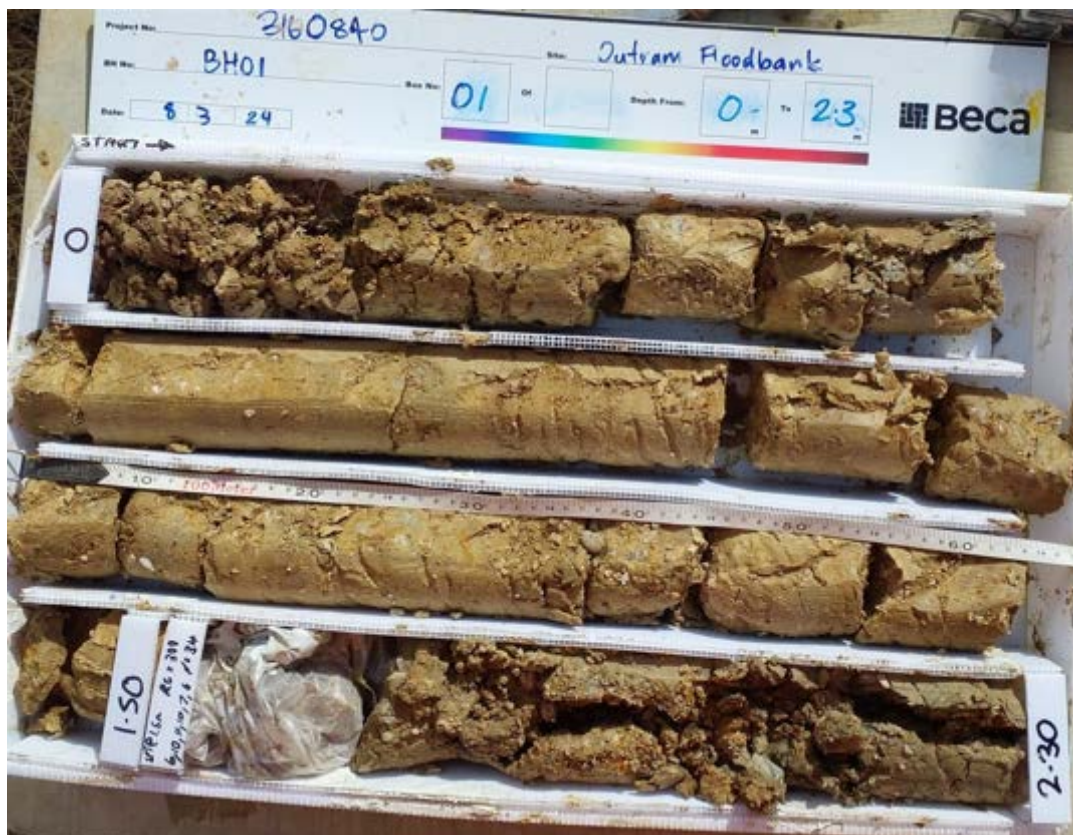
Core Box 01 - 0.00mbgl to 2.30mbgl

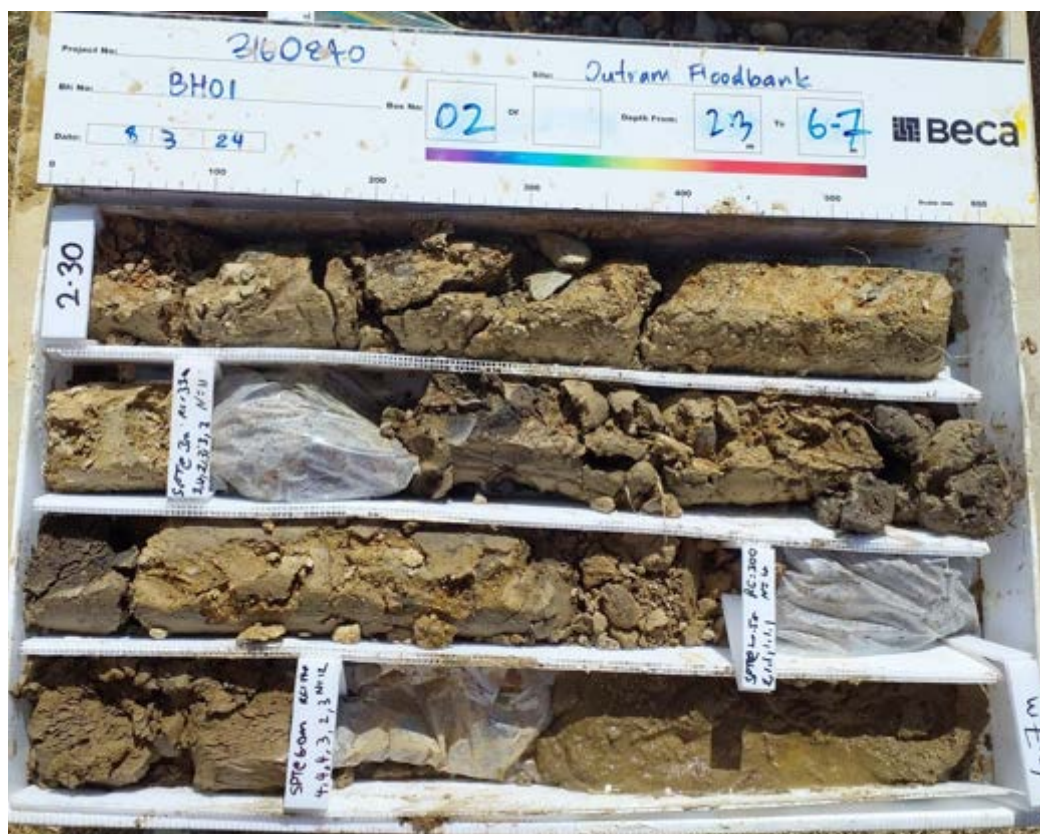
Core Box 02 - 2.30mbgl to 6.70mbgl

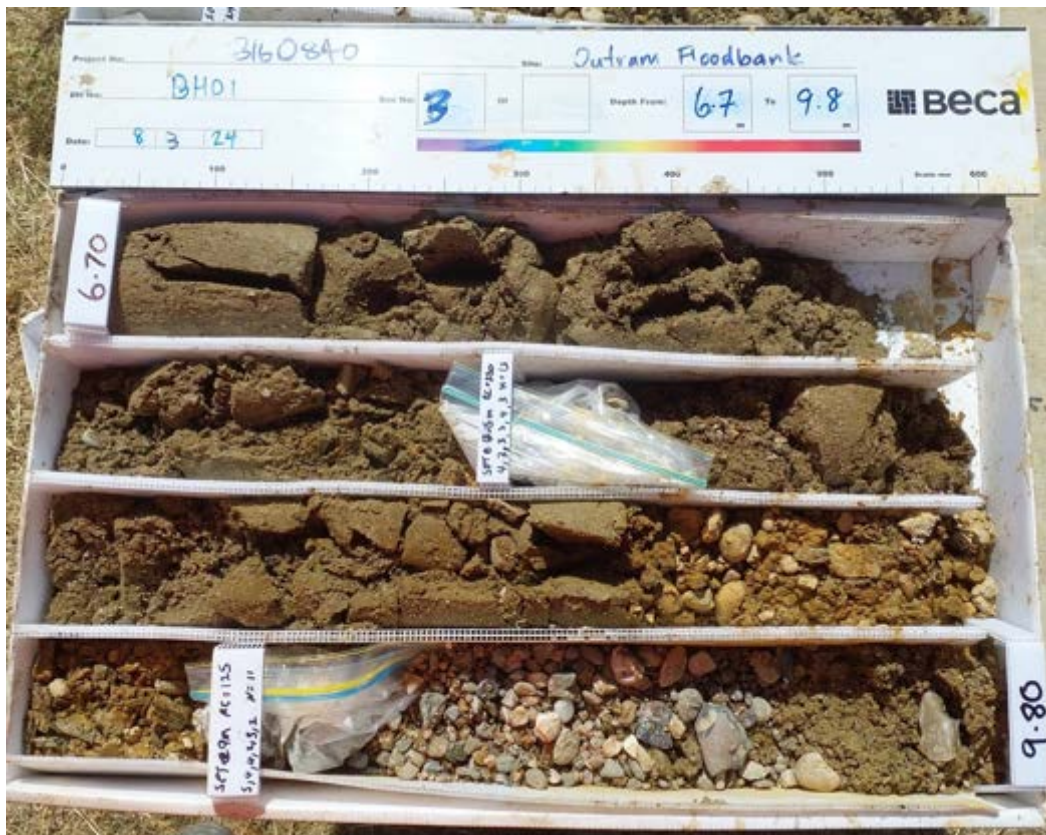
Core Box 03 - 6.70mbgl to 9.80mbgl

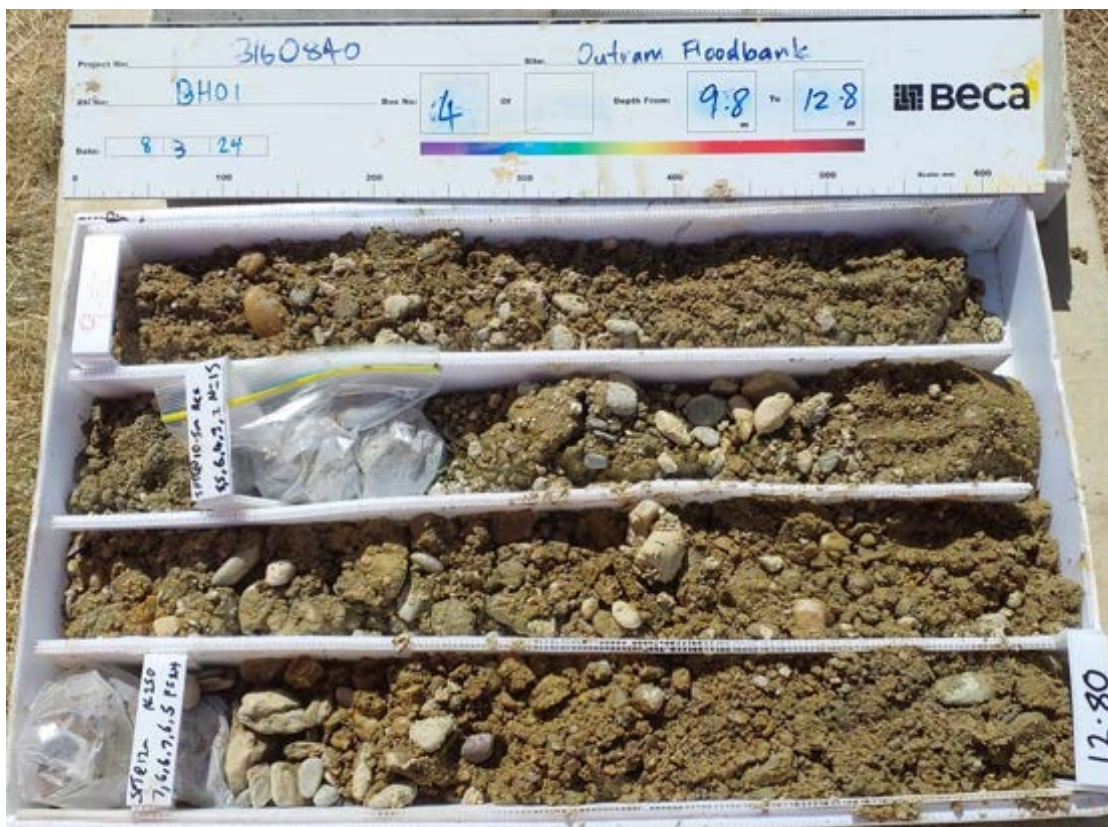
Core Box 04 - 9.80mbgl to 12.80mbgl

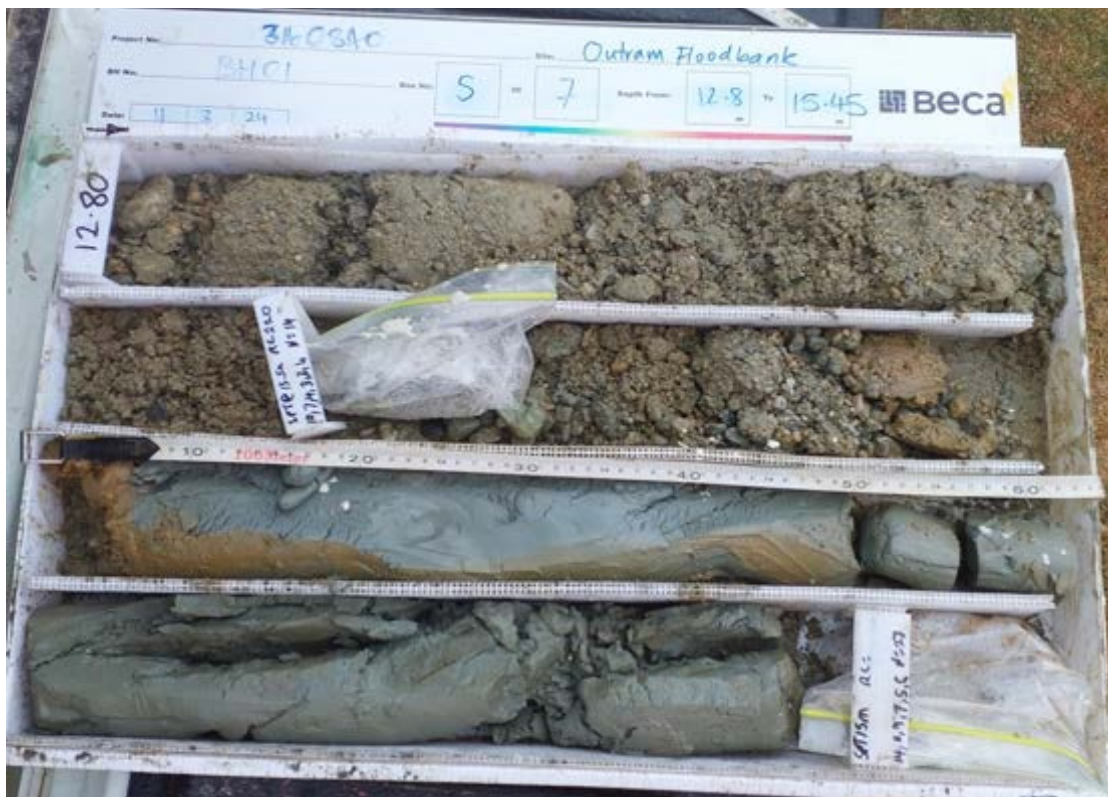
Core Box 05 - 12.80mbgl to 15.45mbgl

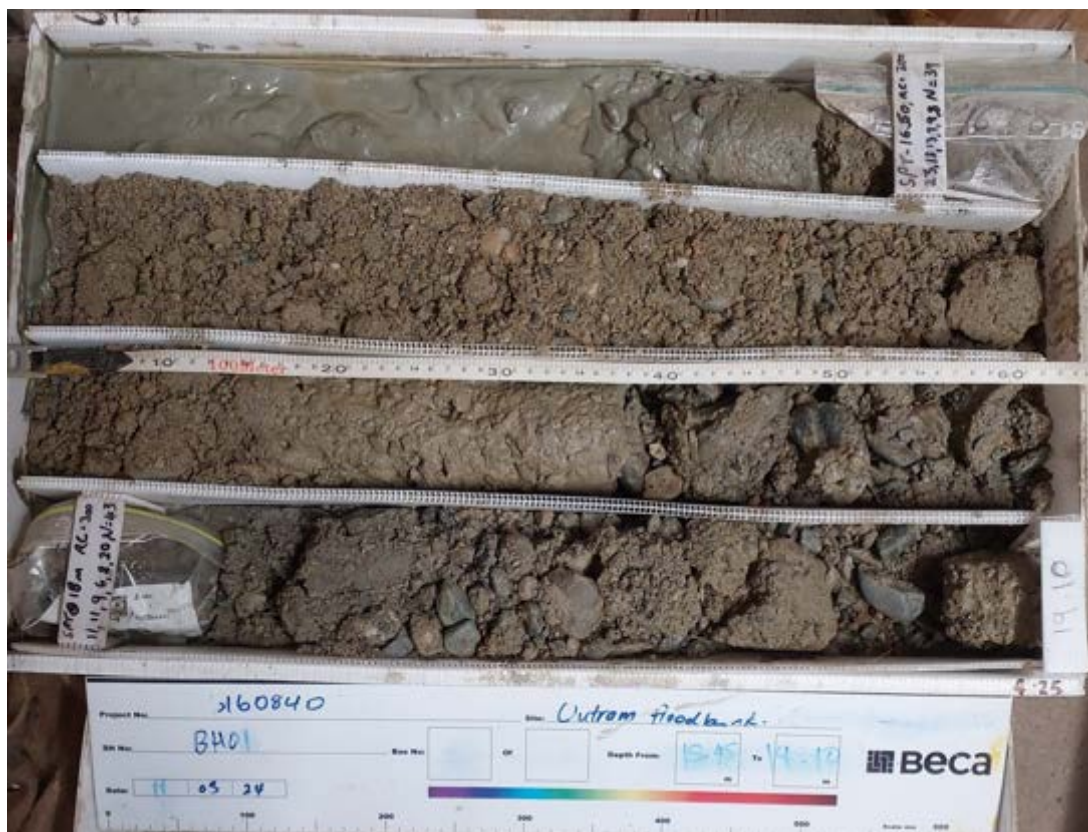
Core Box 06 - 15.45mbgl to 19.10mbgl

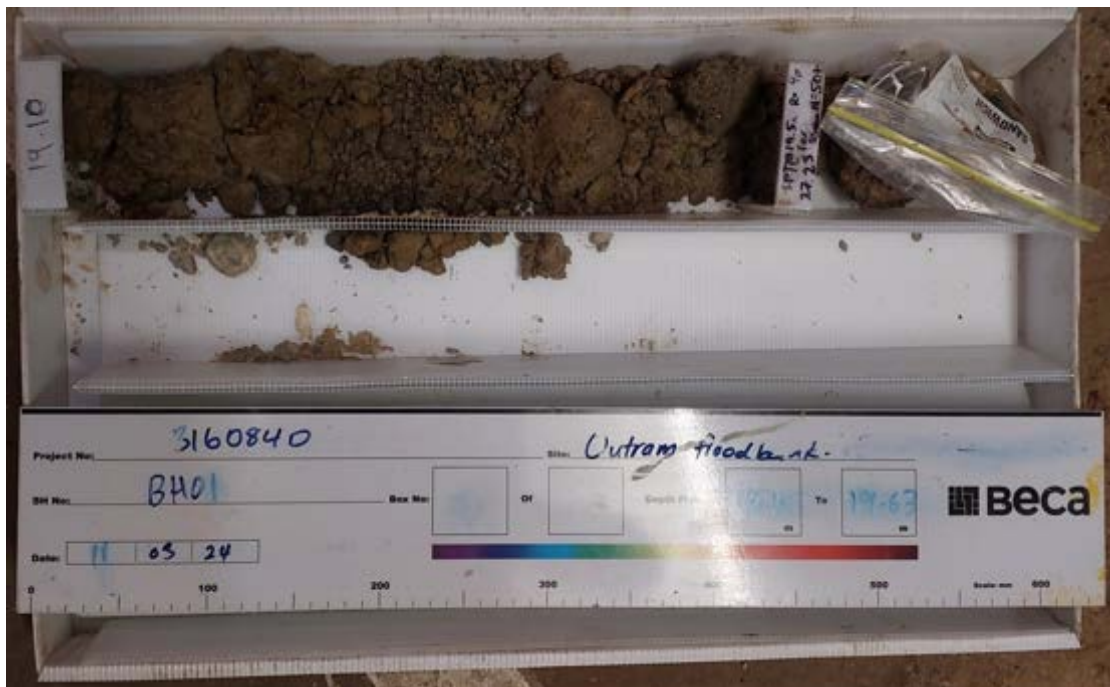
Core Box 07 - 19.10mbgl to 19.63mbgl

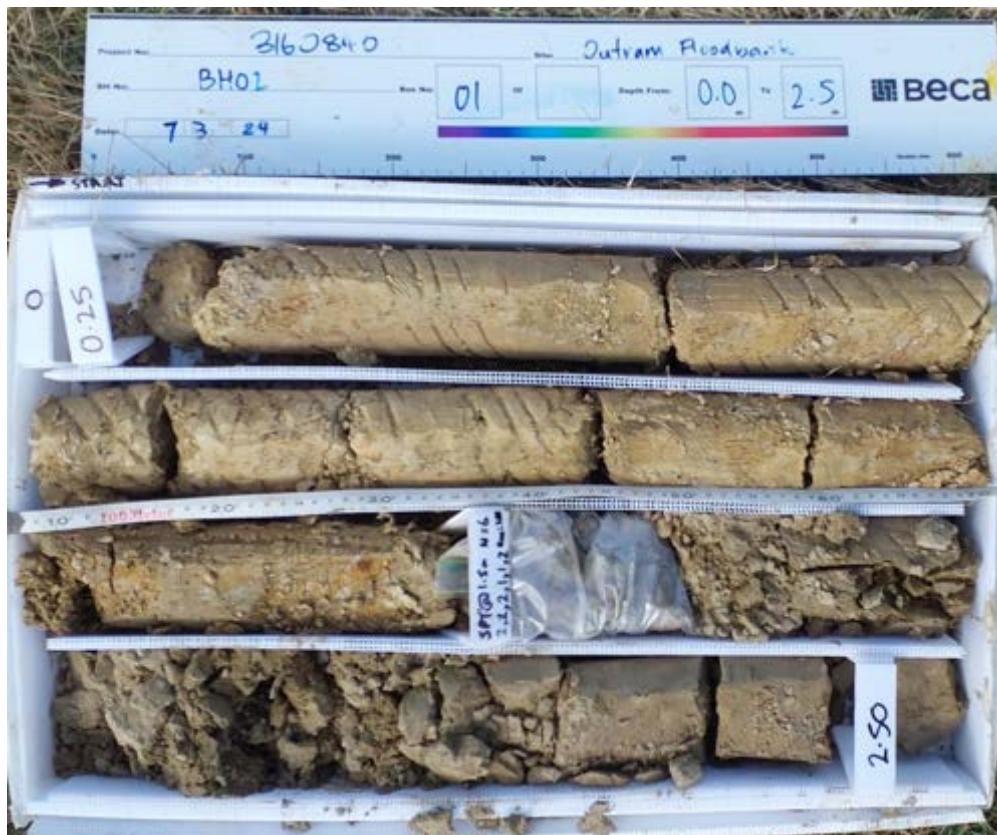
Core Box 01 - 0.00mbgl to 2.50mbgl

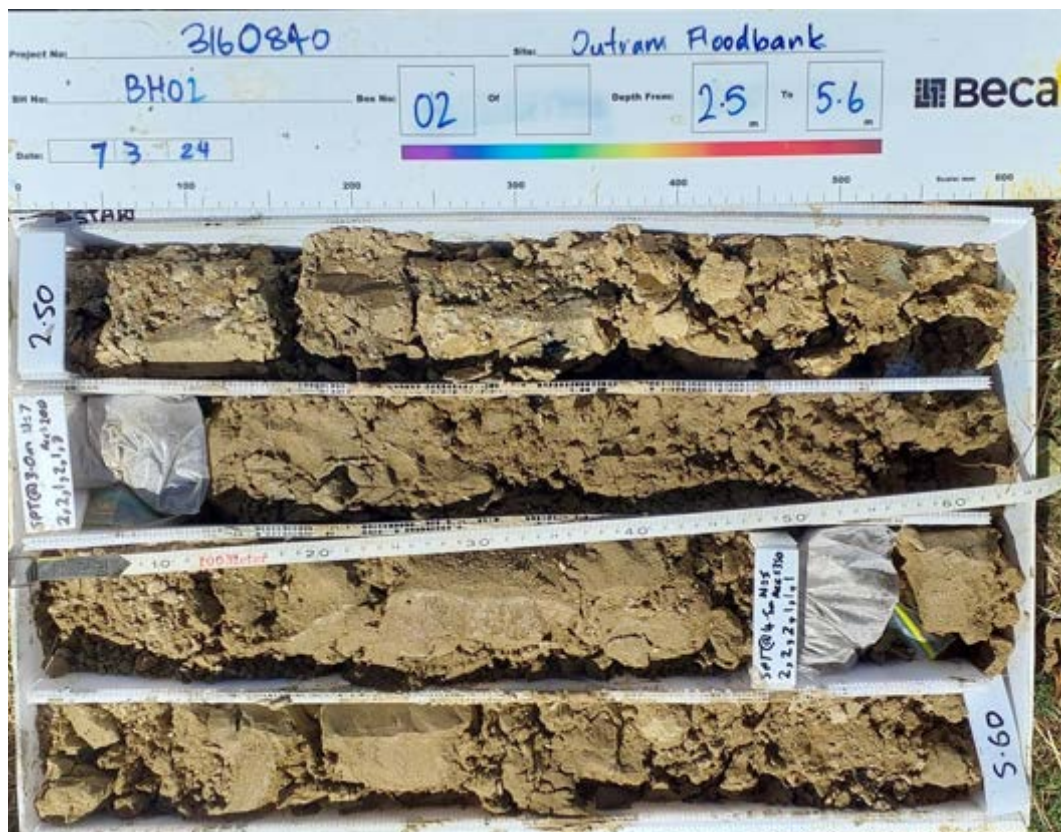
Core Box 02 - 2.50mbgl to 5.60mbgl
