# TAIERI LIAISON GROUP AGENDA

## 1. MEETING DETAILS

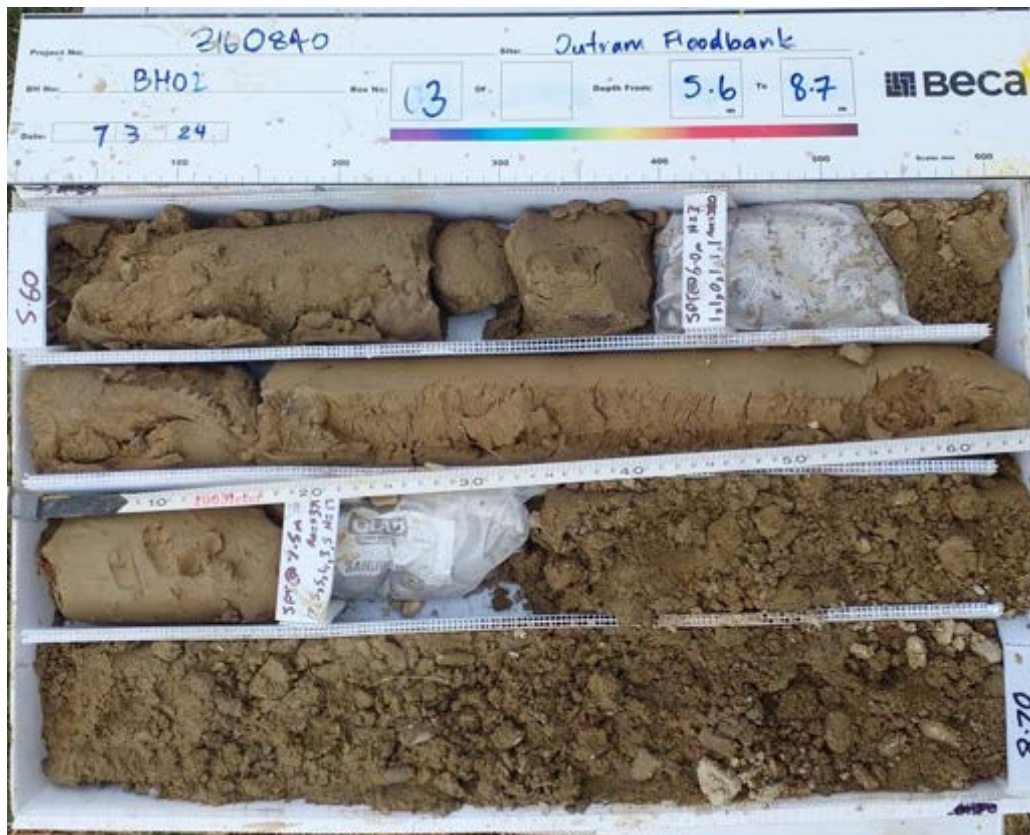
Core Box 03 - 5.60mbgl to 8.70mbgl

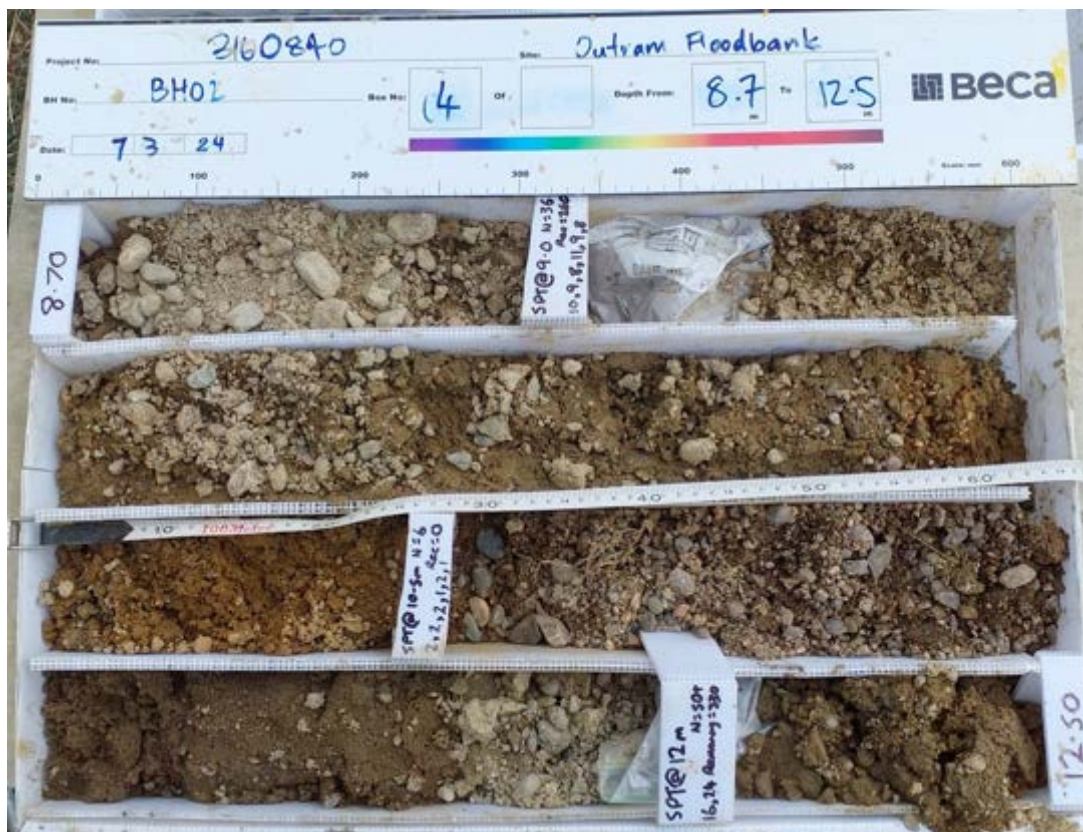
Core Box 04 - 8.70mbgl to 12.50mbgl

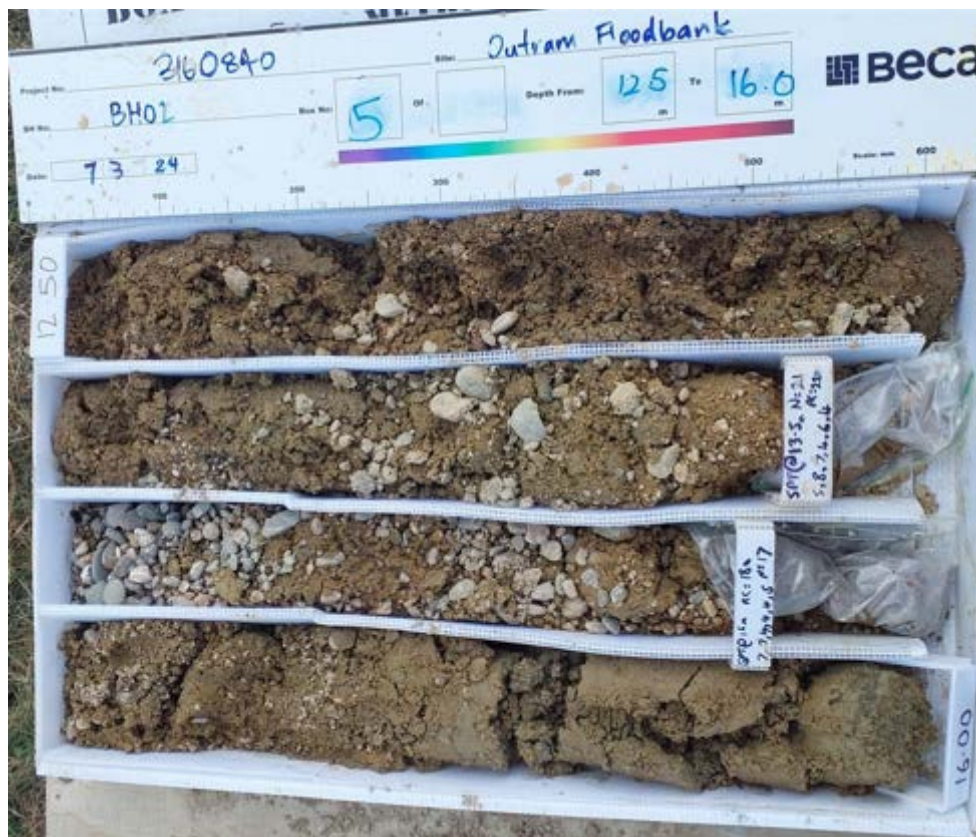
Core Box 05 - 12.50mbgl to 16.00mbgl

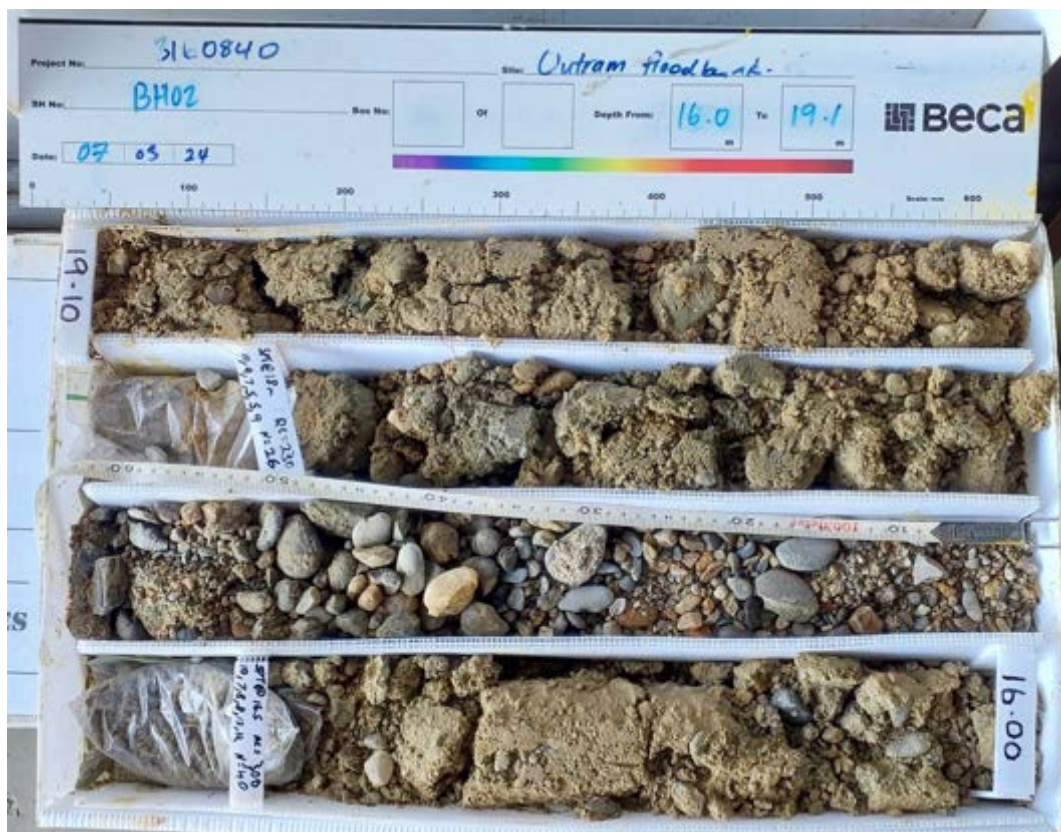
Core Box 06 - 16.00mbgl to 19.10mbgl

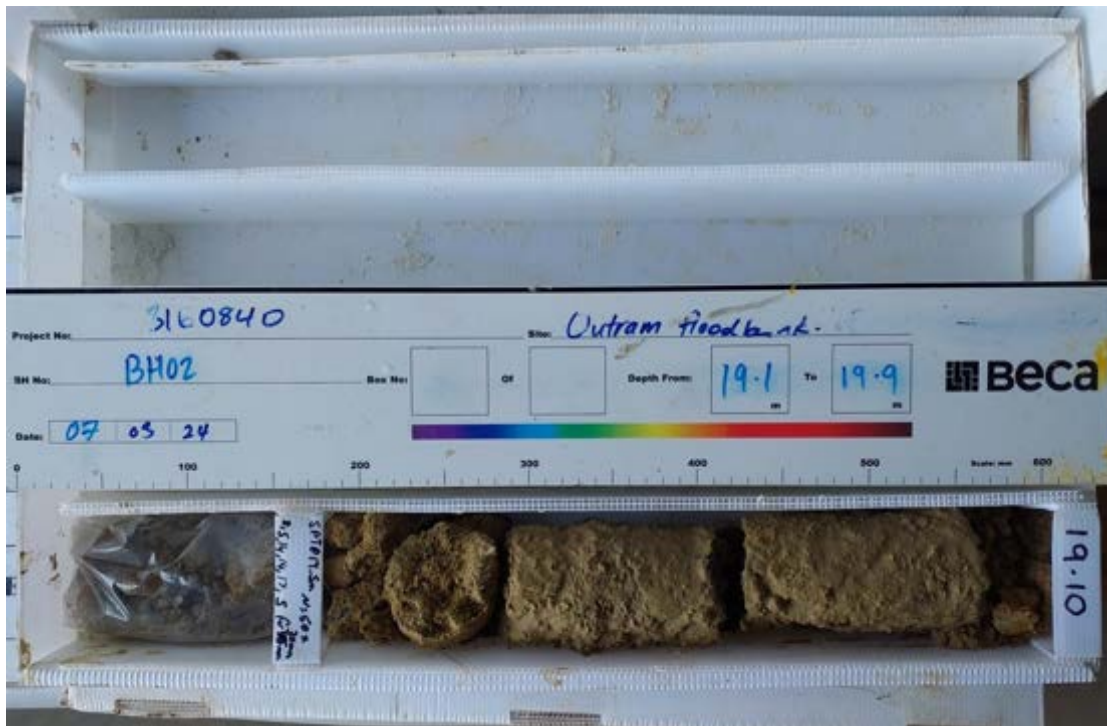
Core Box 07 - 19.10mbgl to 19.90mbgl

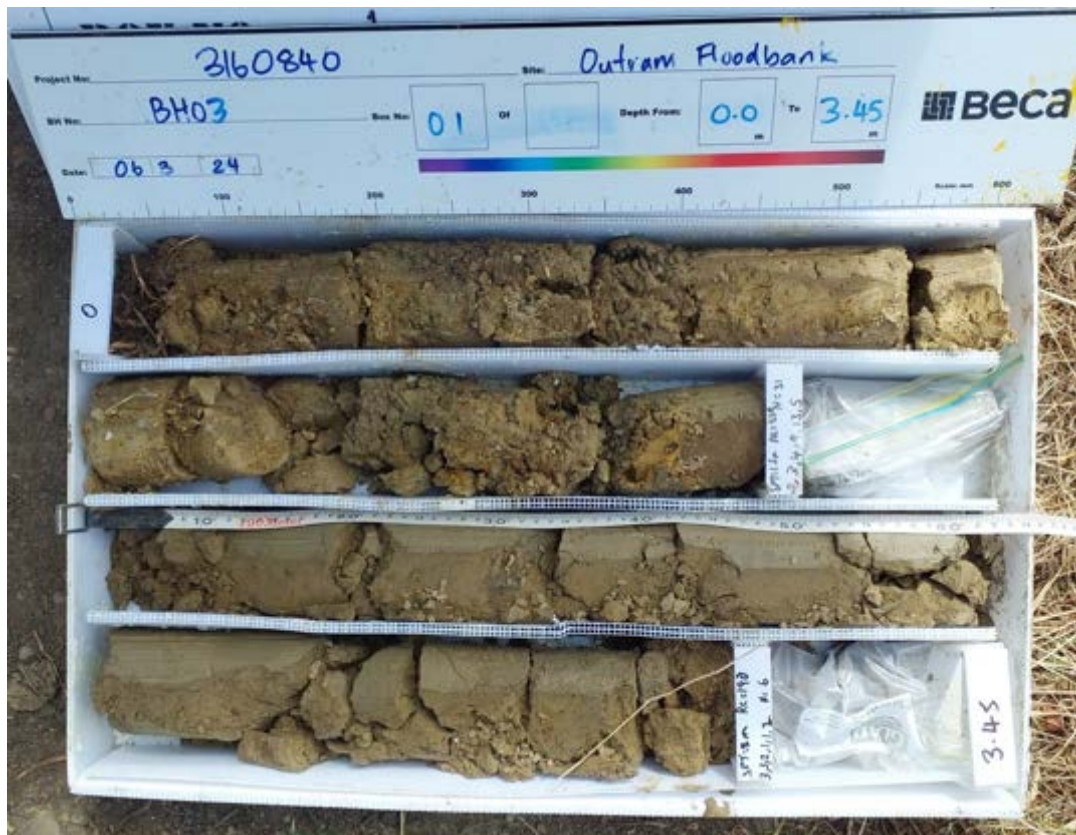
Core Box 01 - 0.00mbgl to 3.45mbgl

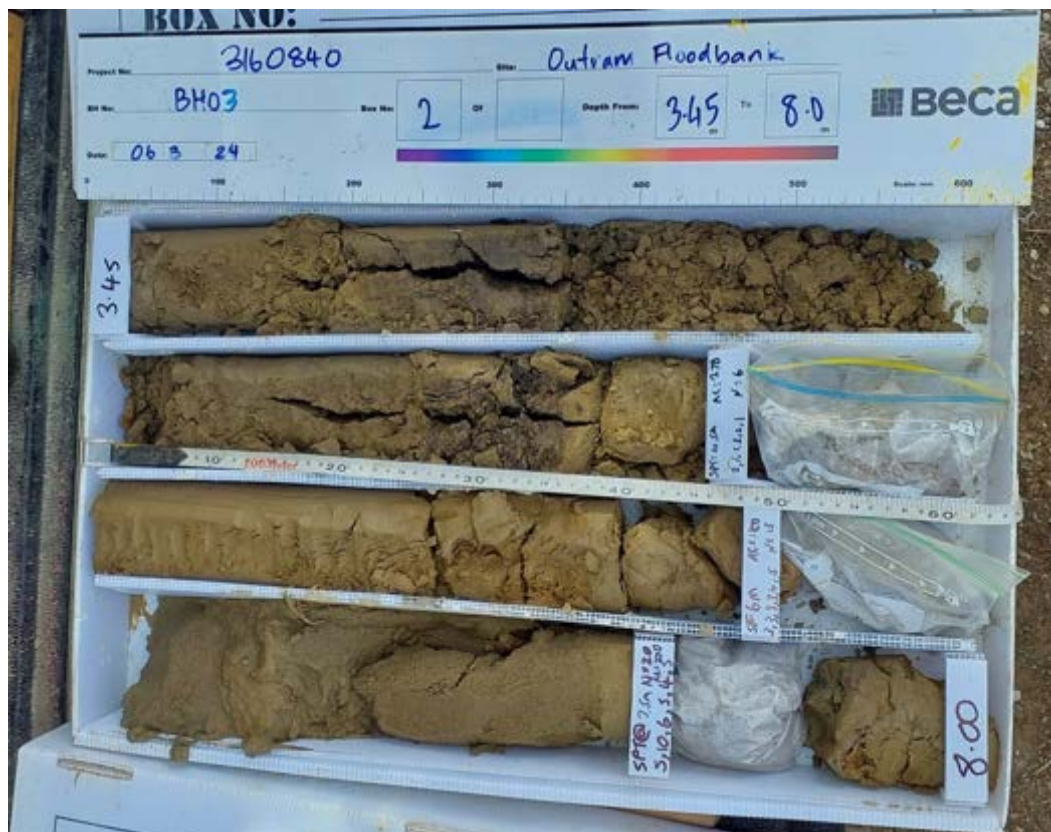
Core Box 02 - 3.45mbgl to 8.00mbgl

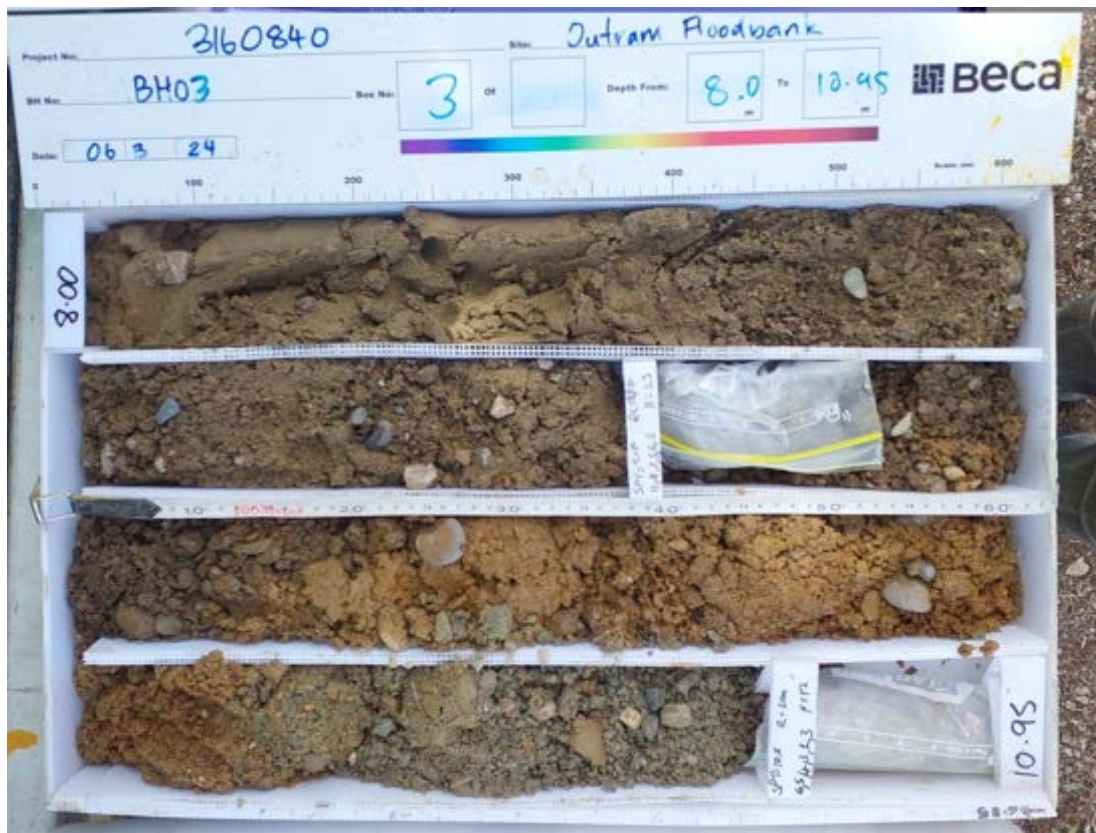
Core Box 03 - 8.00mbgl to 10.95mbgl

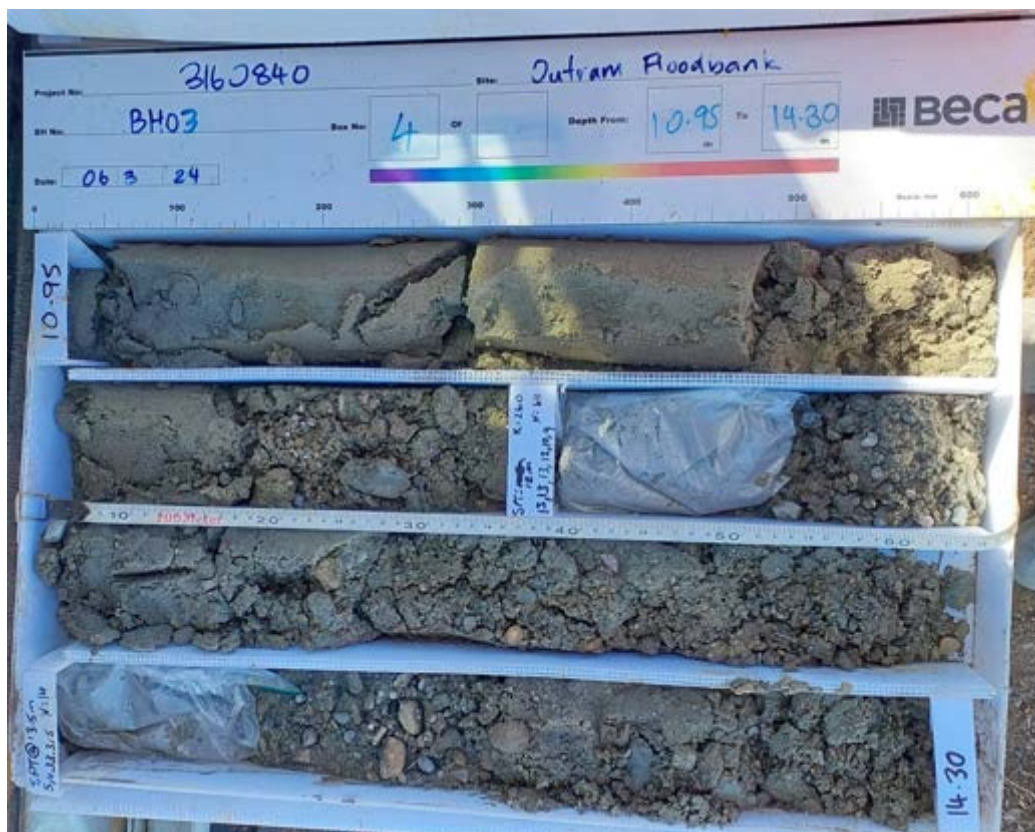
Core Box 04 - 10.95mbgl to 14.30mbgl

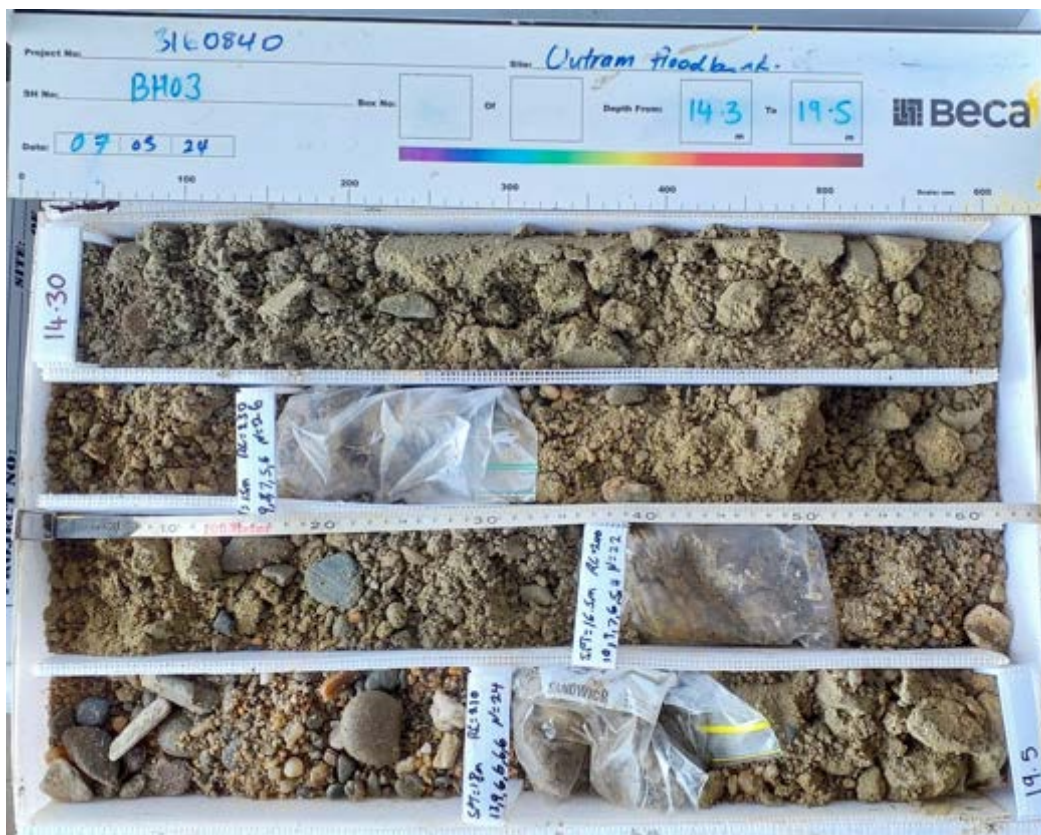
Core Box 05 - 14.30mbgl to 19.50mbgl

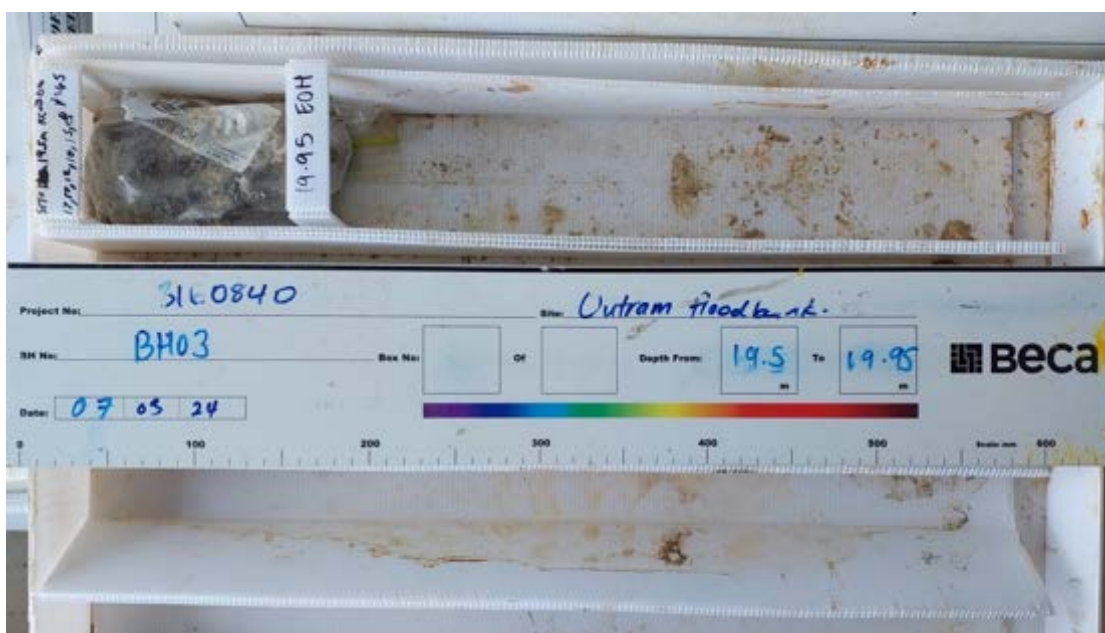
Core Box 06 - 19.50mbgl to 19.95mbgl

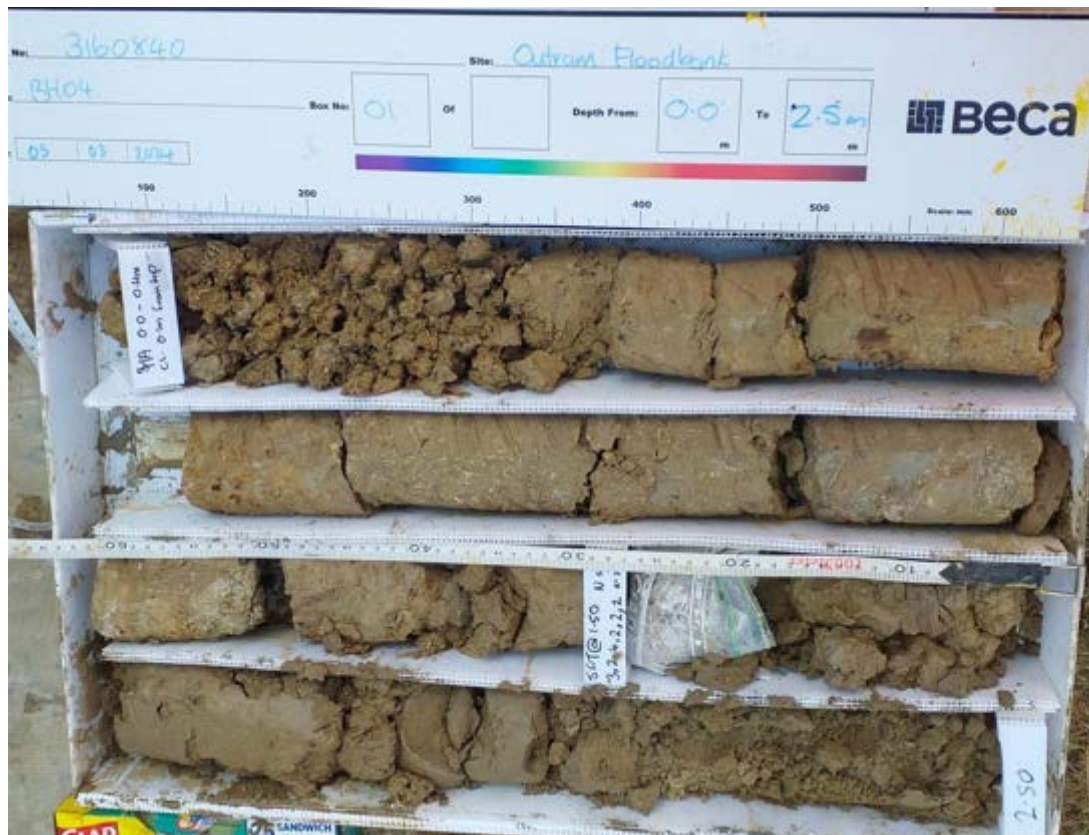
Core Box 01 - 0.00mbgl to 2.50mbgl

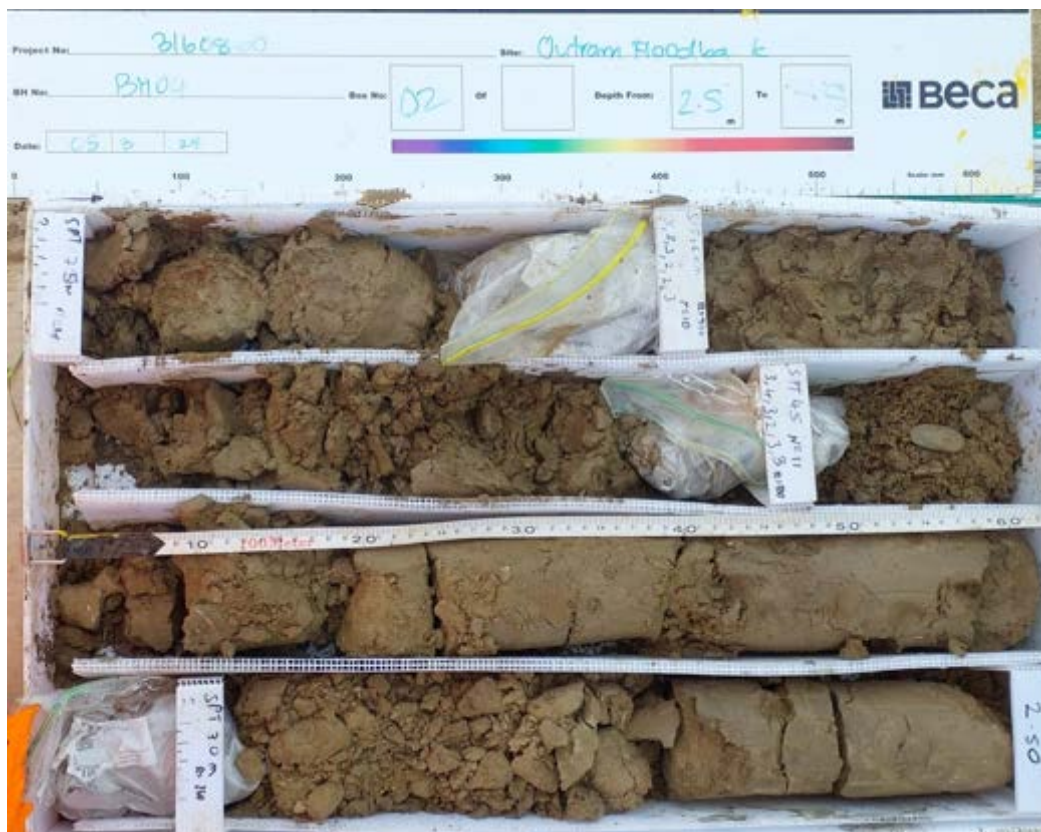
Core Box 02 - 2.50mbgl to 7.50mbgl

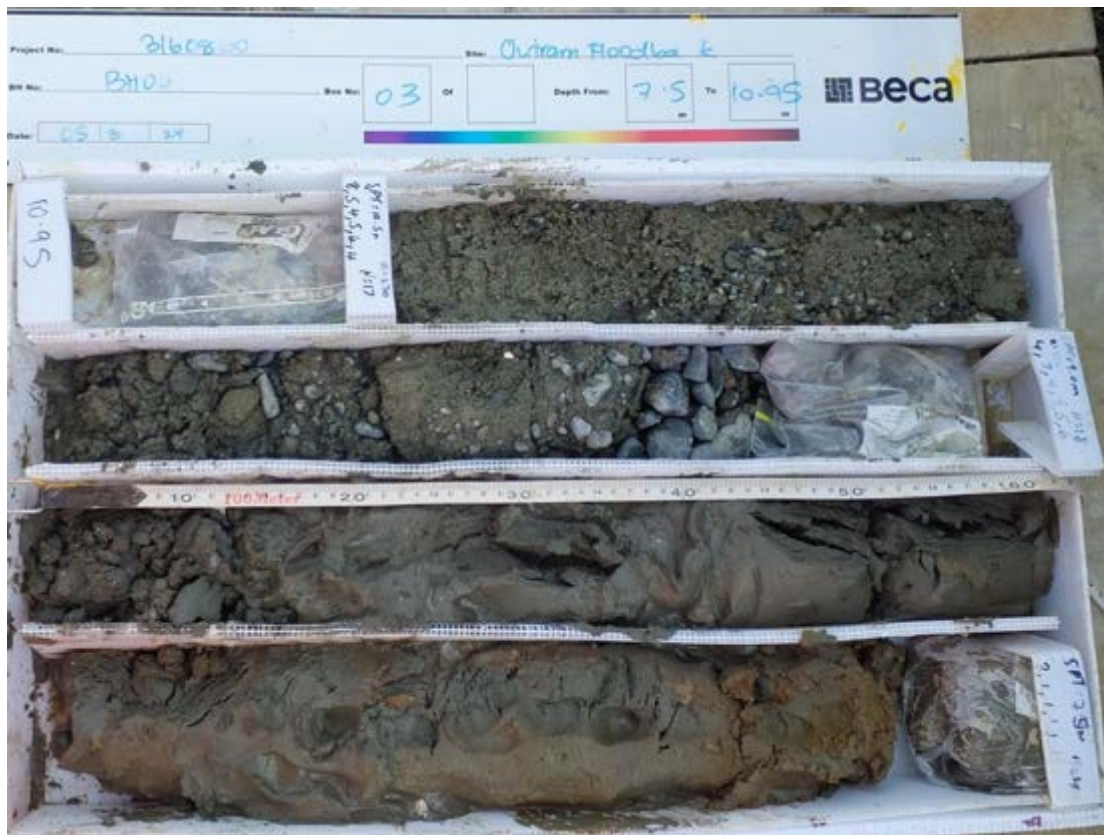
Core Box 03 - 7.50mbgl to 10.95mbgl

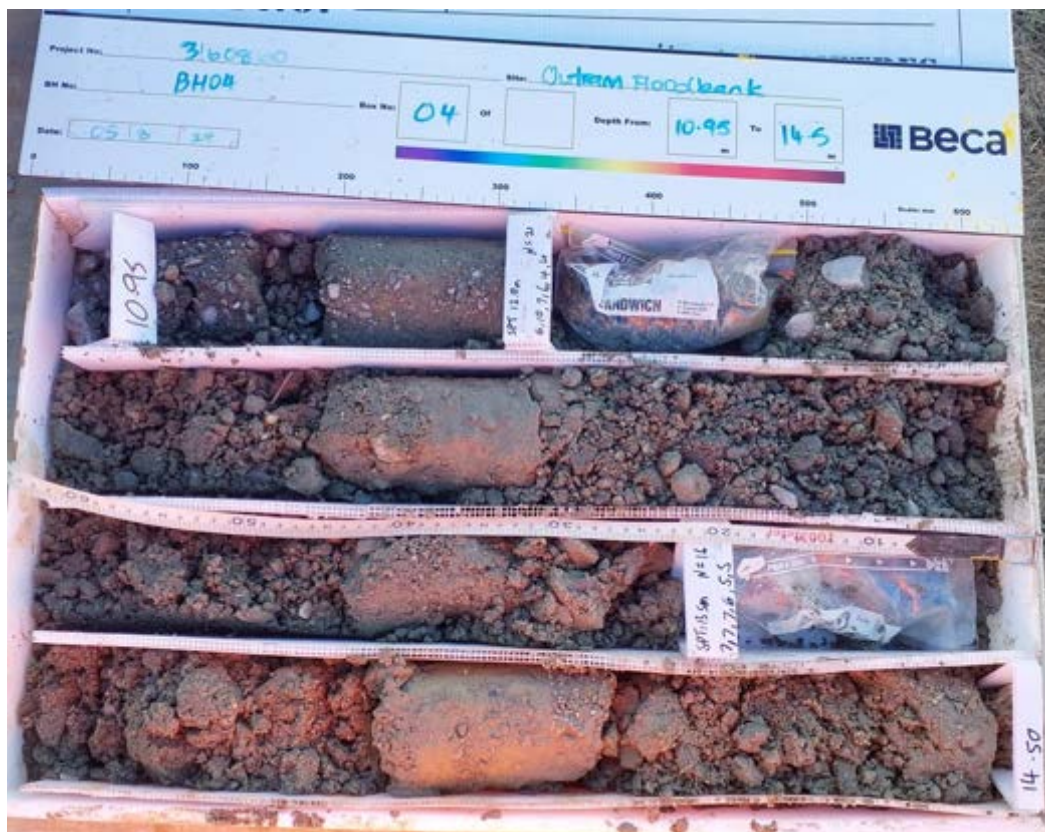
Core Box 04 - 10.95mbgl to 14.50mbgl

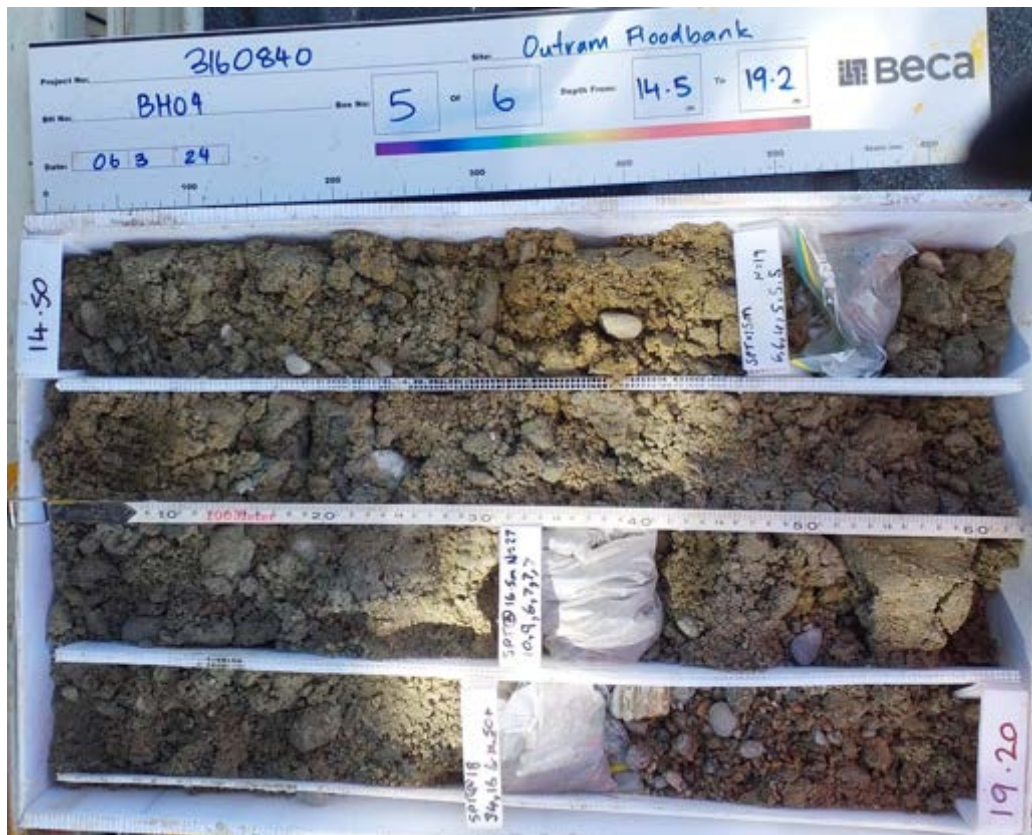
Core Box 05 - 14.50mbgl to 19.20mbgl

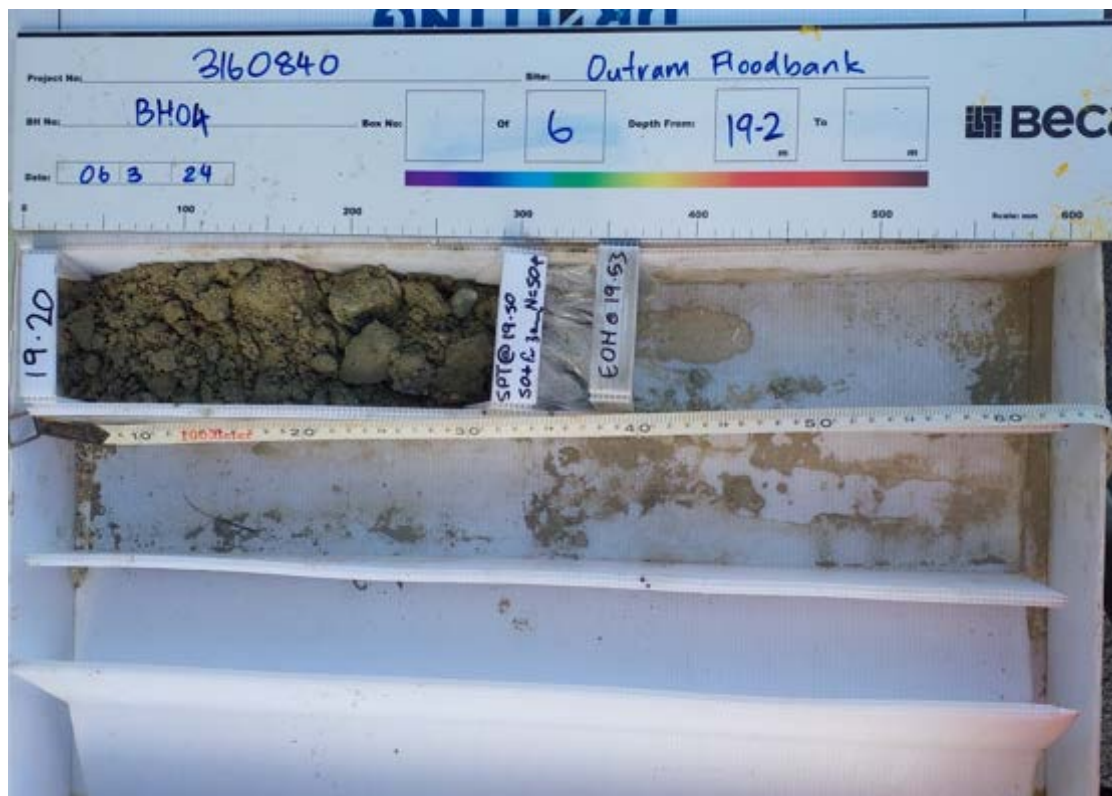
Core Box 06 - 19.20mbgl to 19.53mbgl

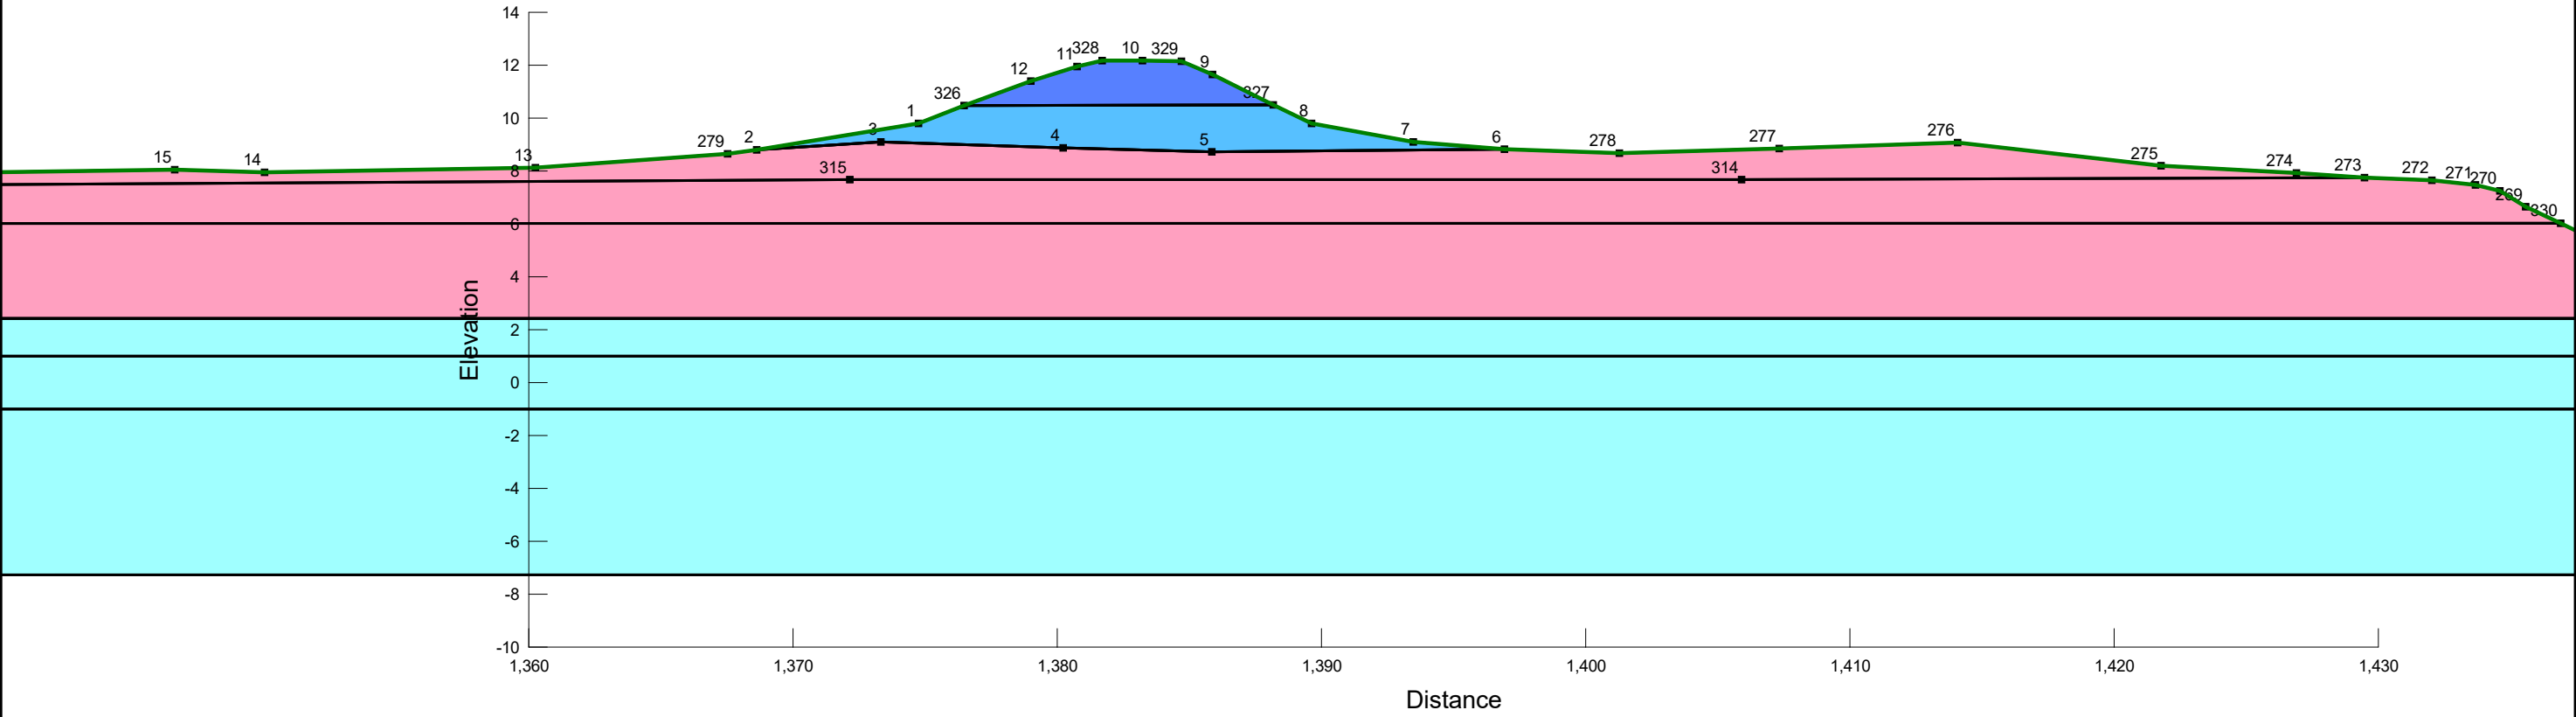
| Section B-B' |

| Outram_SEEP-W Model_Average Conditions.gsz |

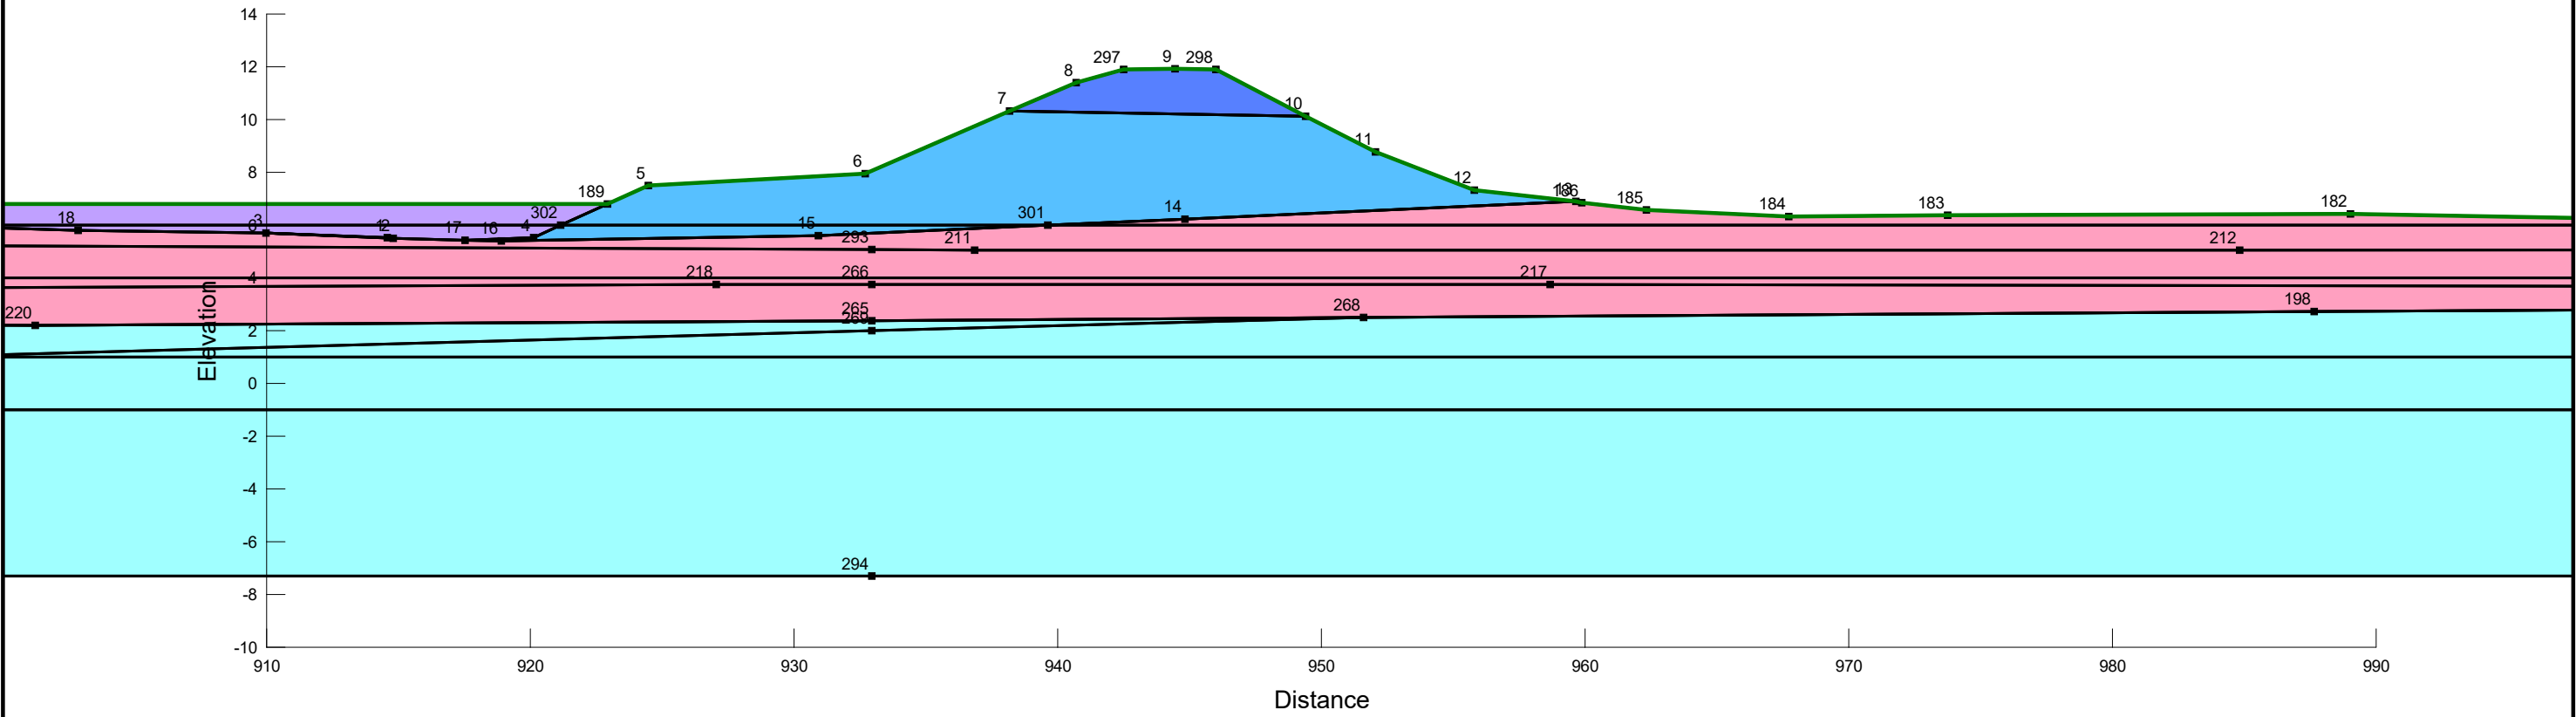
| Color | Name | Slope Stability<br>Material Model | Unit<br>Weight<br>(kN/m³) | Effective<br>Cohesion<br>(kPa) | Effective<br>Friction<br>Angle (°) | Phi-B<br>(°) |
|---|---|---|---|---|---|---|
| <div></div> | Medium dense gravelly SAND (holocene river deposits) | Mohr-Coulomb | 18 | 0 | 32 | 0 |
| <div></div> | Weighted Blanket - Alluvial SILT | Mohr-Coulomb | 17 | 1 | 28 | 0 |

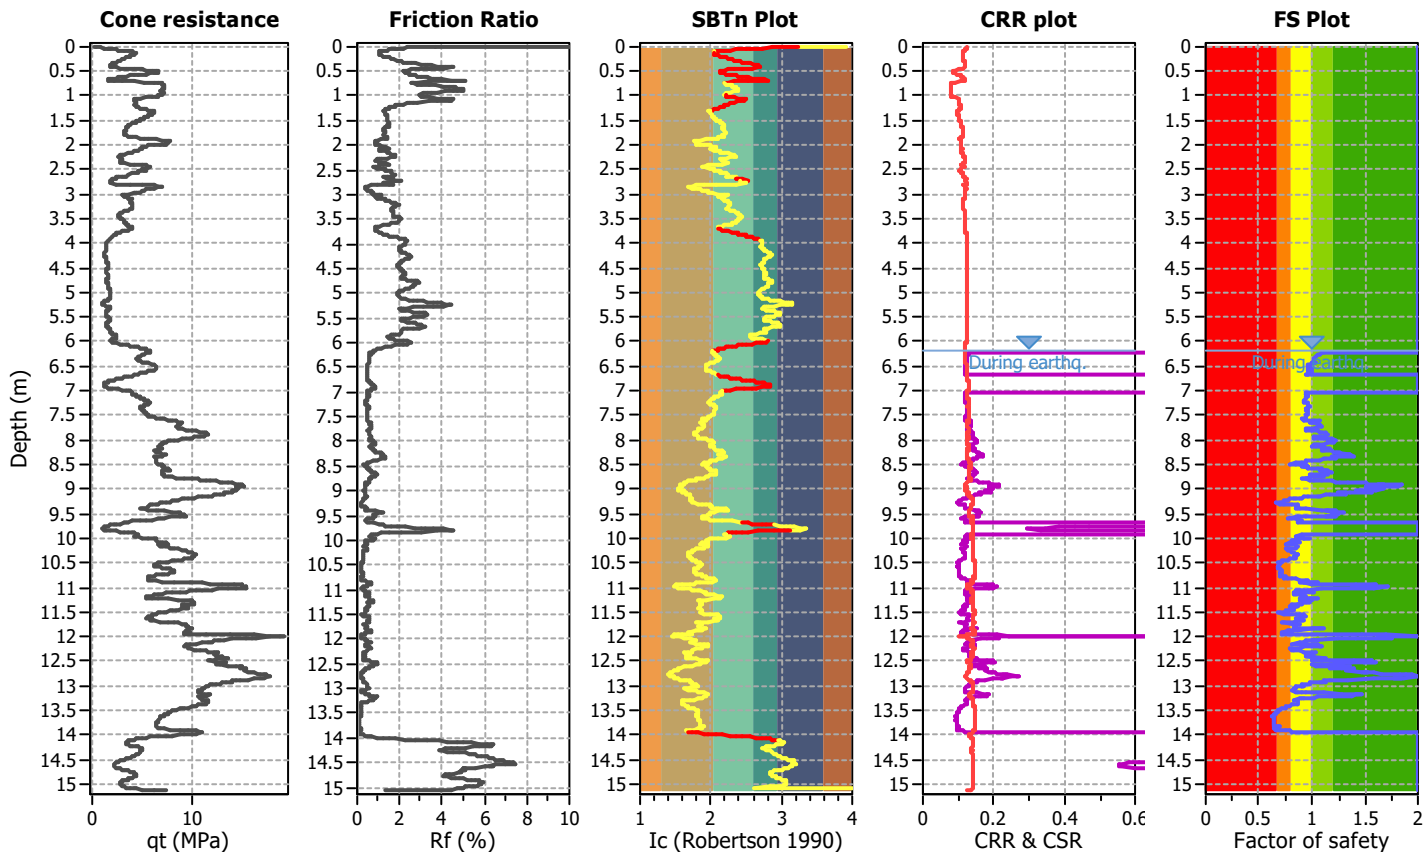
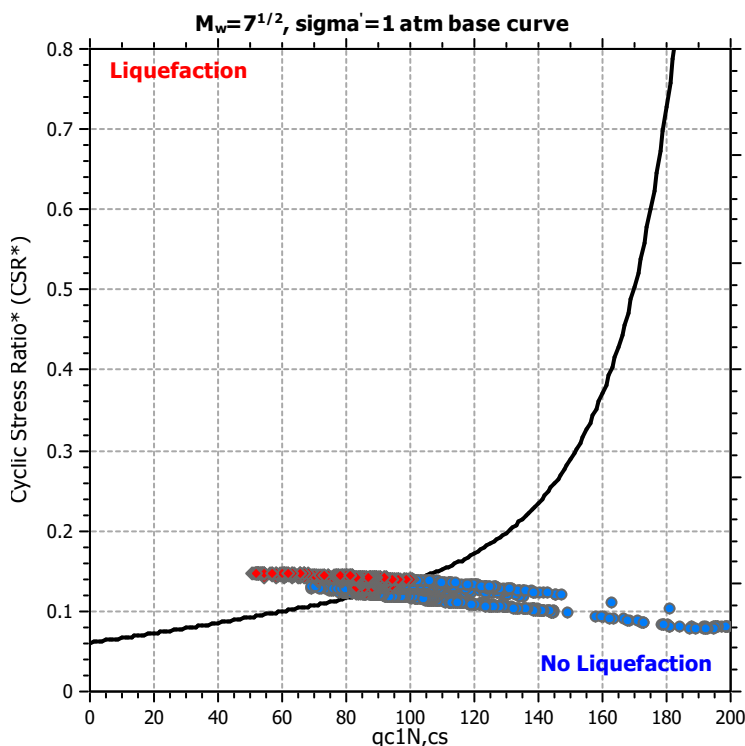
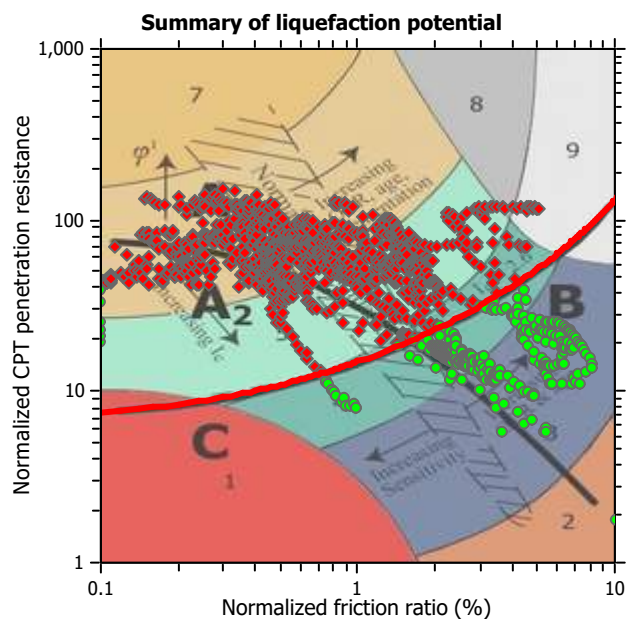
Zone A1: Cyclic liquefaction likely depending on size and duration of cyclic loading  
 Zone A2: Cyclic liquefaction and strength loss likely depending on loading and ground geometry  
 Zone B: Liquefaction and post-earthquake strength loss unlikely, check cyclic softening  
 Zone C: Cyclic liquefaction and strength loss possible depending on soil plasticity, brittleness/sensitivity, strain to peak undrained strength and ground geometry

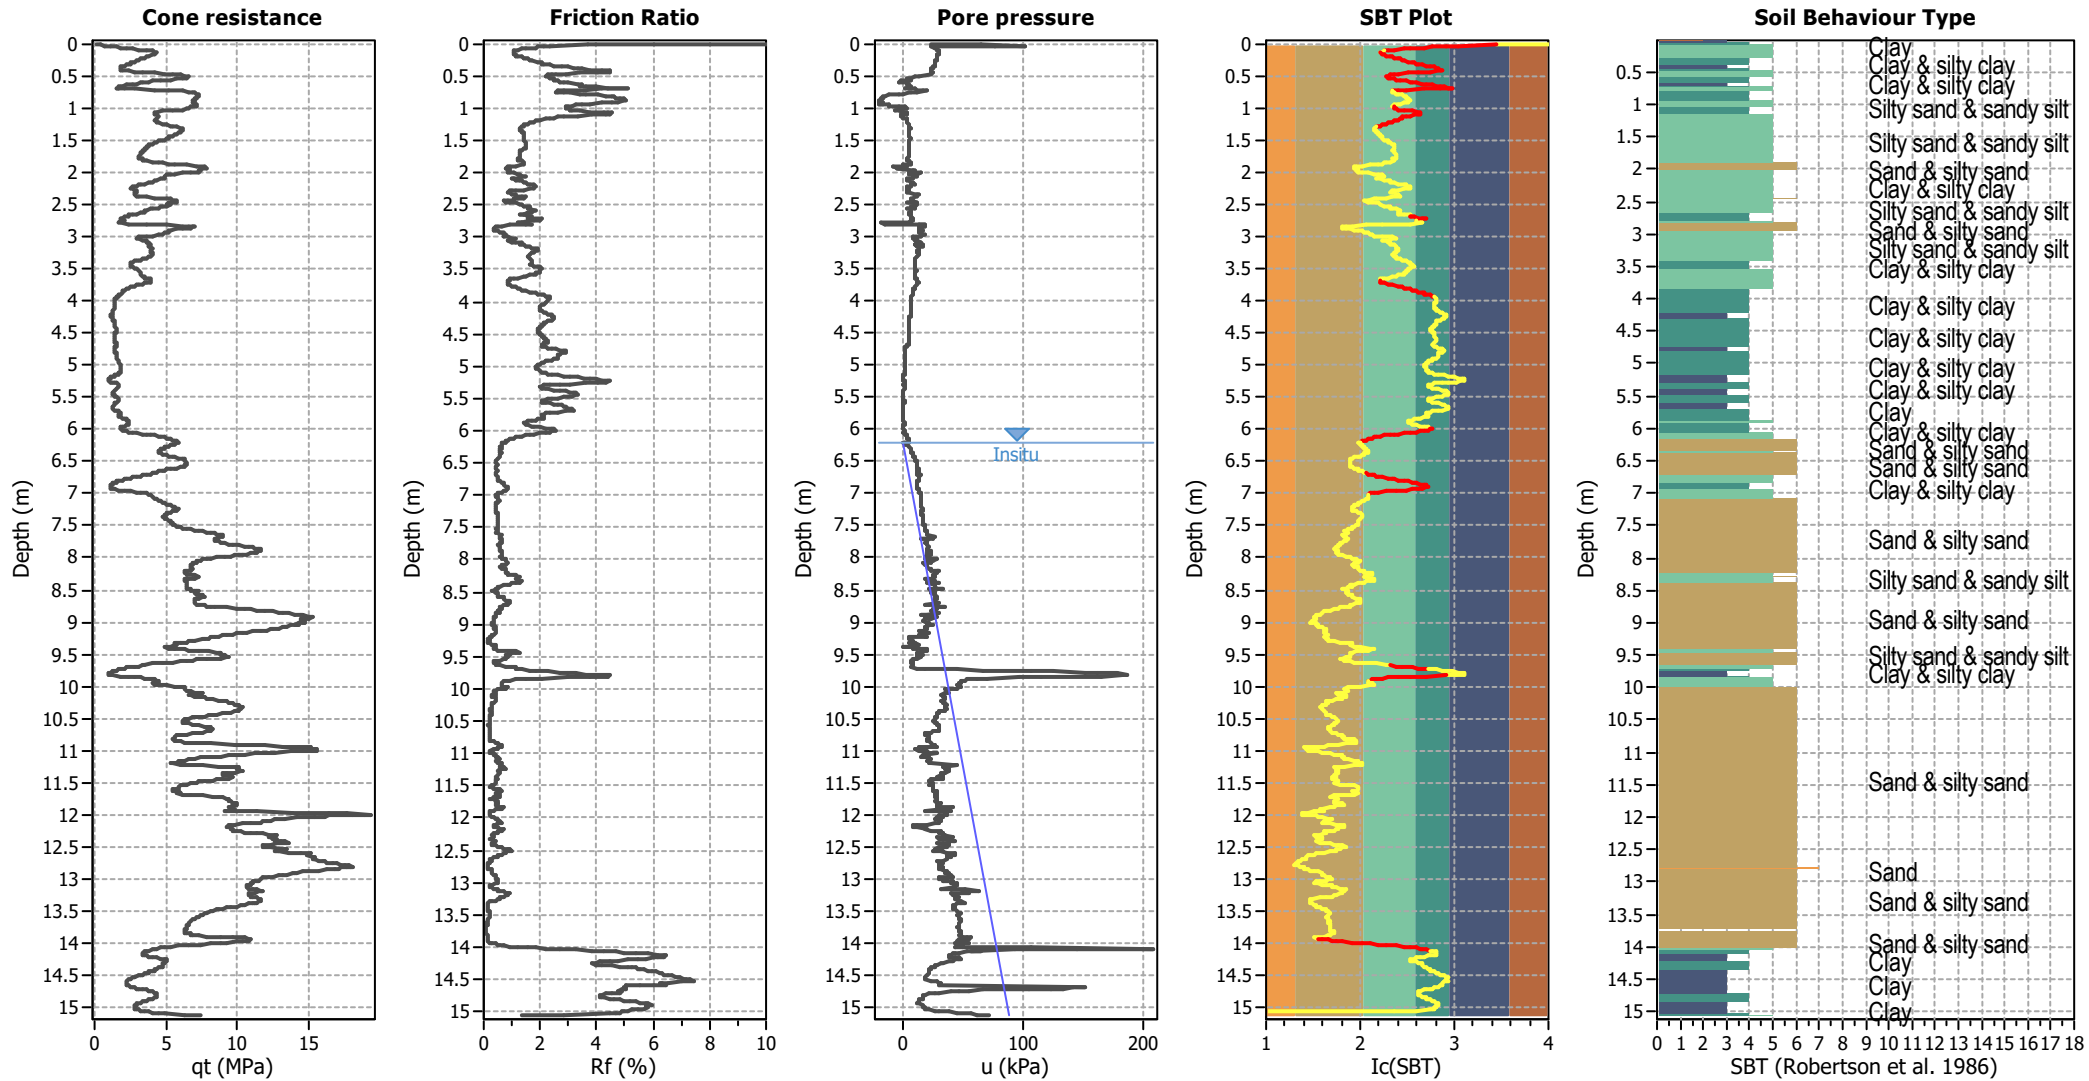
CPT basic interpretation plots

Input parameters and analysis data

| Analysis method: | B&I (2014) | Depth to GWT (erthq.): | 6.20 m | Fill weight: | N/A |
