# TAIERI LIAISON GROUP AGENDA

## 1. MEETING DETAILS

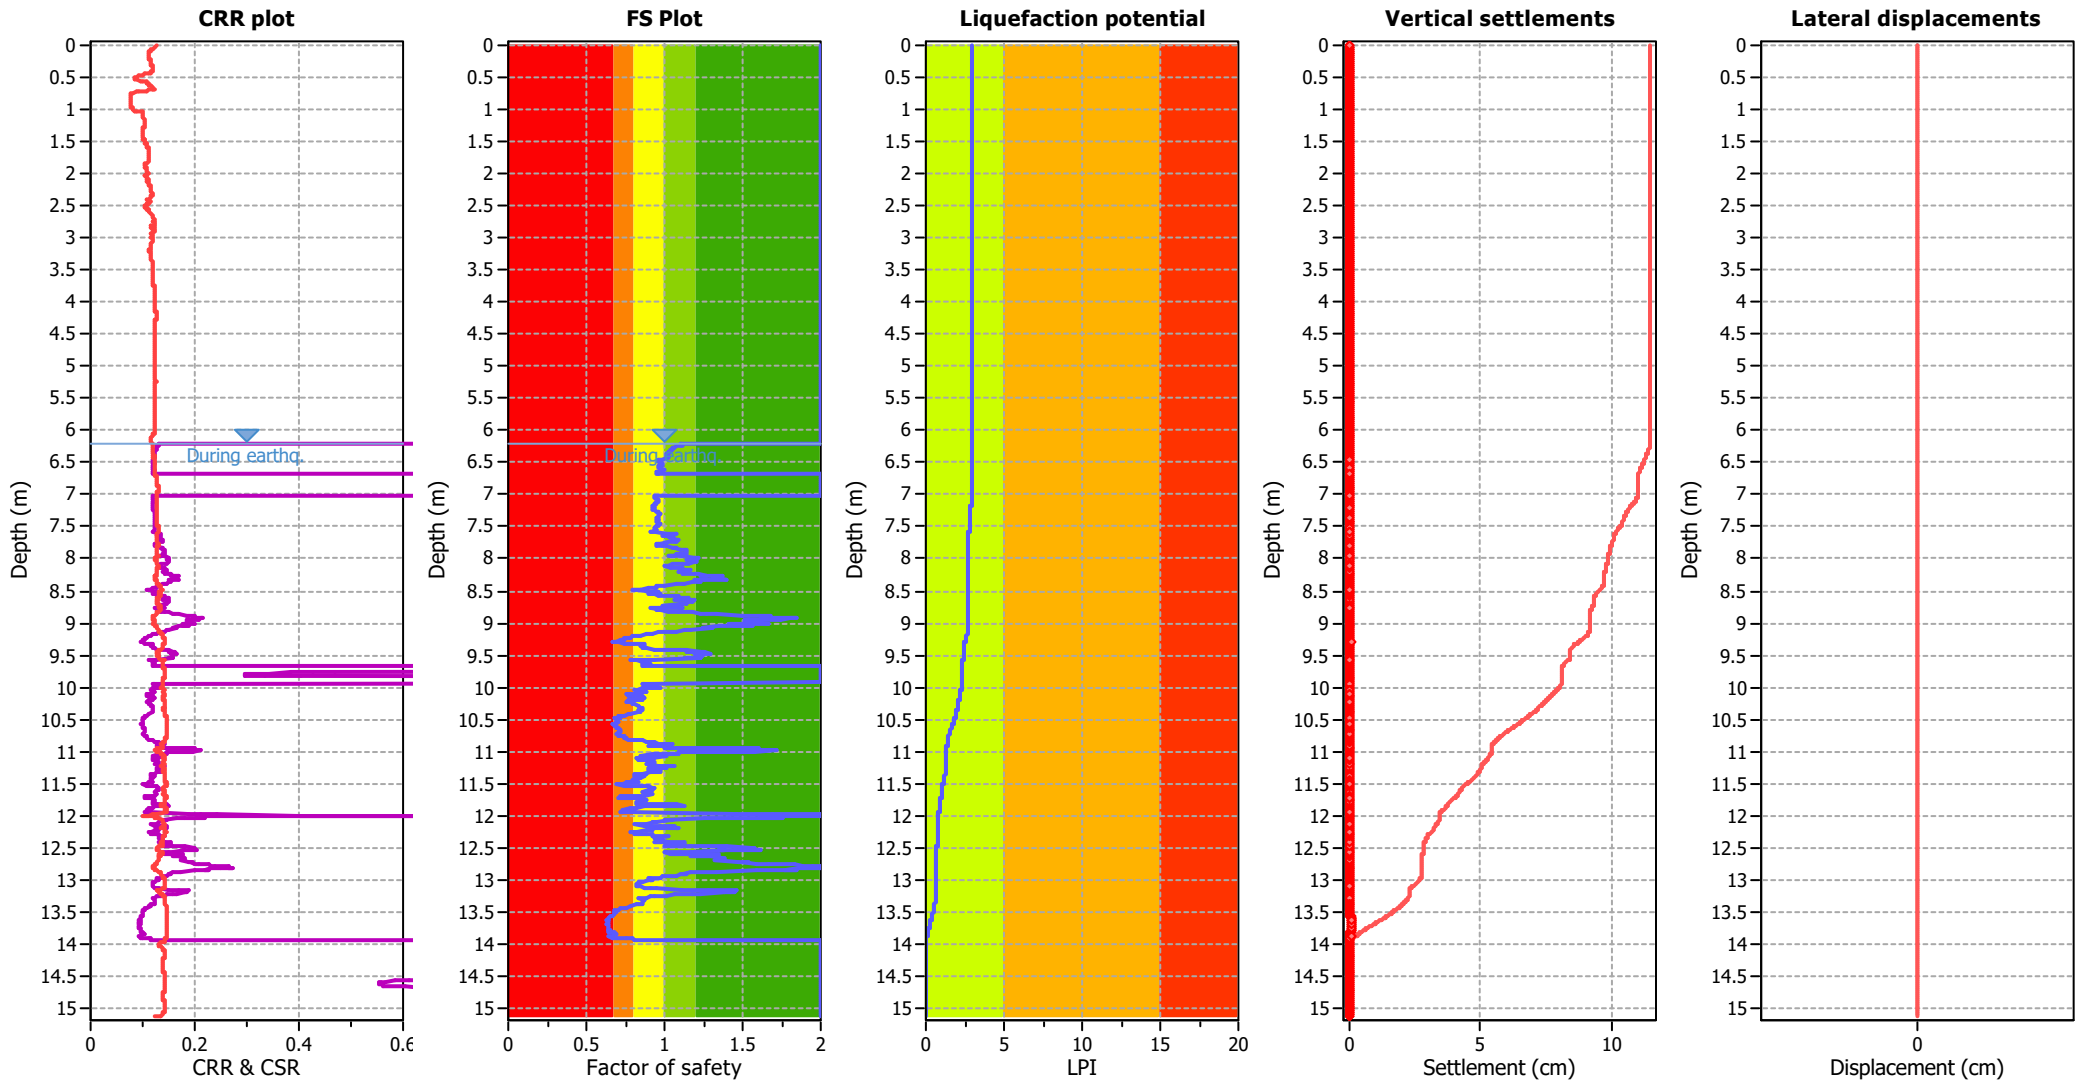
Liquefaction analysis overall plots

| Analysis method: | B&I (2014) | Depth to GWT (earthq.): | 6.20 m | Fill weight: | N/A |

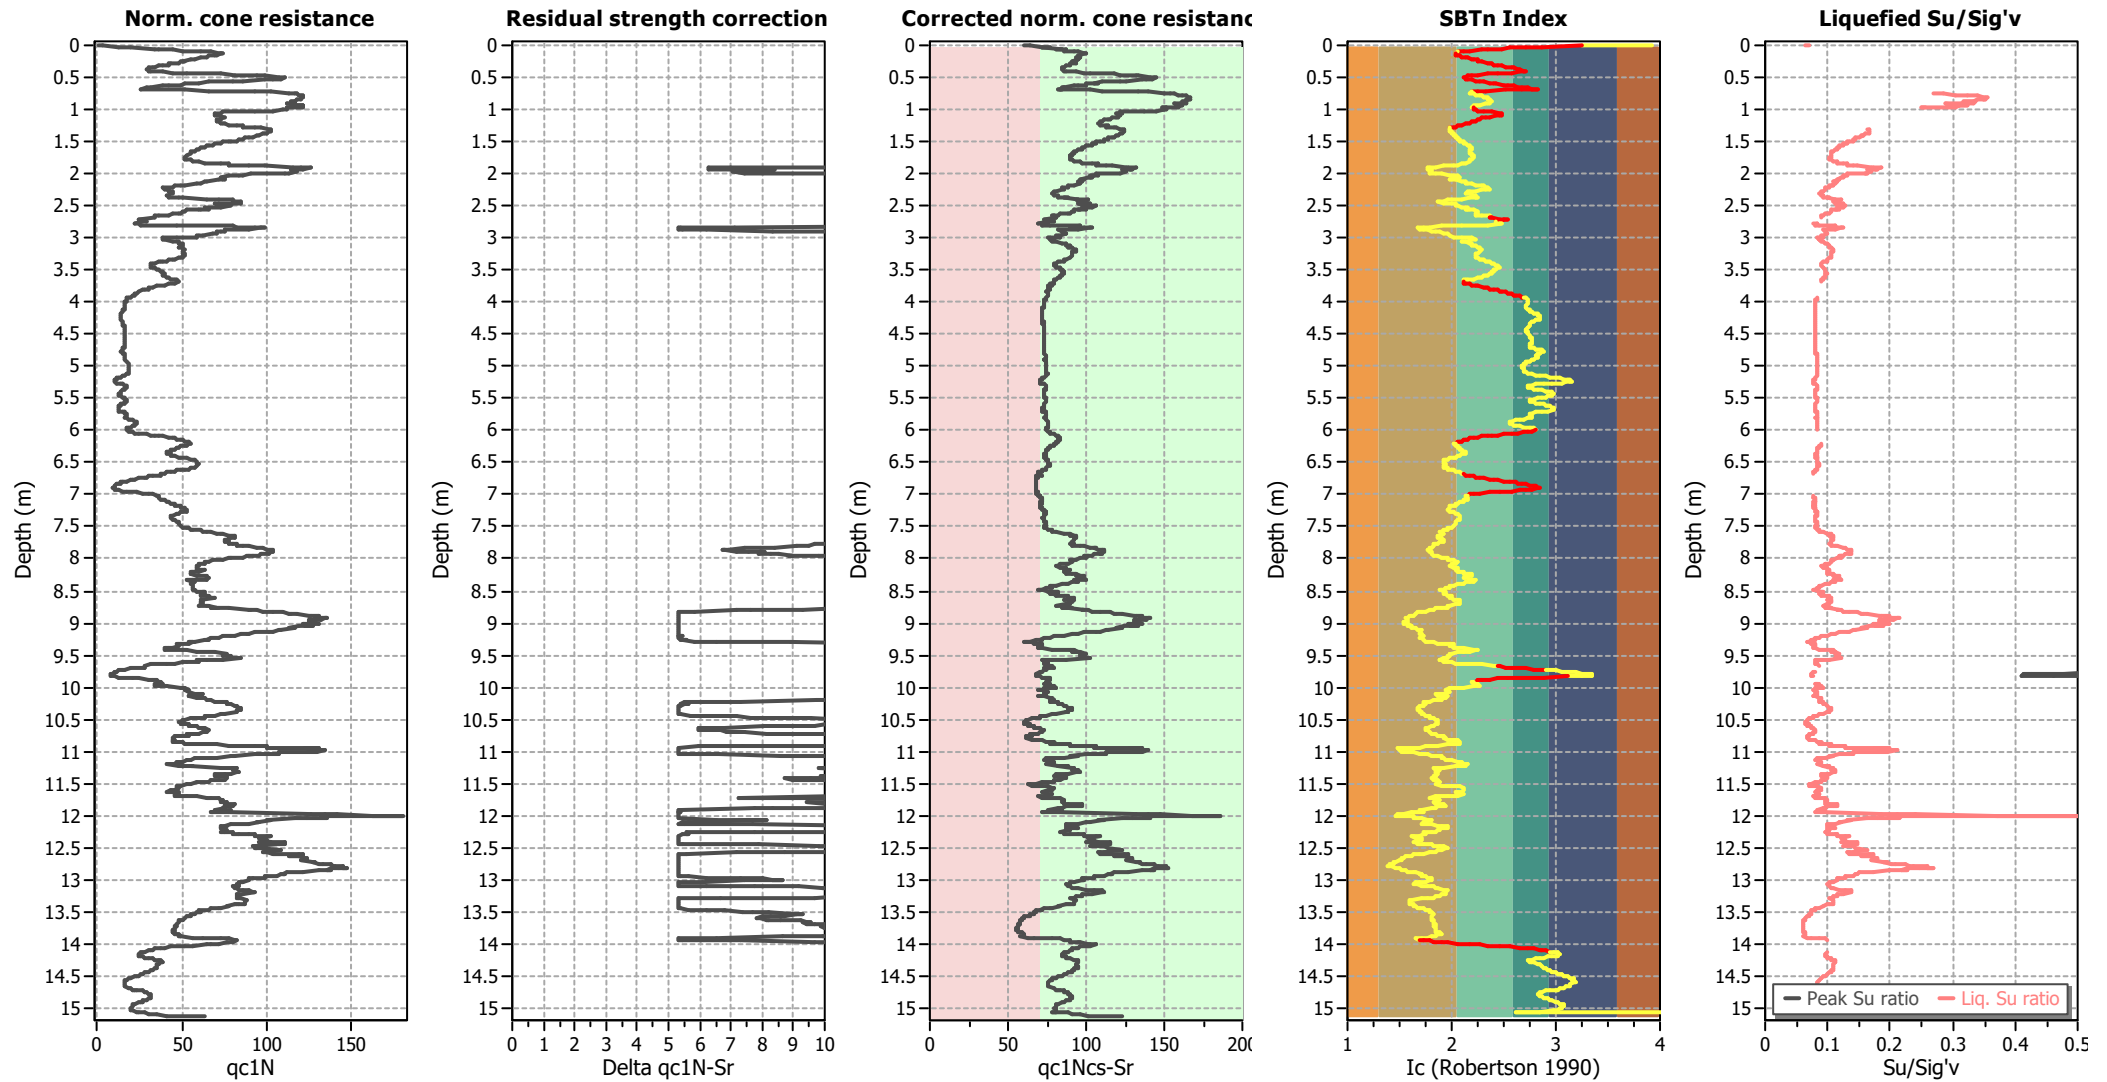
### Check for strength loss plots (Idriss & Boulanger (2008))

| Analysis method: | B&I (2014) | Depth to GWT (erthq.): | 6.20 m | Fill weight: | N/A |

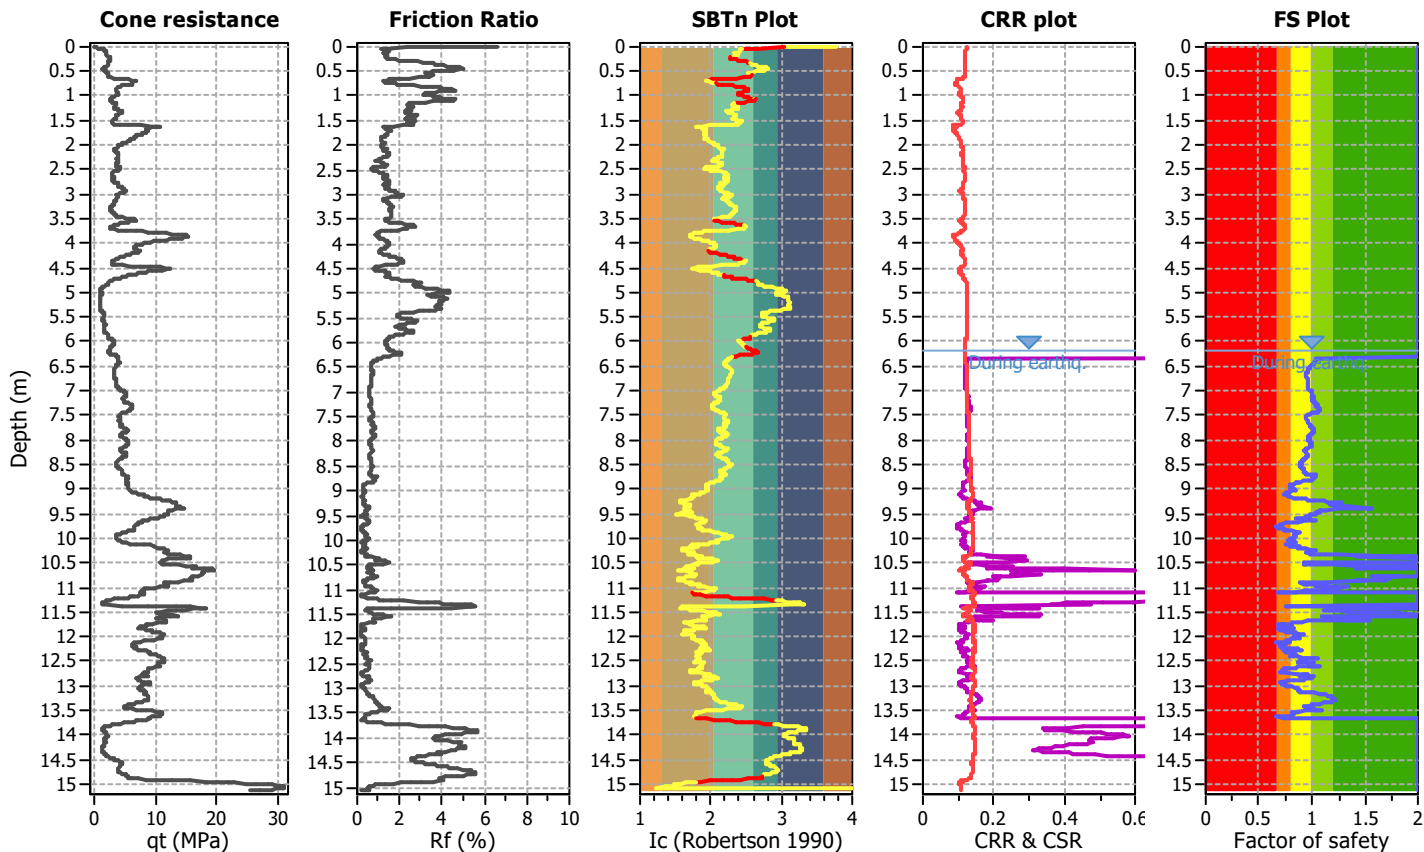
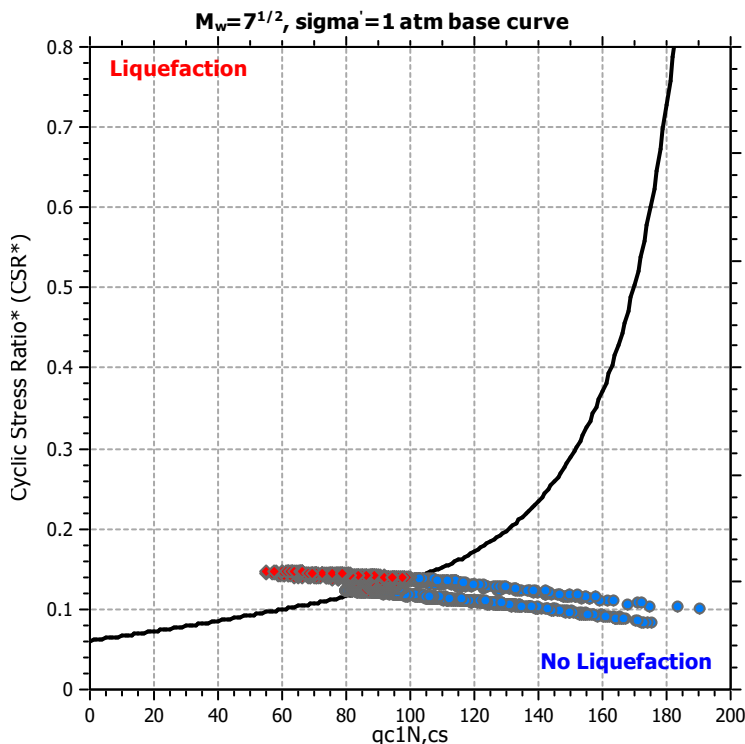
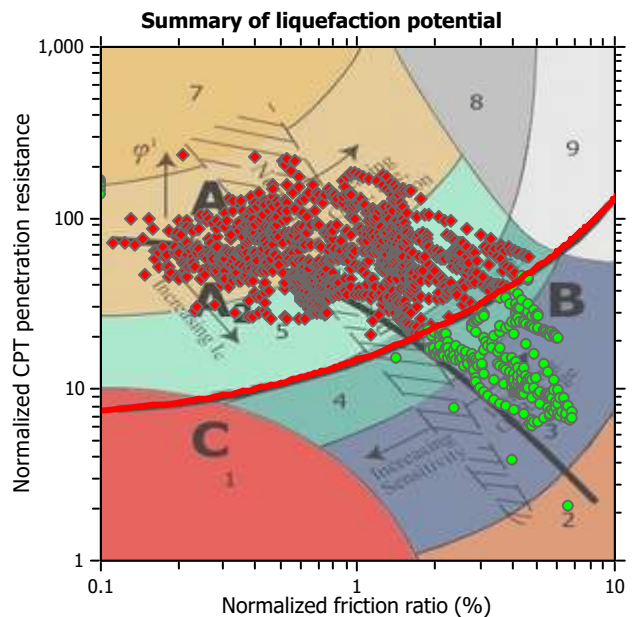
Zone A1: Cyclic liquefaction likely depending on size and duration of cyclic loading  
 Zone A2: Cyclic liquefaction and strength loss likely depending on loading and ground geometry  
 Zone B: Liquefaction and post-earthquake strength loss unlikely, check cyclic softening  
 Zone C: Cyclic liquefaction and strength loss possible depending on soil plasticity, brittleness/sensitivity, strain to peak undrained strength and ground geometry

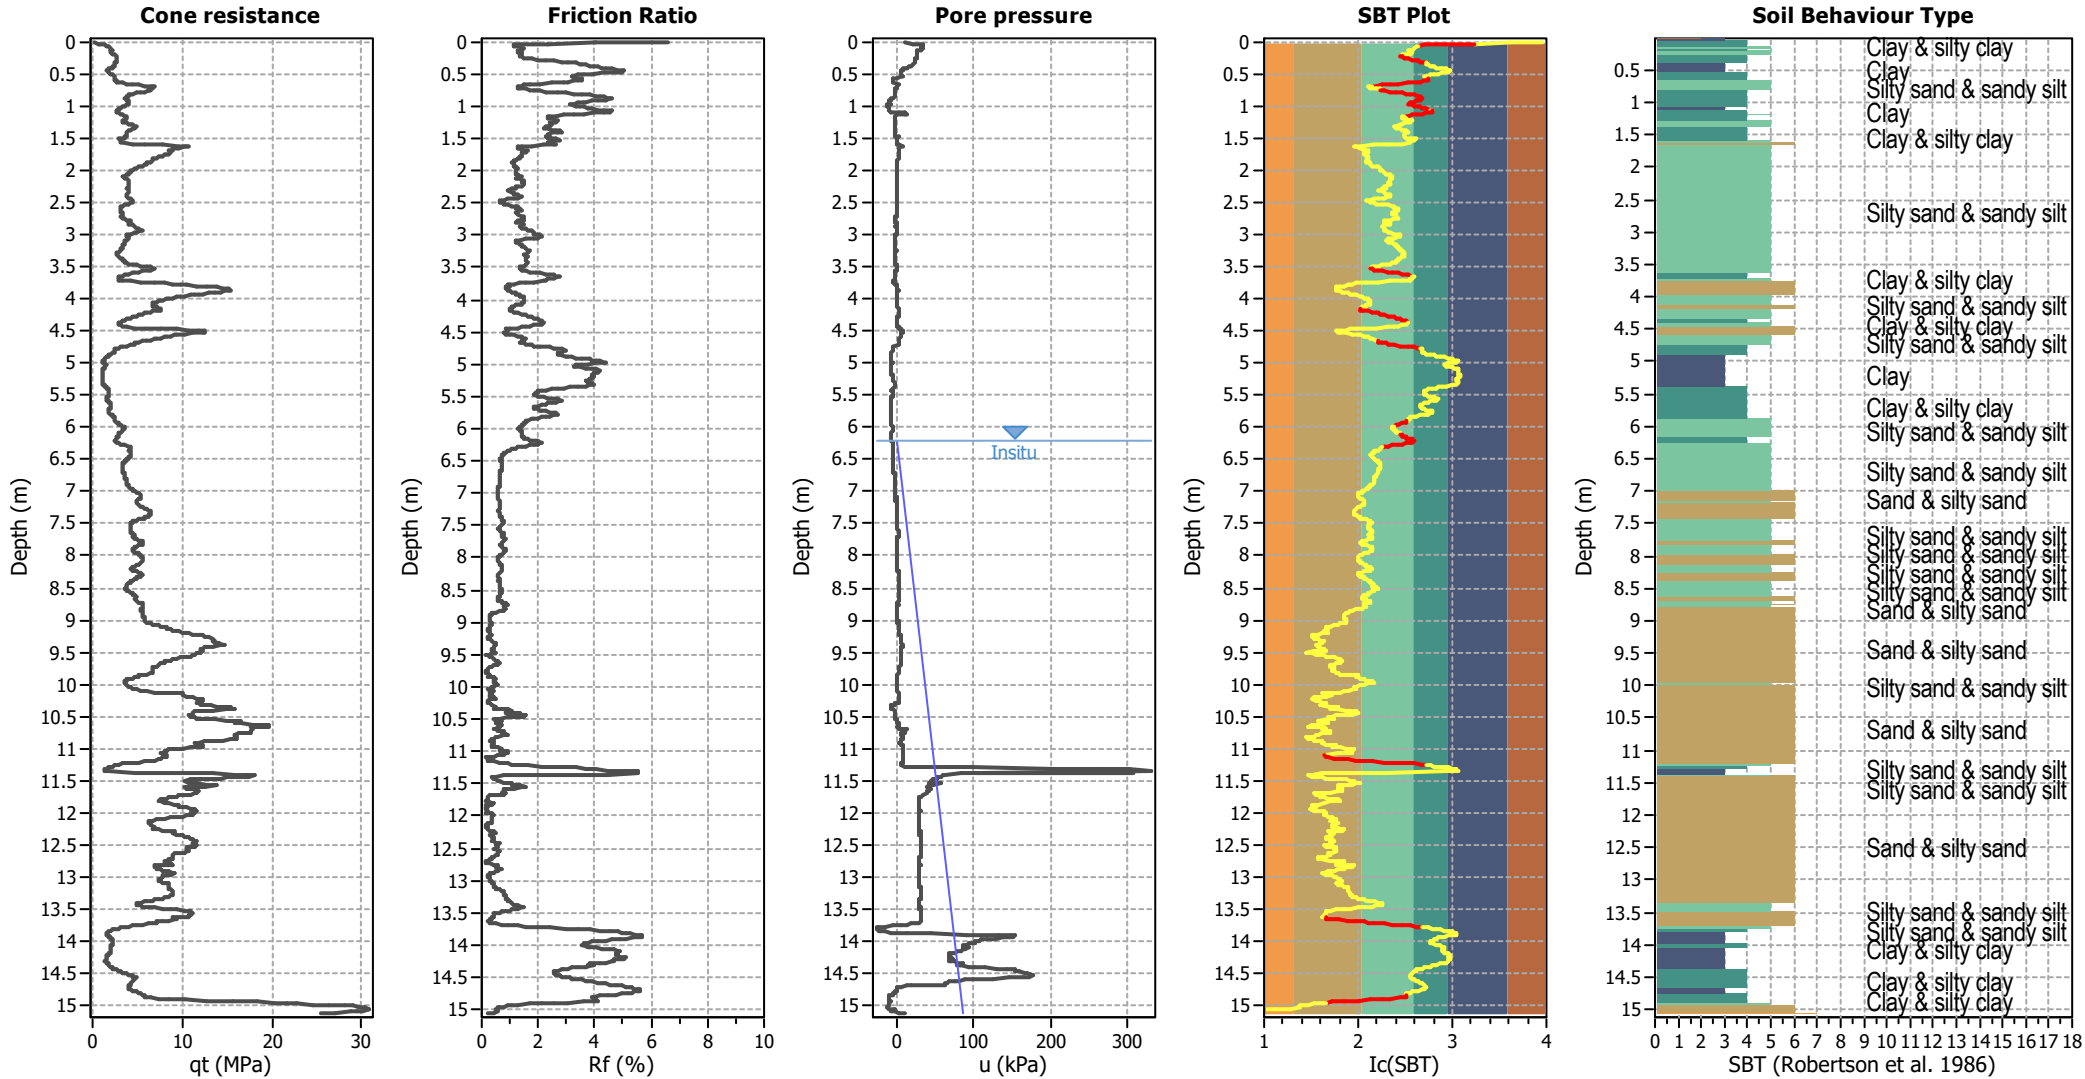
CPT basic interpretation plots

| Analysis method: | B&I (2014) | Depth to GWT (erthq.): | 6.20 m | Fill weight: | N/A |

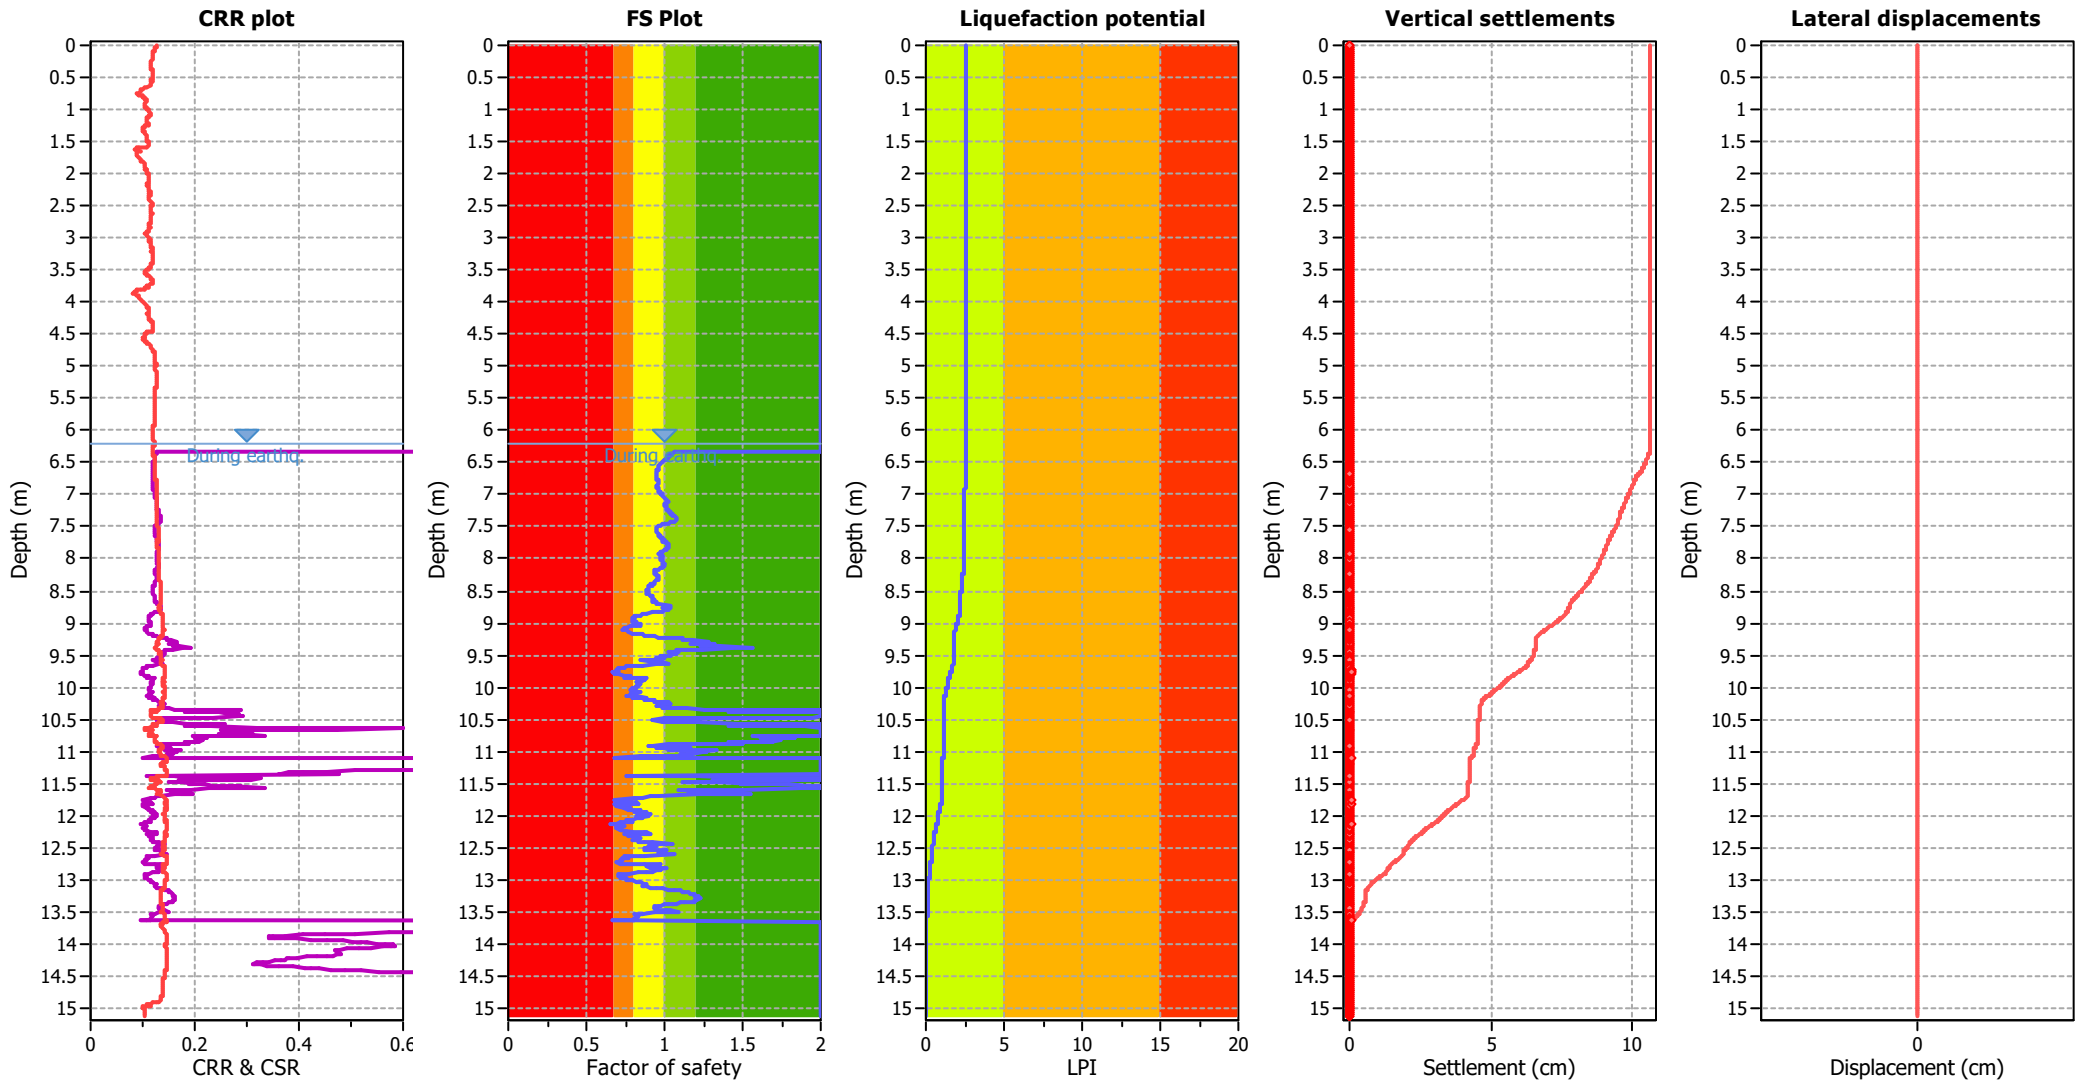
Liquefaction analysis overall plots

| Analysis method: | B&I (2014) | Depth to GWT (earthq.): | 6.20 m | Fill weight: | N/A |

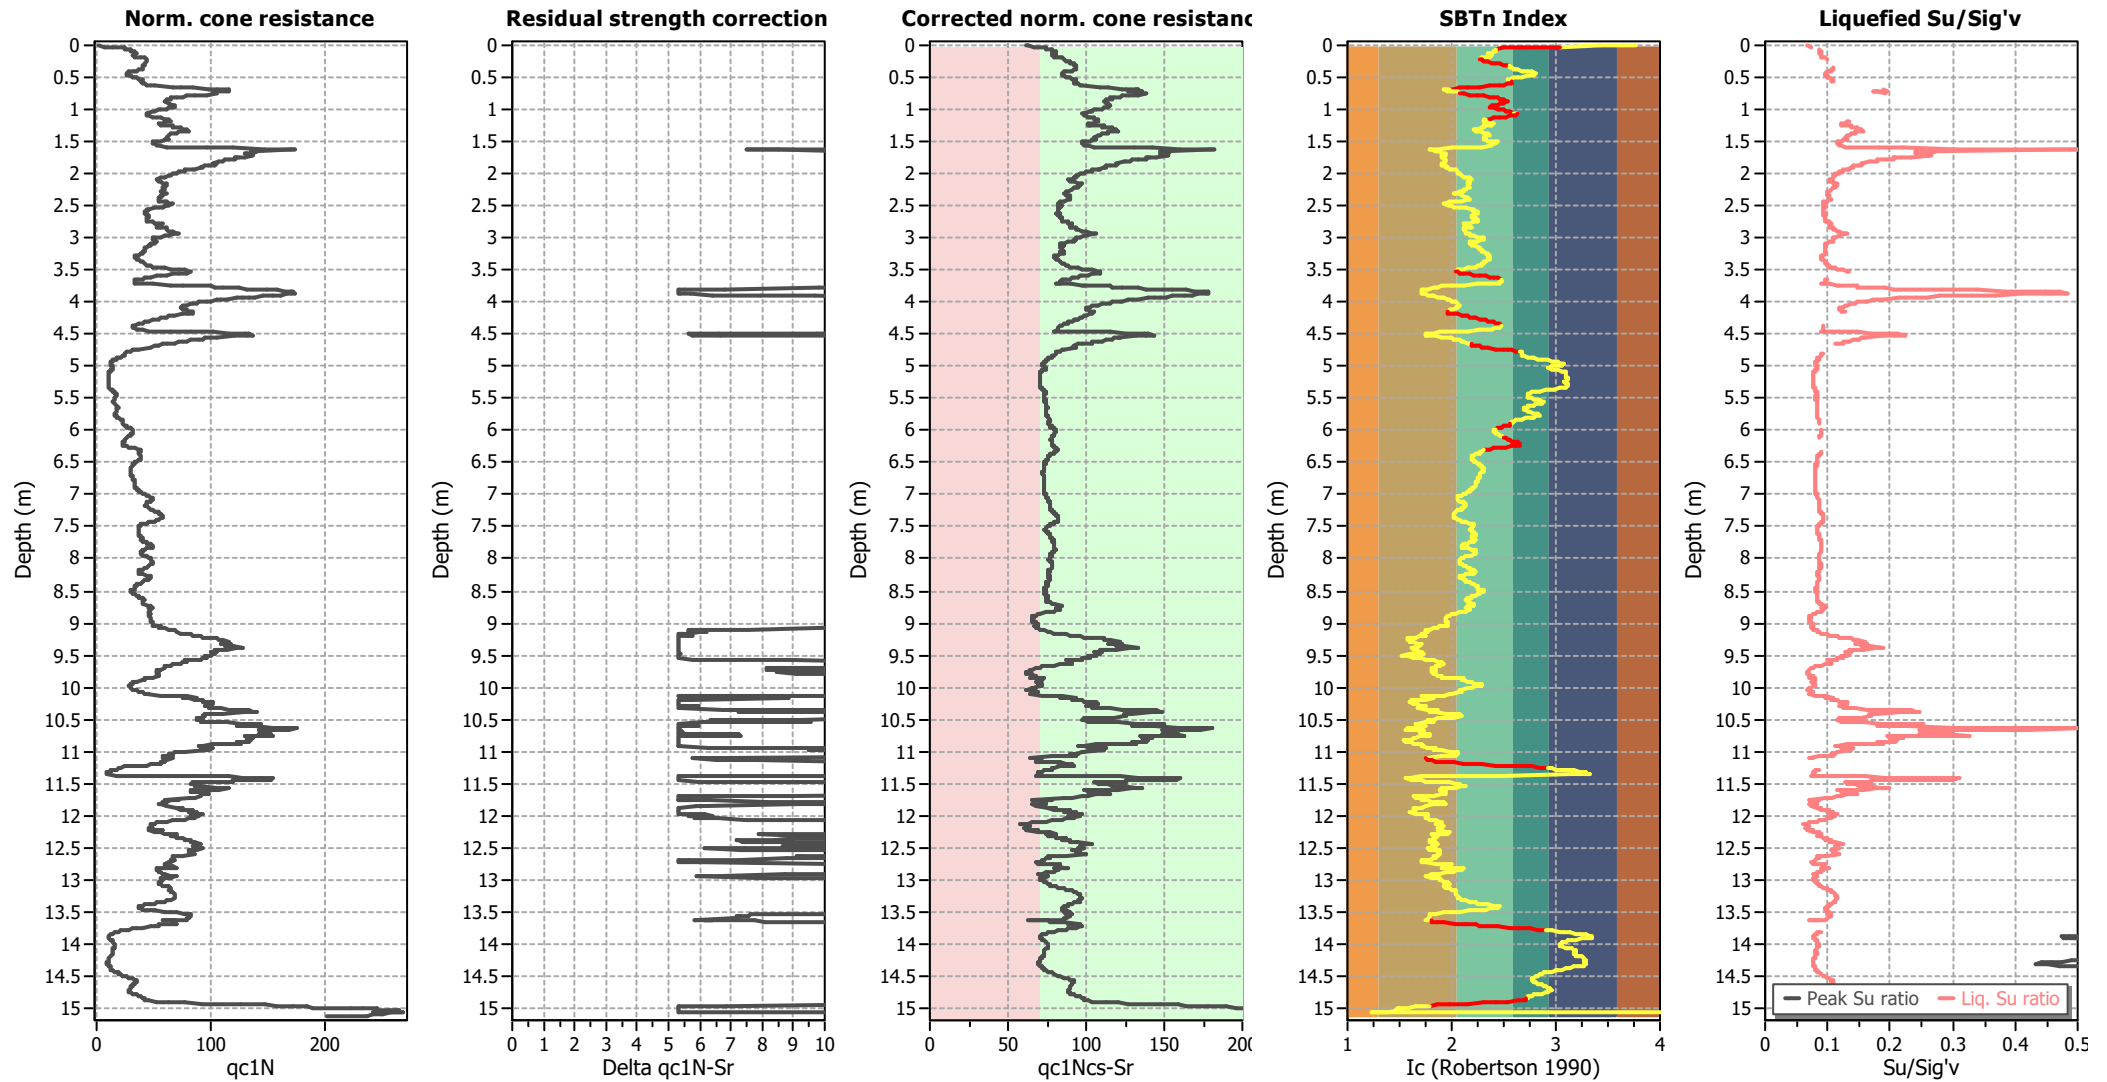
### Check for strength loss plots (Idriss & Boulanger (2008))

| Analysis method: | B&I (2014) | Depth to GWT (erthq.): | 6.20 m | Fill weight: | N/A |

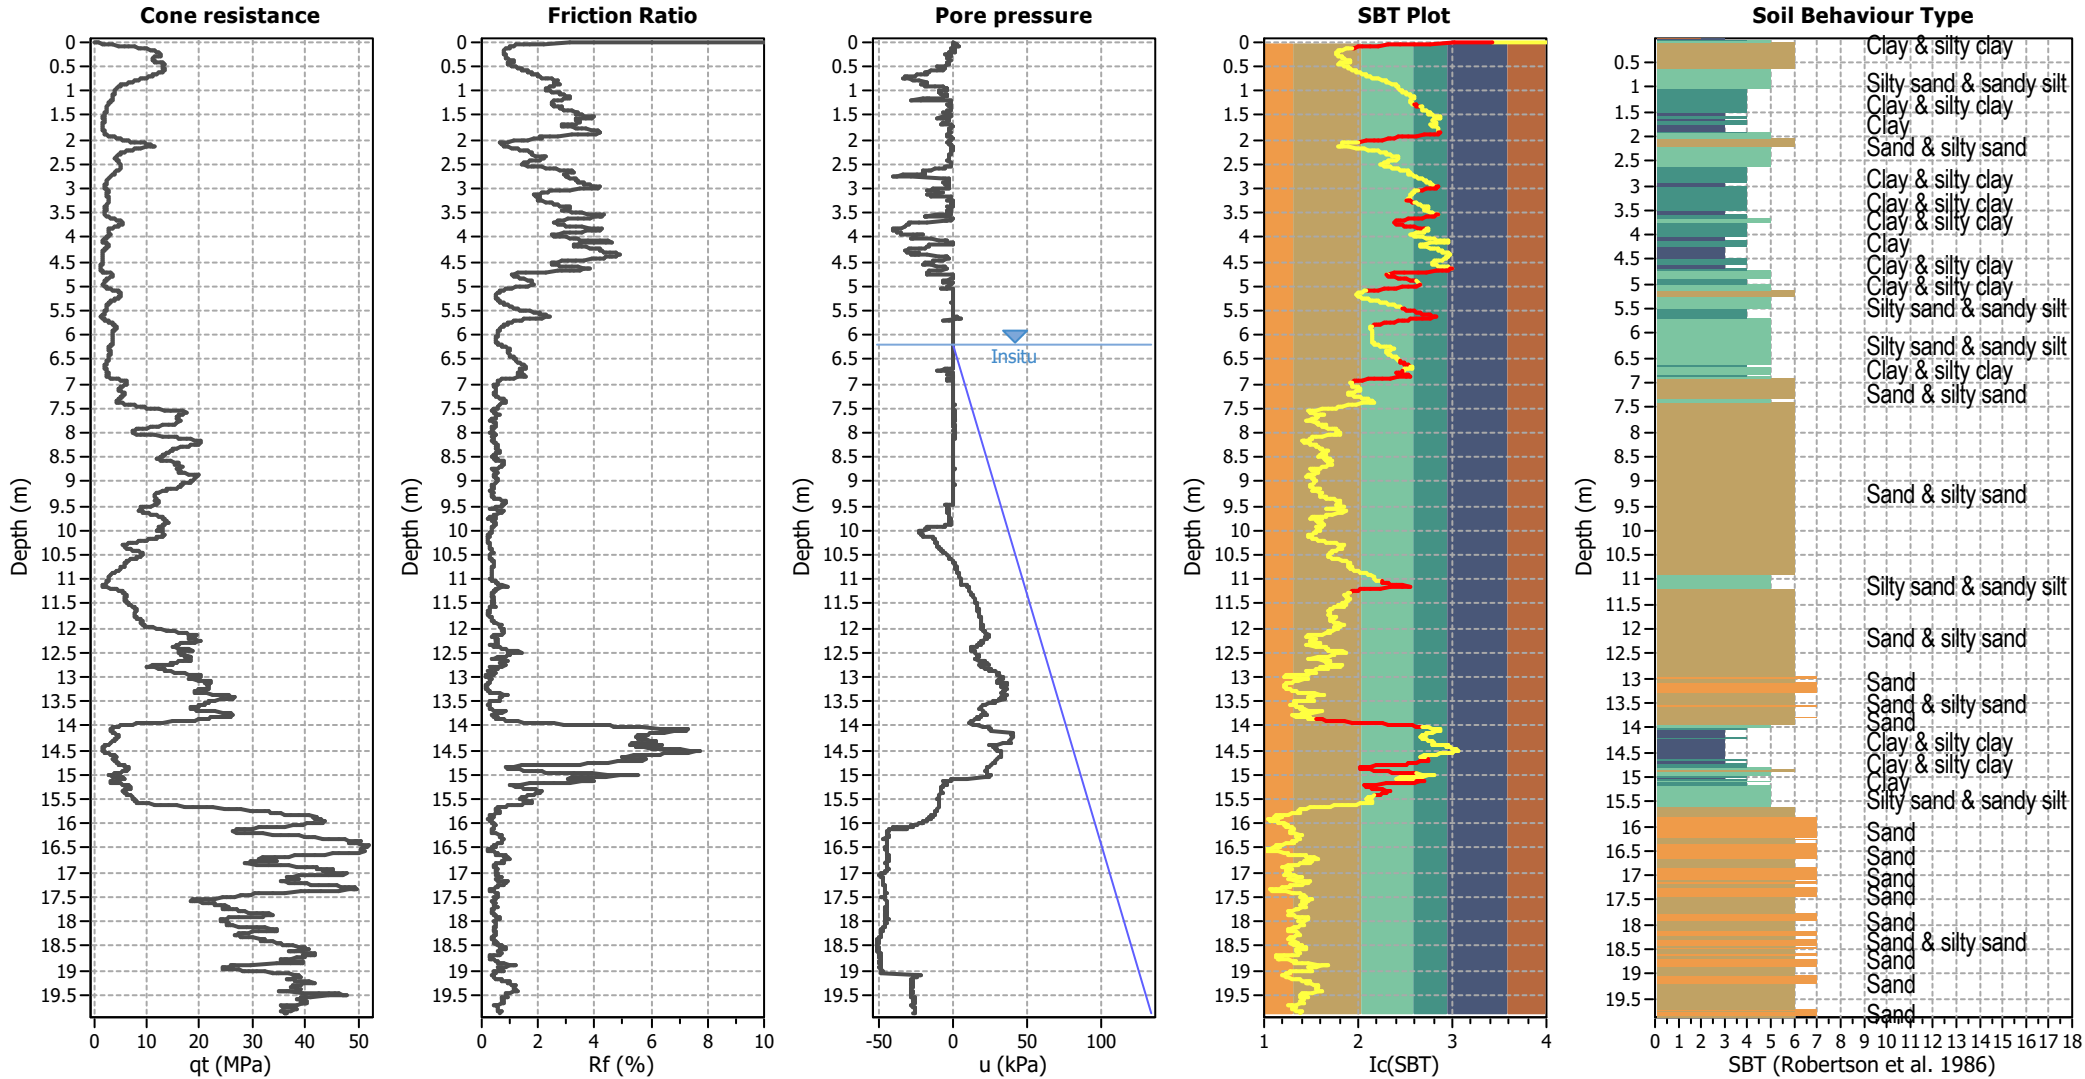
CPT basic interpretation plots

| Analysis method: | B&I (2014) | Depth to GWT (erthq.): | 6.20 m | Fill weight: | N/A |

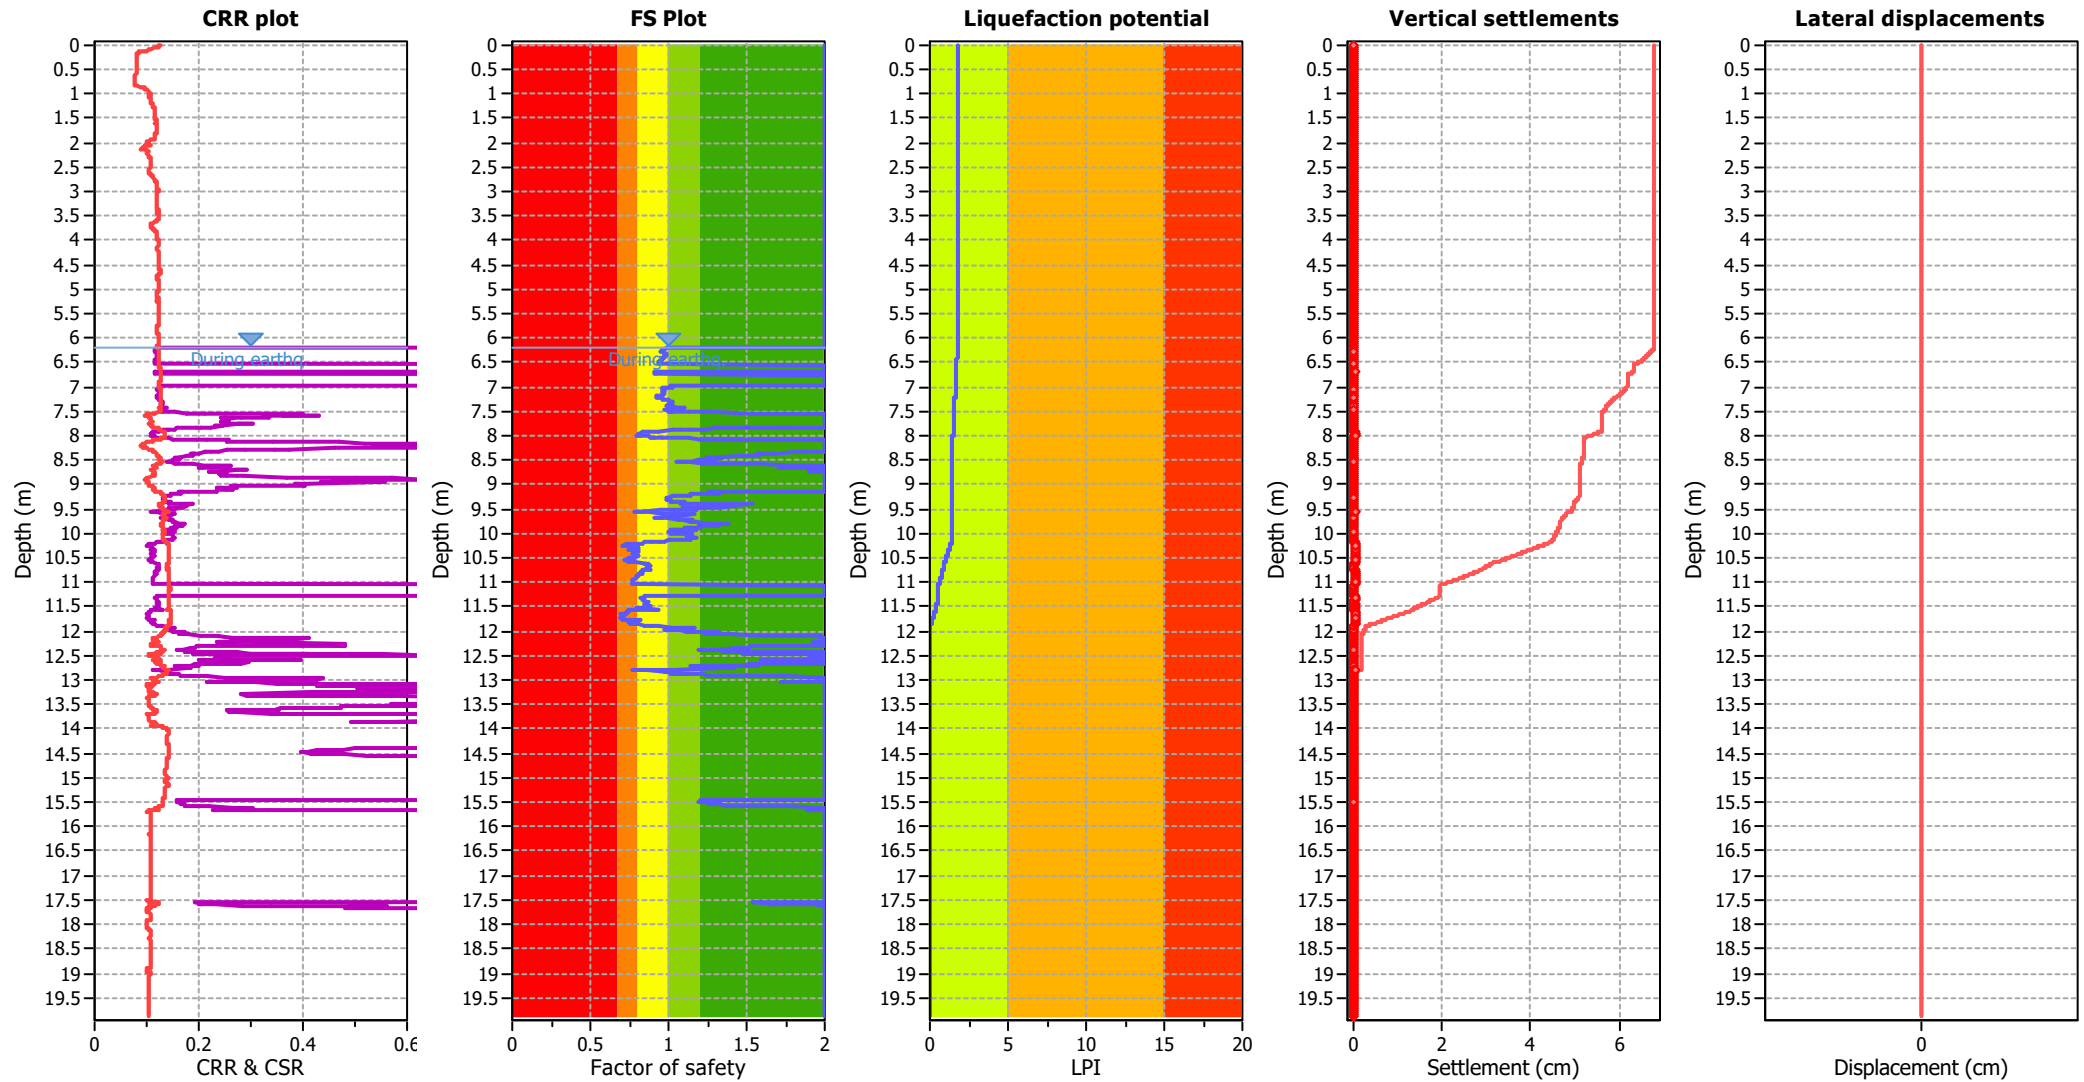
## Liquefaction analysis overall plots

| Analysis method: | B&I (2014) | Depth to GWT (erthq.): | 6.20 m | Fill weight: | N/A |

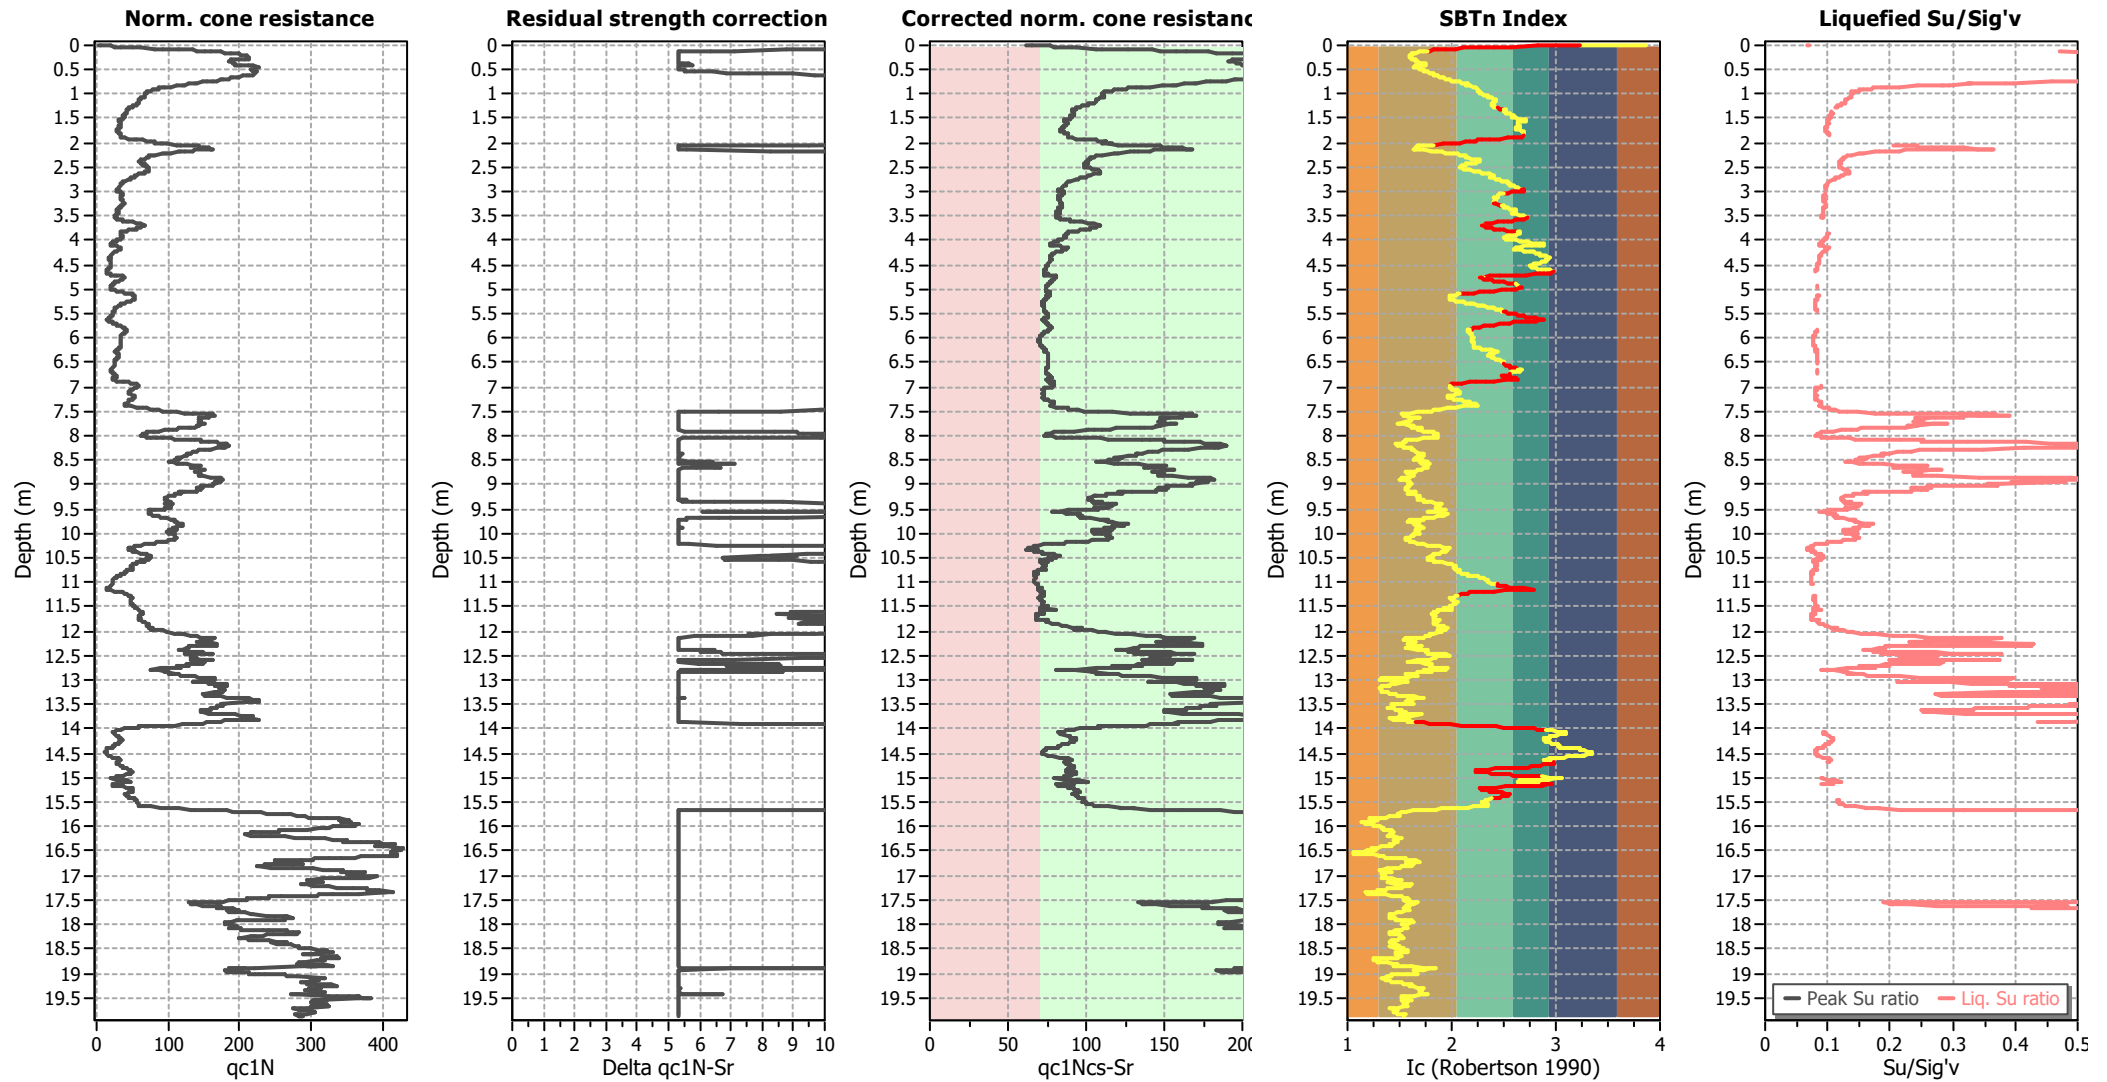
## Check for strength loss plots (Idriss & Boulanger (2008))

| Analysis method: | B&I (2014) | Depth to GWT (erthq.): | 6.20 m | Fill weight: | N/A |

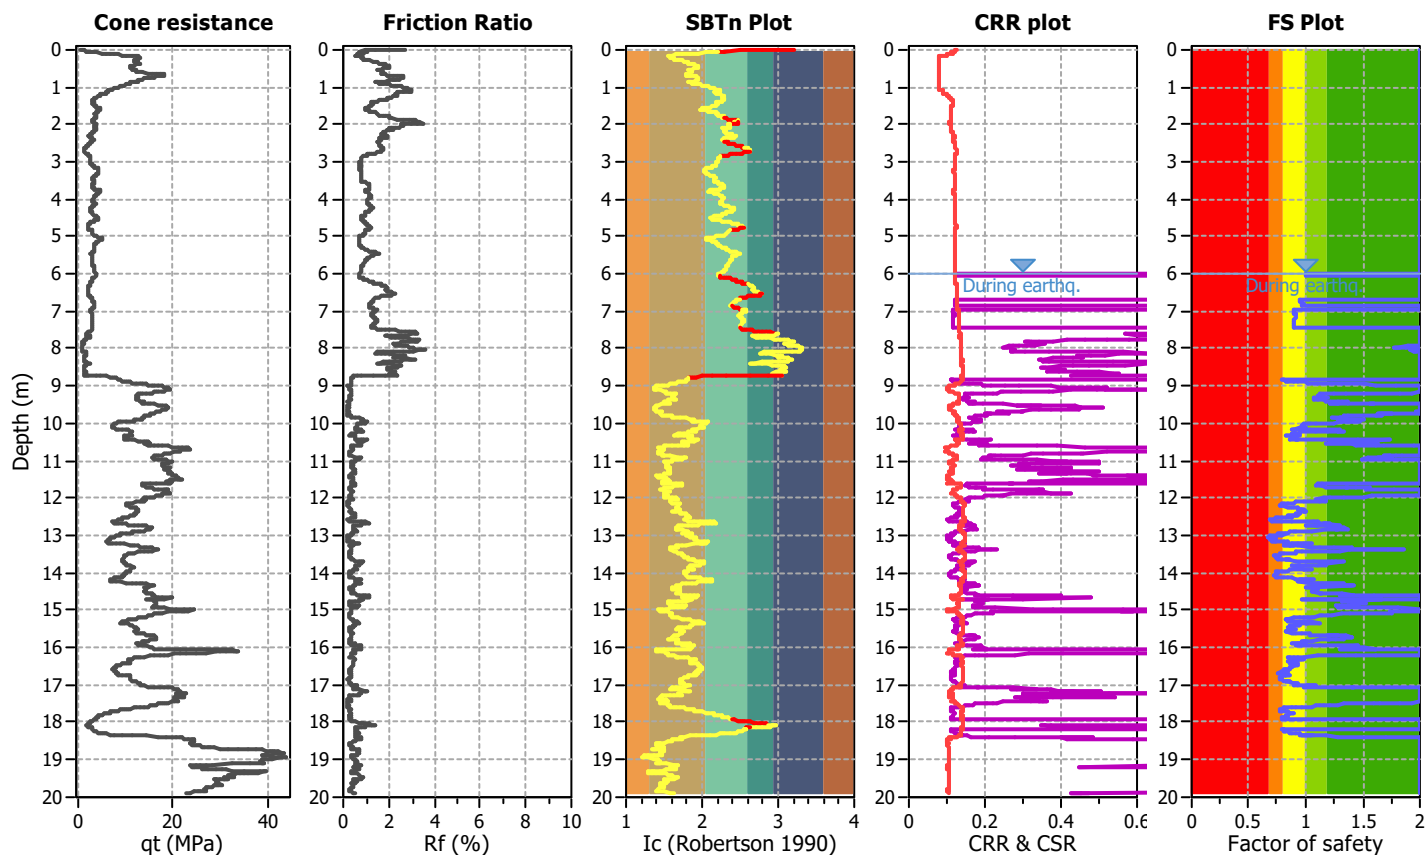
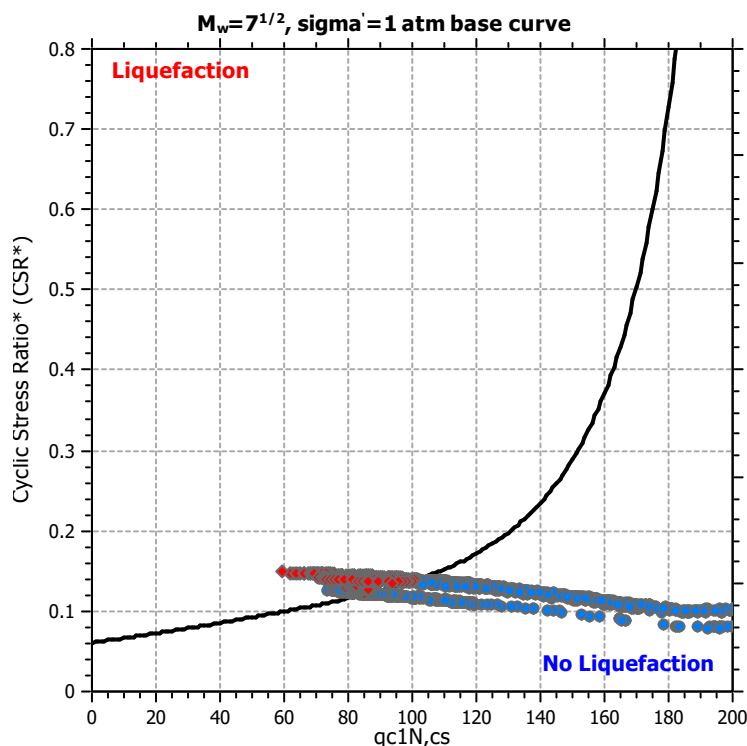
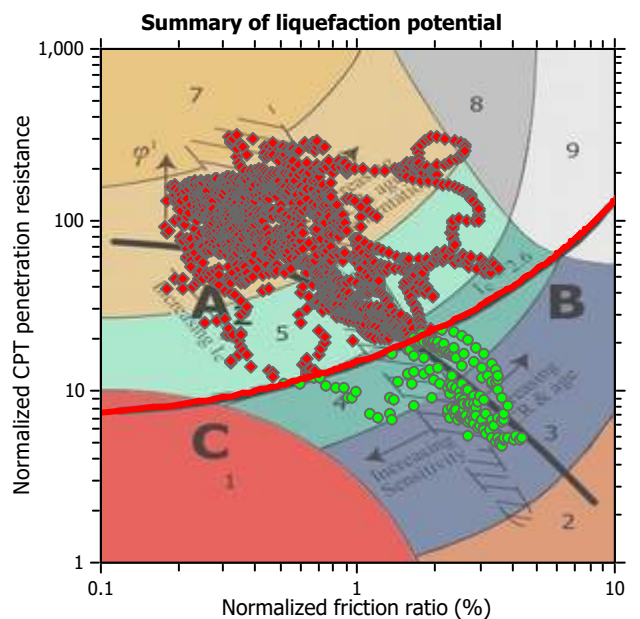
Zone A<sub>1</sub>: Cyclic liquefaction likely depending on size and duration of cyclic loading  
 Zone A<sub>2</sub>: Cyclic liquefaction and strength loss likely depending on loading and ground geometry  
 Zone B: Liquefaction and post-earthquake strength loss unlikely, check cyclic softening  
 Zone C: Cyclic liquefaction and strength loss possible depending on soil plasticity, brittleness/sensitivity, strain to peak undrained strength and ground geometry
