# TAIERI LIAISON GROUP AGENDA

## 1. MEETING DETAILS

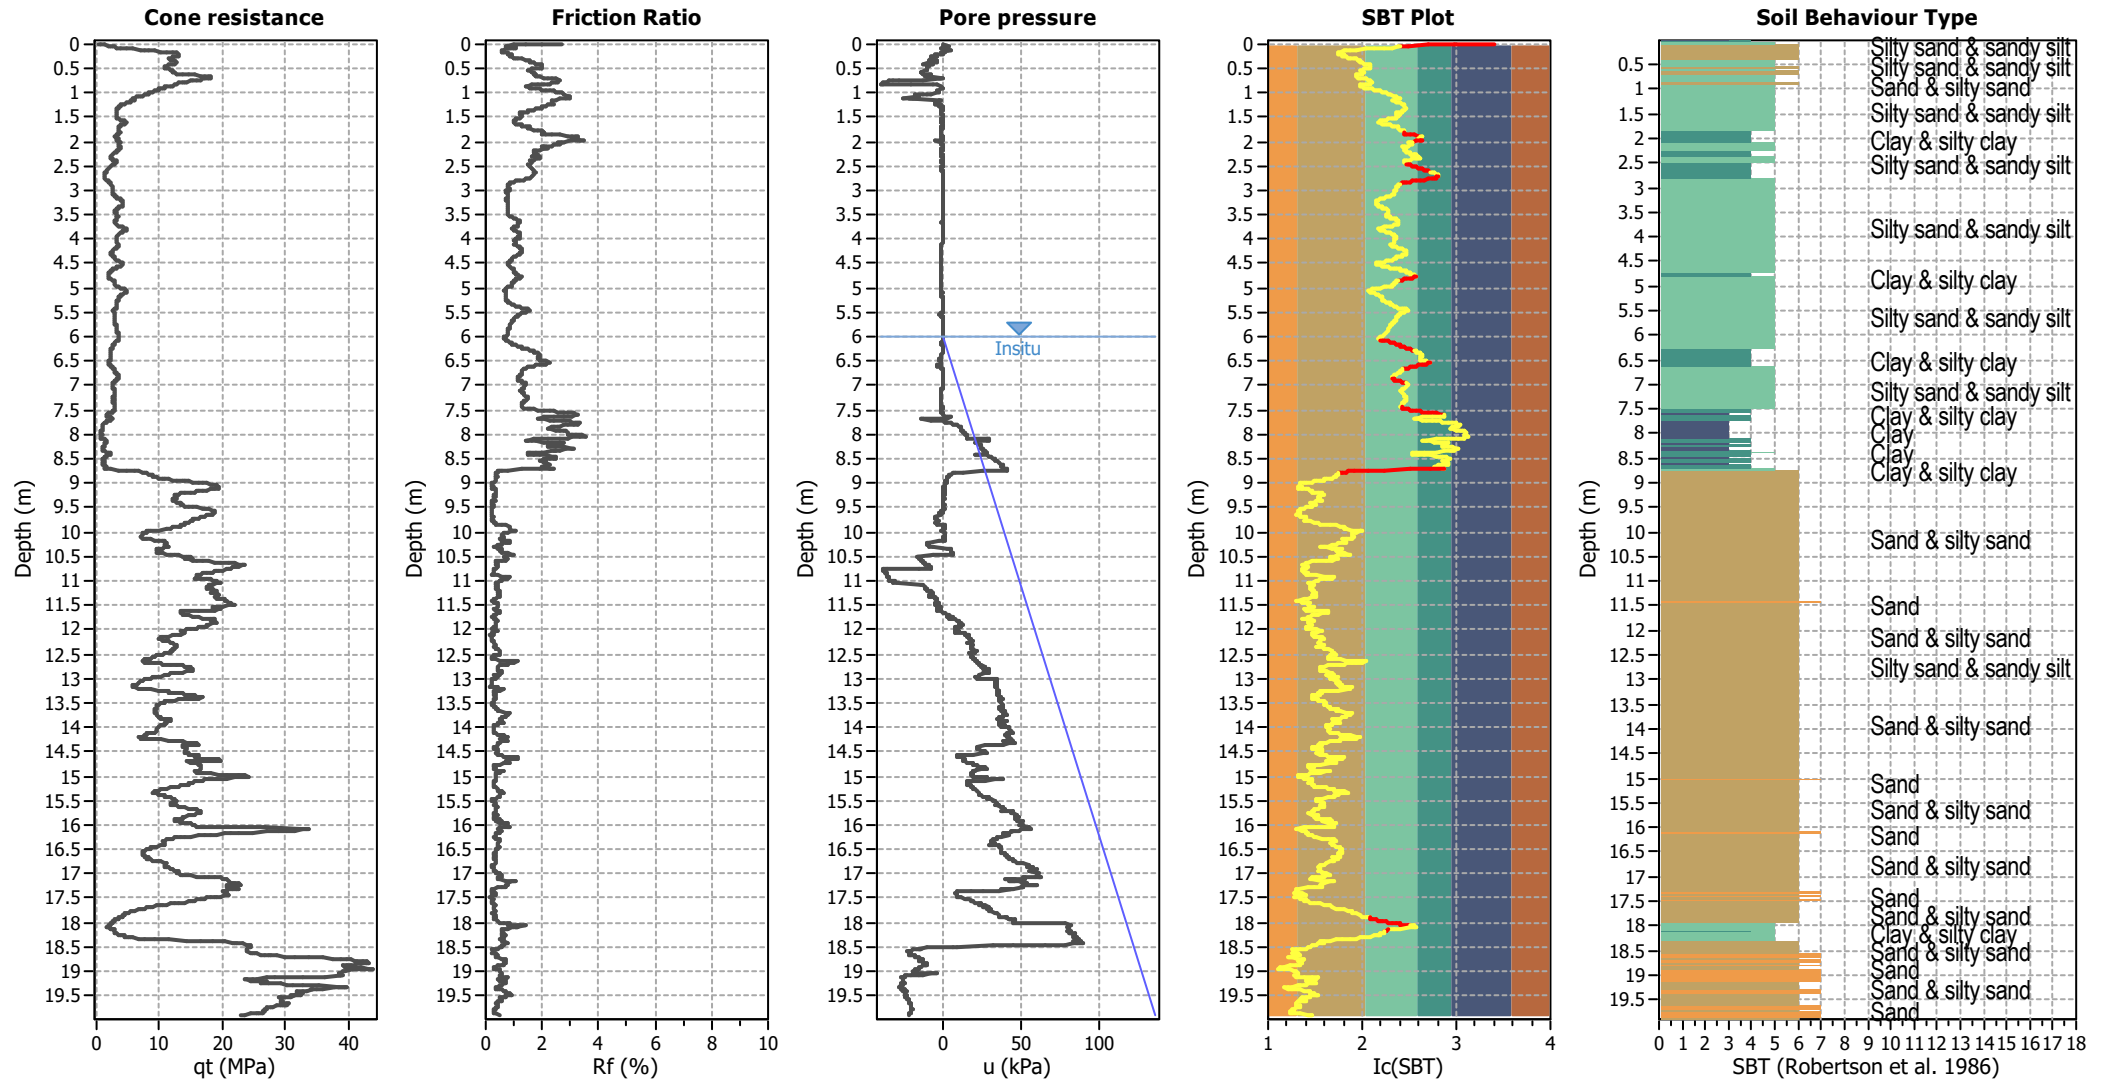
## CPT basic interpretation plots

| Analysis method: | B&I (2014) | Depth to GWT (erthq.): | 6.00 m | Fill weight: | N/A |

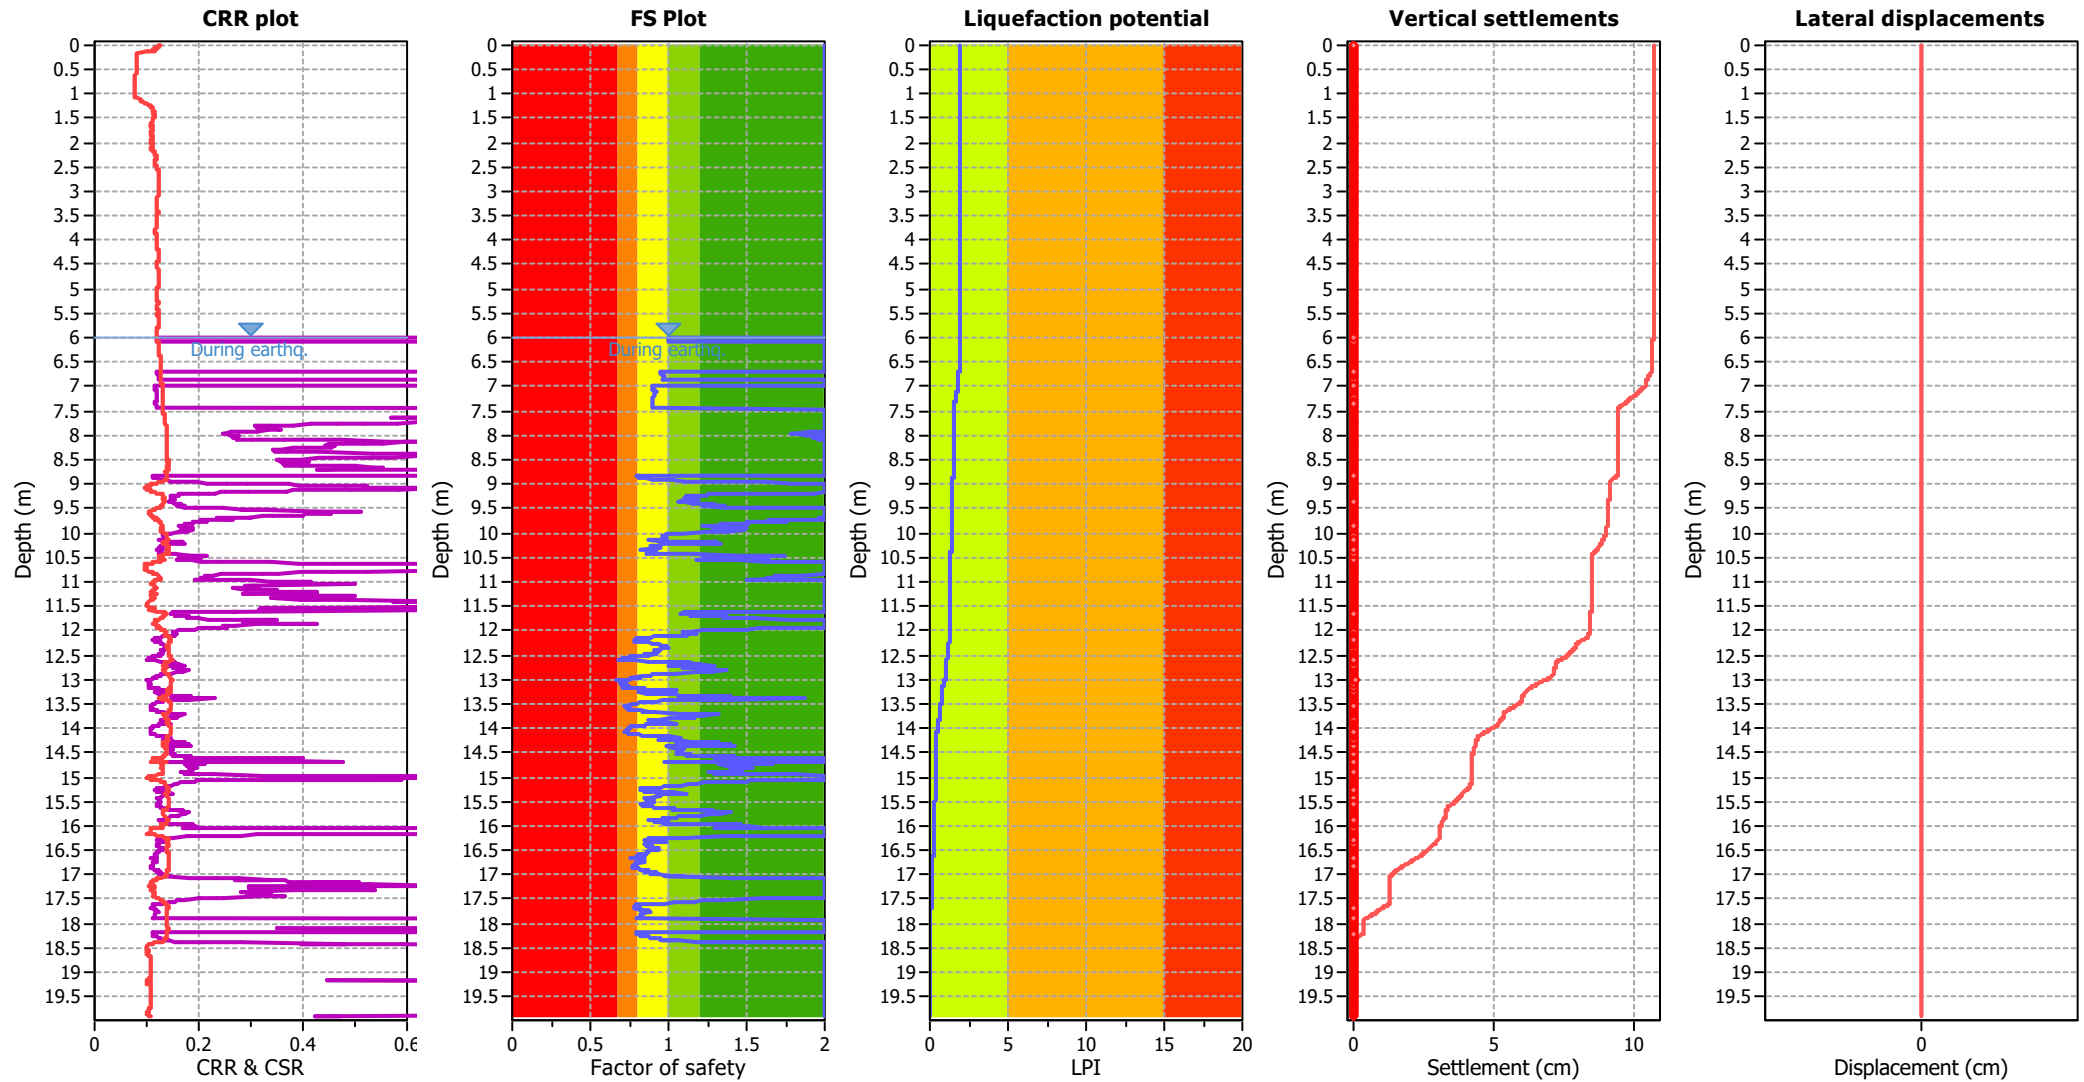
## Liquefaction analysis overall plots

| Analysis method: | B&I (2014) | Depth to GWT (earthq.): | 6.00 m | Fill weight: | N/A |

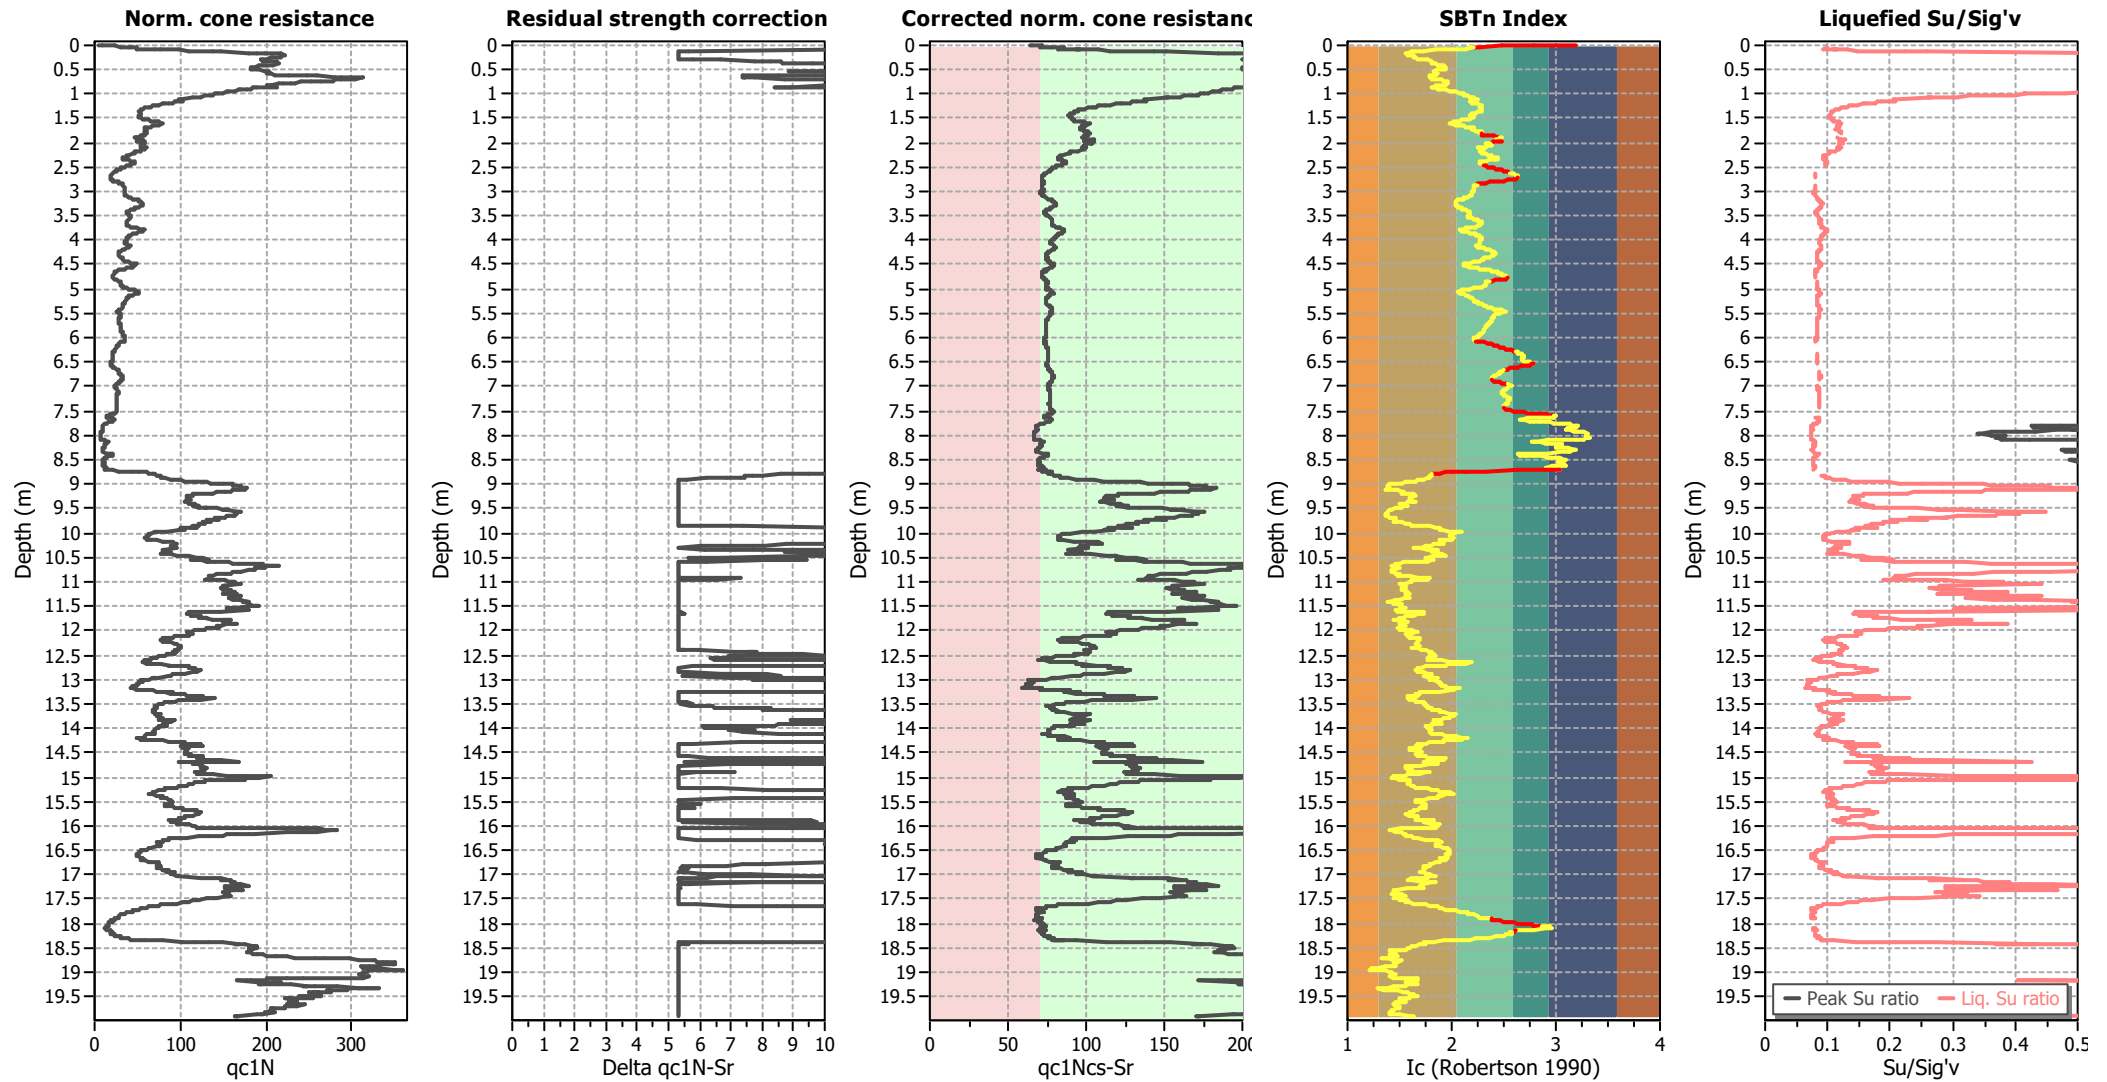
## Check for strength loss plots (Idriss & Boulanger (2008))

| Analysis method: | B&I (2014) | Depth to GWT (erthq.): | 6.00 m | Fill weight: | N/A |

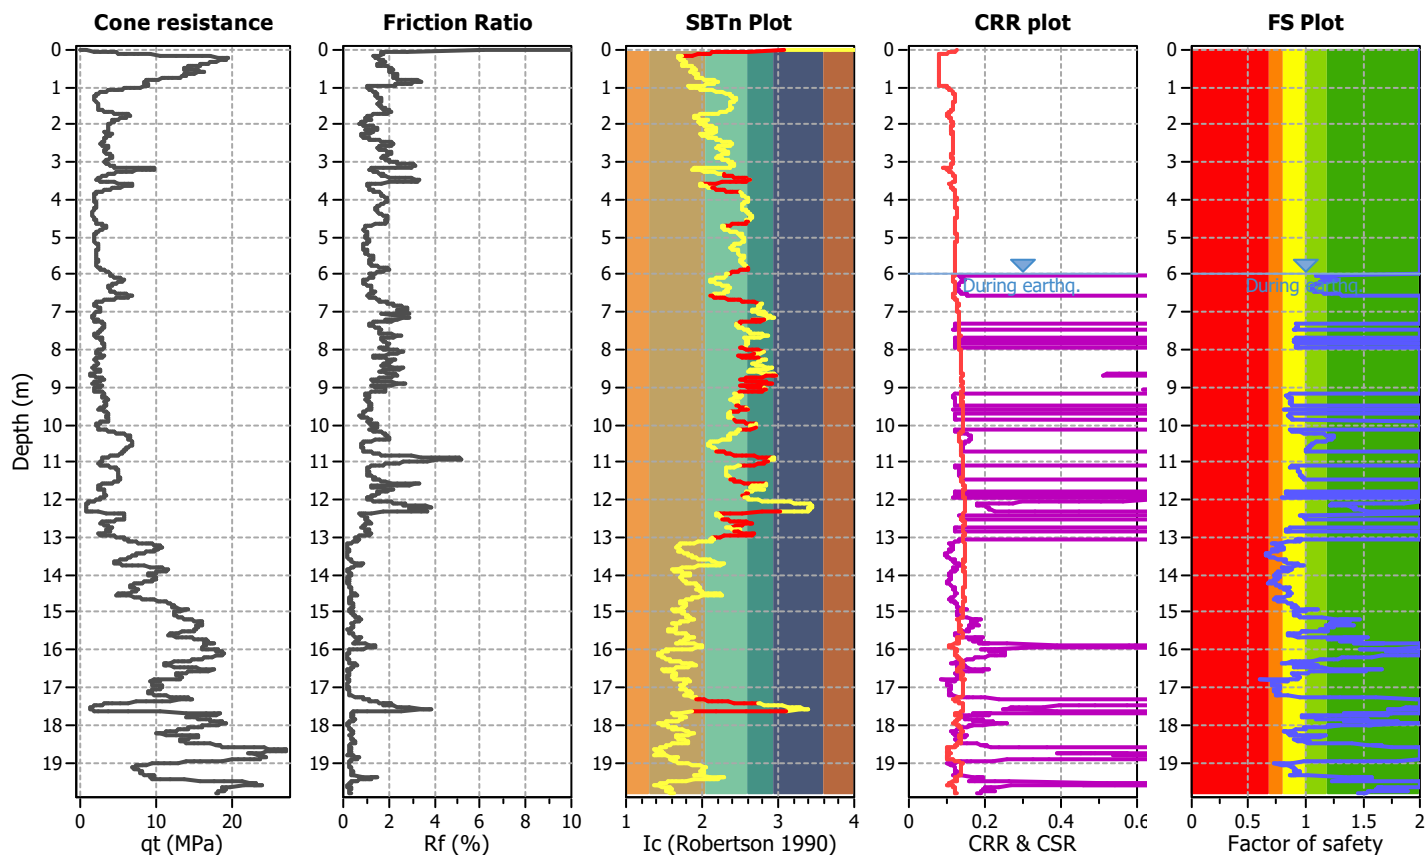
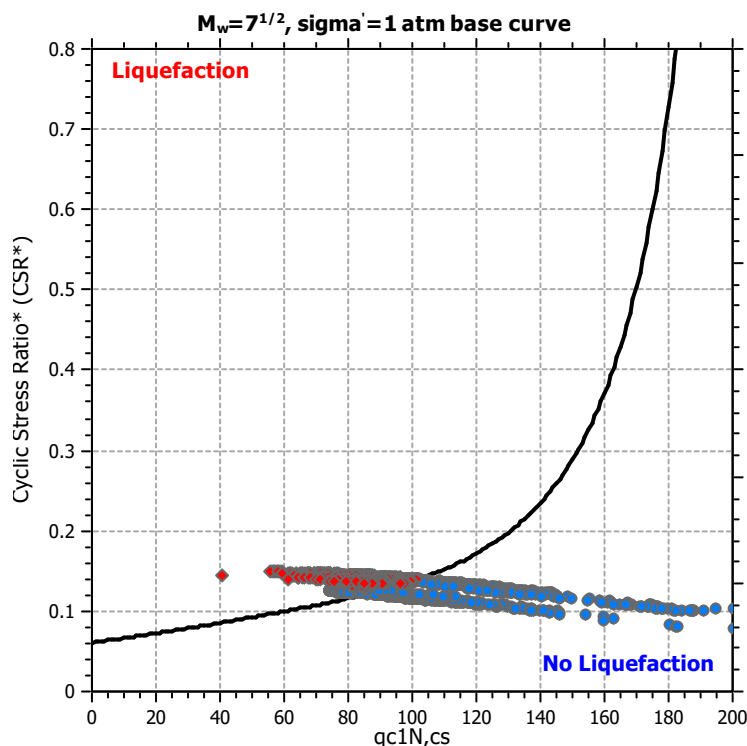
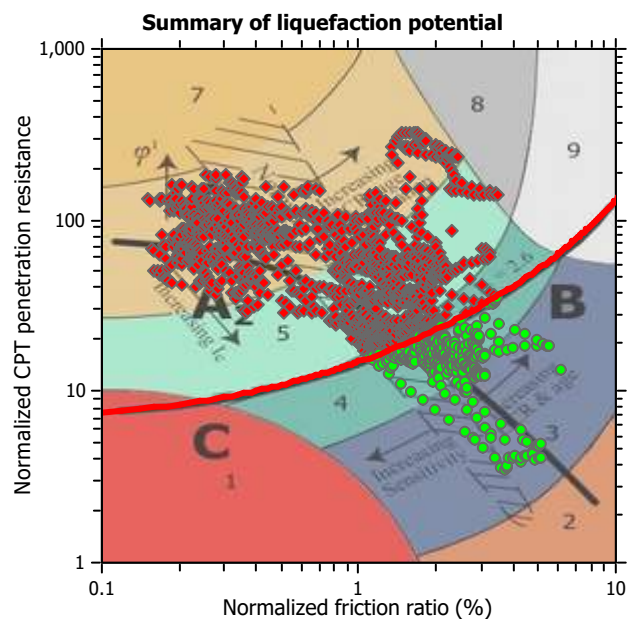
Zone A1: Cyclic liquefaction likely depending on size and duration of cyclic loading  
Zone A2: Cyclic liquefaction and strength loss likely depending on loading and ground geometry  
Zone B: Liquefaction and post-earthquake strength loss unlikely, check cyclic softening  
Zone C: Cyclic liquefaction and strength loss possible depending on soil plasticity, brittleness/sensitivity, strain to peak undrained strength and ground geometry

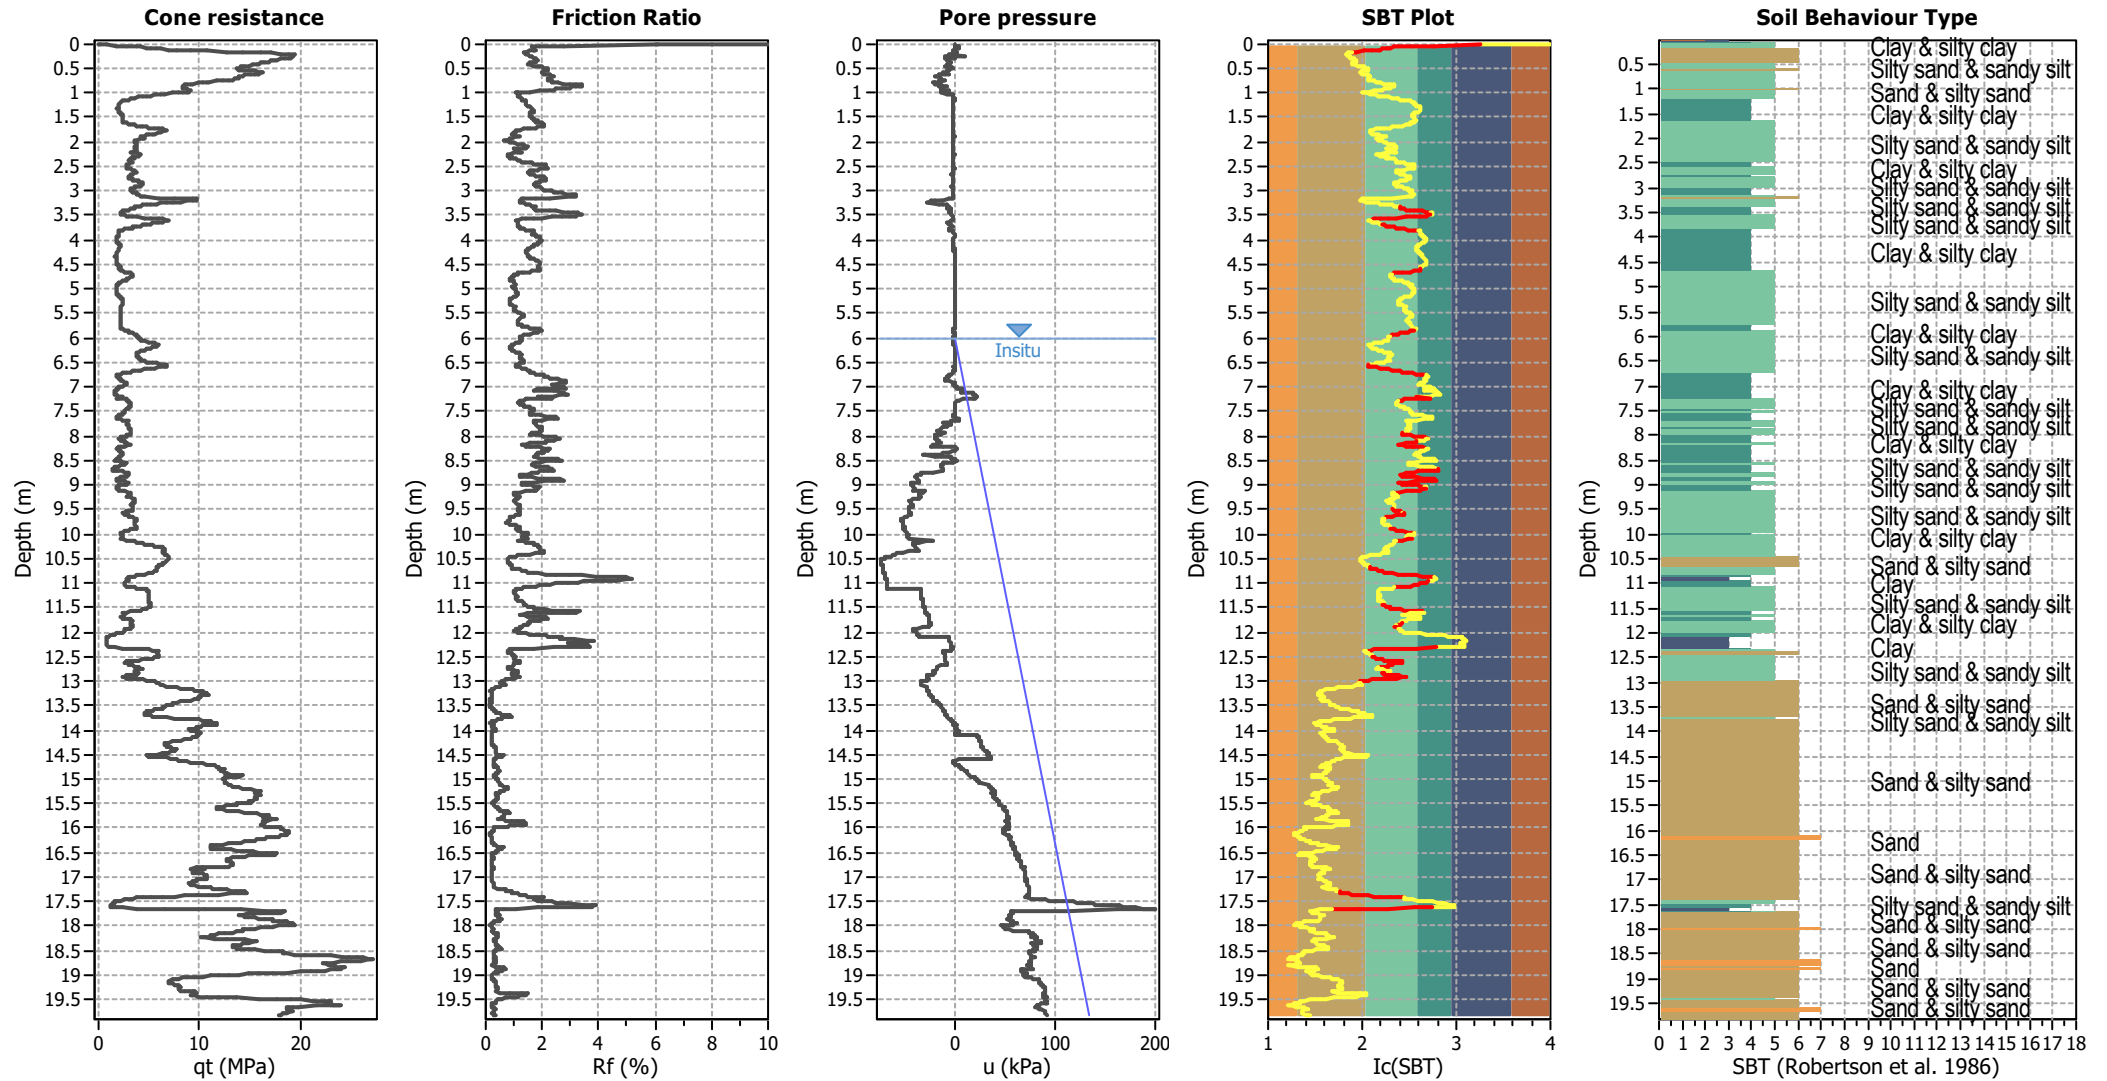
## CPT basic interpretation plots

| Analysis method: | B&I (2014) | Depth to GWT (erthq.): | 6.00 m | Fill weight: | N/A |

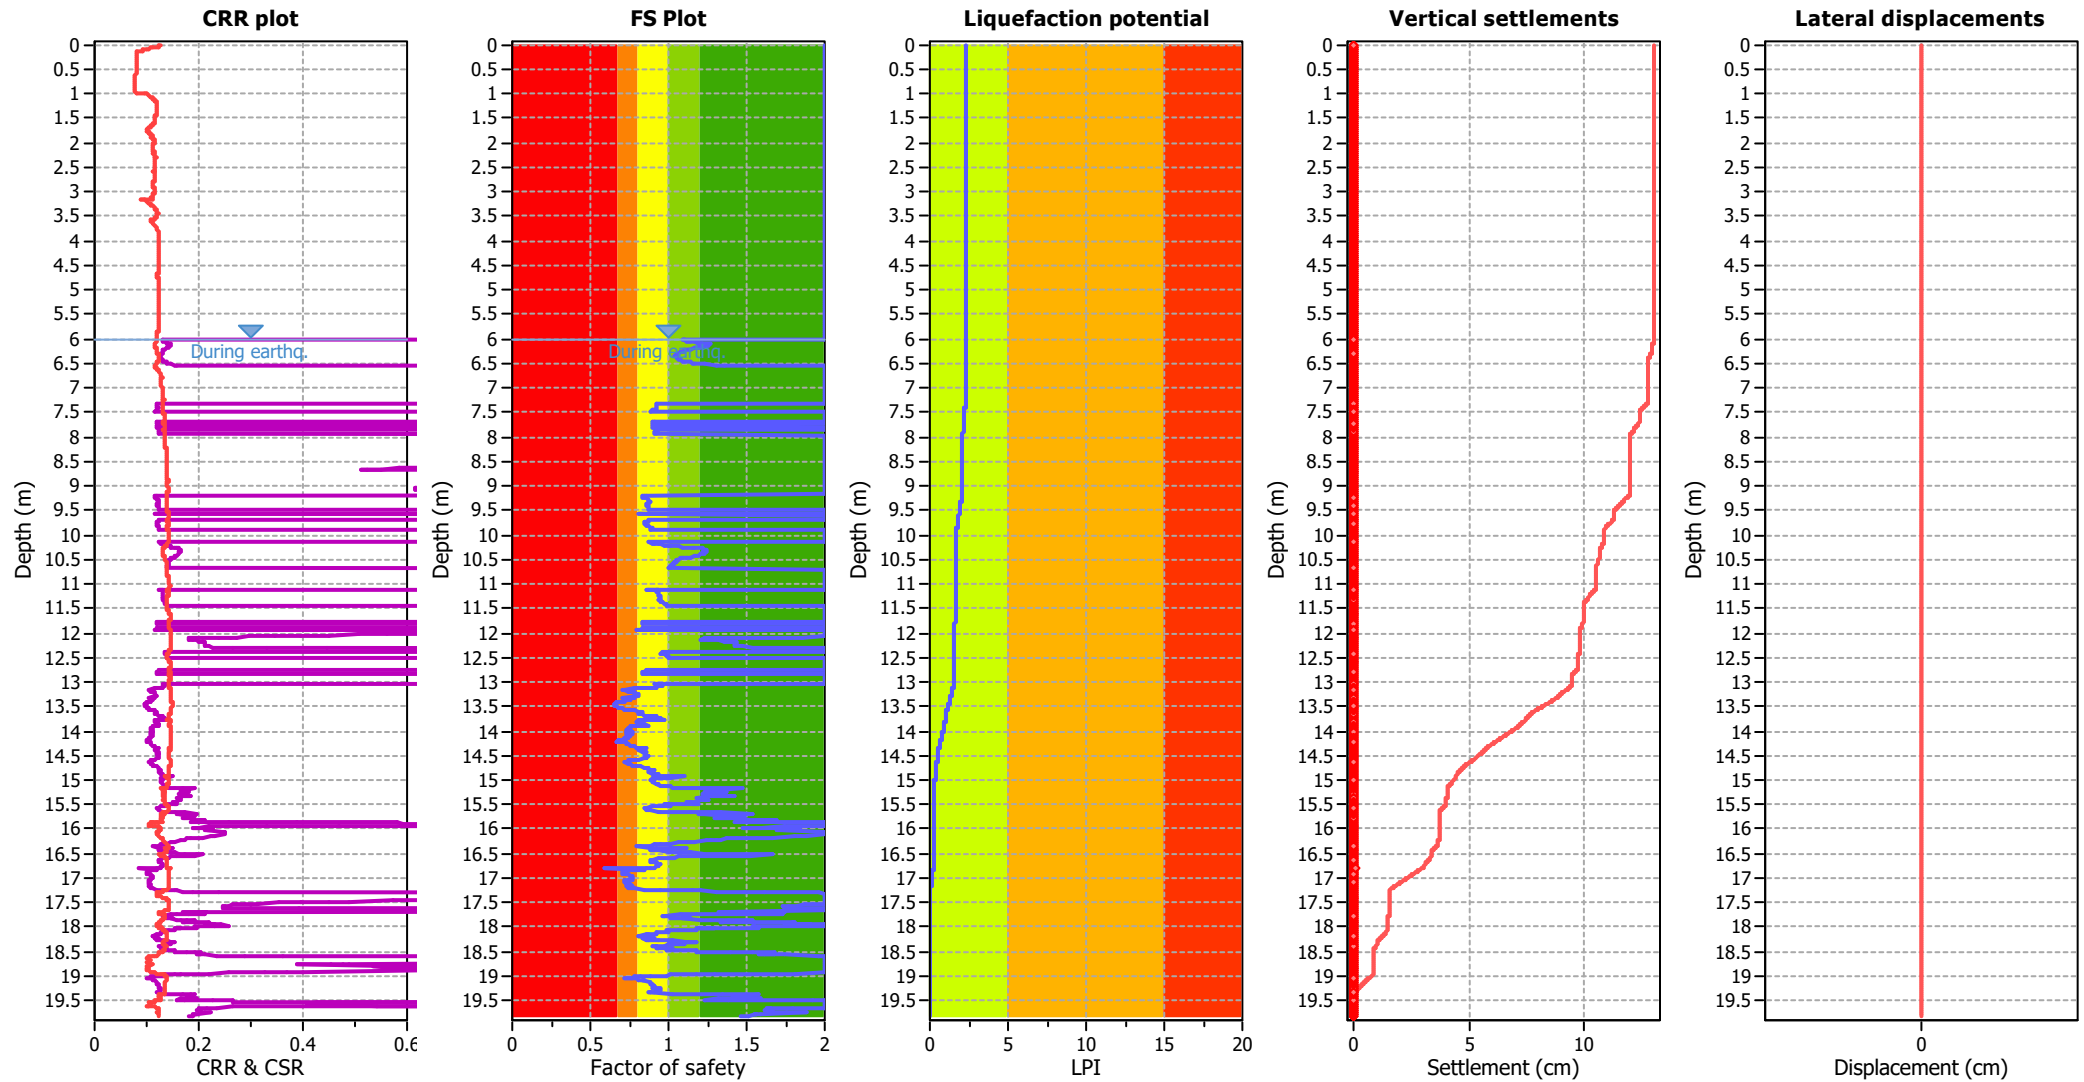
## Liquefaction analysis overall plots

| Analysis method: | B&I (2014) | Depth to GWT (earthq.): | 6.00 m | Fill weight: | N/A |

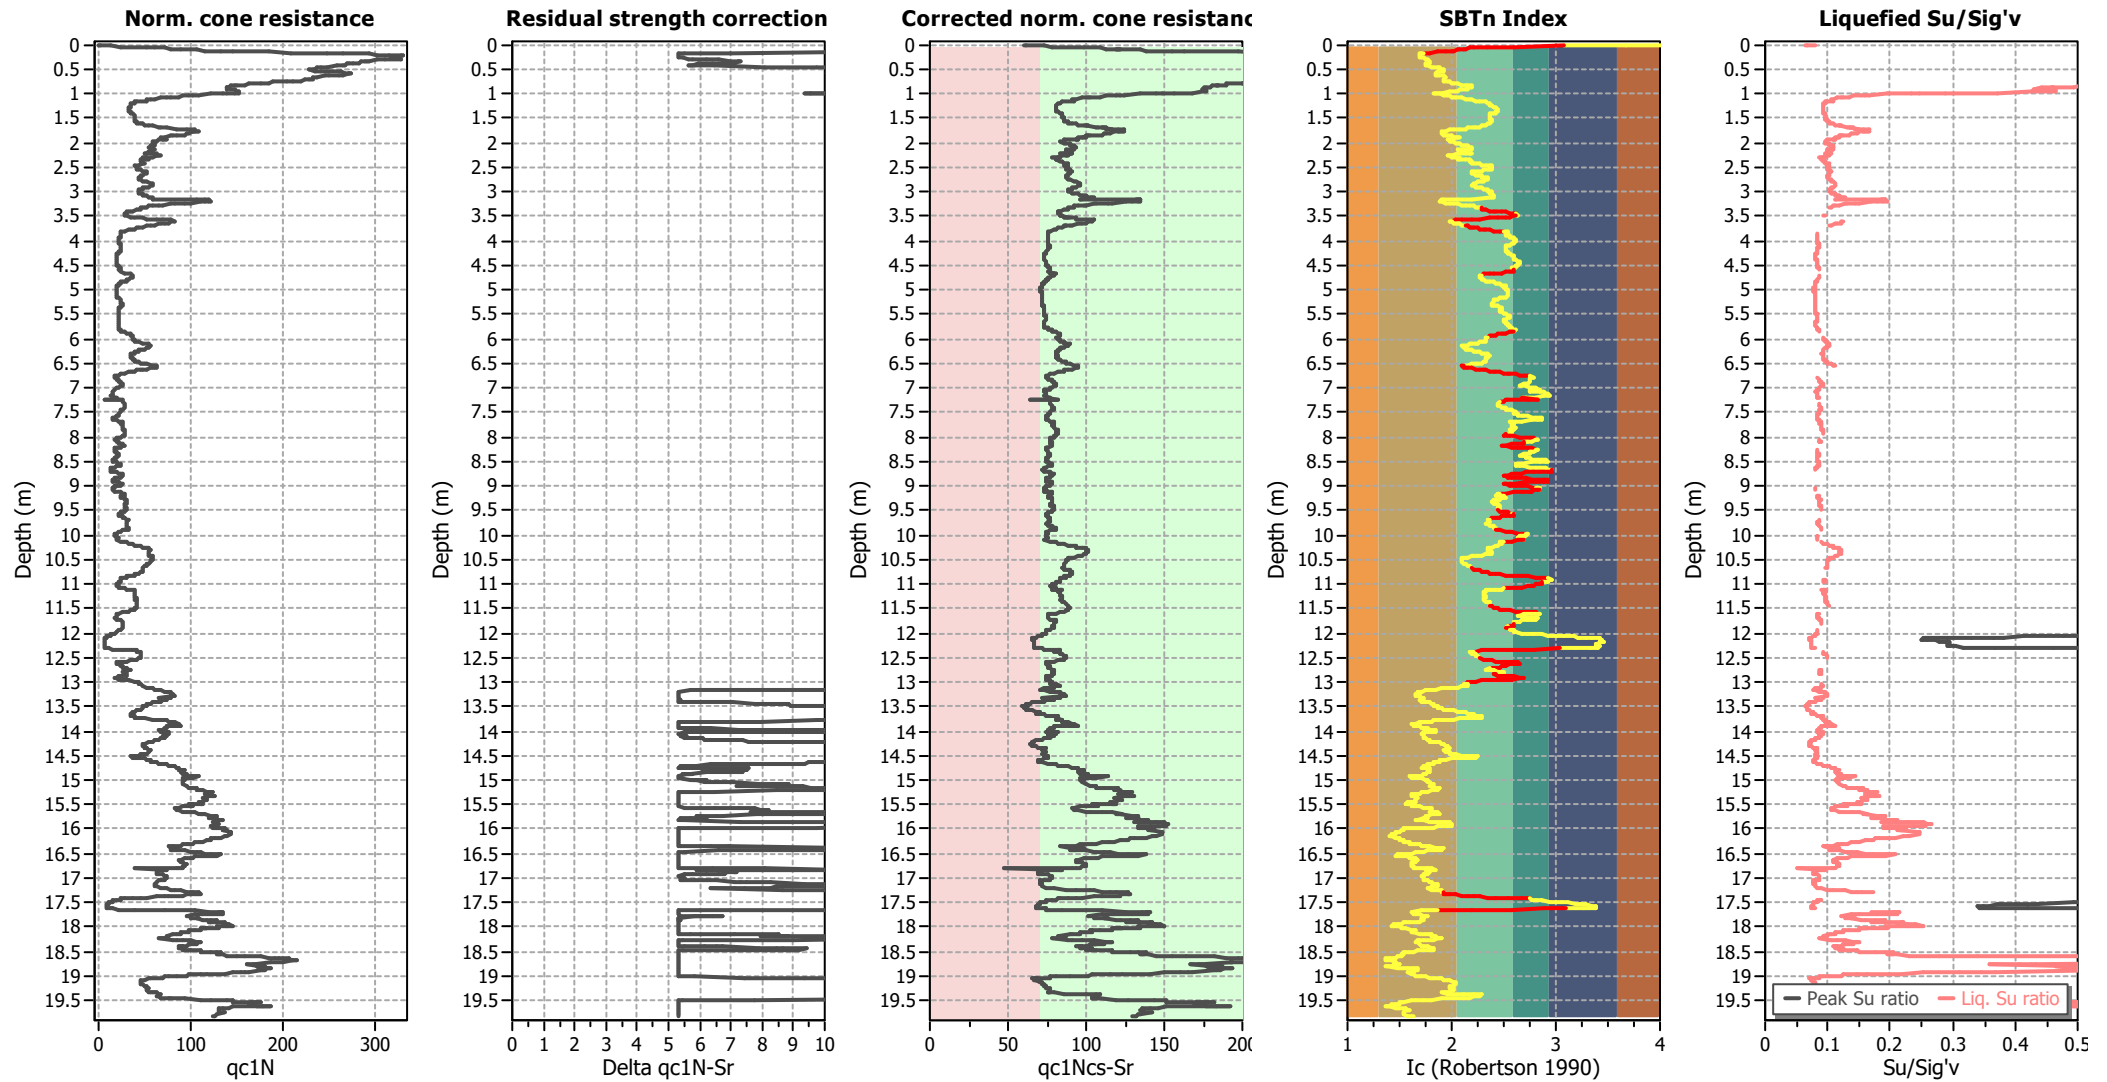
### Check for strength loss plots (Idriss & Boulanger (2008))

| Analysis method: | B&I (2014) | Depth to GWT (erthq.): | 6.00 m | Fill weight: | N/A |

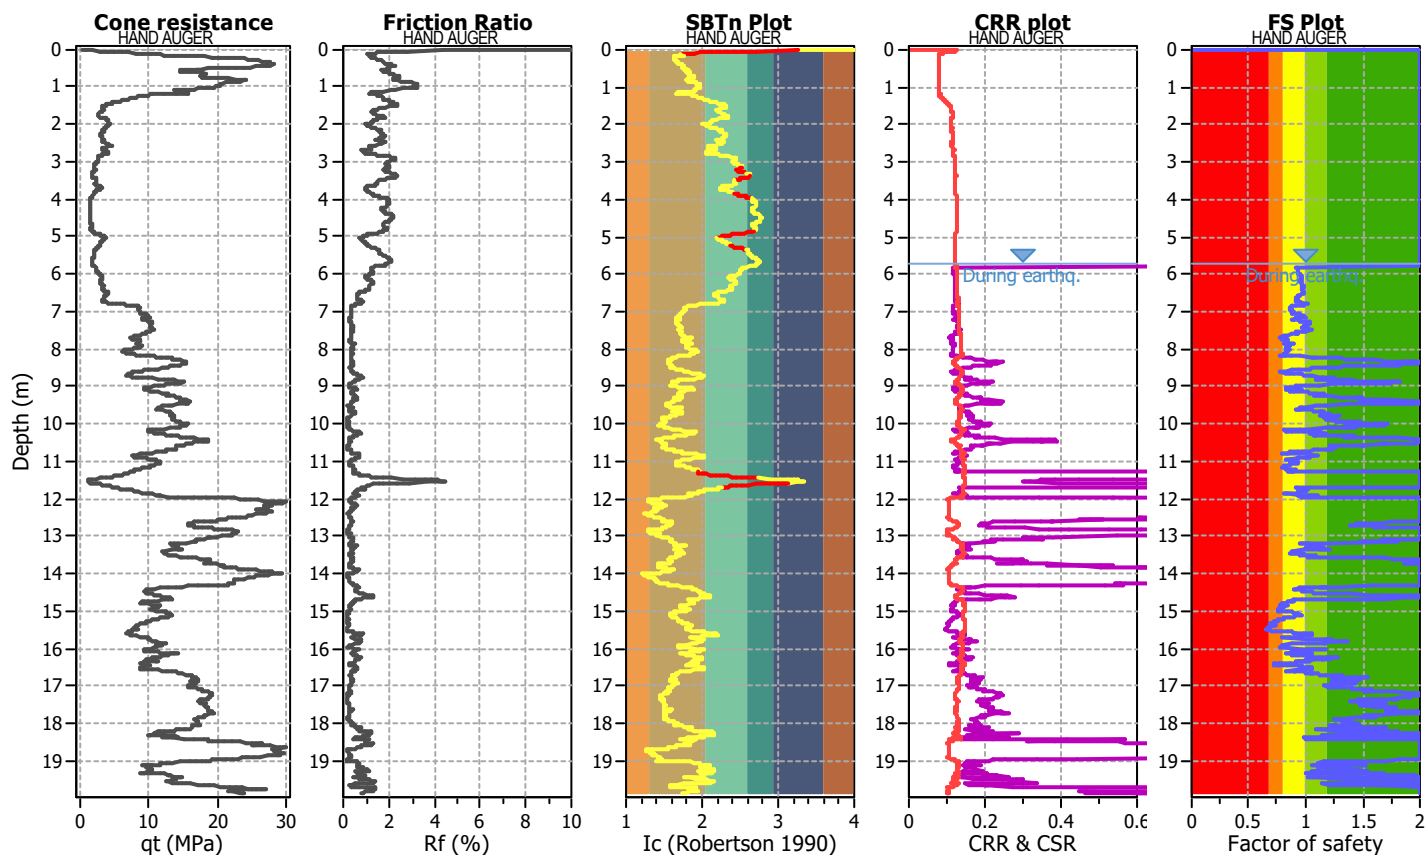
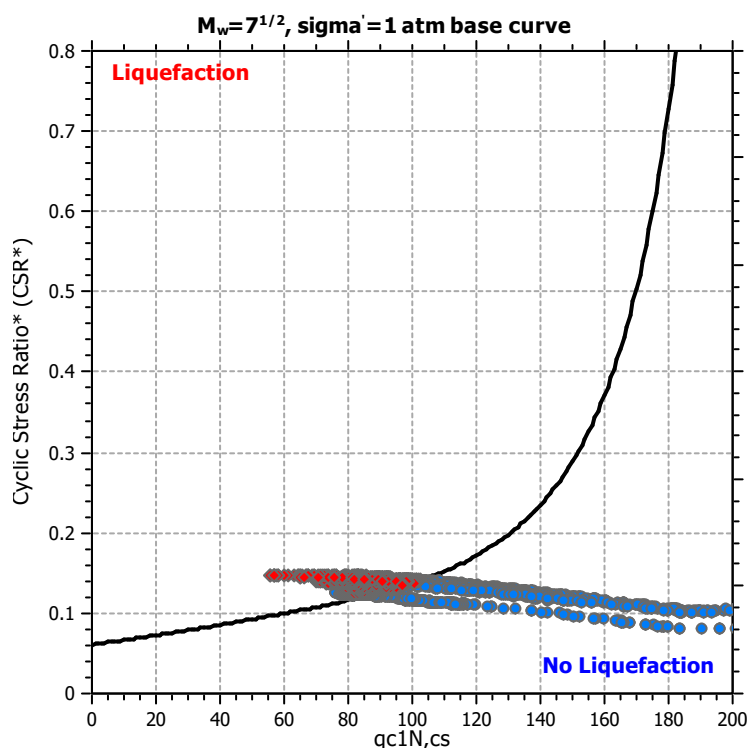
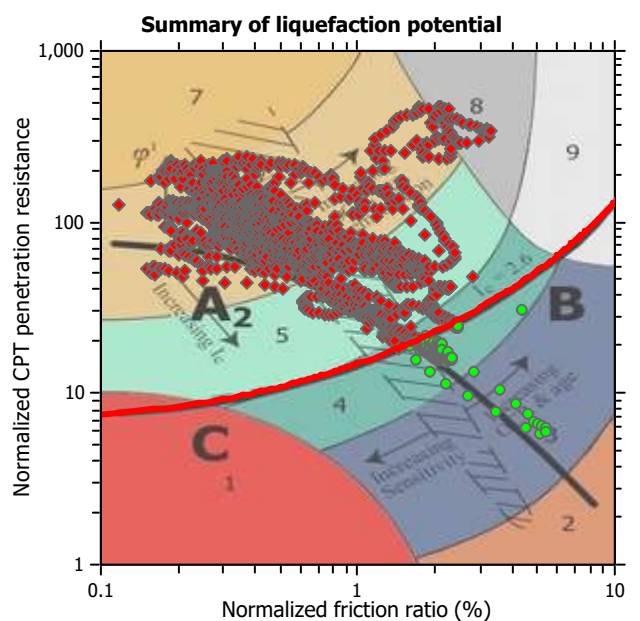
Zone A<sub>1</sub>: Cyclic liquefaction likely depending on size and duration of cyclic loading  
 Zone A<sub>2</sub>: Cyclic liquefaction and strength loss likely depending on loading and ground geometry  
 Zone B: Liquefaction and post-earthquake strength loss unlikely, check cyclic softening  
 Zone C: Cyclic liquefaction and strength loss possible depending on soil plasticity, brittleness/sensitivity, strain to peak undrained strength and ground geometry

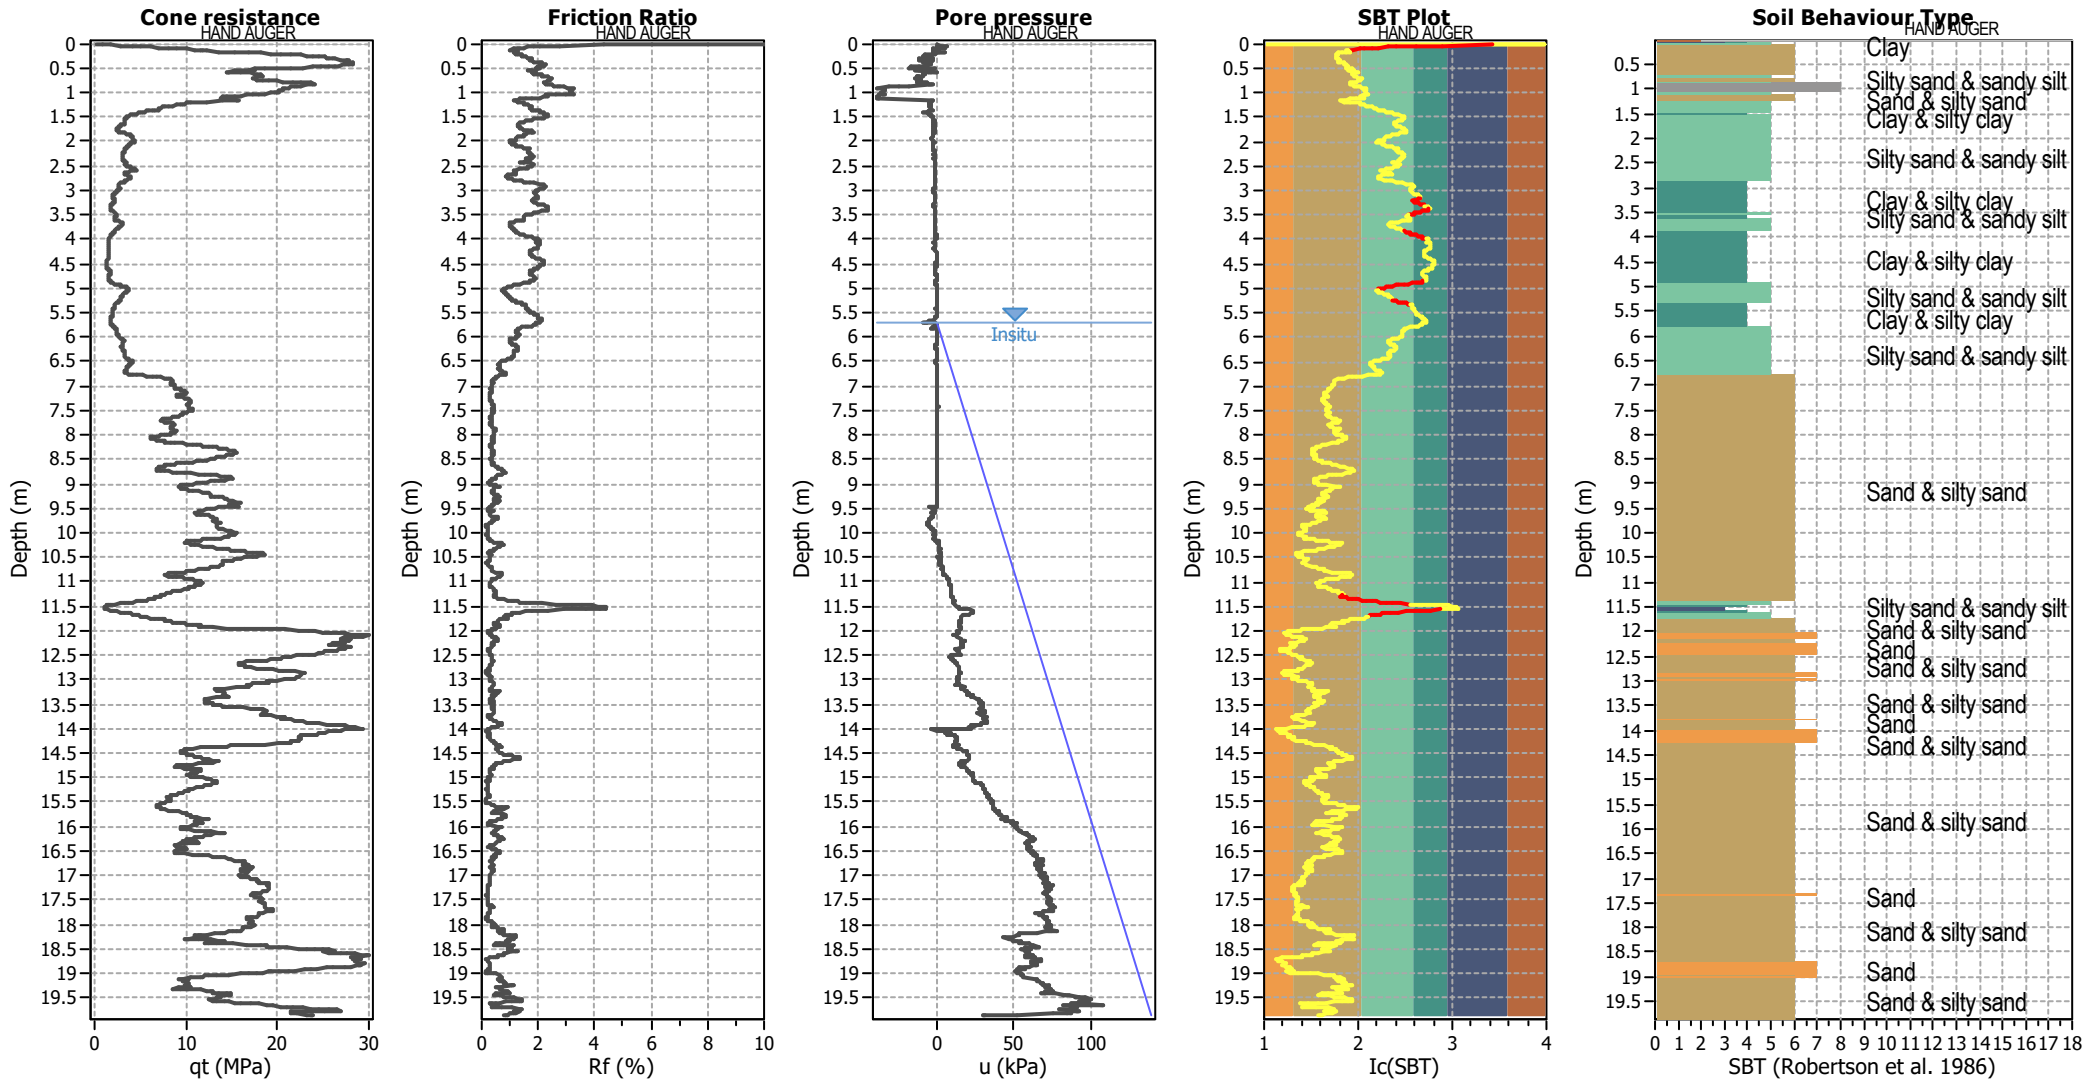
CPT basic interpretation plots

| Analysis method: | B&I (2014) | Depth to GWT (erthq.): | 5.70 m | Fill weight: | N/A |

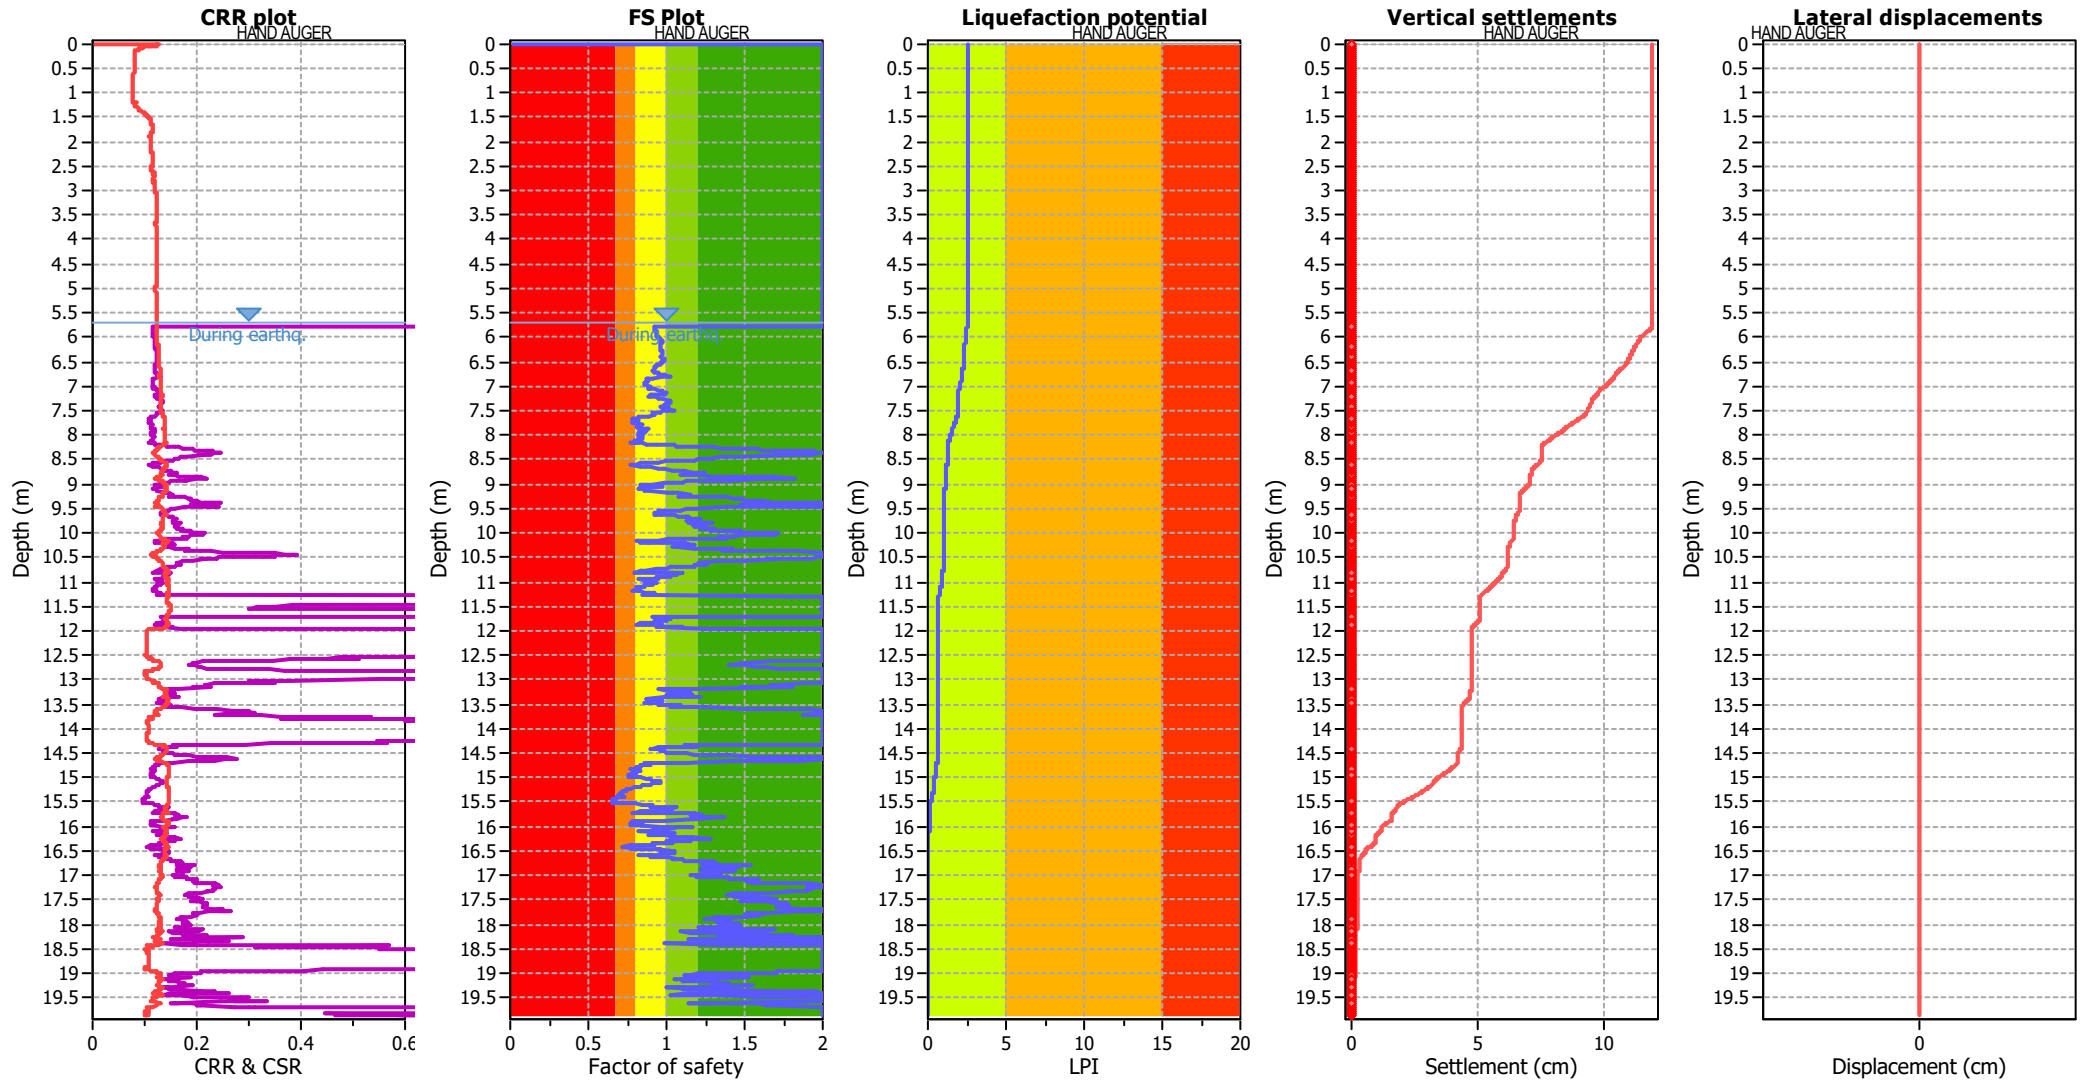
Liquefaction analysis overall plots

| Analysis method: | B&I (2014) | Depth to GWT (erthq.): | 5.70 m | Fill weight: | N/A |
