# TAIERI LIAISON GROUP AGENDA

## 1. MEETING DETAILS

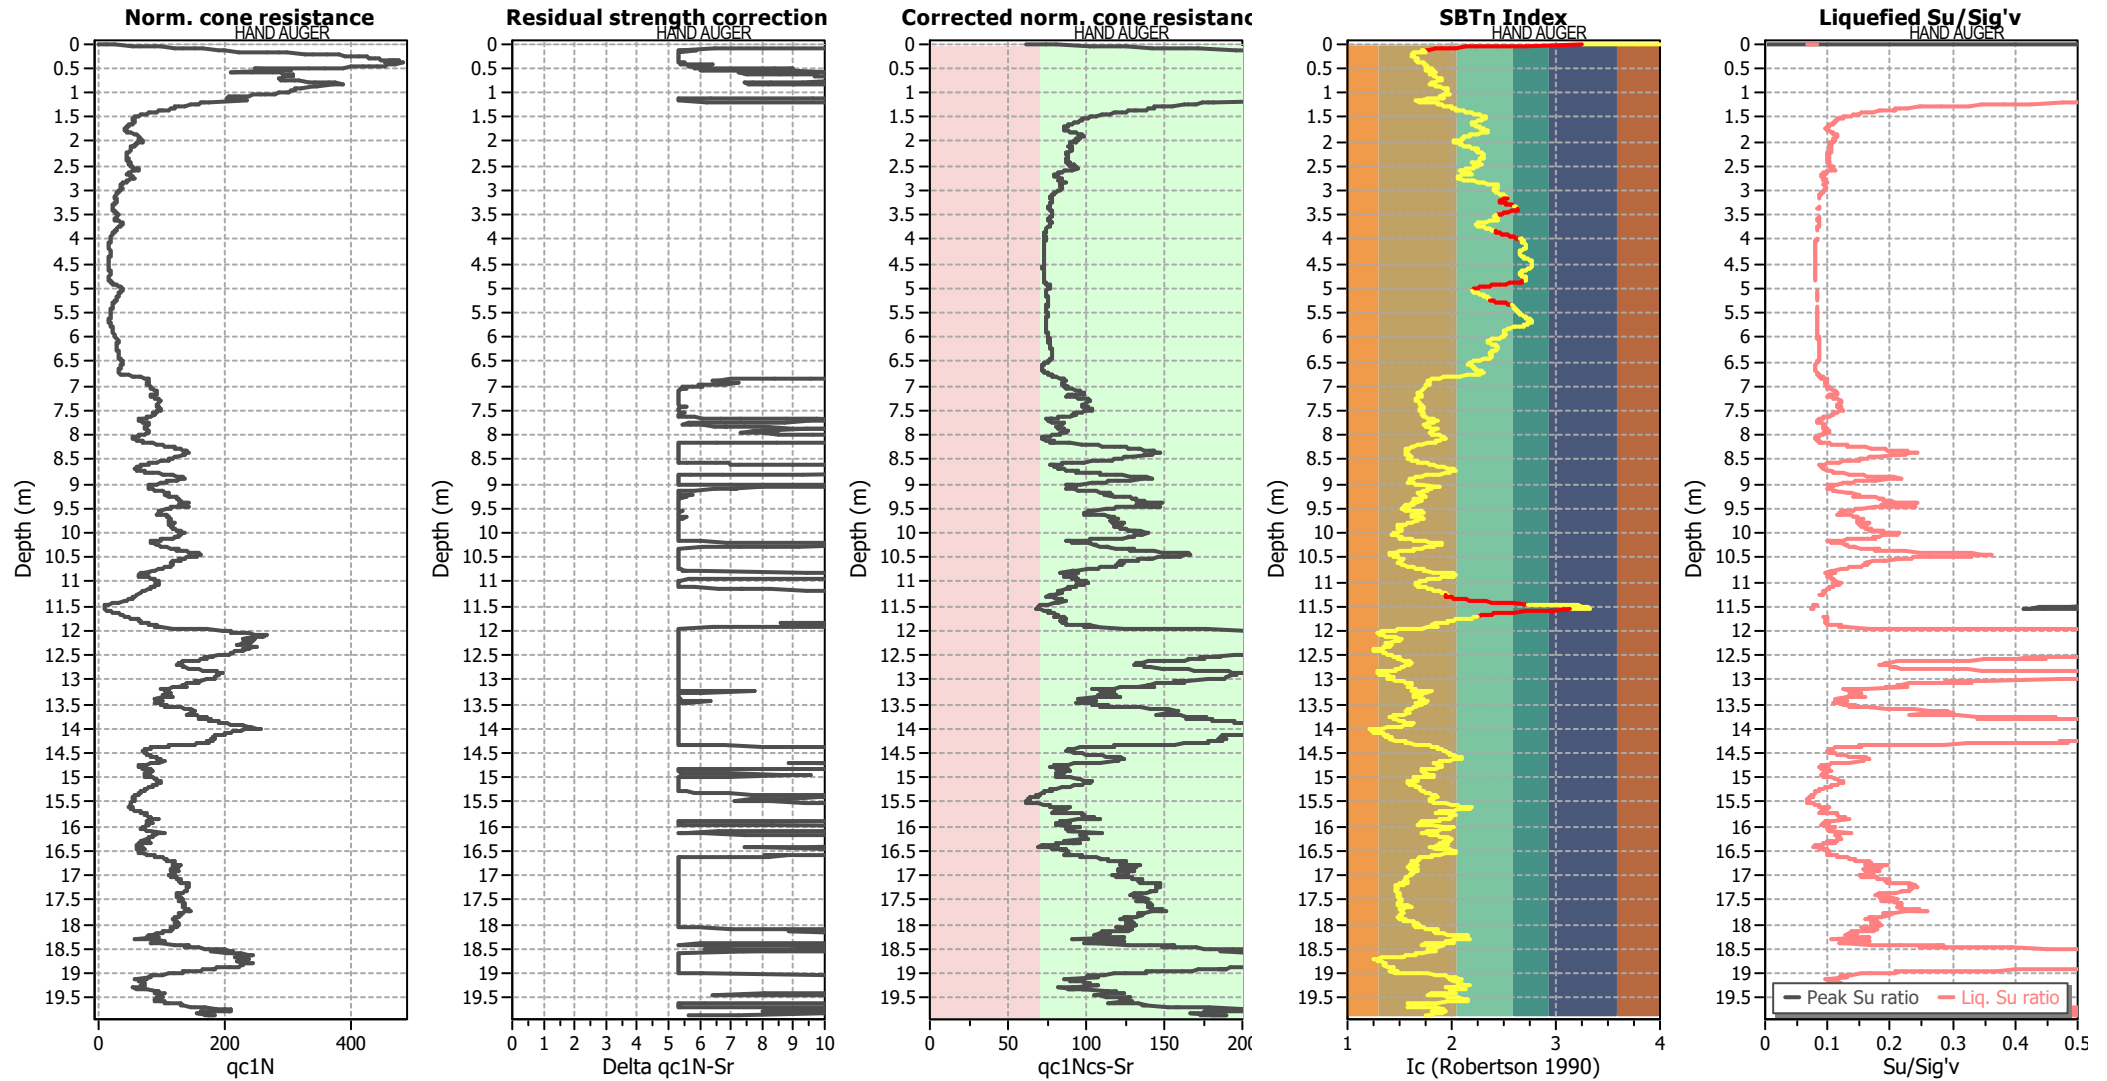
## Check for strength loss plots (Idriss & Boulanger (2008))

| Analysis method: | B&I (2014) | Depth to GWT (erthq.): | 5.70 m | Fill weight: | N/A |

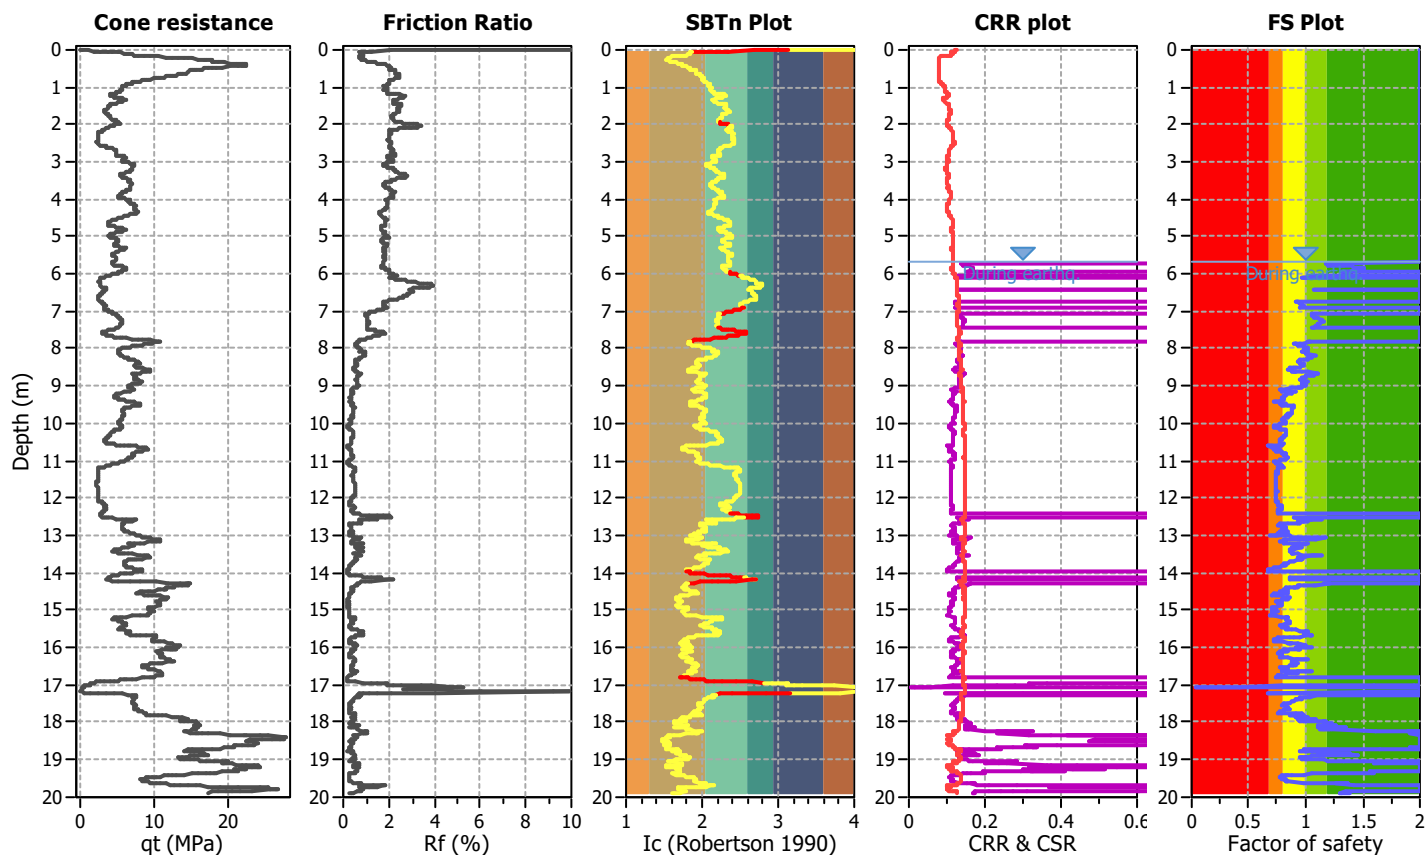
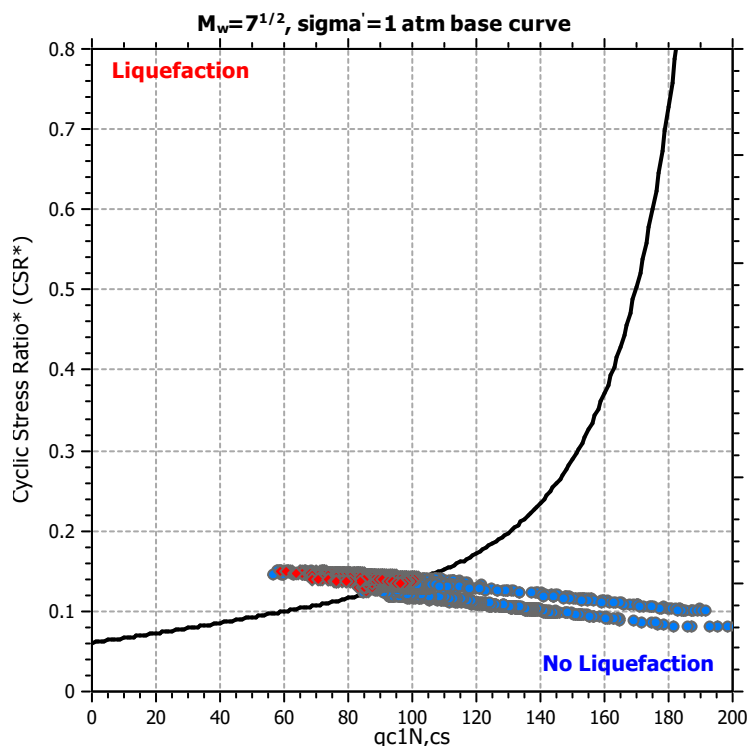
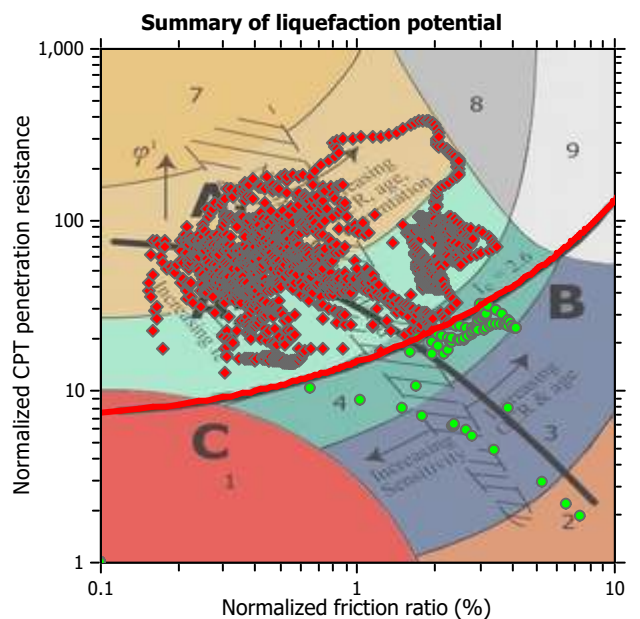
Zone A<sub>1</sub>: Cyclic liquefaction likely depending on size and duration of cyclic loading  
 Zone A<sub>2</sub>: Cyclic liquefaction and strength loss likely depending on loading and ground geometry  
 Zone B: Liquefaction and post-earthquake strength loss unlikely, check cyclic softening  
 Zone C: Cyclic liquefaction and strength loss possible depending on soil plasticity, brittleness/sensitivity, strain to peak undrained strength and ground geometry

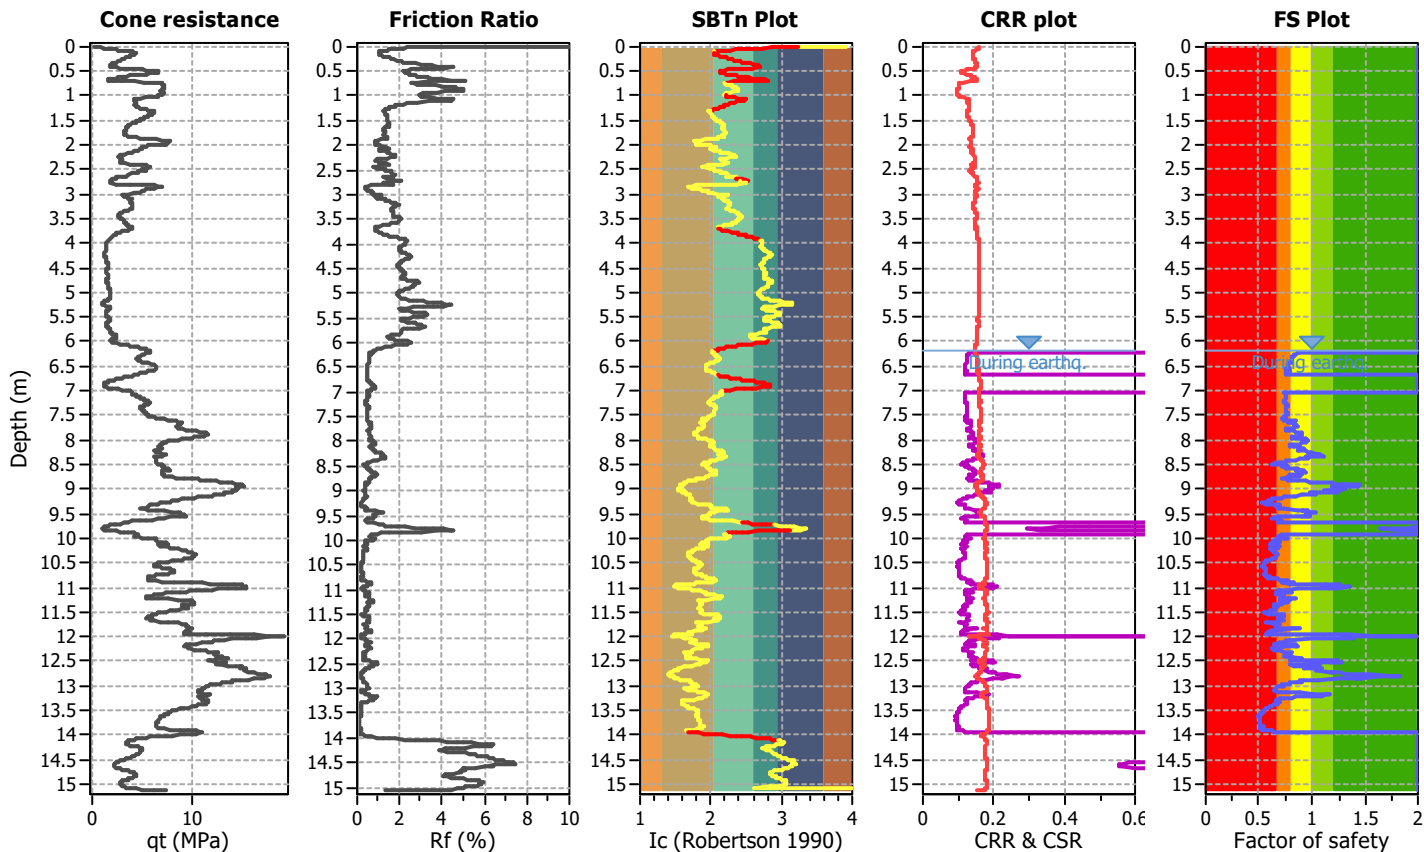
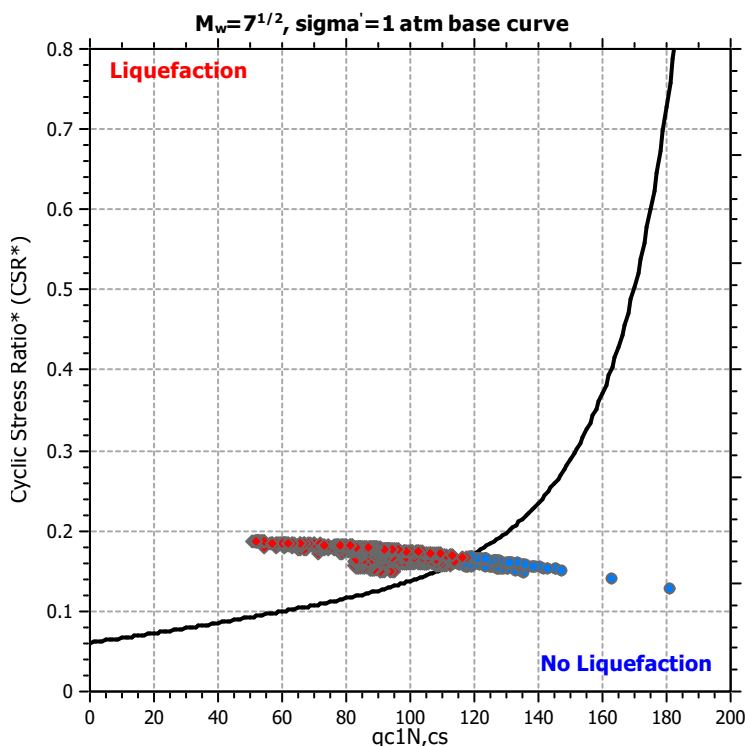
Zone A1: Cyclic liquefaction likely depending on size and duration of cyclic loading  
Zone A2: Cyclic liquefaction and strength loss likely depending on loading and ground geometry  
Zone B: Liquefaction and post-earthquake strength loss unlikely, check cyclic softening  
Zone C: Cyclic liquefaction and strength loss possible depending on soil plasticity, brittleness/sensitivity, strain to peak undrained strength and ground geometry

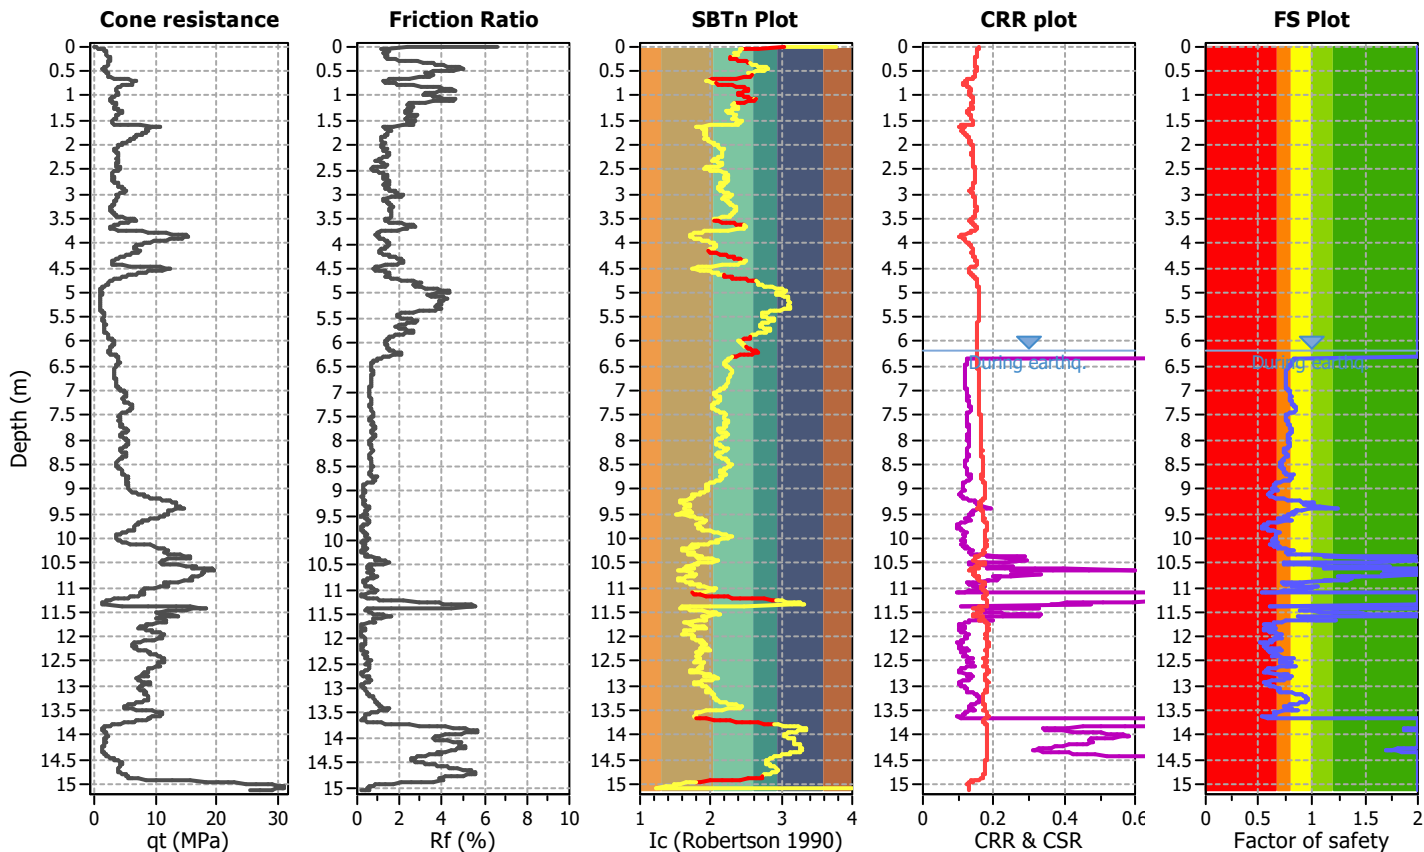
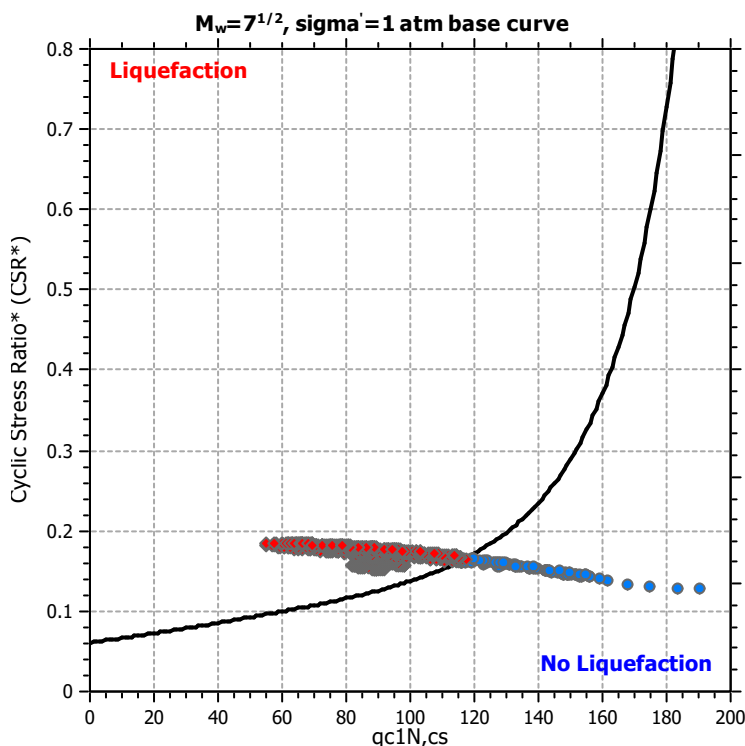
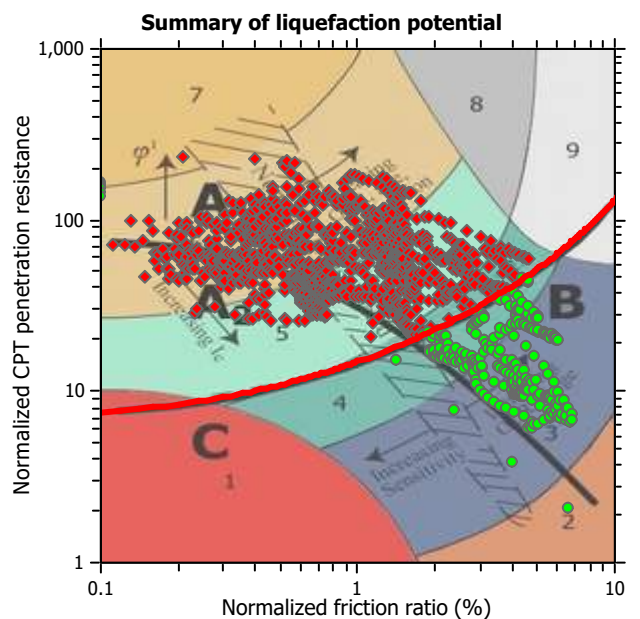
Zone A<sub>1</sub>: Cyclic liquefaction likely depending on size and duration of cyclic loading  
 Zone A<sub>2</sub>: Cyclic liquefaction and strength loss likely depending on loading and ground geometry  
 Zone B: Liquefaction and post-earthquake strength loss unlikely, check cyclic softening  
 Zone C: Cyclic liquefaction and strength loss possible depending on soil plasticity, brittleness/sensitivity, strain to peak undrained strength and ground geometry

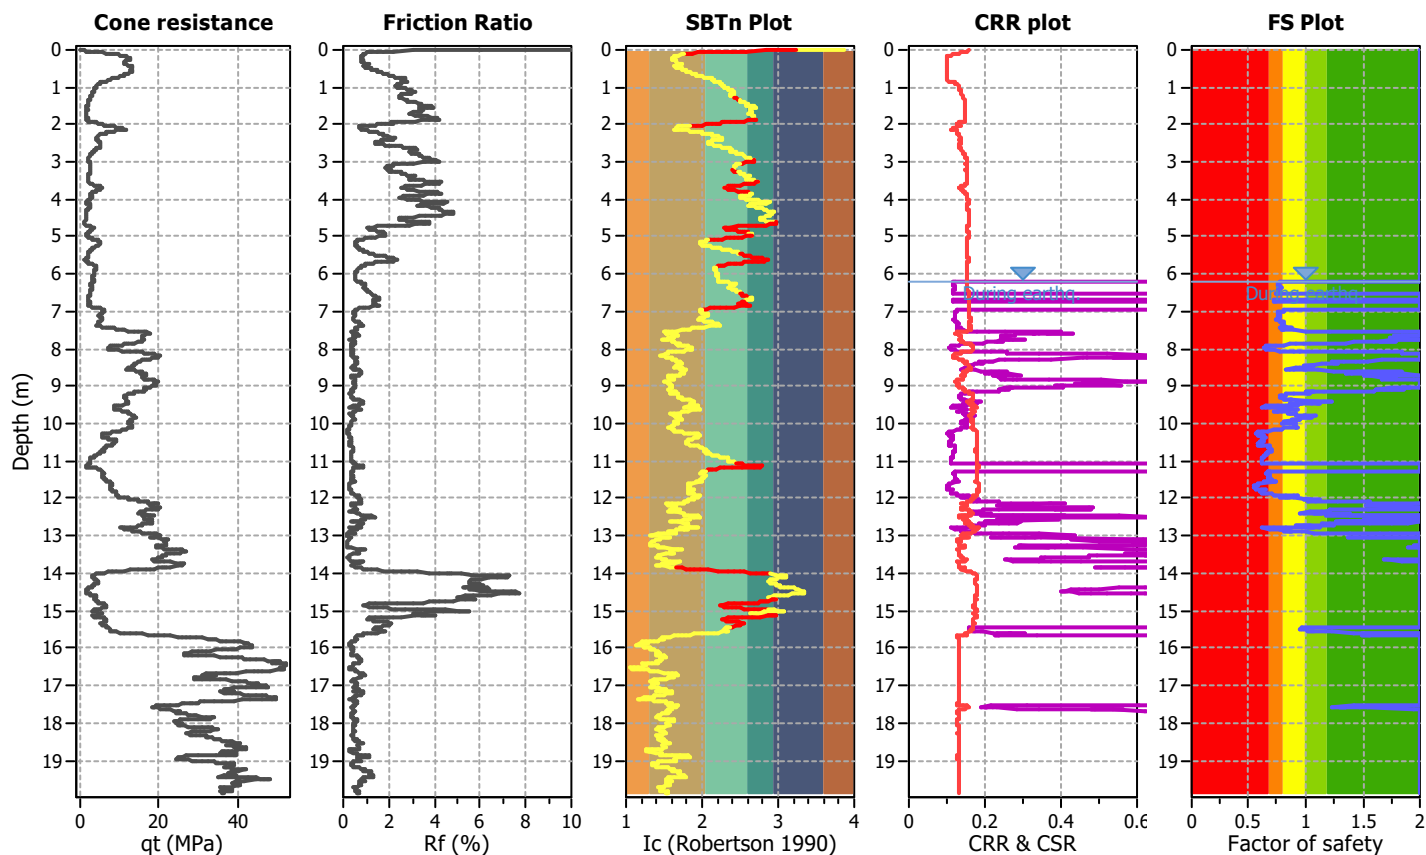
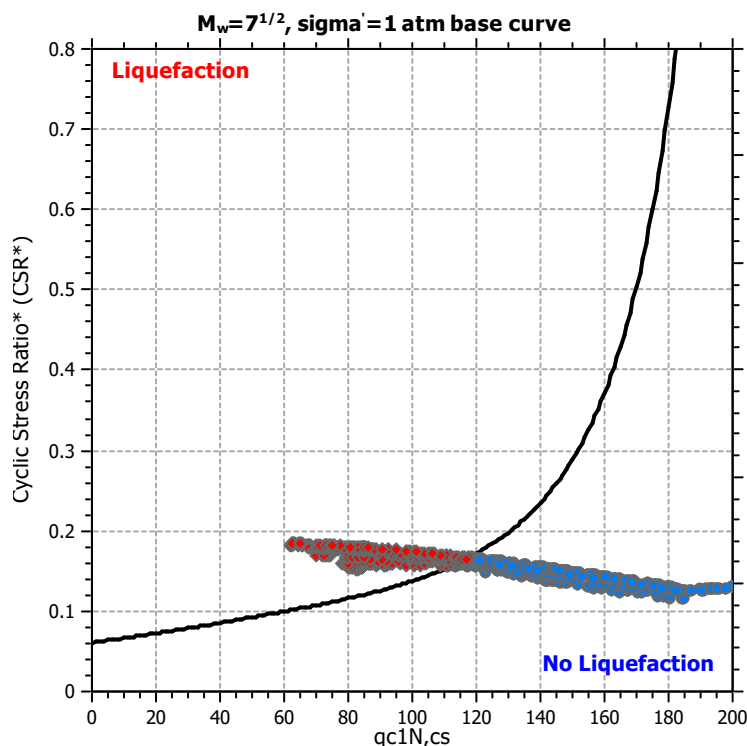
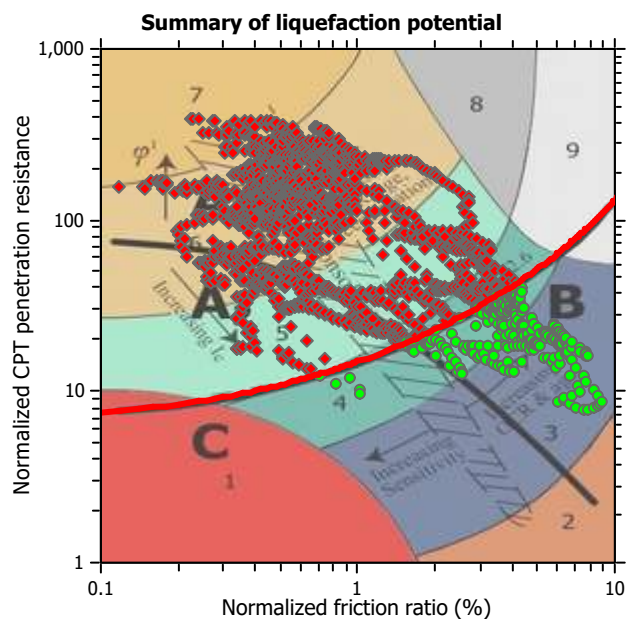
Zone A<sub>1</sub>: Cyclic liquefaction likely depending on size and duration of cyclic loading  
 Zone A<sub>2</sub>: Cyclic liquefaction and strength loss likely depending on loading and ground geometry  
 Zone B: Liquefaction and post-earthquake strength loss unlikely, check cyclic softening  
 Zone C: Cyclic liquefaction and strength loss possible depending on soil plasticity, brittleness/sensitivity, strain to peak undrained strength and ground geometry

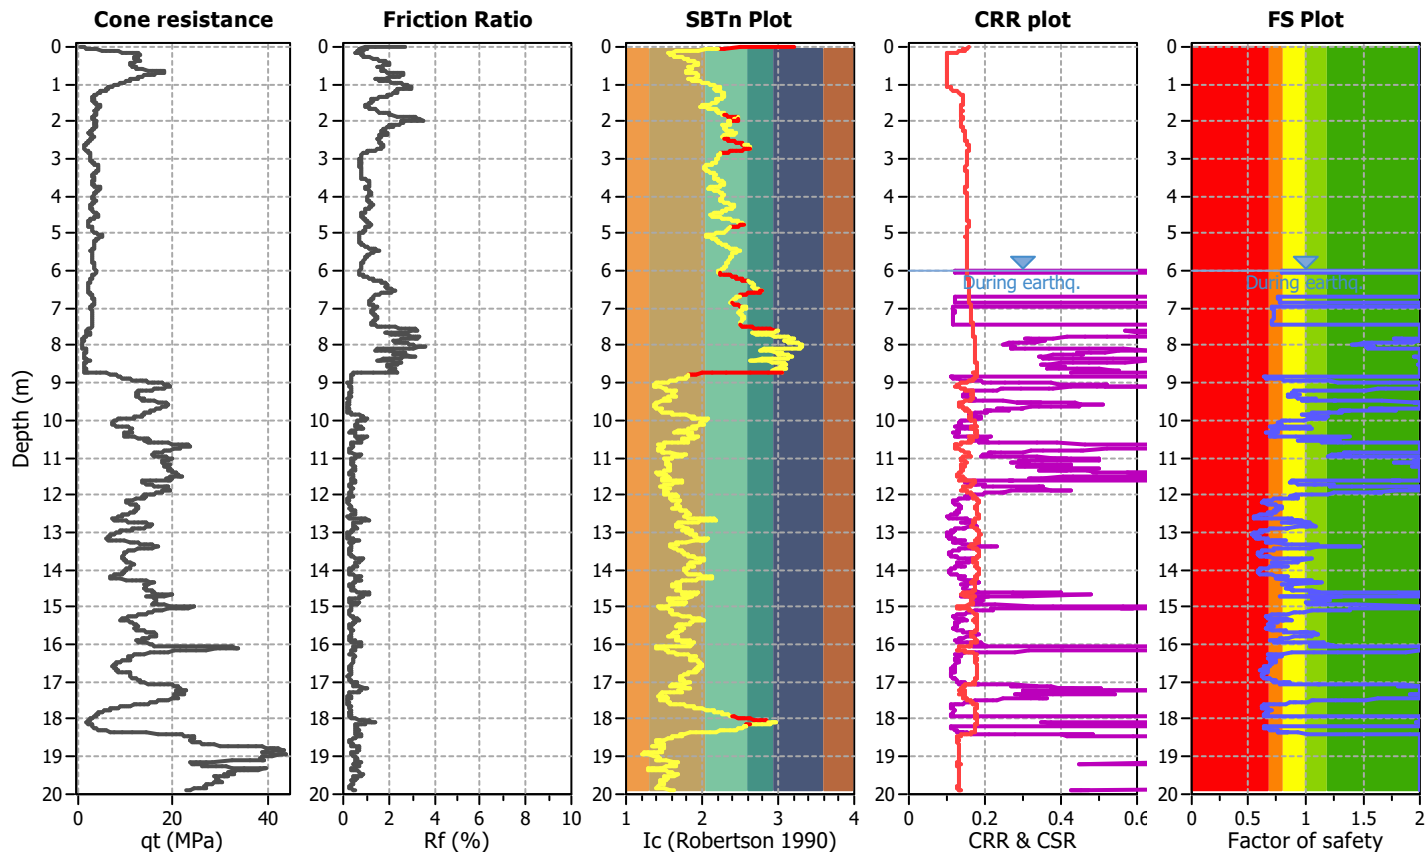
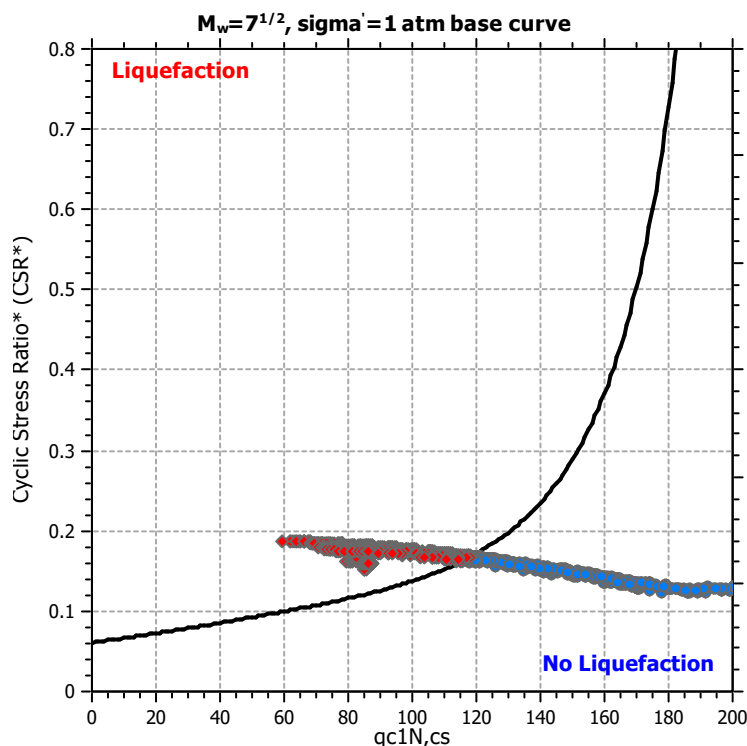
Zone A<sub>1</sub>: Cyclic liquefaction likely depending on size and duration of cyclic loading  
 Zone A<sub>2</sub>: Cyclic liquefaction and strength loss likely depending on loading and ground geometry  
 Zone B: Liquefaction and post-earthquake strength loss unlikely, check cyclic softening  
 Zone C: Cyclic liquefaction and strength loss possible depending on soil plasticity, brittleness/sensitivity, strain to peak undrained strength and ground geometry

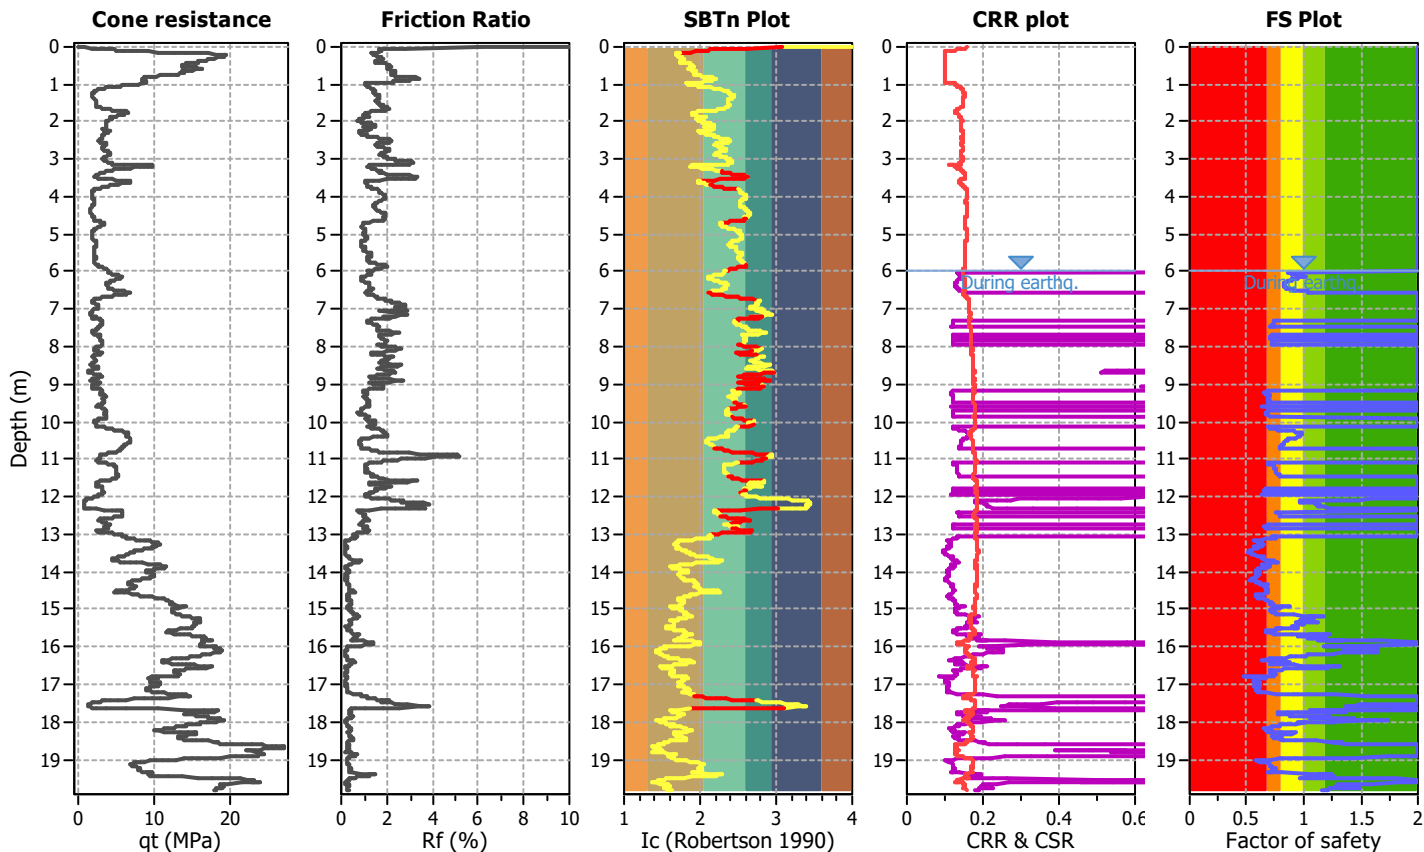
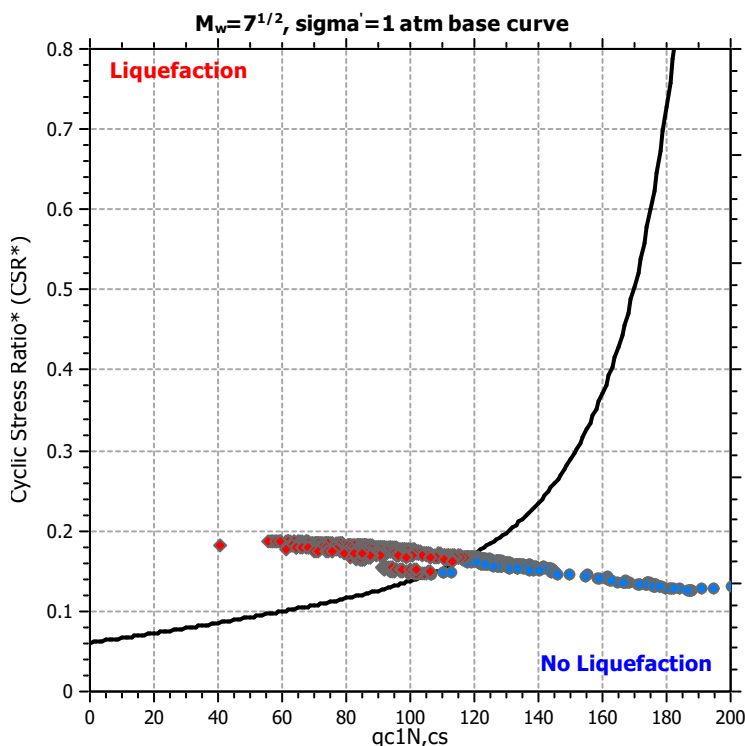
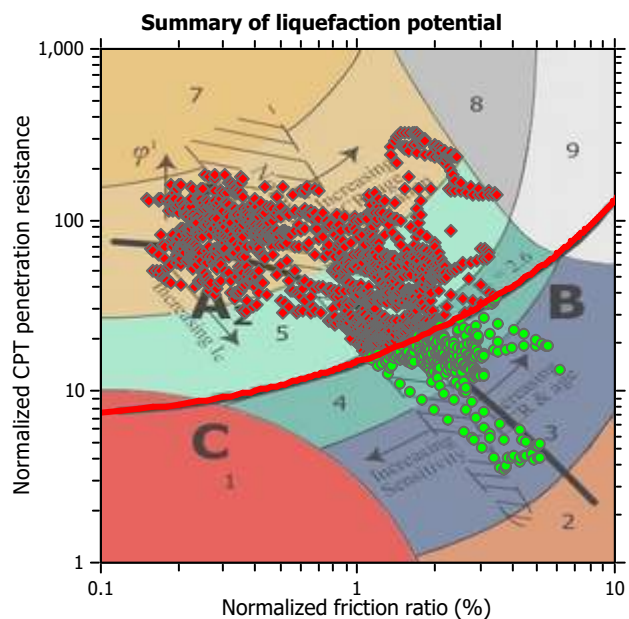
Zone A1: Cyclic liquefaction likely depending on size and duration of cyclic loading  
 Zone A2: Cyclic liquefaction and strength loss likely depending on loading and ground geometry  
 Zone B: Liquefaction and post-earthquake strength loss unlikely, check cyclic softening  
 Zone C: Cyclic liquefaction and strength loss possible depending on soil plasticity, brittleness/sensitivity, strain to peak undrained strength and ground geometry

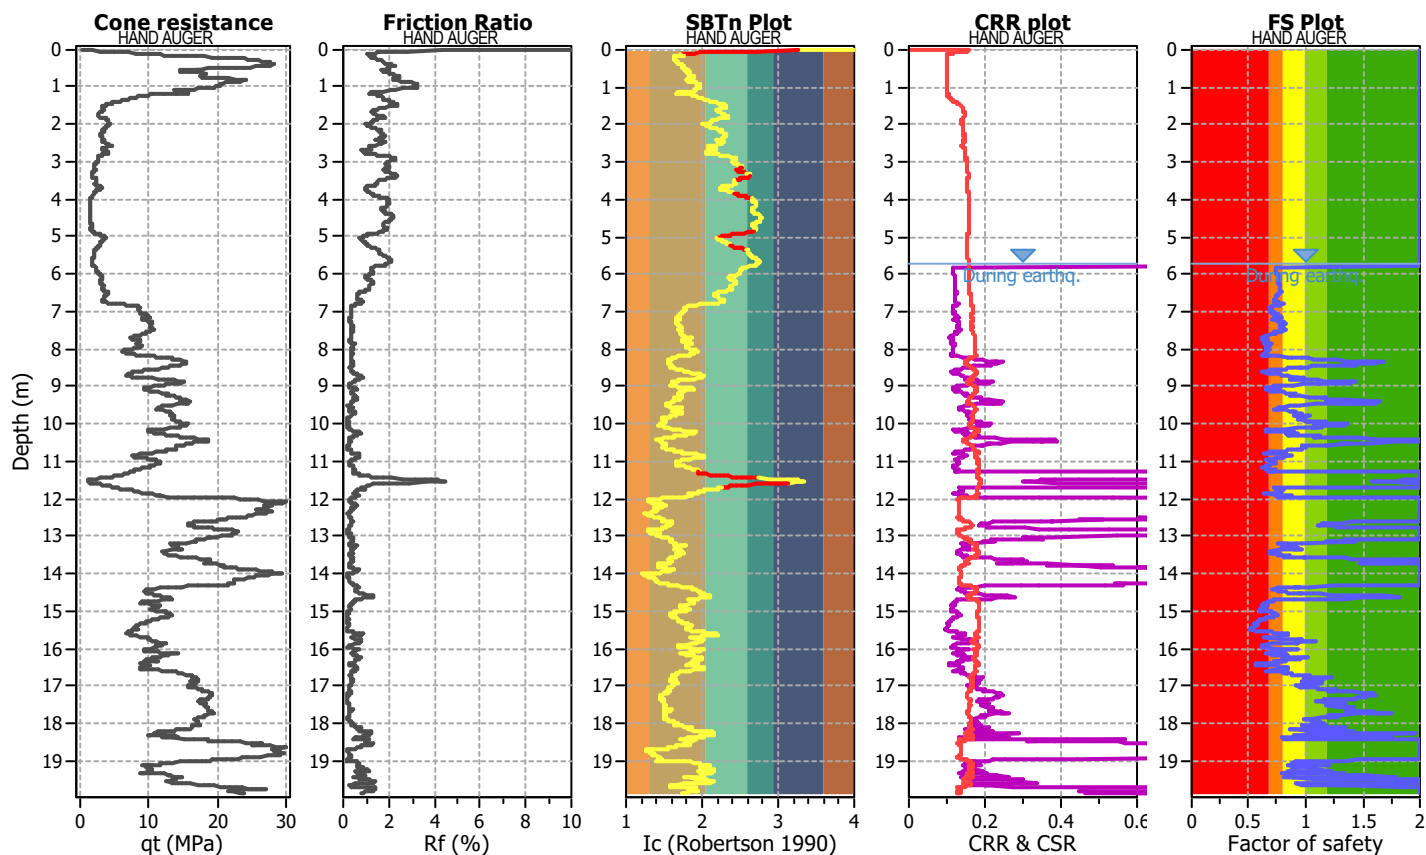
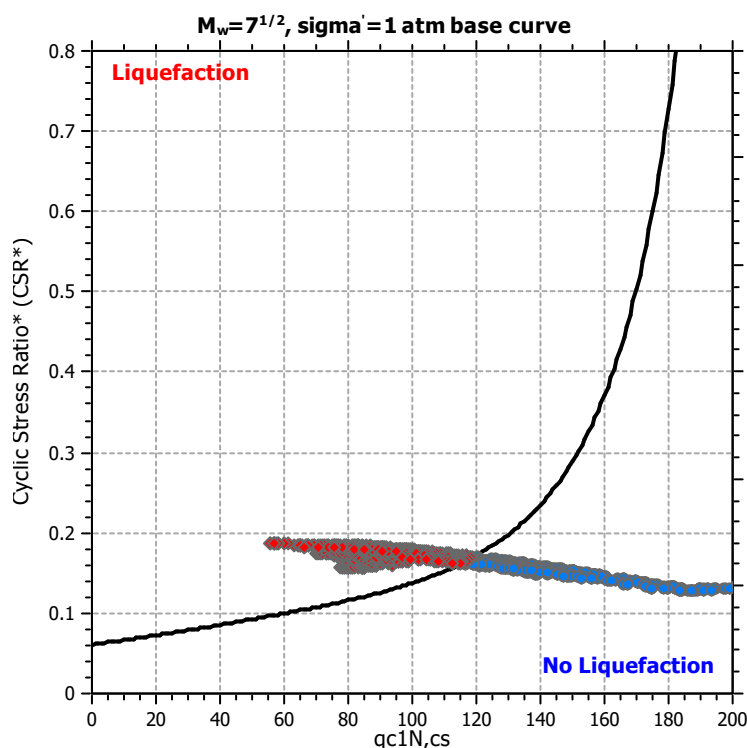
Zone A<sub>1</sub>: Cyclic liquefaction likely depending on size and duration of cyclic loading  
 Zone A<sub>2</sub>: Cyclic liquefaction and strength loss likely depending on loading and ground geometry  
 Zone B: Liquefaction and post-earthquake strength loss unlikely, check cyclic softening  
 Zone C: Cyclic liquefaction and strength loss possible depending on soil plasticity, brittleness/sensitivity, strain to peak undrained strength and ground geometry

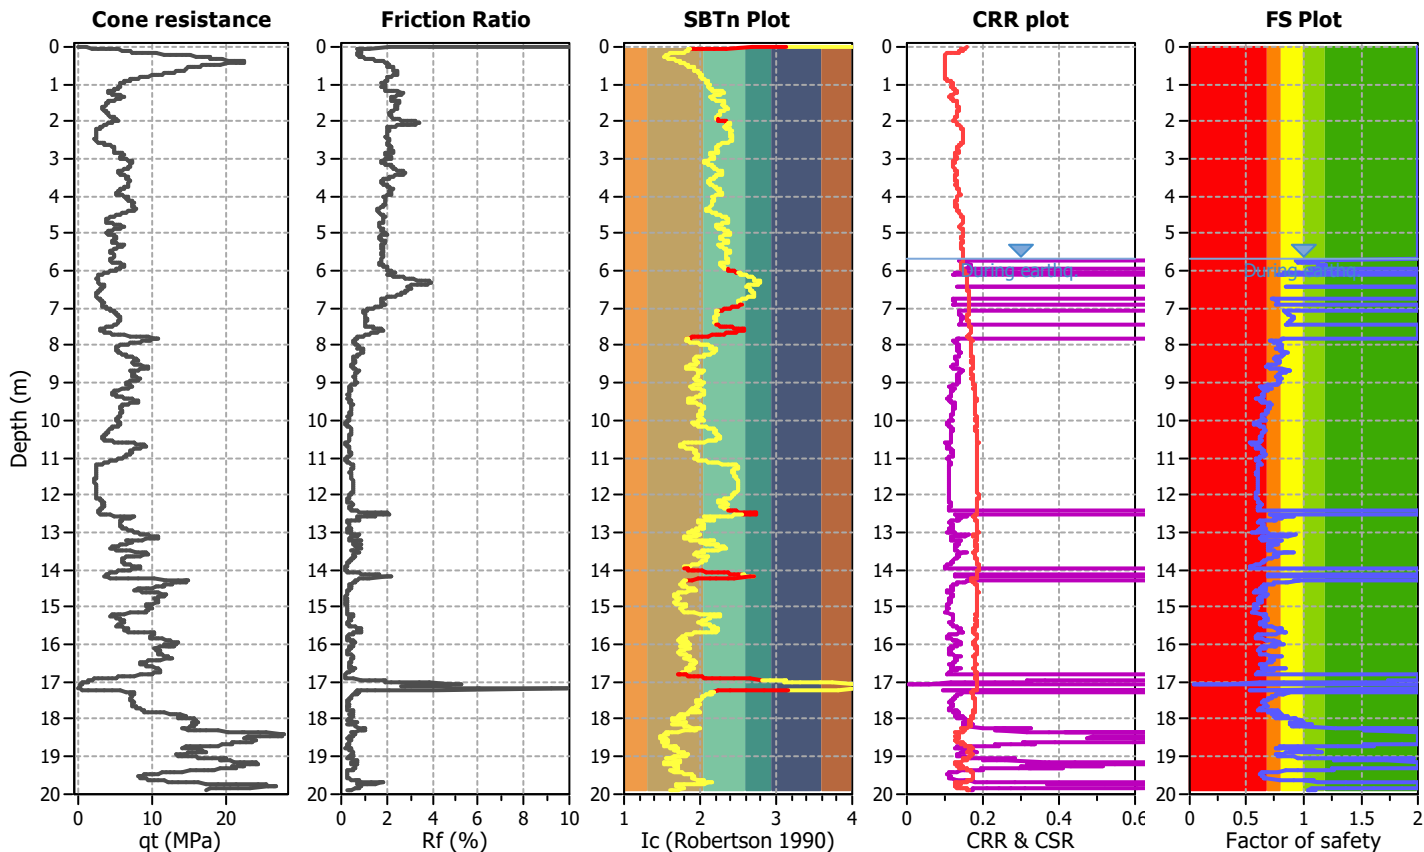
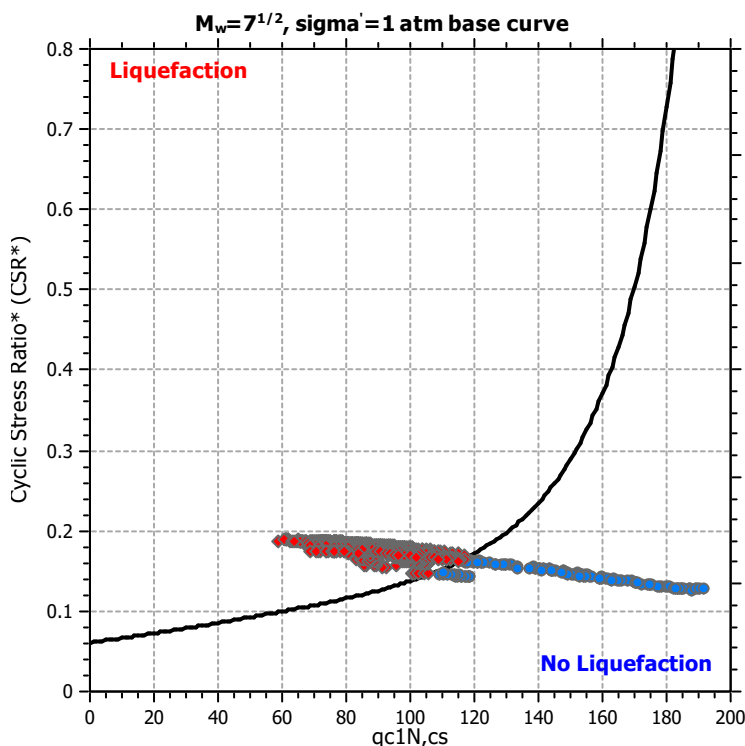
Zone A1: Cyclic liquefaction likely depending on size and duration of cyclic loading  
 Zone A2: Cyclic liquefaction and strength loss likely depending on loading and ground geometry  
 Zone B: Liquefaction and post-earthquake strength loss unlikely, check cyclic softening  
 Zone C: Cyclic liquefaction and strength loss possible depending on soil plasticity, brittleness/sensitivity, strain to peak undrained strength and ground geometry

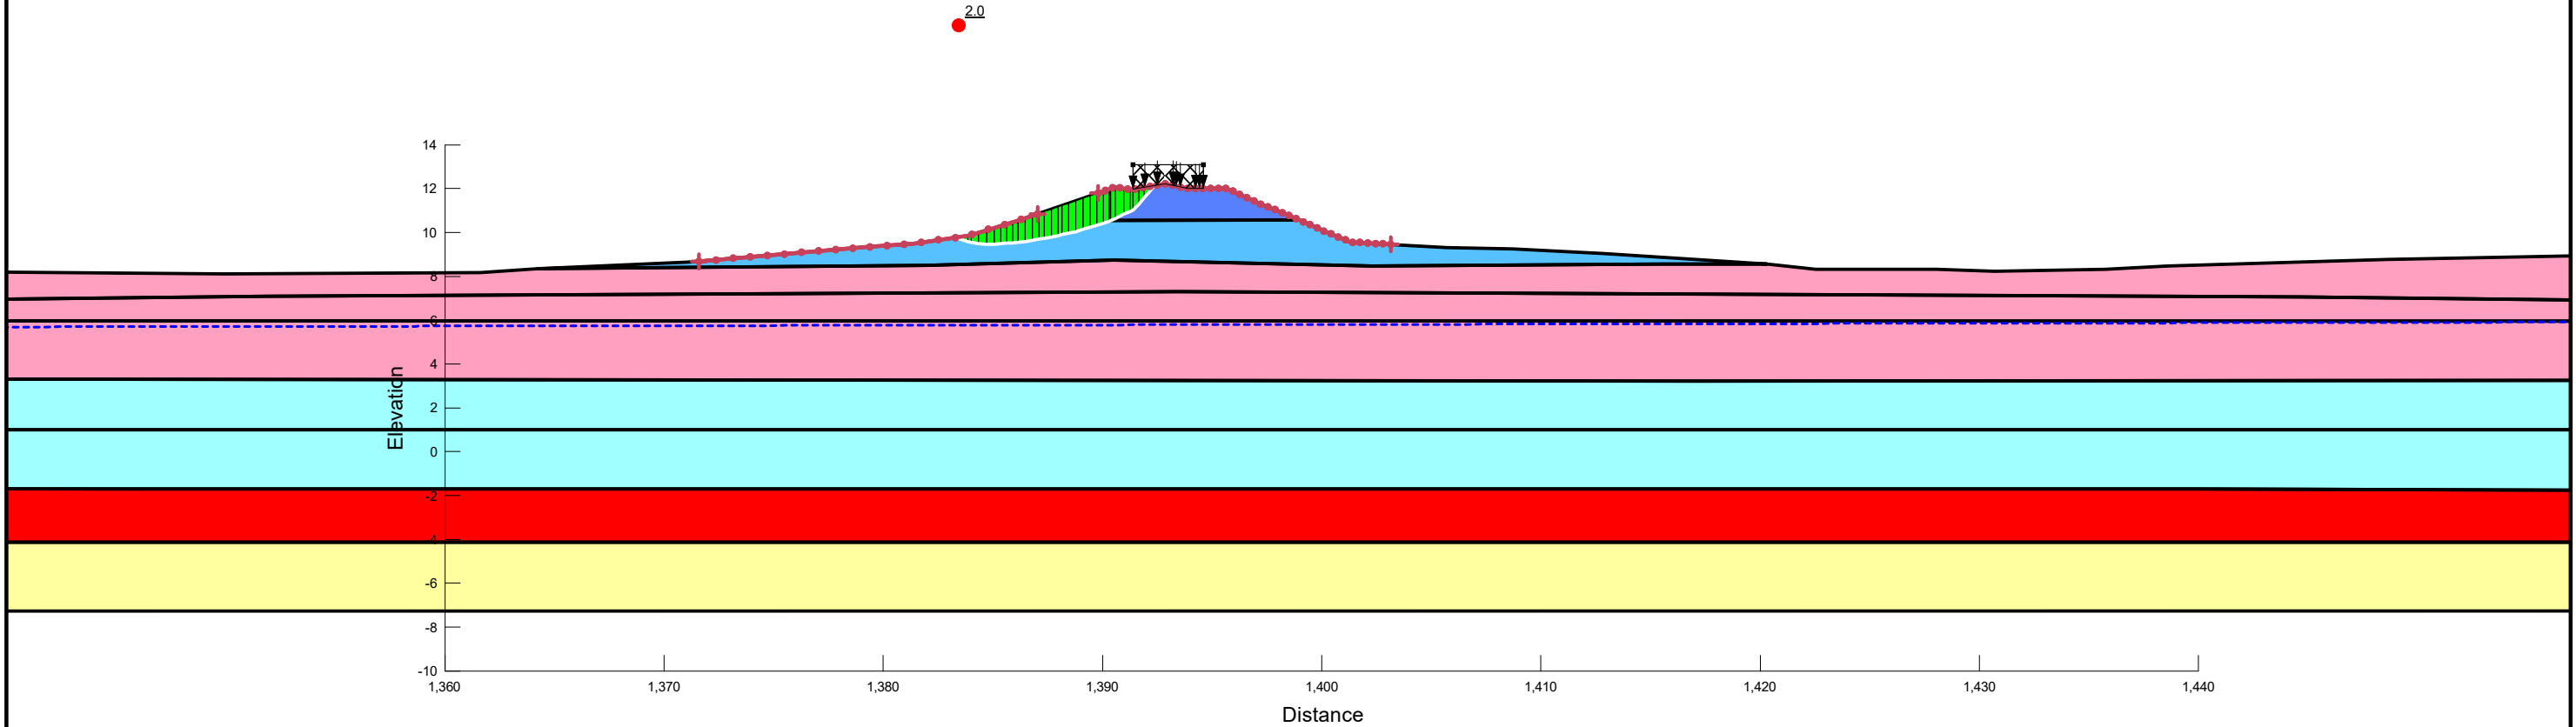
| 01 Static long term landside A-A' |

| Color | Name | Slope Stability<br>Material Model | Unit<br>Weight<br>(kN/m³) | Effective<br>Cohesion<br>(kPa) | Effective<br>Friction<br>Angle (°) | Phi-B<br>(°) |
| <div></div> | Loose sandy SILT (embankment Fill) | Mohr-Coulomb | 17 | 0 | 28 | 0 |
| <div></div> | Loose sandy SILT (holocene river deposits) | Mohr-Coulomb | 17 | 0 | 30 | 0 |
| <div></div> | Medium dense gravelly SAND (holocene river deposits) | Mohr-Coulomb | 18 | 0 | 32 | 0 |
| <div></div> | Stiff SILT | Mohr-Coulomb | 18 | 2 | 28 | 0 |

Surcharge (Unit Weight): 12 kN/m³

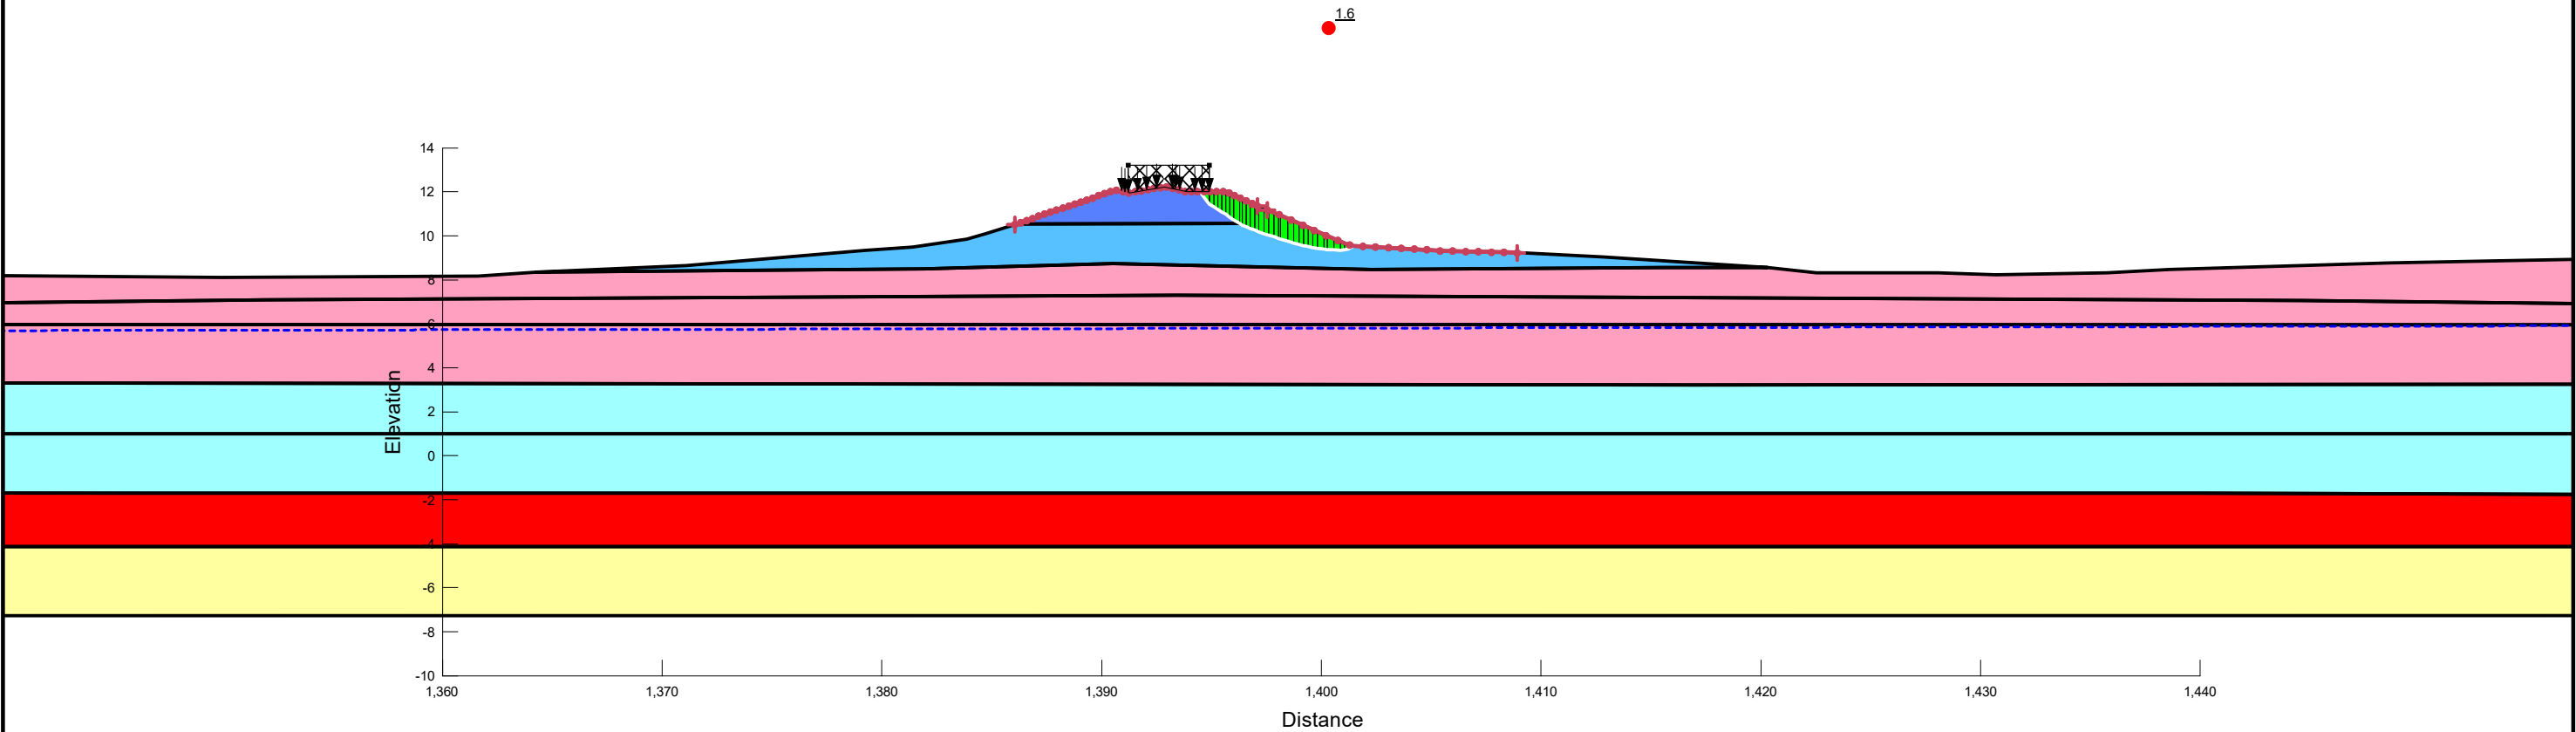
| 02 Static long term riverside A-A' |

Surcharge (Unit Weight): 12 kN/m³

| Outram_SEEP-W Model_Average Conditions.gsz |
