# TAIERI LIAISON GROUP AGENDA

## 1. MEETING DETAILS

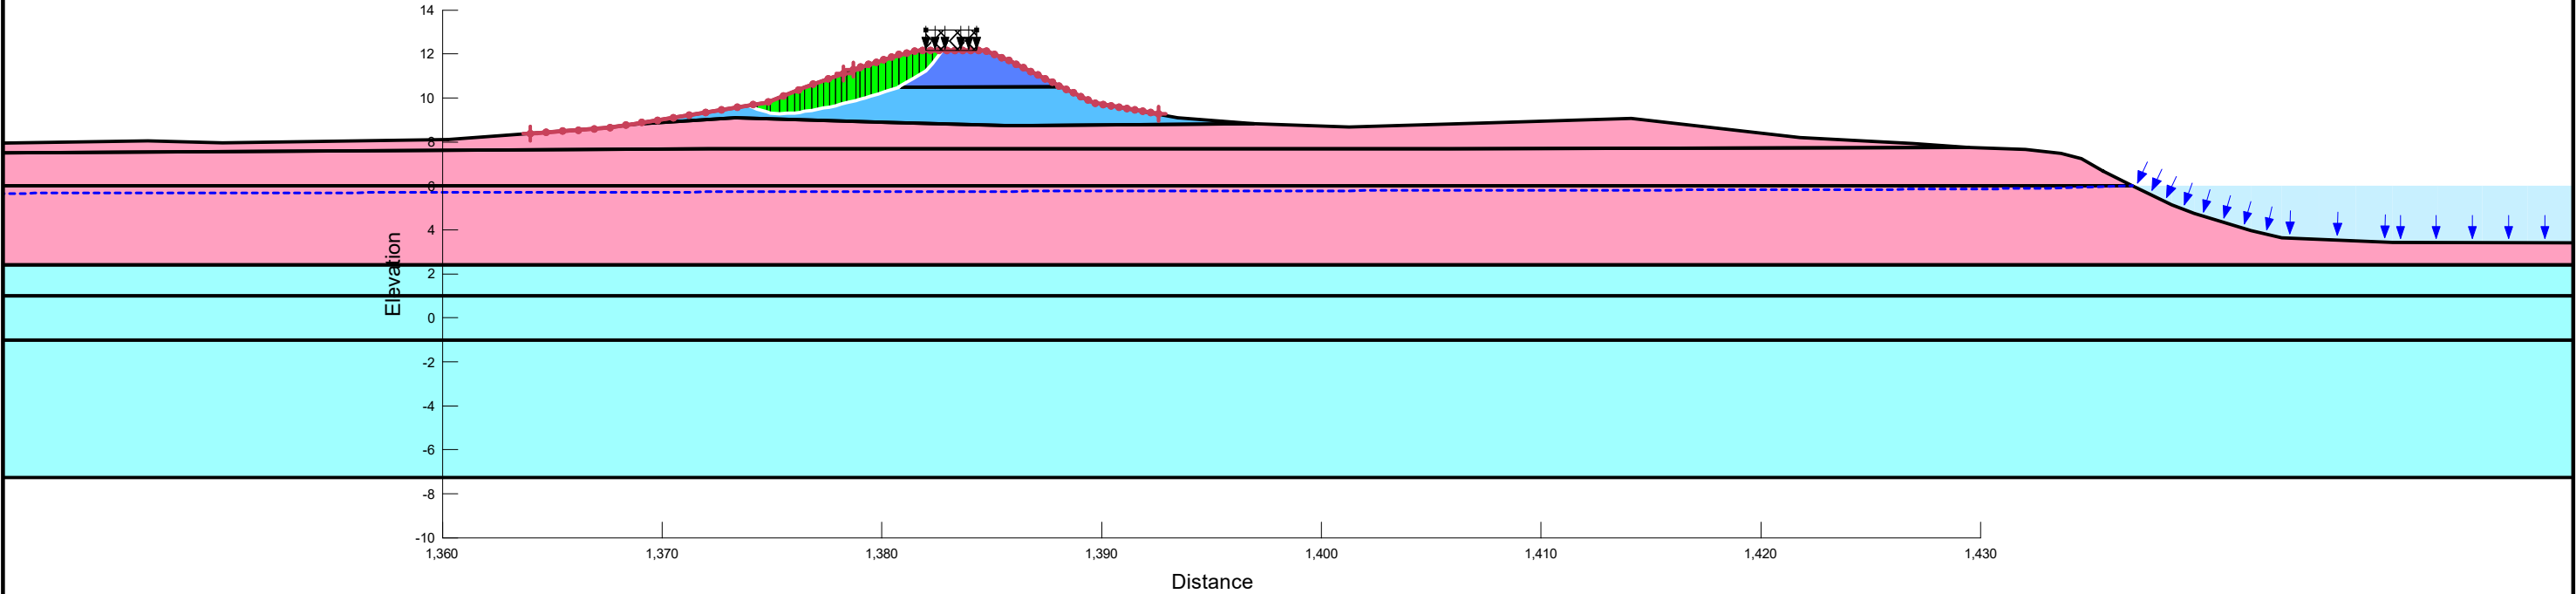
| 01 Static long term landside B'B' |

Surcharge (Unit Weight): 12 kN/m³

| Outram_SEEP-W Model_Average Conditions.gsz |

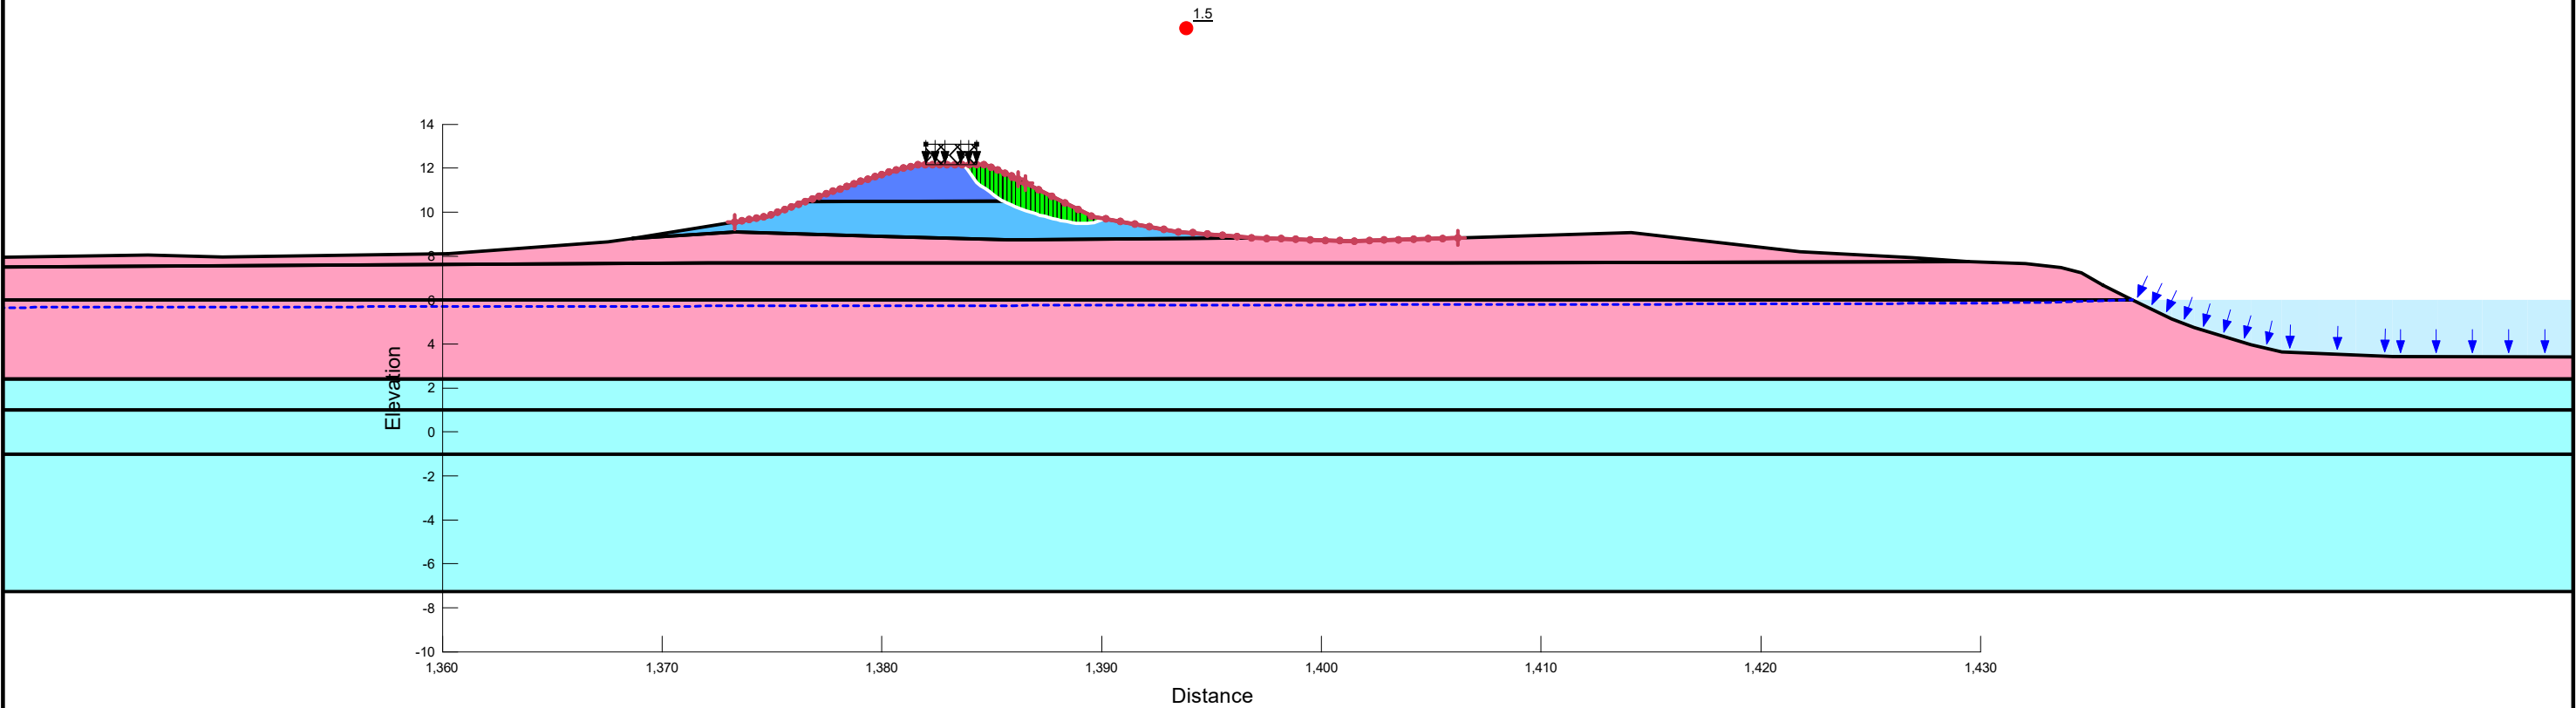
| 02 Static long term riverside B'B' |

Surcharge (Unit Weight): 12 kN/m³

| Outram_SEEP-W Model_Average Conditions.gsz |

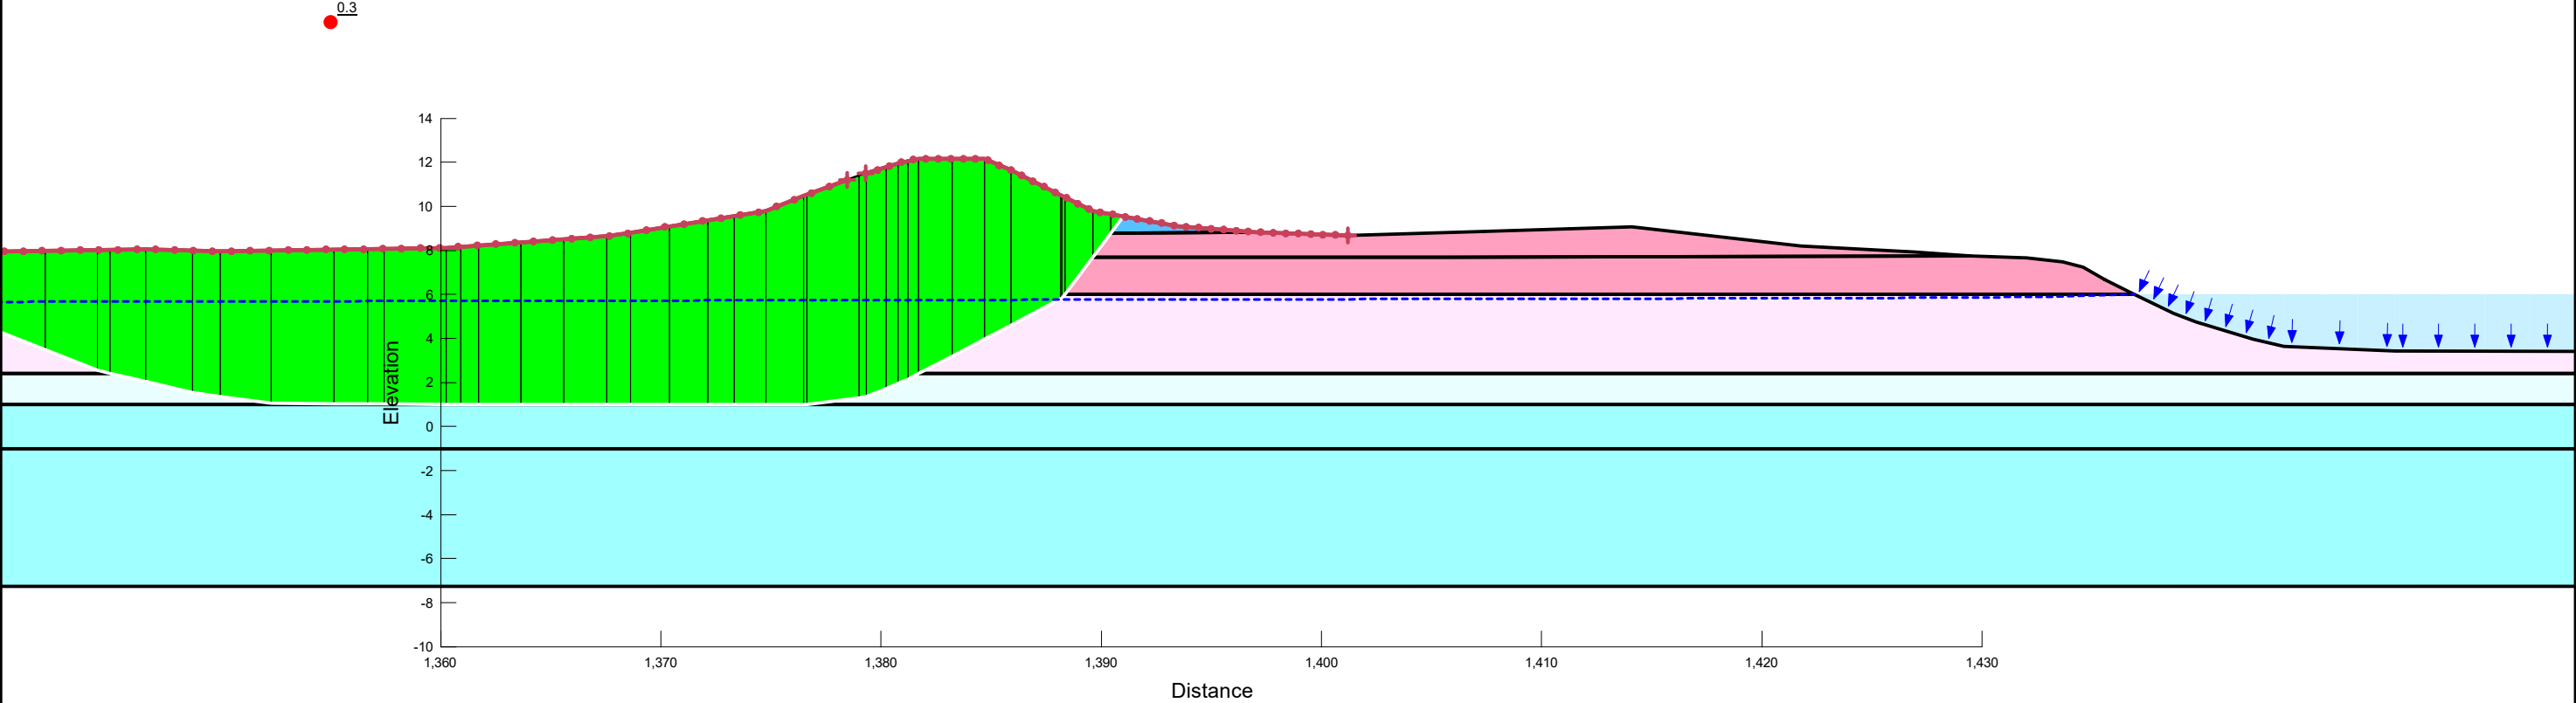
07 Seismic ULS IL2 landside B'B'

Outram\_SEEP-W Model\_Average Conditions.gsz

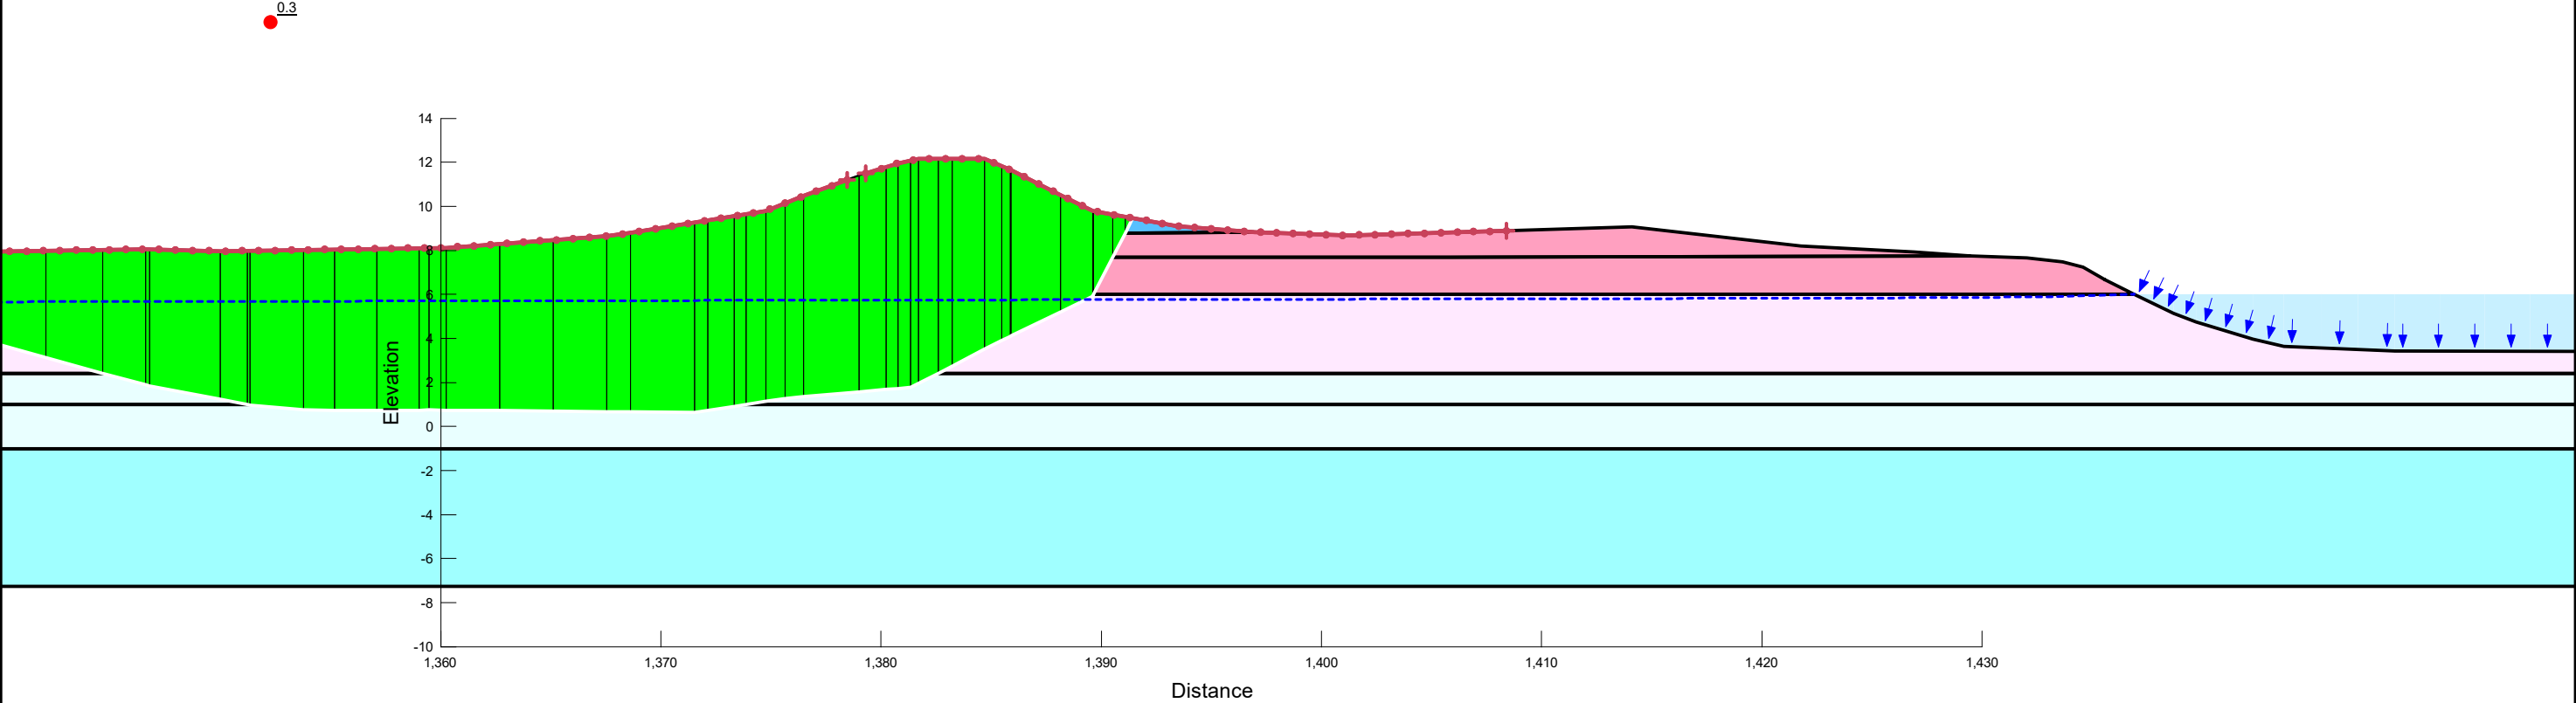
09 Seismic ULS IL3 landside B'B'

Outram\_SEEP-W Model\_Average Conditions.gsz

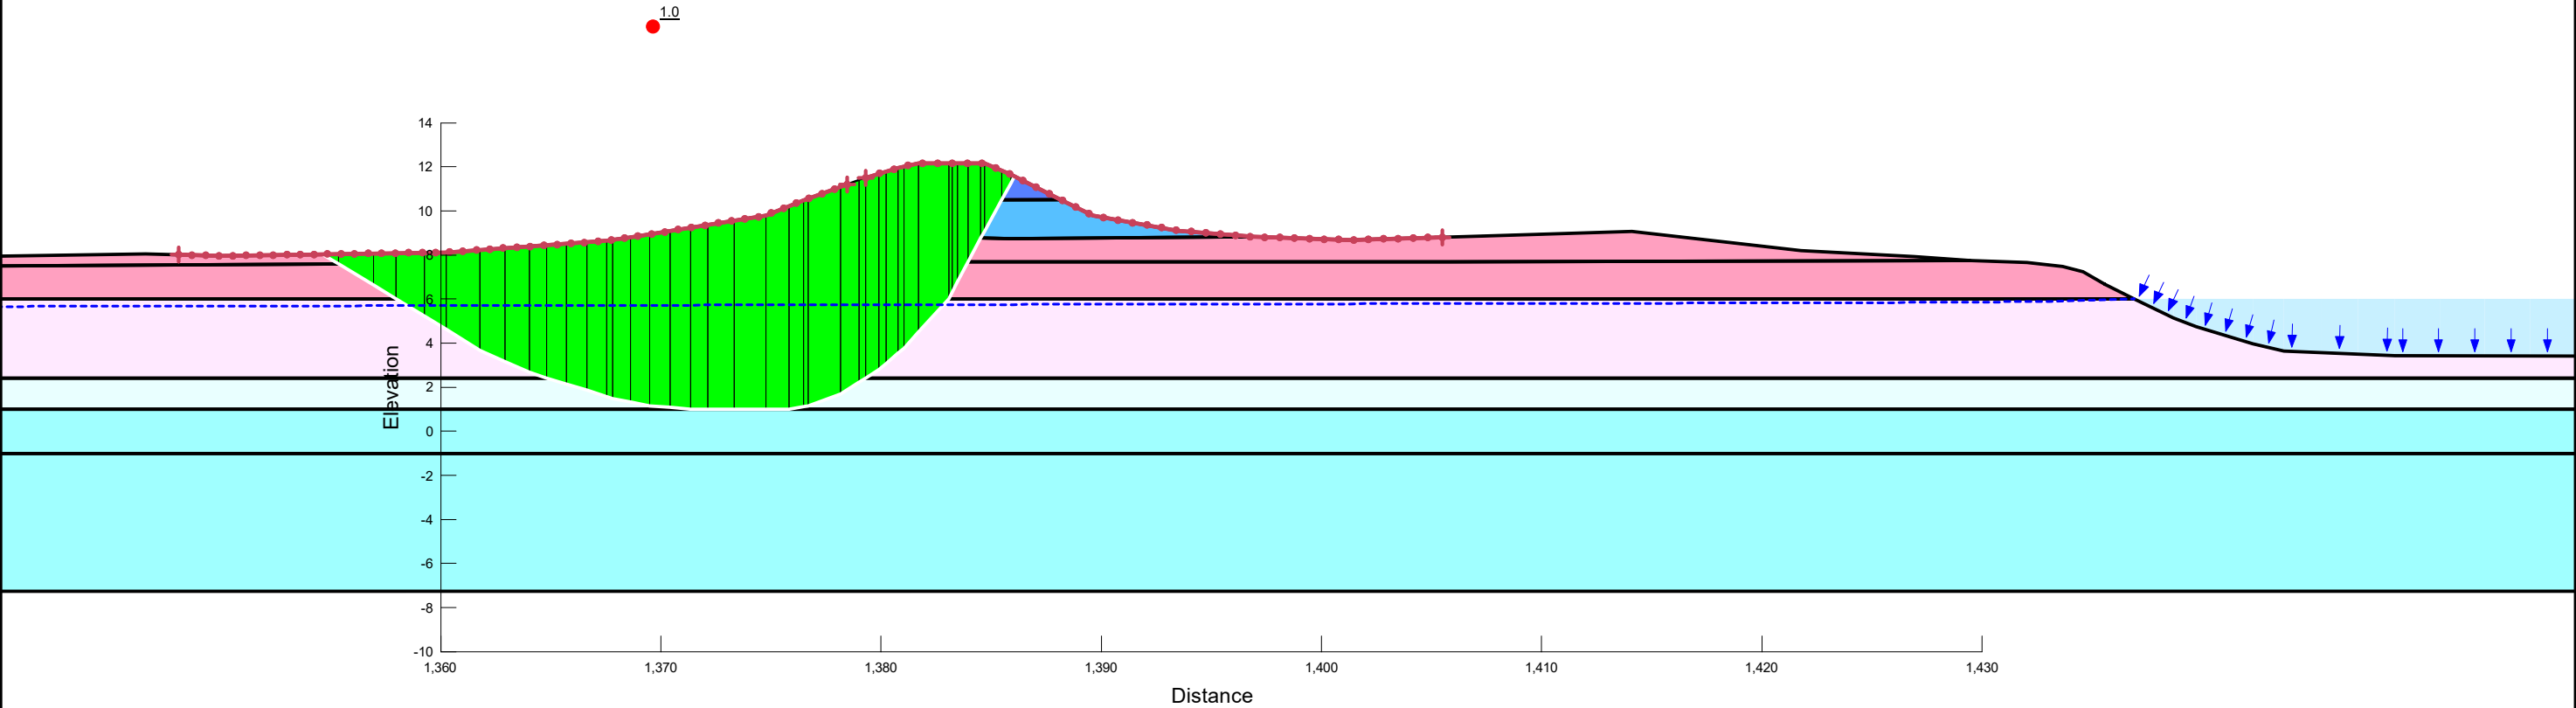
11 Seismic - Yield Acceleration landside B'B'

Outram\_SEEP-W Model\_Average Conditions.gsz

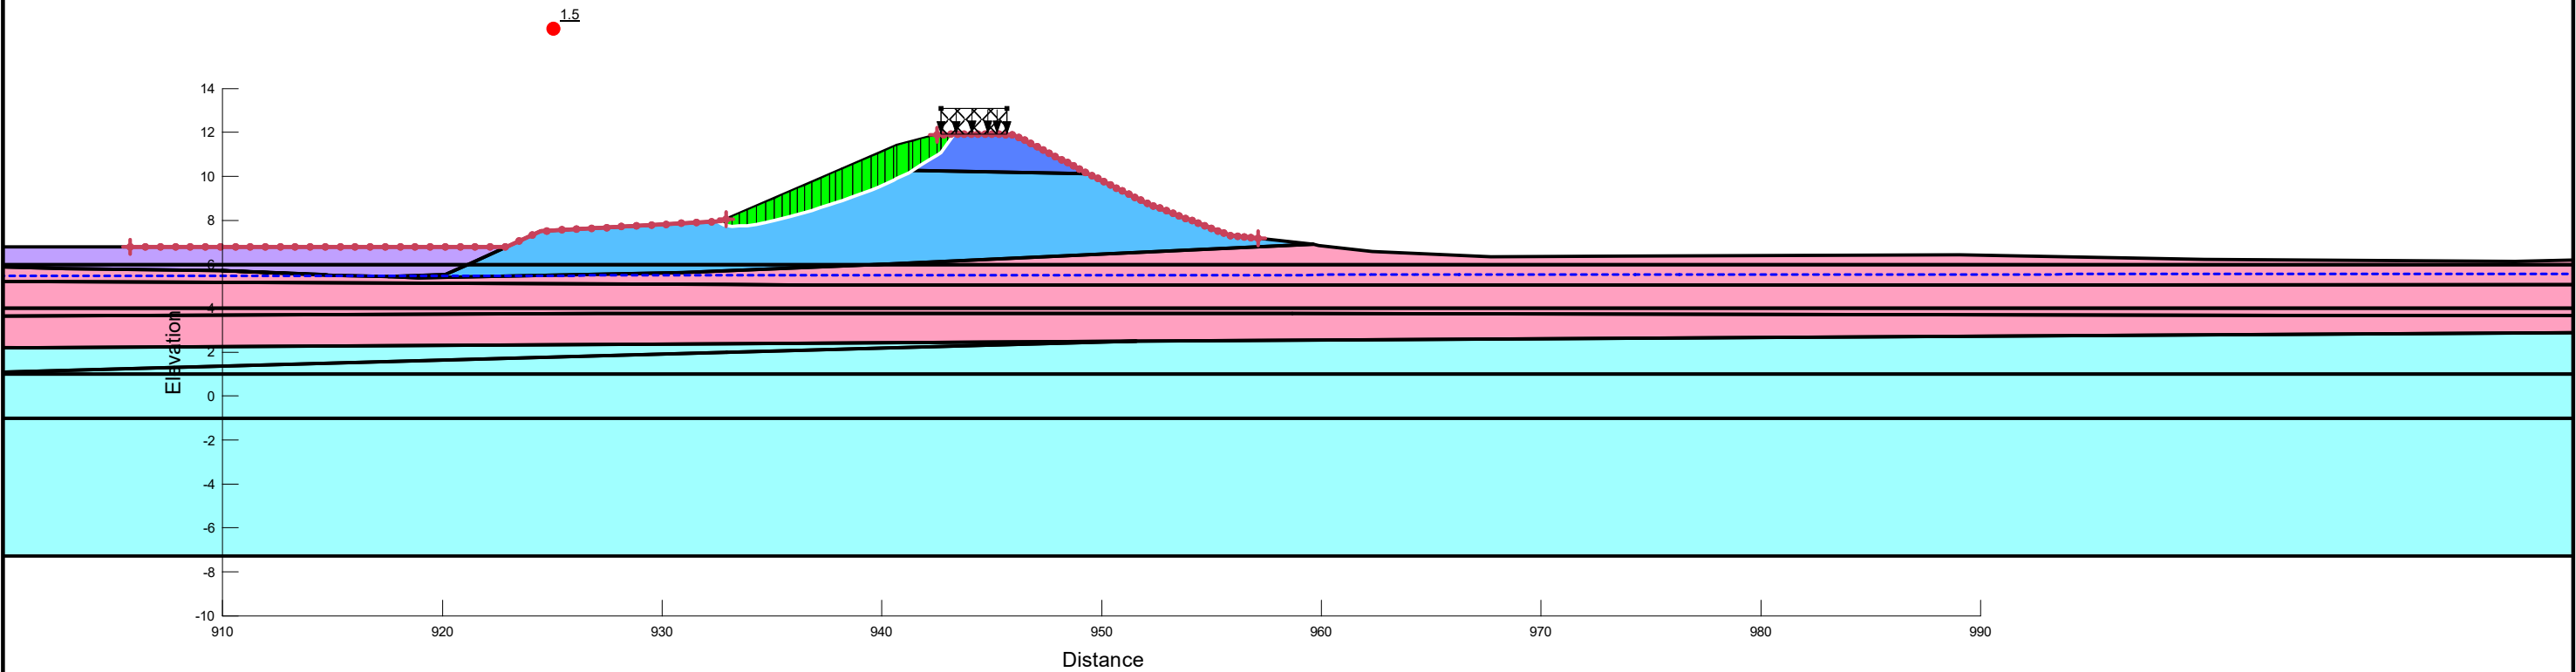
| 01 Static long term landside C-C' |

Surcharge (Unit Weight): 12 kN/m³

| Outram_SEEP-W Model_Average Conditions.gsz |

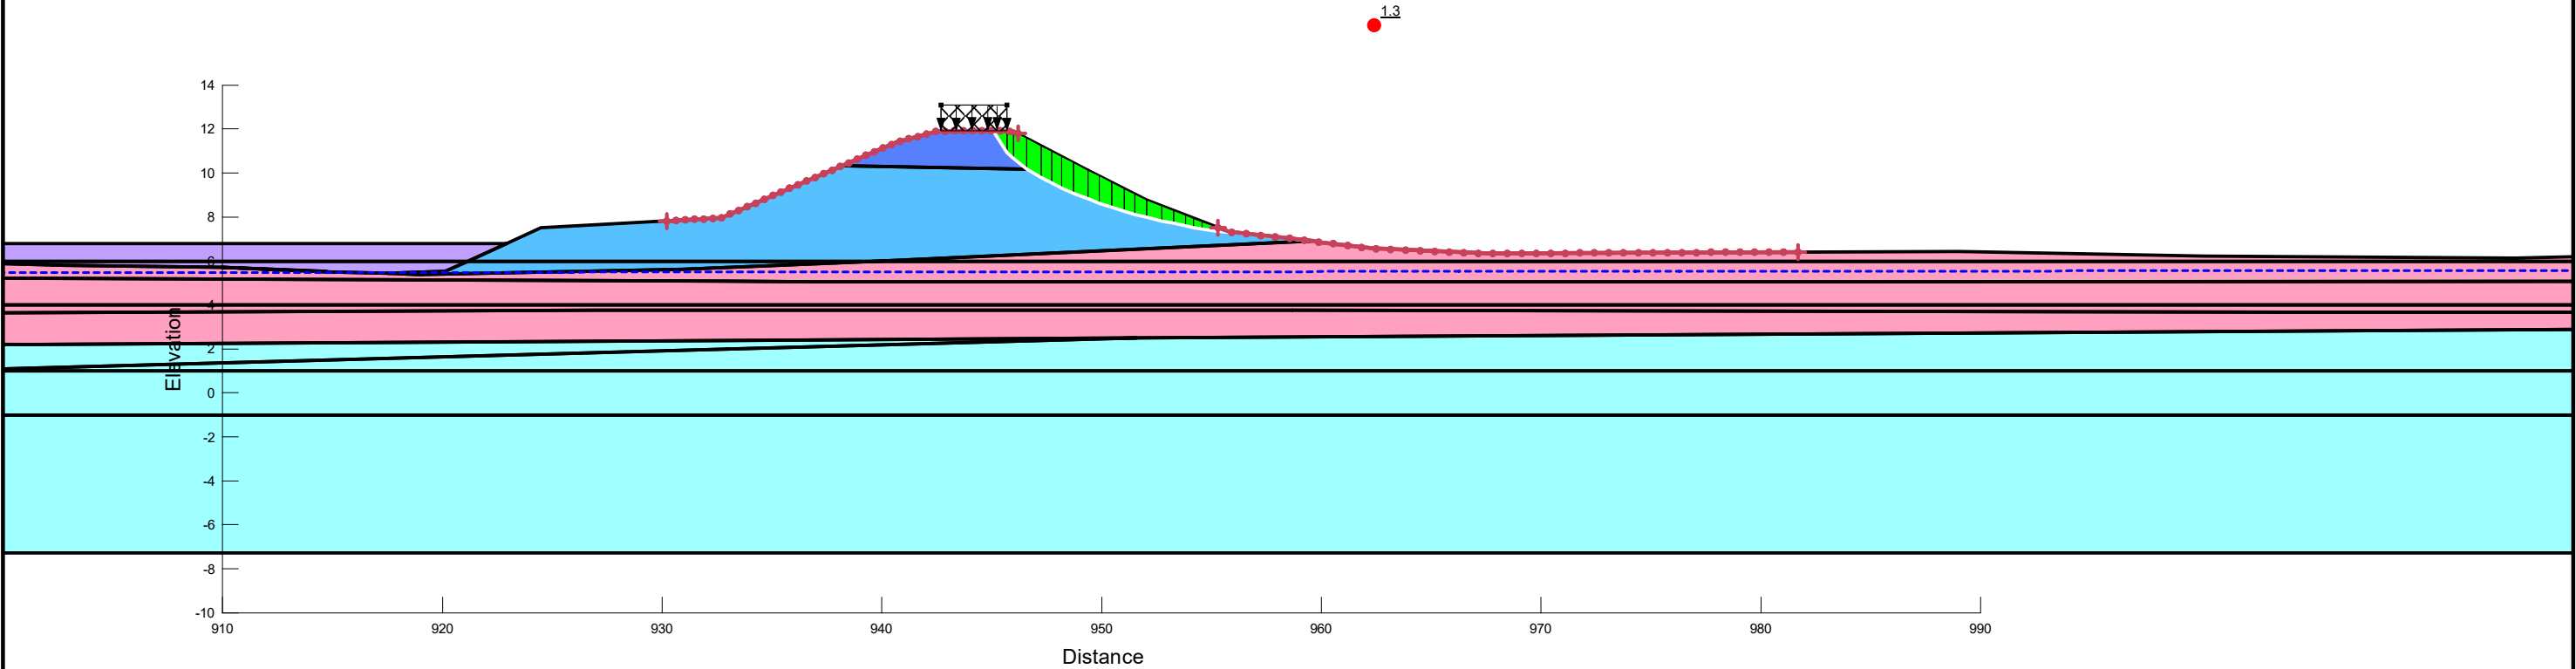
| 02 static long term riverside C-C' |

Surcharge (Unit Weight): 12 kN/m³

| Outram_SEEP-W Model_Average Conditions.gsz |

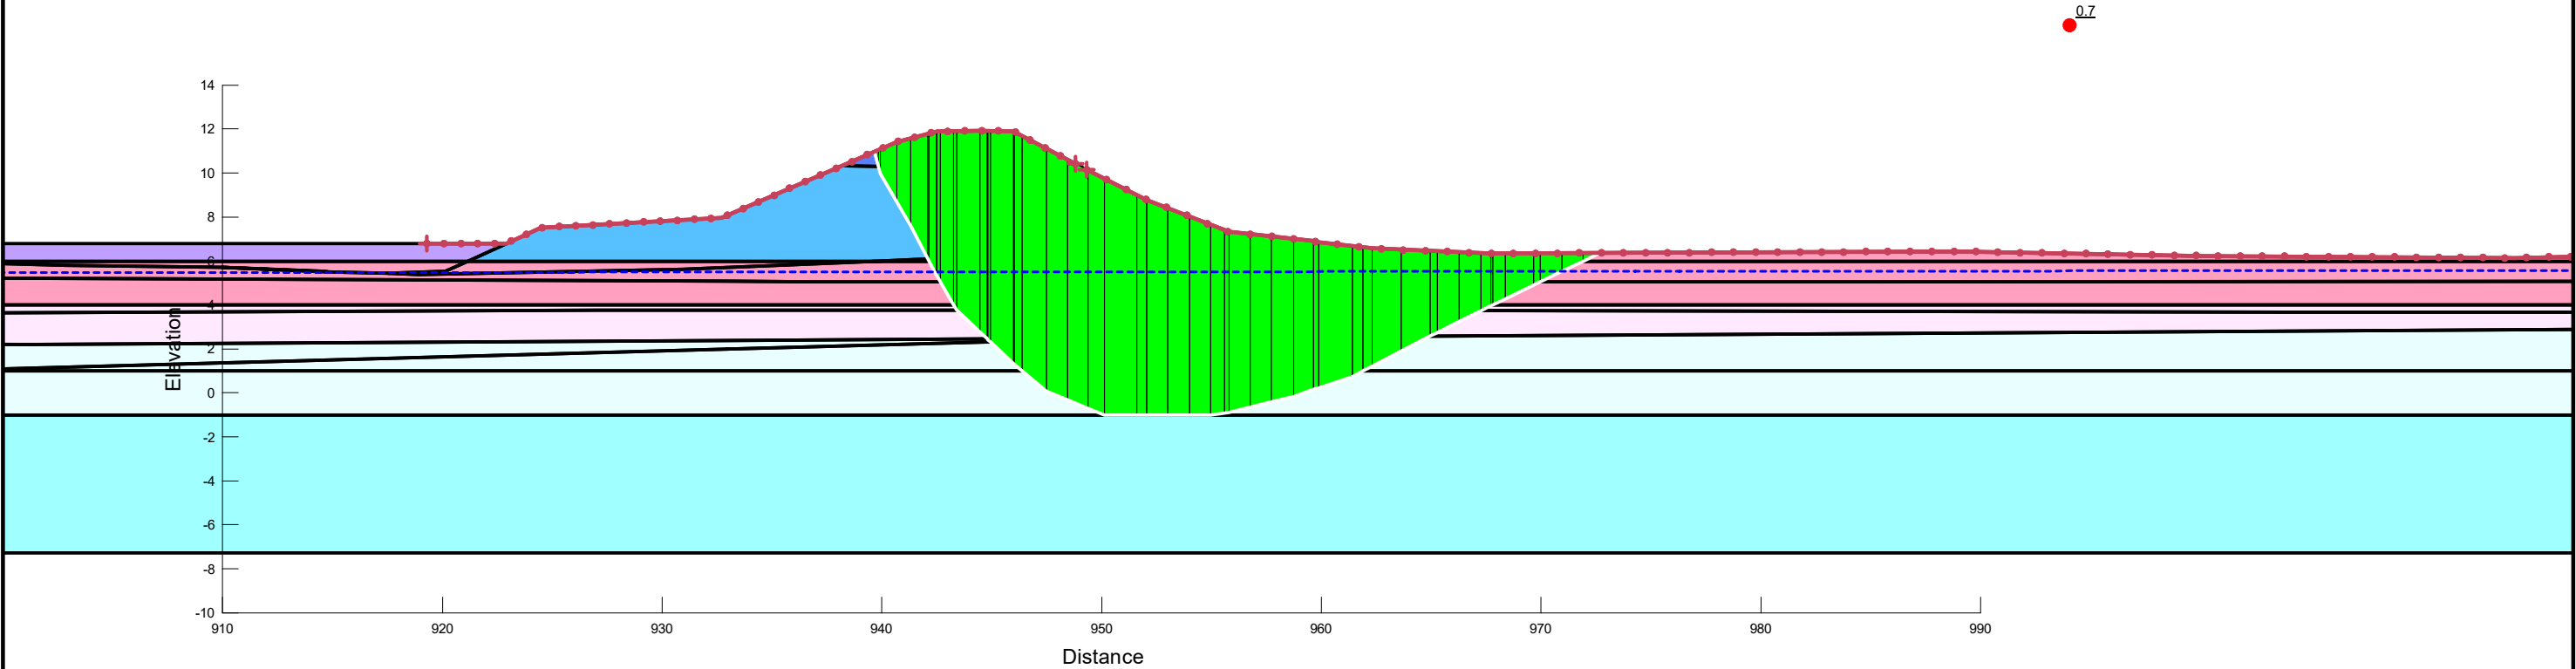
12 Seismic - Yield Acceleration riverside 2 m crust C-C'

Outram\_SEEP-W Model\_Average Conditions.gsz

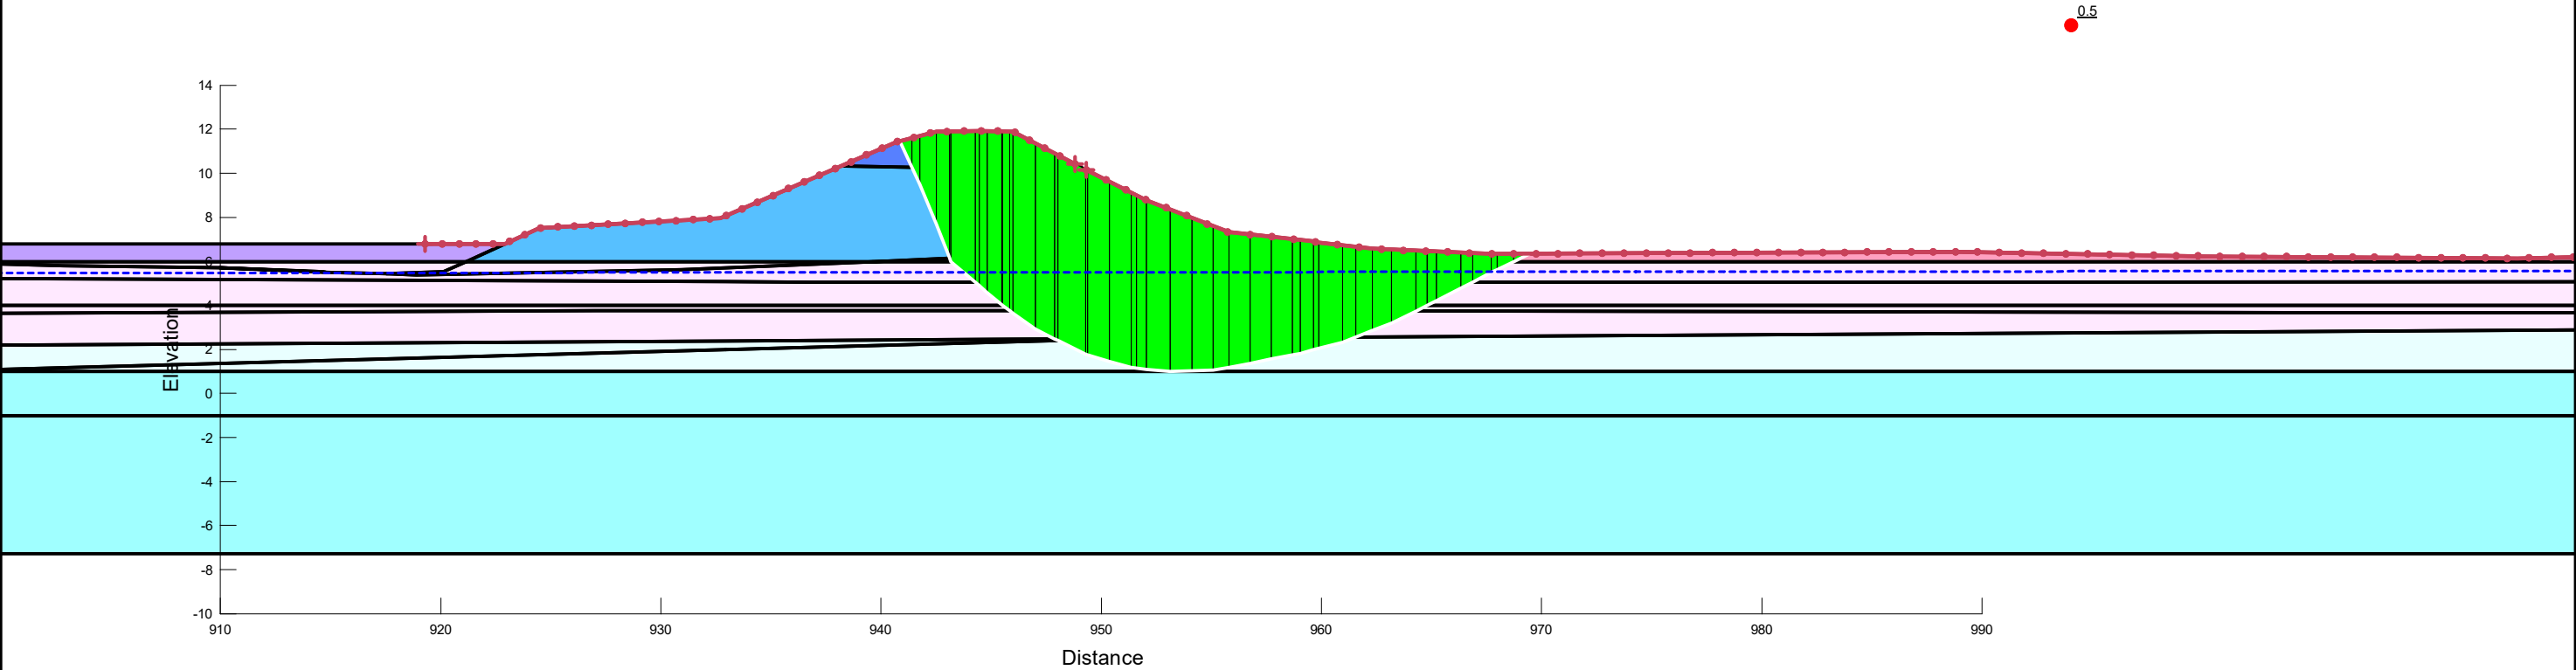
12 Seismic - Yield Acceleration riverside C-C'

Outram\_SEEP-W Model\_Average Conditions.gsz

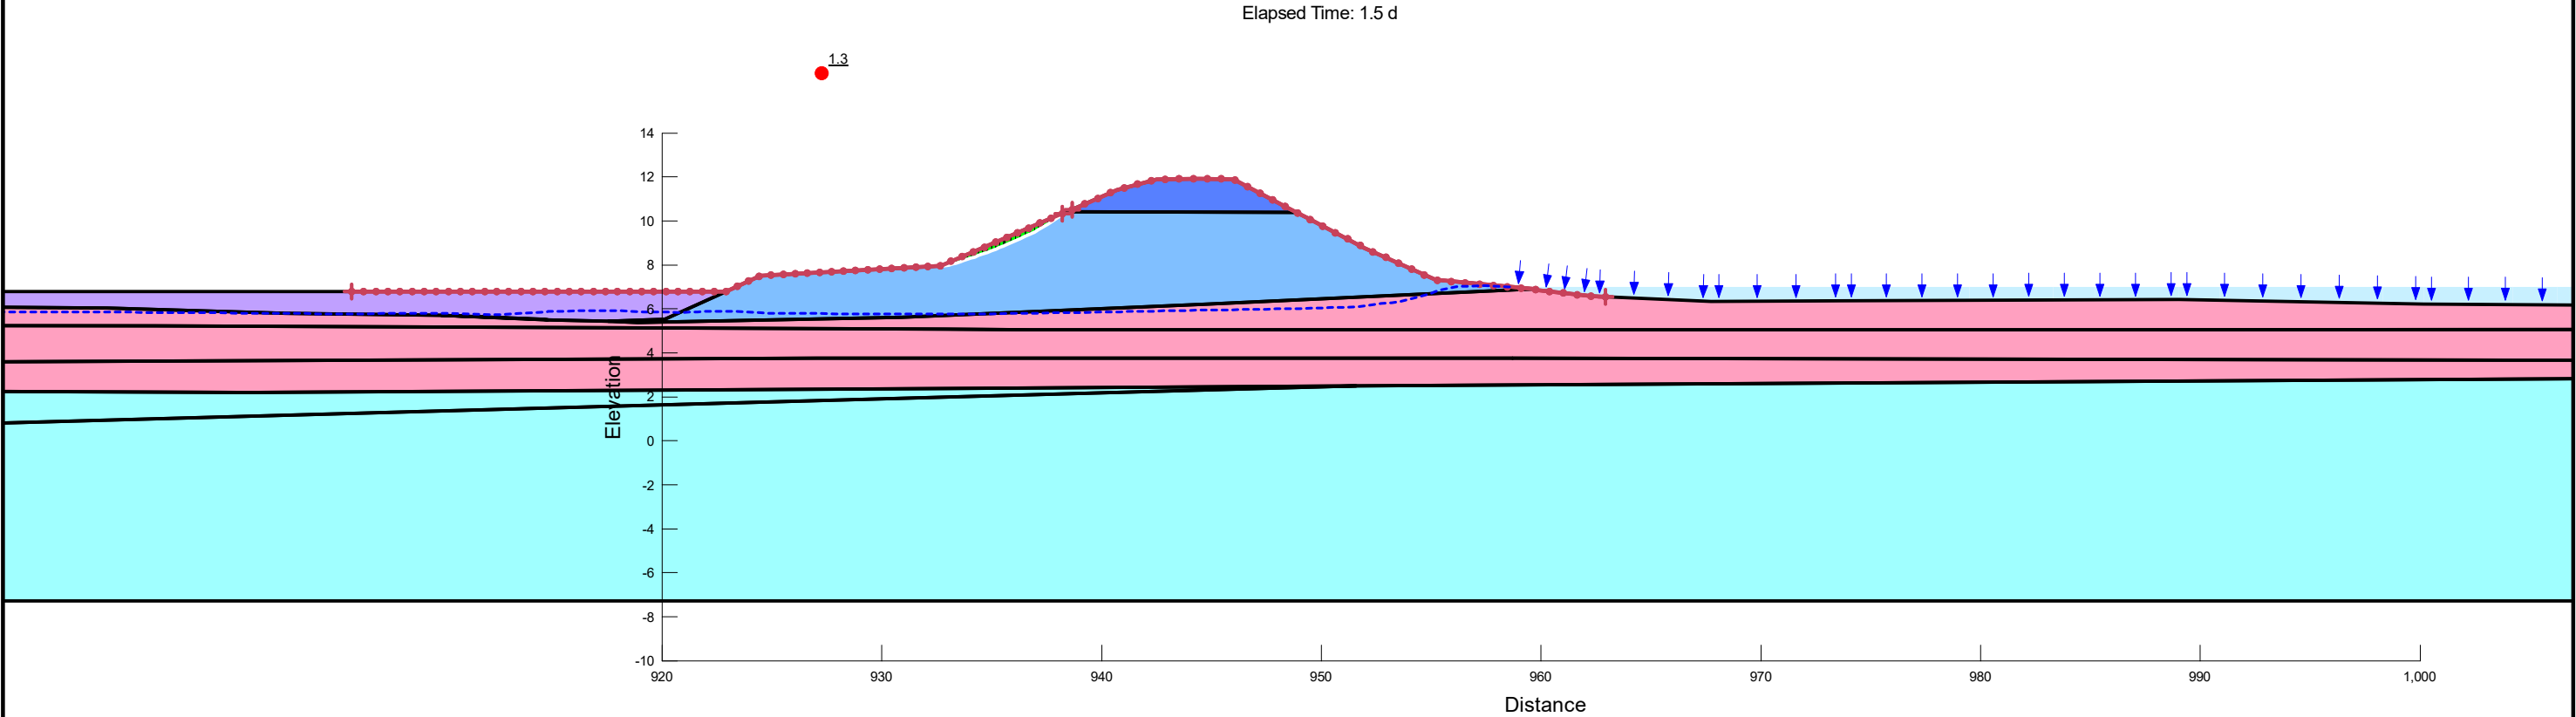
| 03 Rapid drawdown landside C-C' |

| Outram_SEEP-W scenario rapid ddn_2hr.gsz |

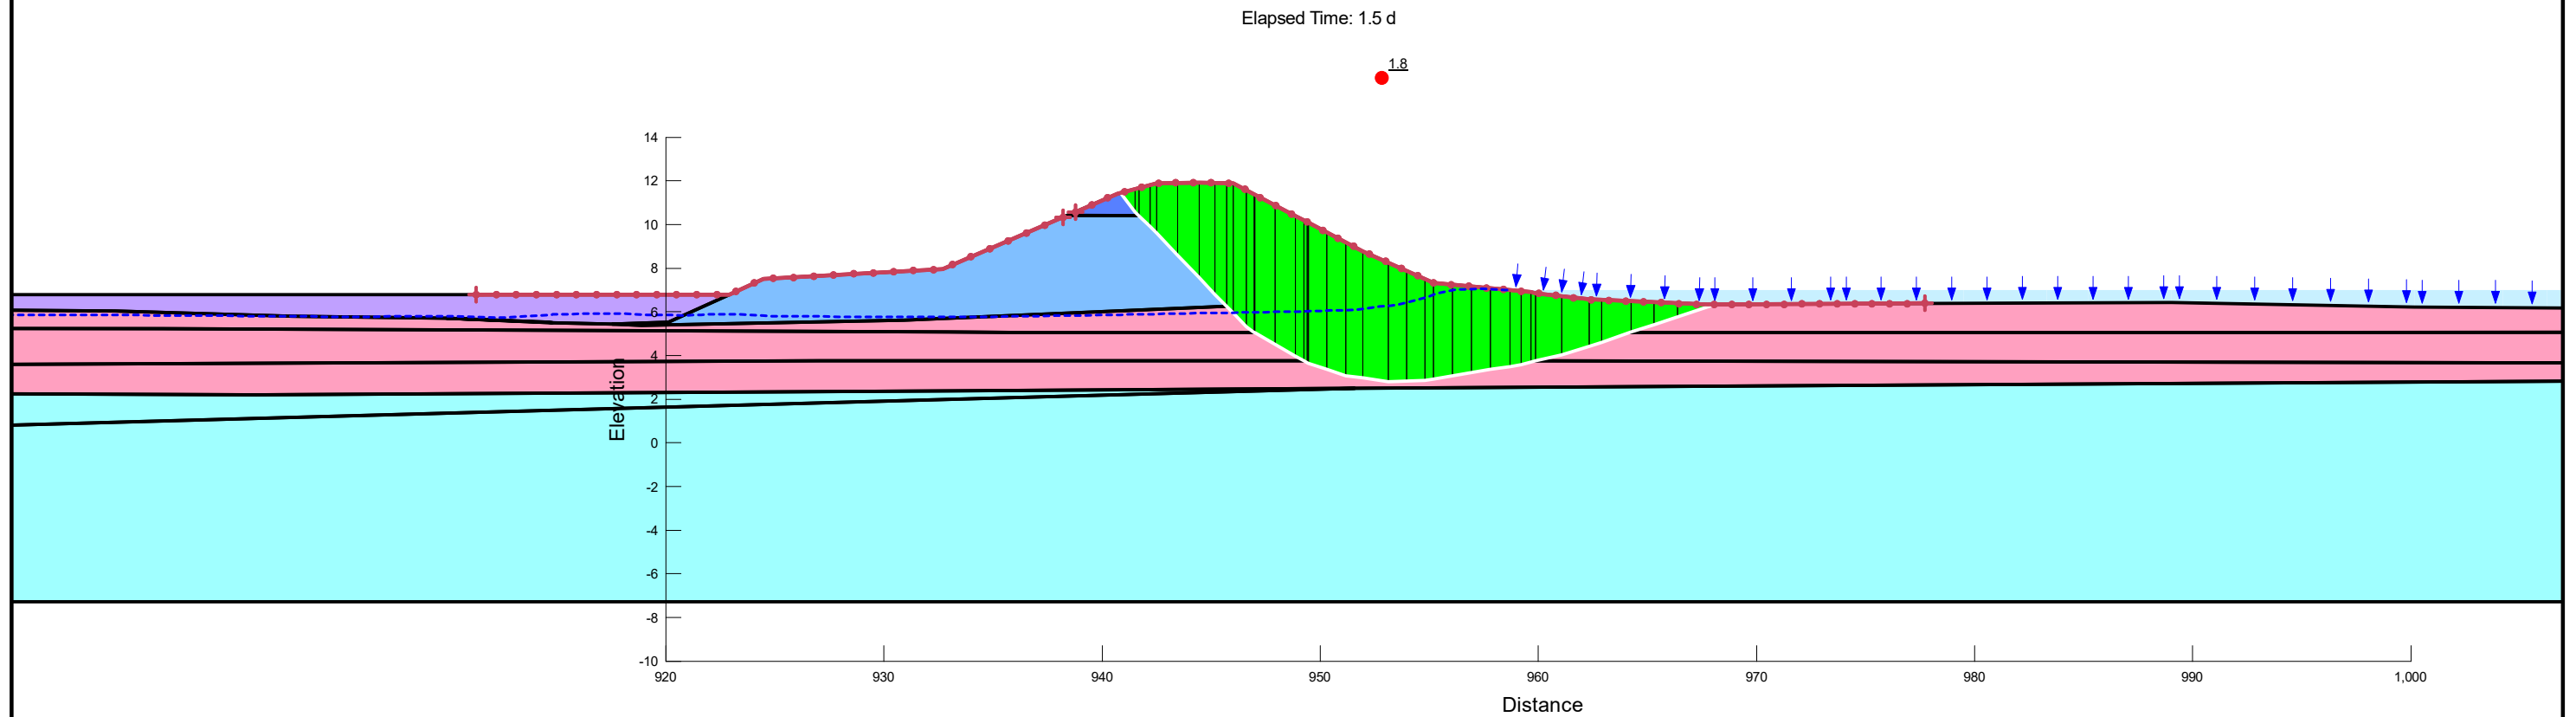
04 Rapid drawdown riverside C-C'

Outram\_SEEP-W scenario rapid ddn\_2hr.gsz

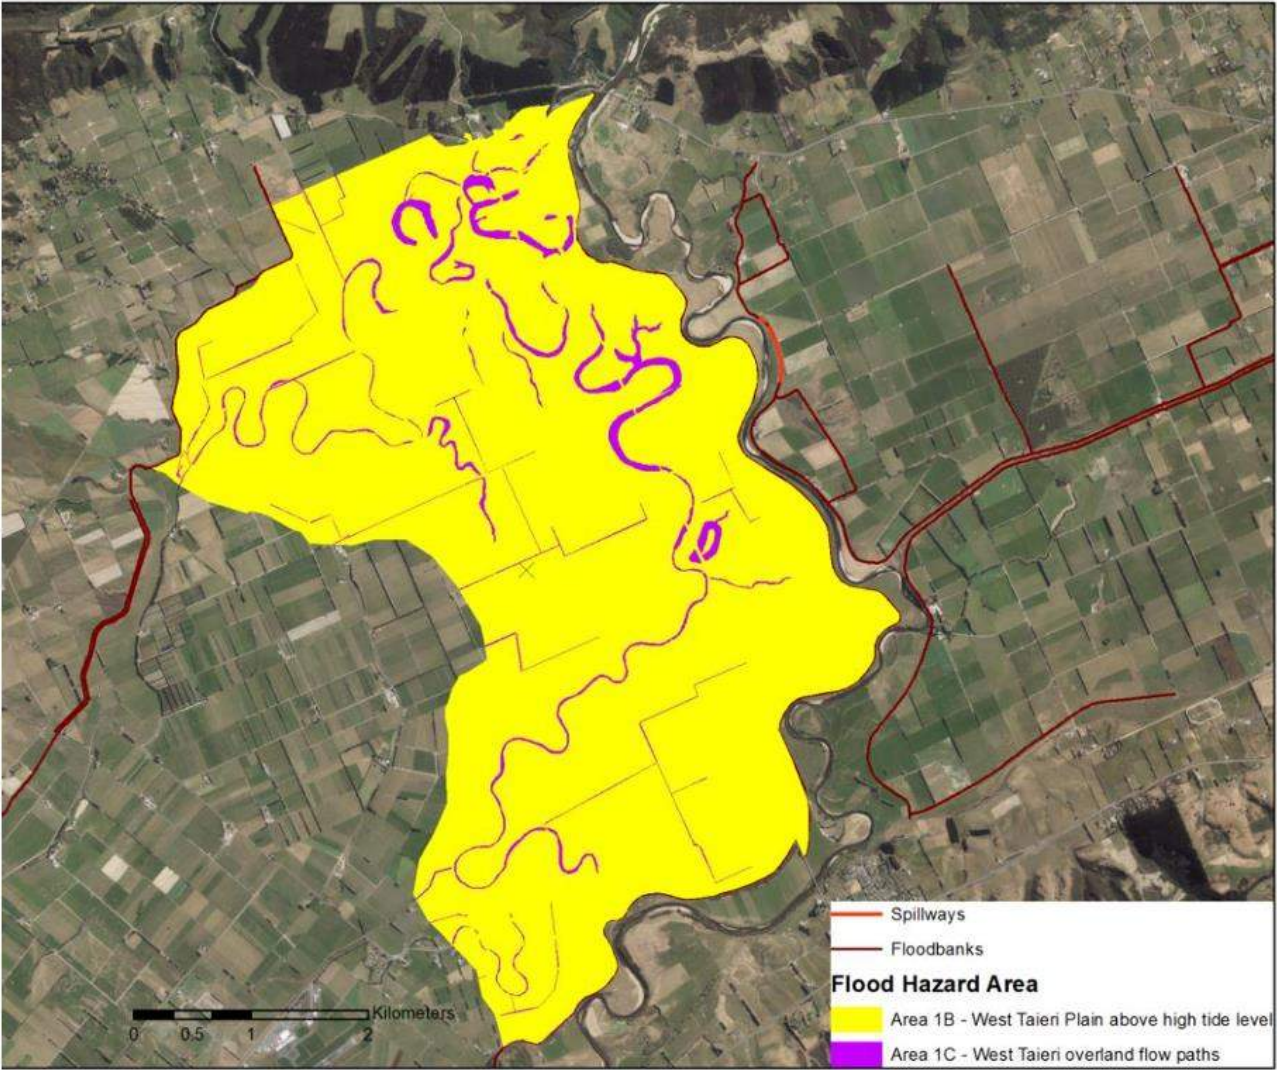
Appendix F – Paleochannels/ Overland Flow Paths in and below Outram

Flood Hazard Map Showing Paleochannels/ Overland Flow Paths in Pink. Source: ORC, 2015.
