# TAIERI LIAISON GROUP AGENDA

## 1. MEETING DETAILS

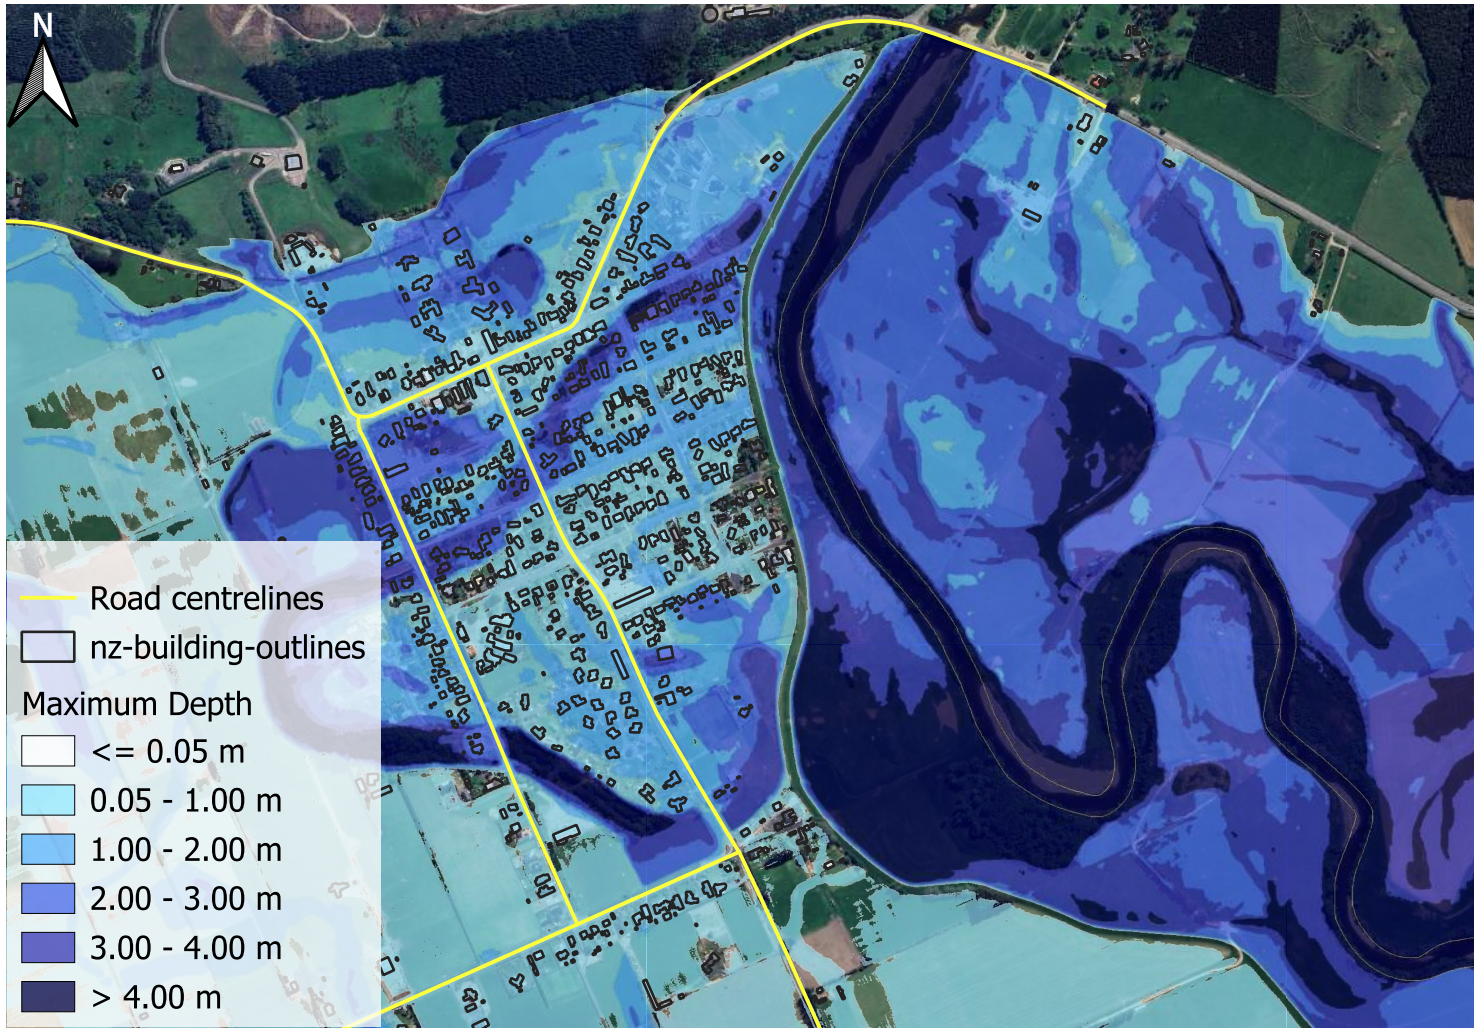
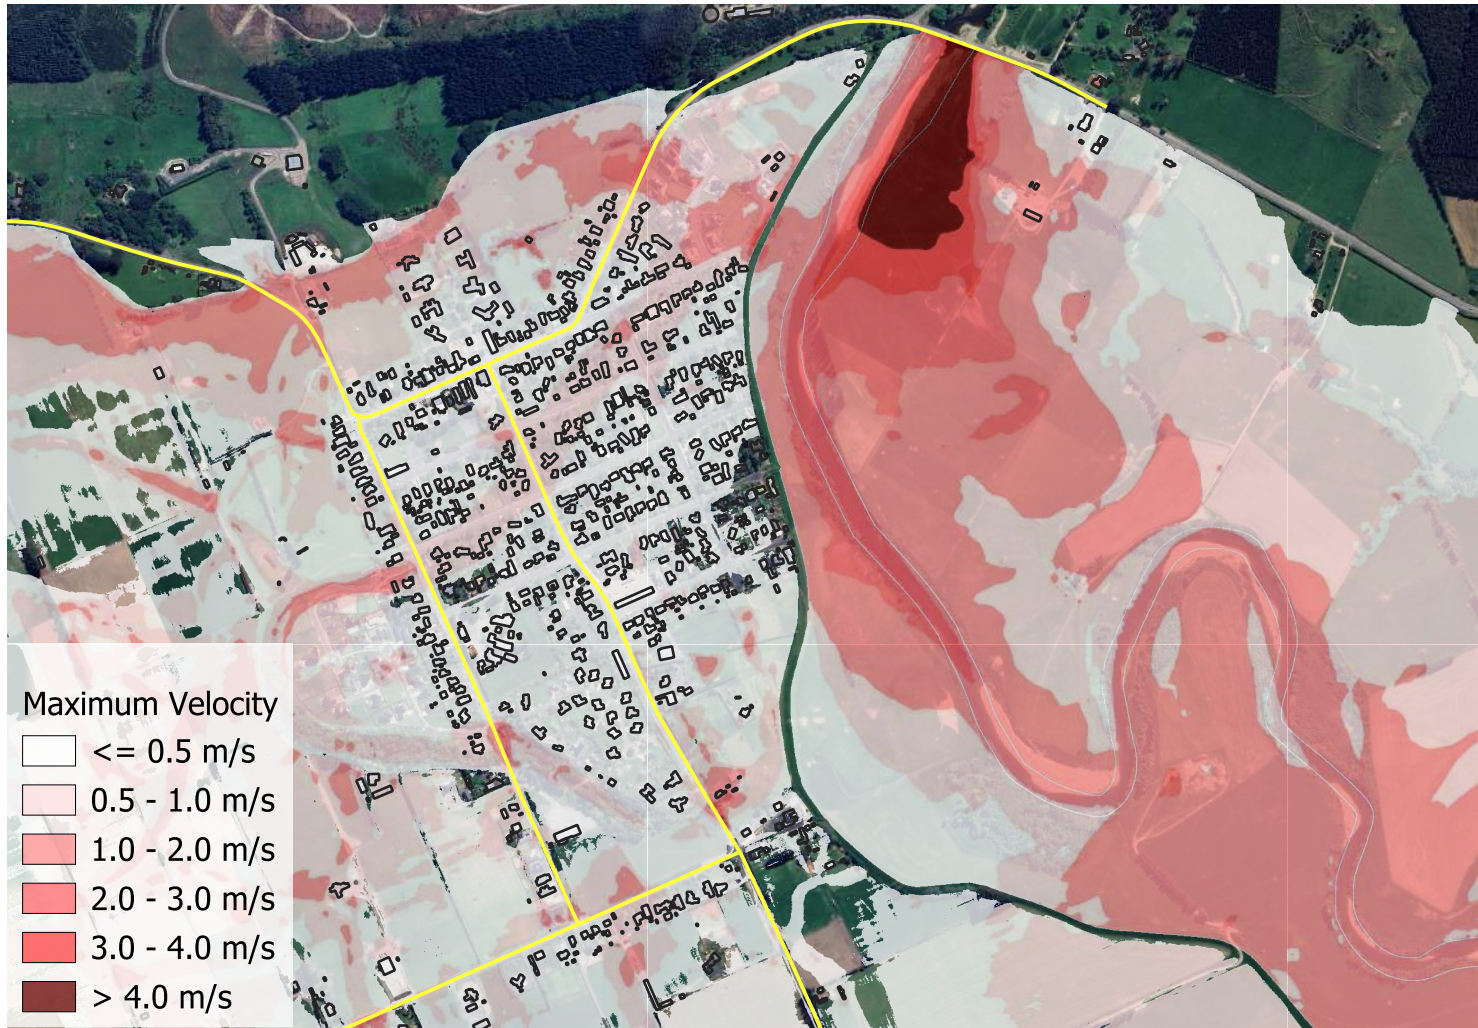
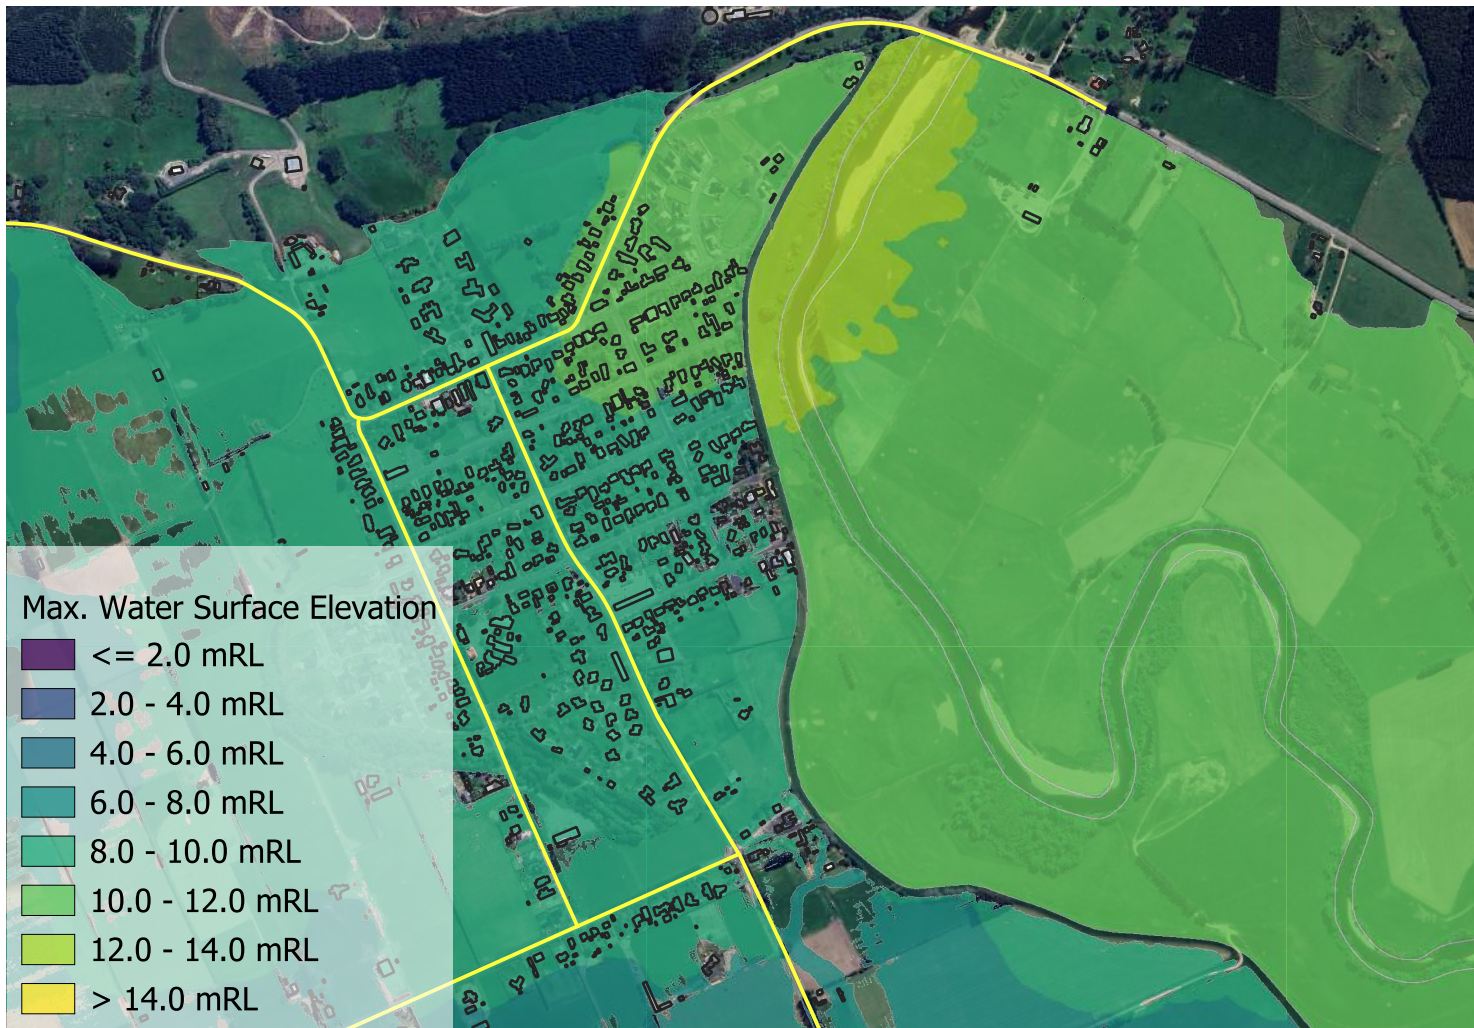
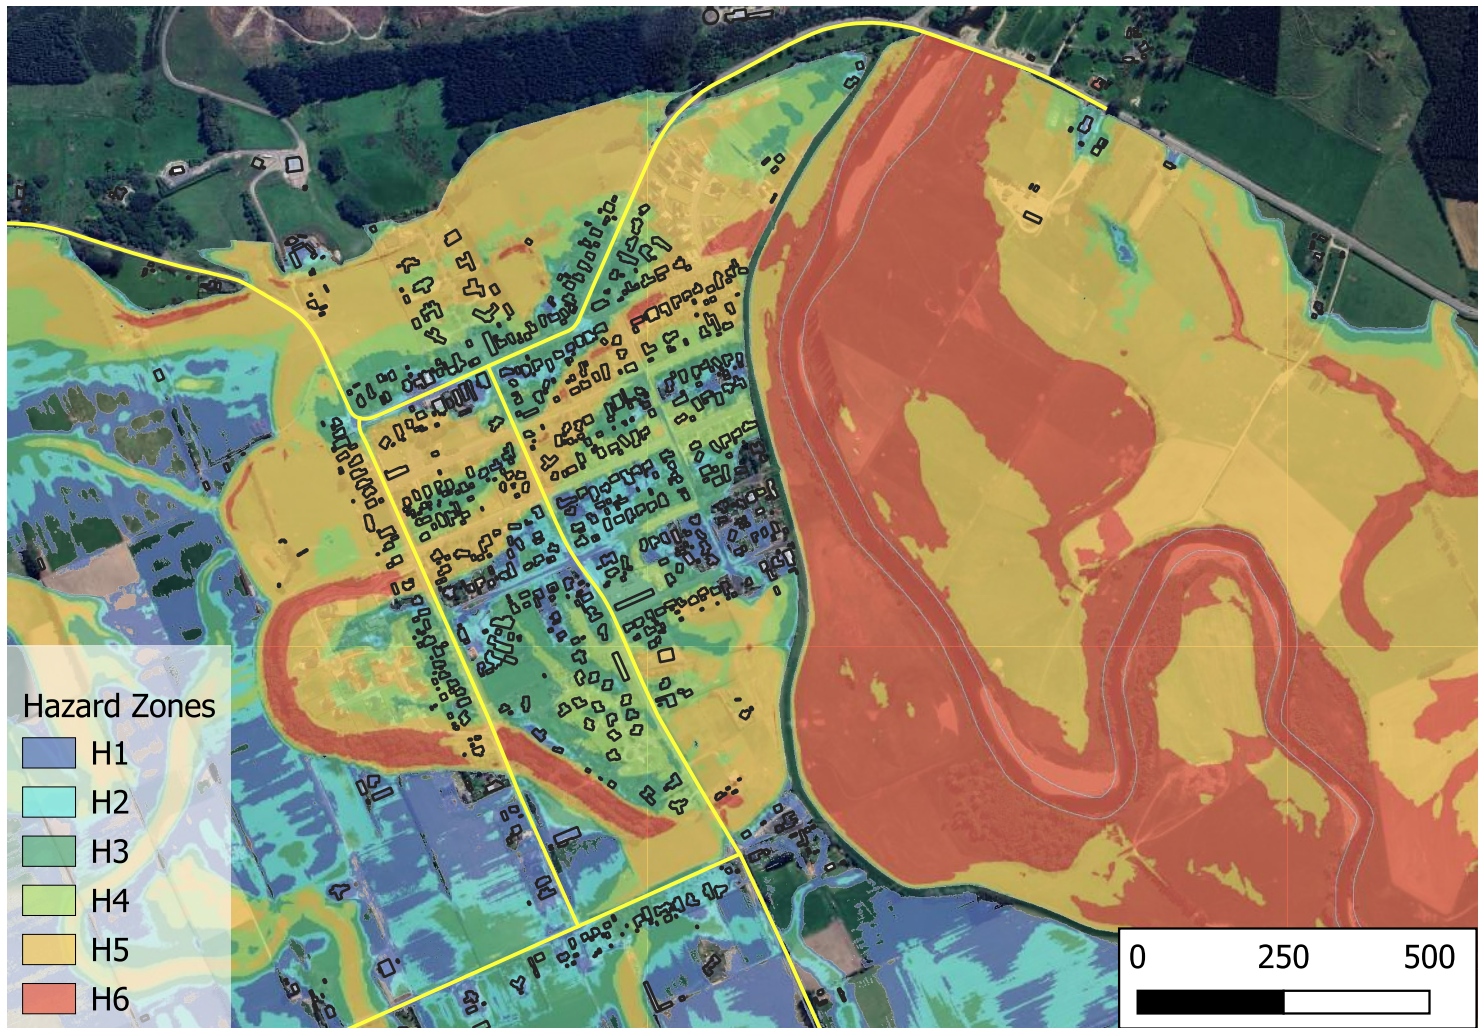
200-year ARI Breach 390CH Scenario

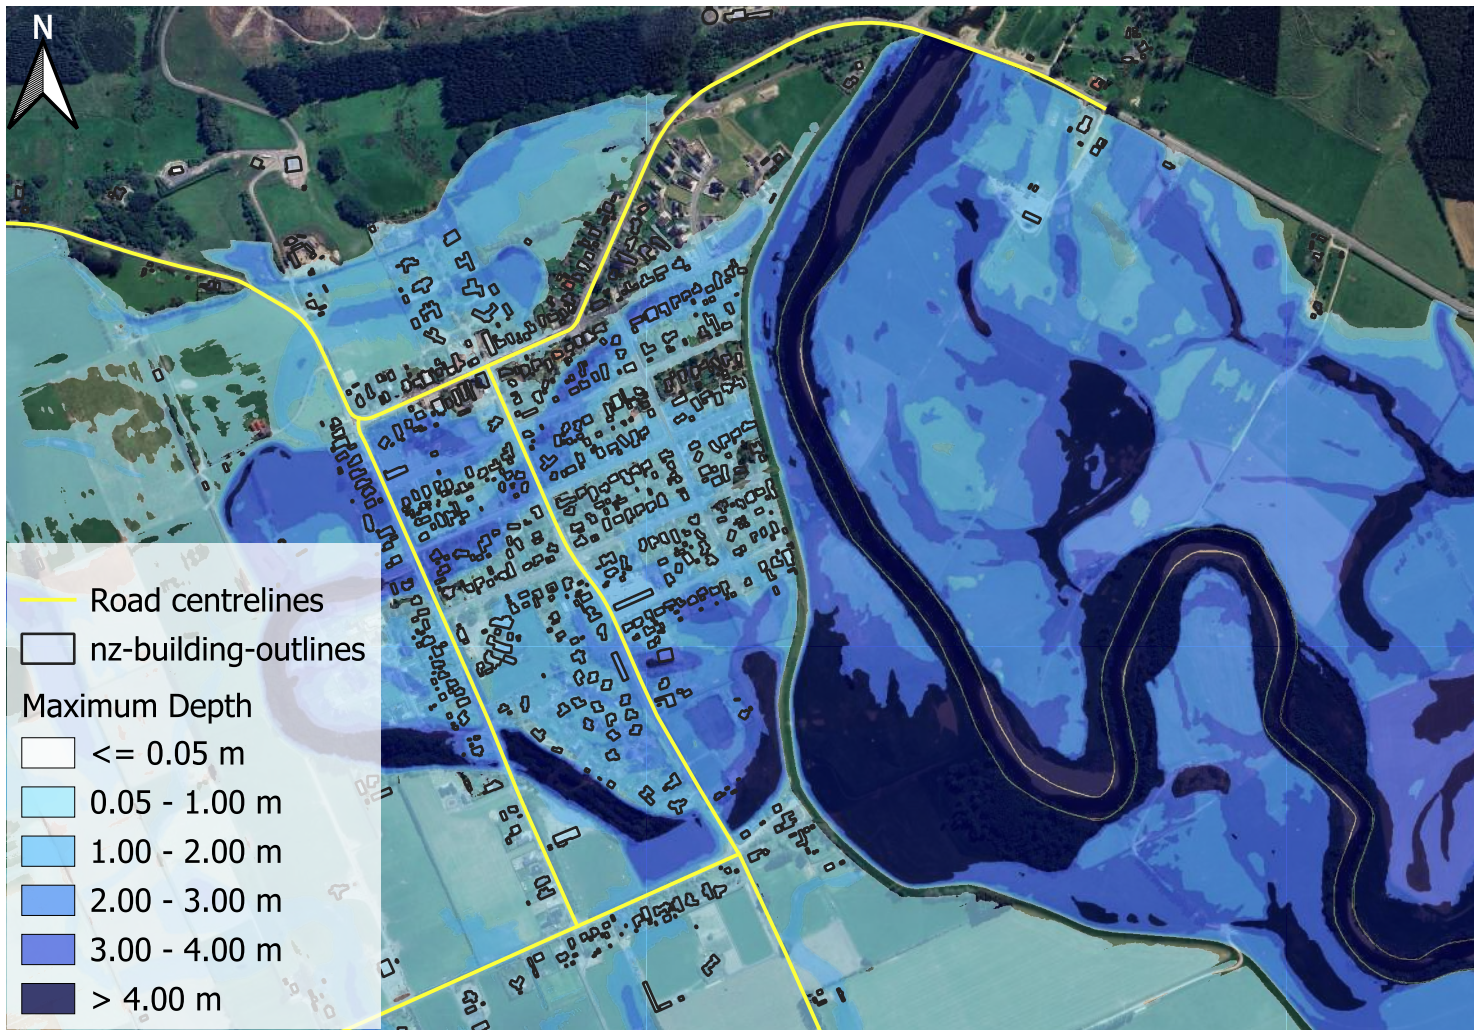
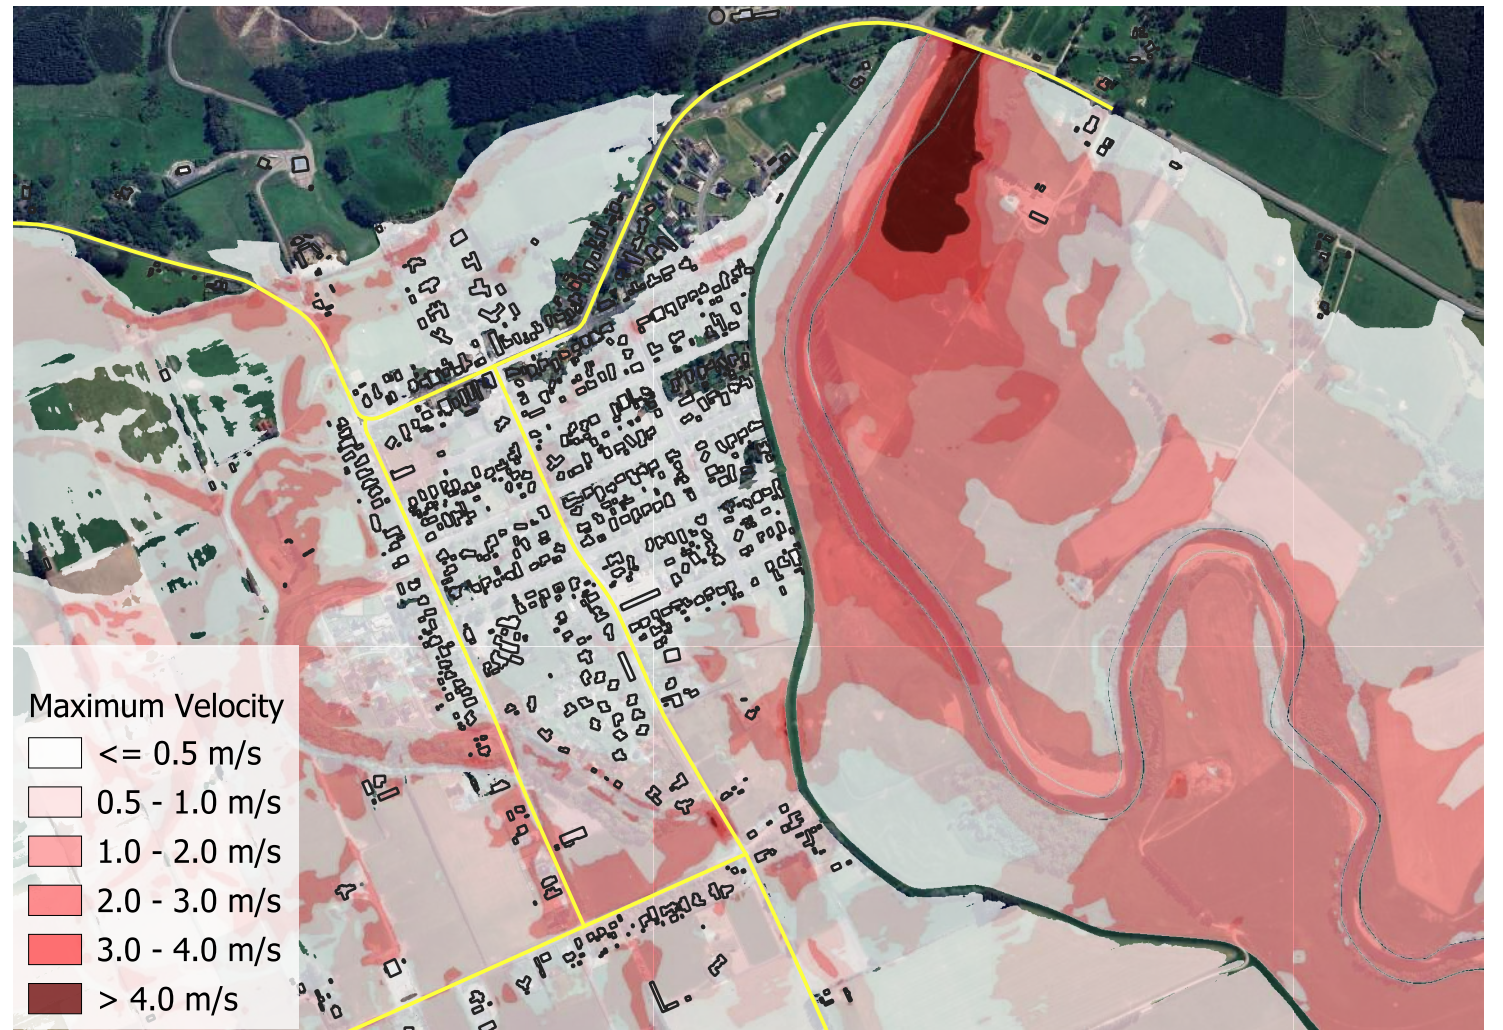
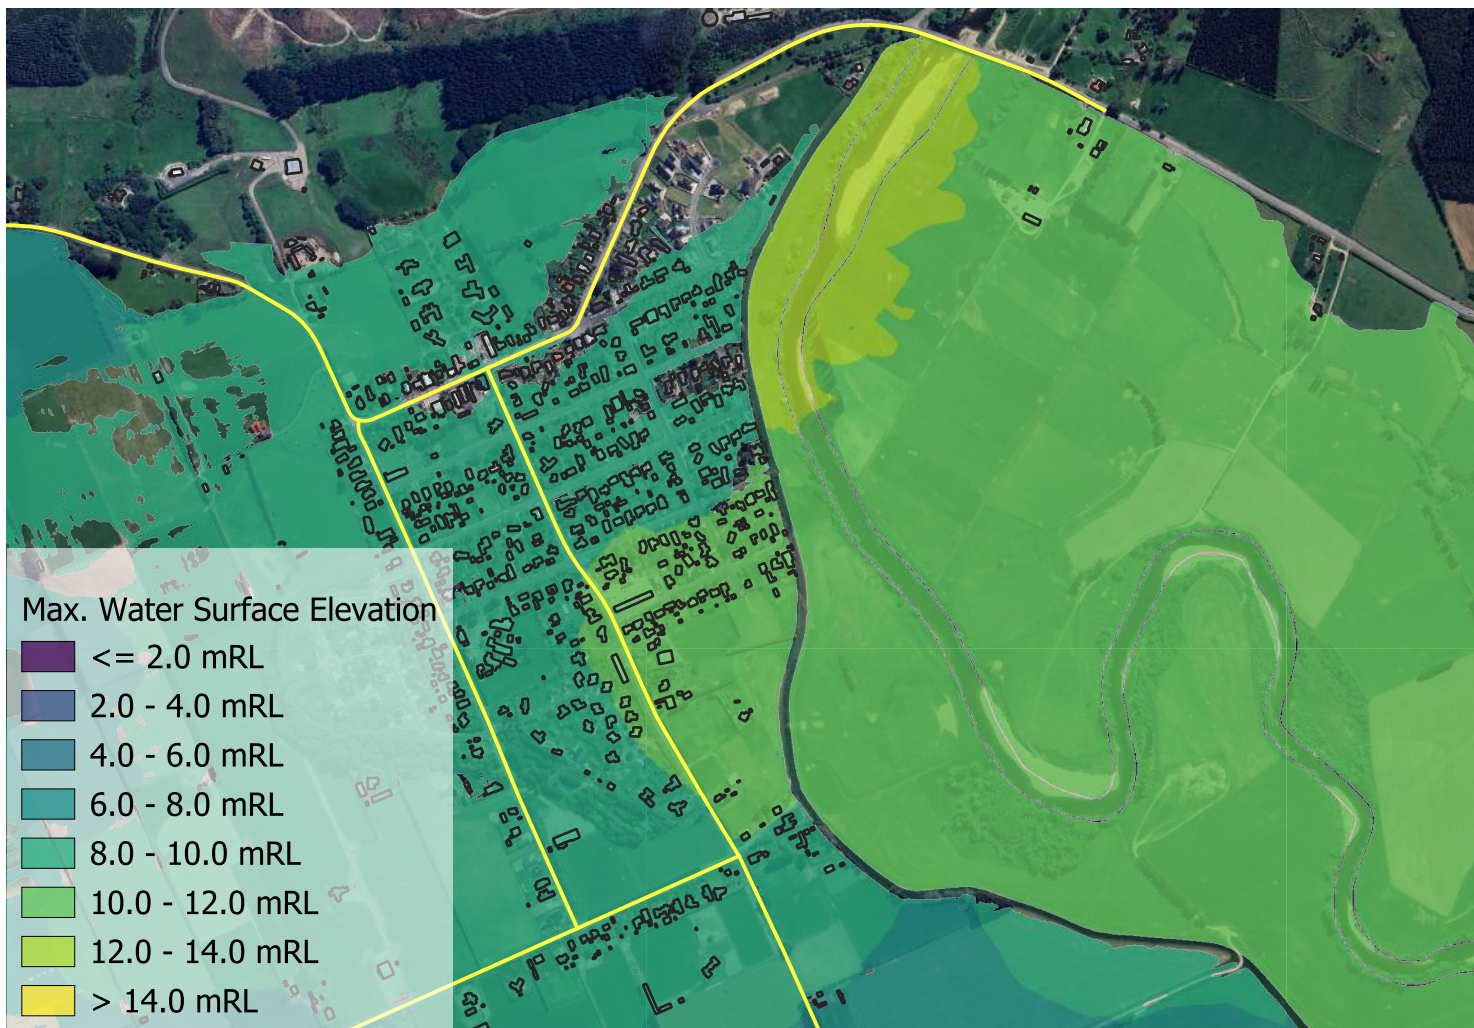
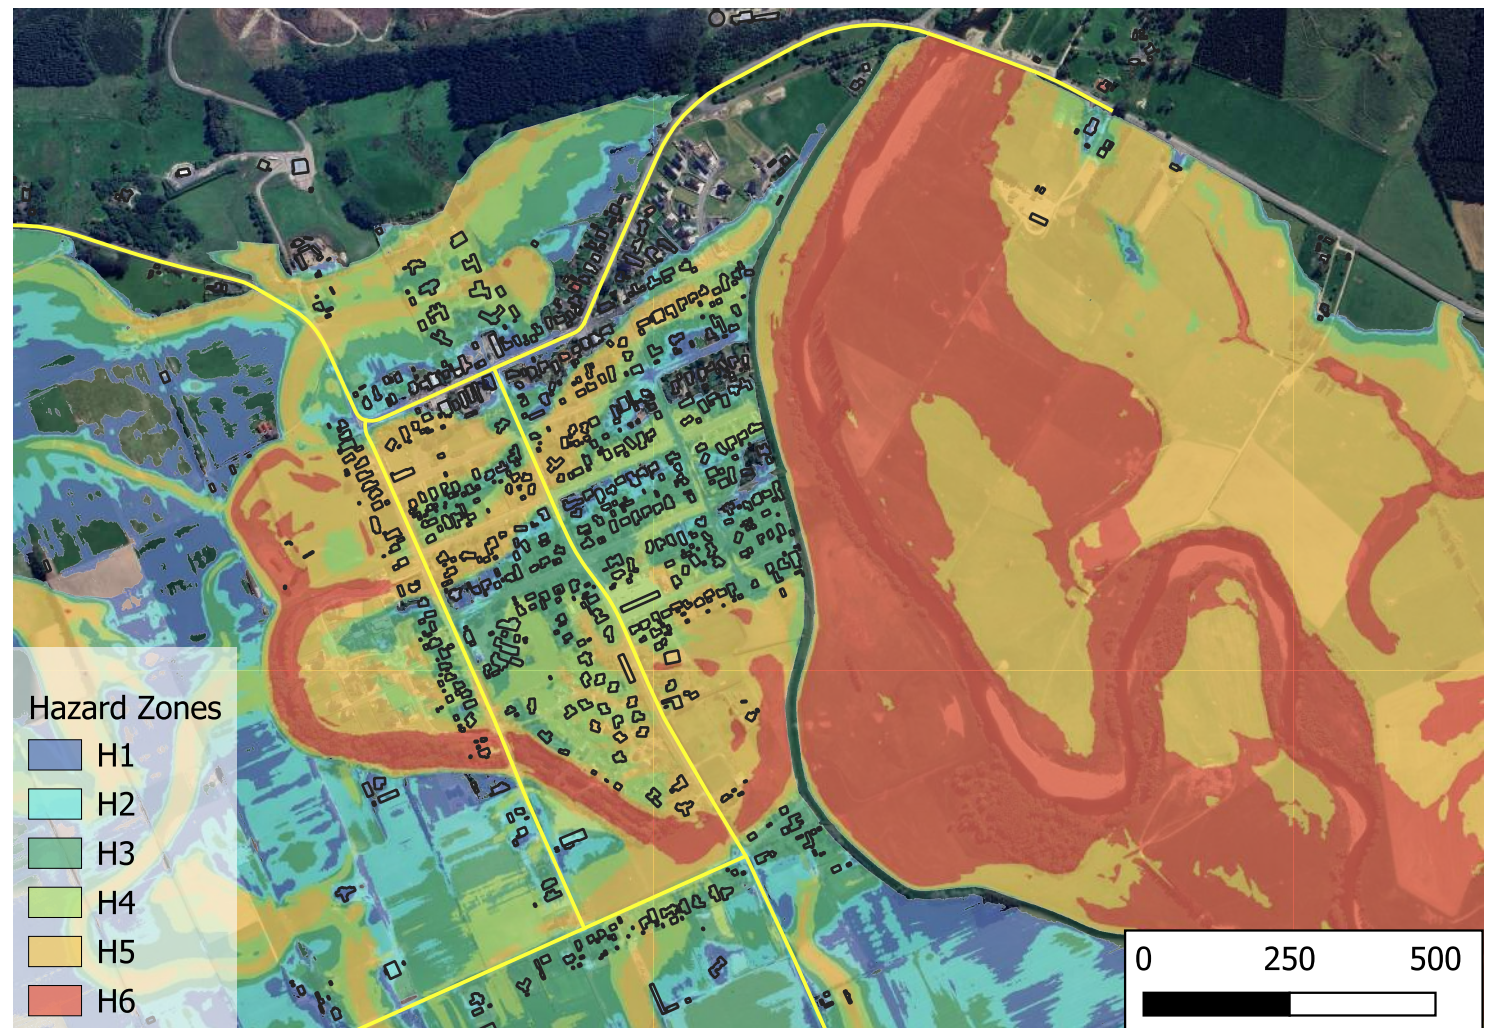
200-year ARI Breach 1250CH Scenario
