OCEANA GOLD NZ LIMITED

FRASERS BACKFILL STAGE 2 DESIGN TO SUPPORT RESOURCE CONSENT APPLICATION

MACRAES GOLD MINE

March 2024

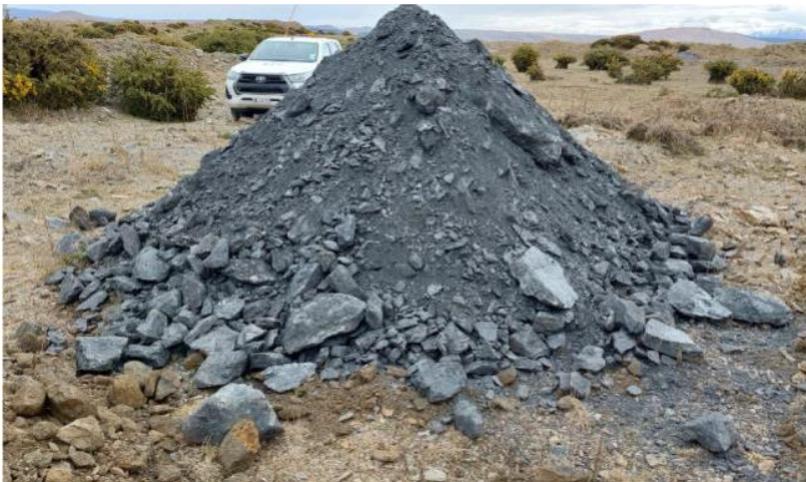
Macraes waste rock consists of a mixture of coarse-to-fine graded psammitic and pelitic schist, with a high proportion of fines. An example of this rock is shown in Figure 7.1, excavated from a test pit in the Frasers West WRS.

Figure 7.1 Typical Macraes waste rock (Frasers West WRS test pit)
