Water quality and ecological health for rivers in the Catlins area

October 2009 to September 2010

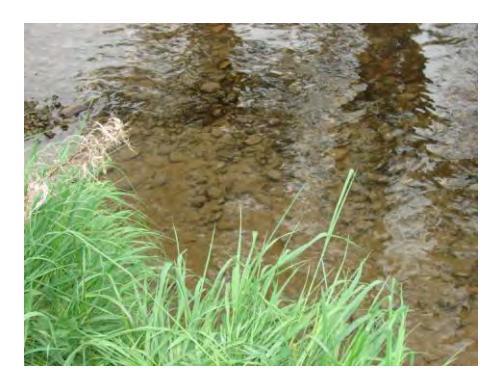
Owaka mid - fine sediment

The sites with more than 20% fine sediment cover were the Owaka sites and the Tahakopa mid-site. Even though the Owaka sites were dominated by bedrock, this fine sediment was visible in areas where bedrock was absent..

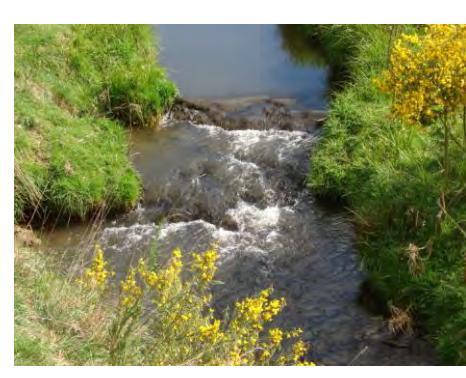
Most of the sites sampled had substrate in good to excellent condition and showed a very similar substrate composition (with the exception of the Owaka upper and mid sites). The Owaka sites contained a greater proportion of bedrock, the presence of which generally restricts the available habitat for fish and macroinvertebrates.

Owaka upper – bedrock
