PRELIMINARY GEOTECHNICAL ASSESSMENT

APPENDIX C

Stereonets of Structural Data

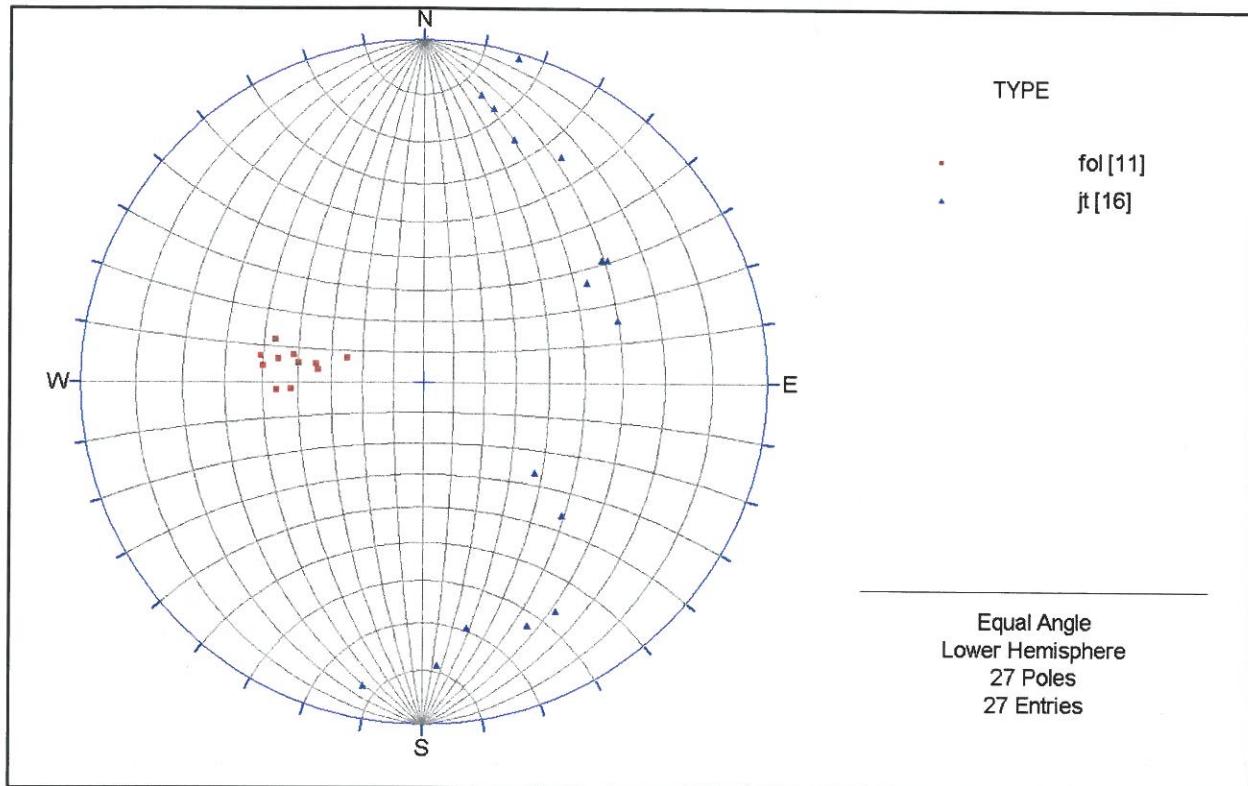
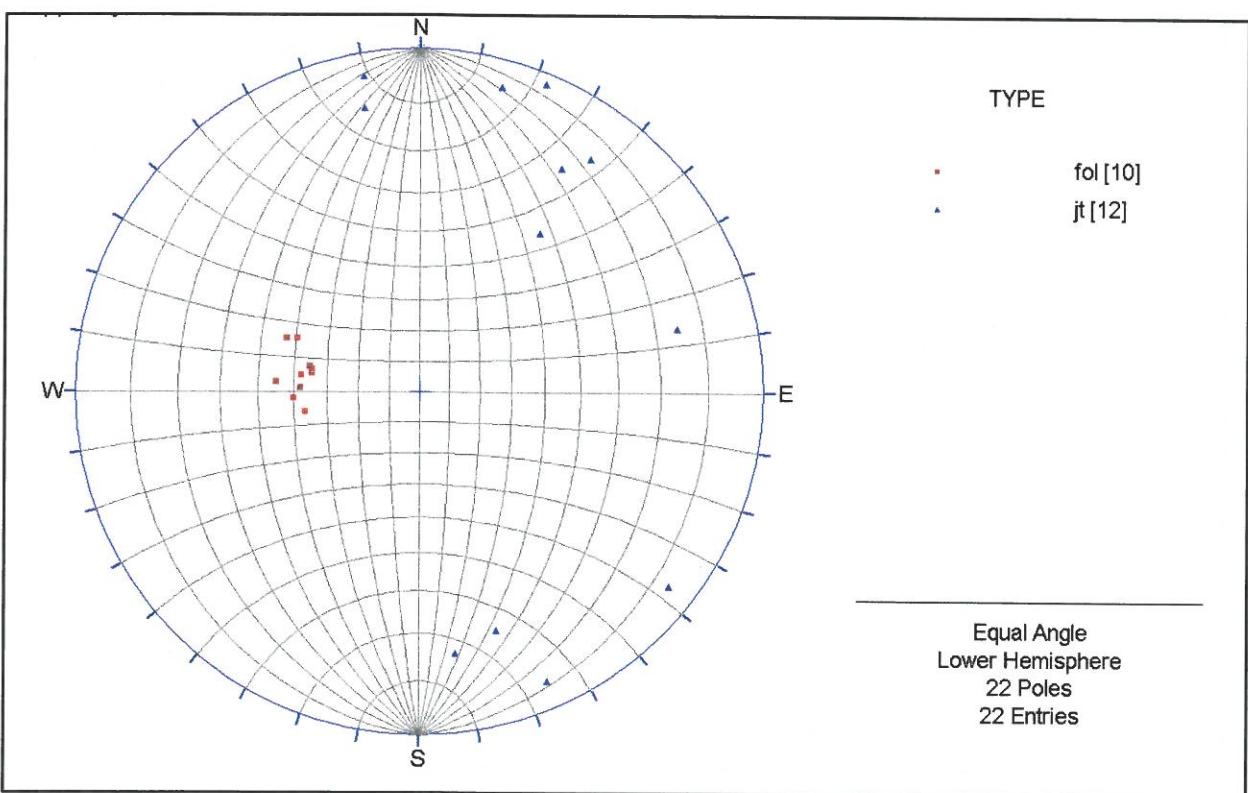
Stereographic projection of discontinuity data

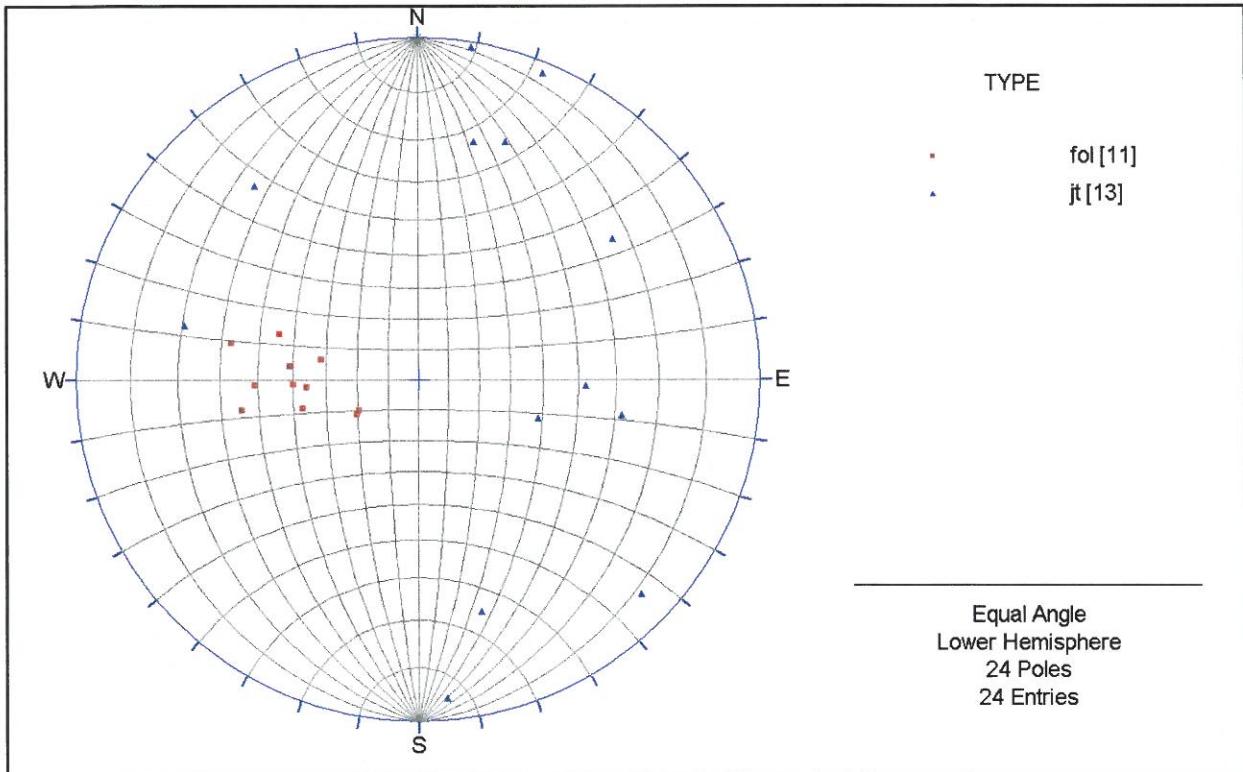
CTP03

Stereographic projection of discontinuity data

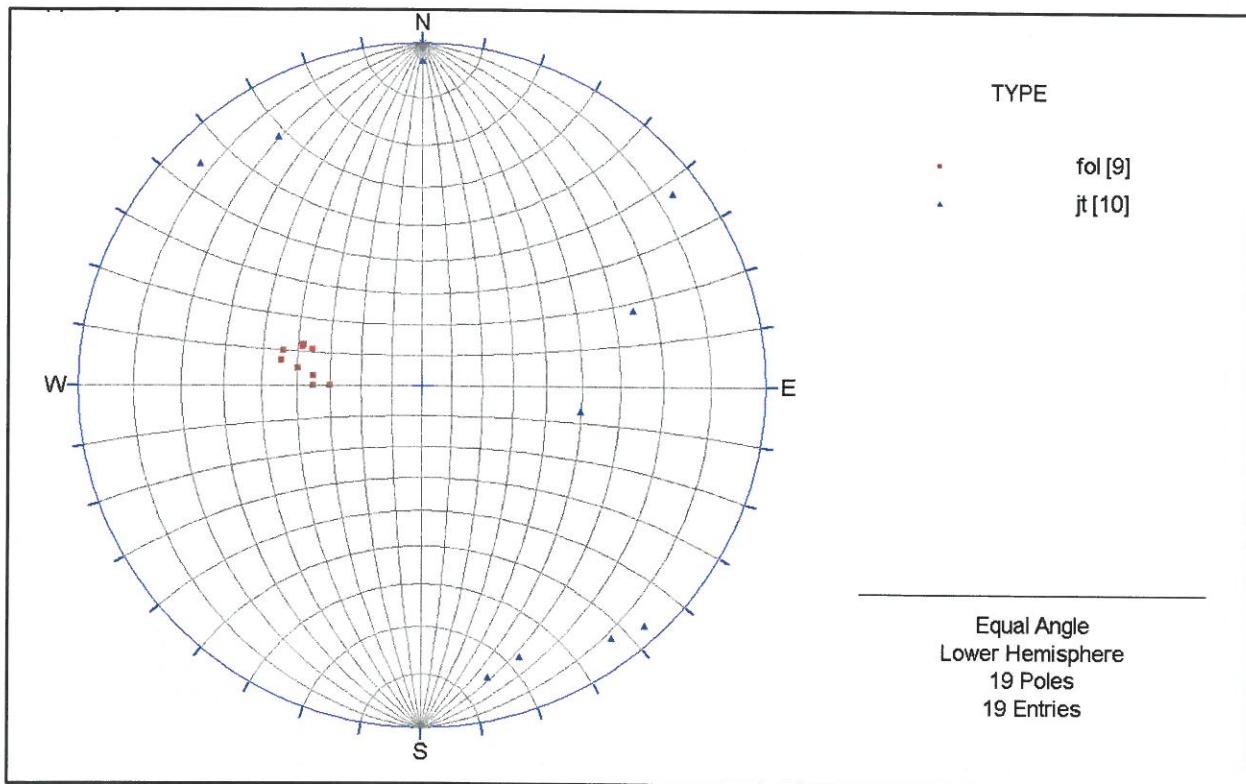
CTP05

Stereographic projection of discontinuity data

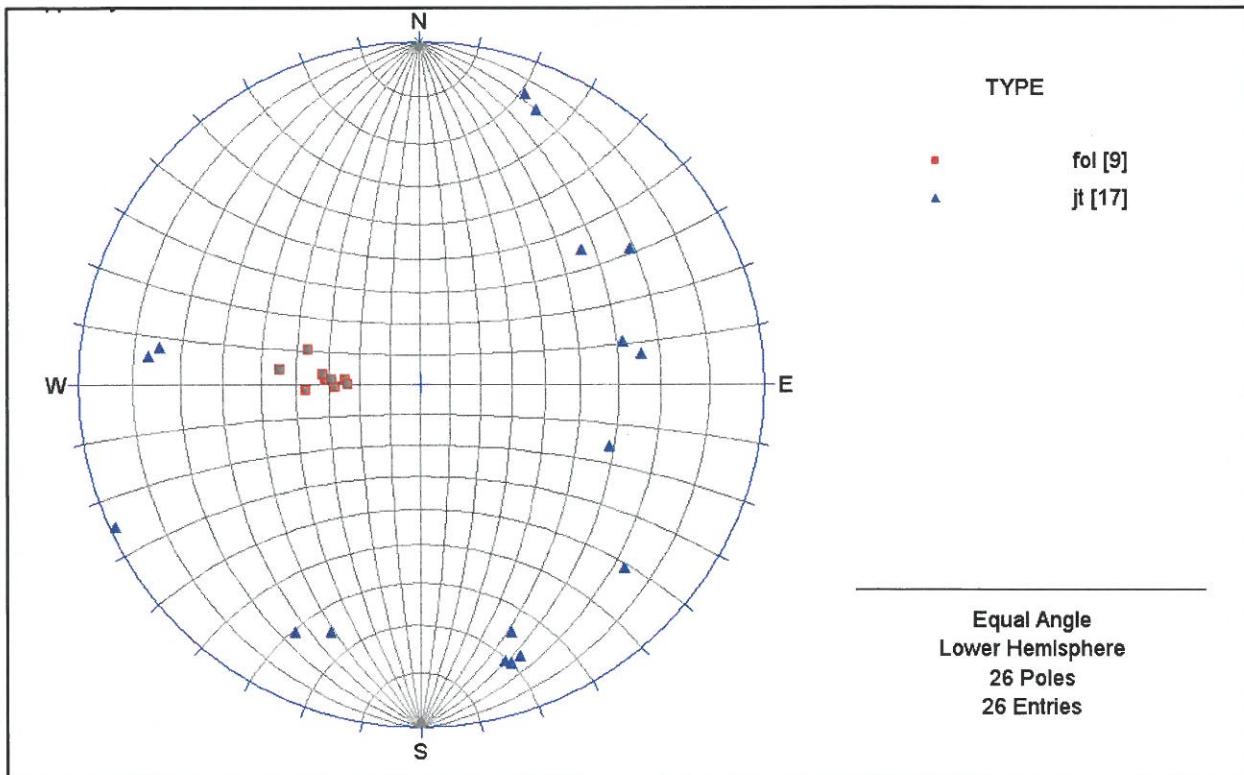
CTP07

Stereographic projection of discontinuity data

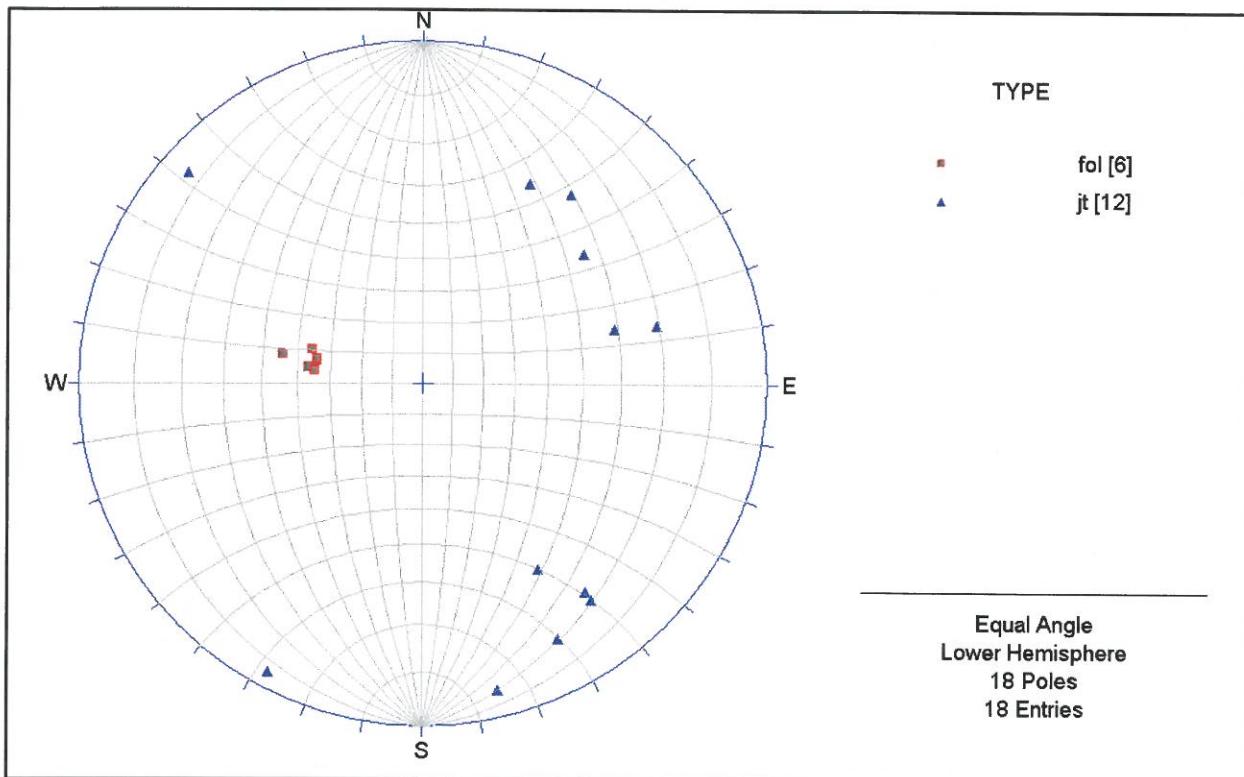
CTP09

Stereographic projection of discontinuity data

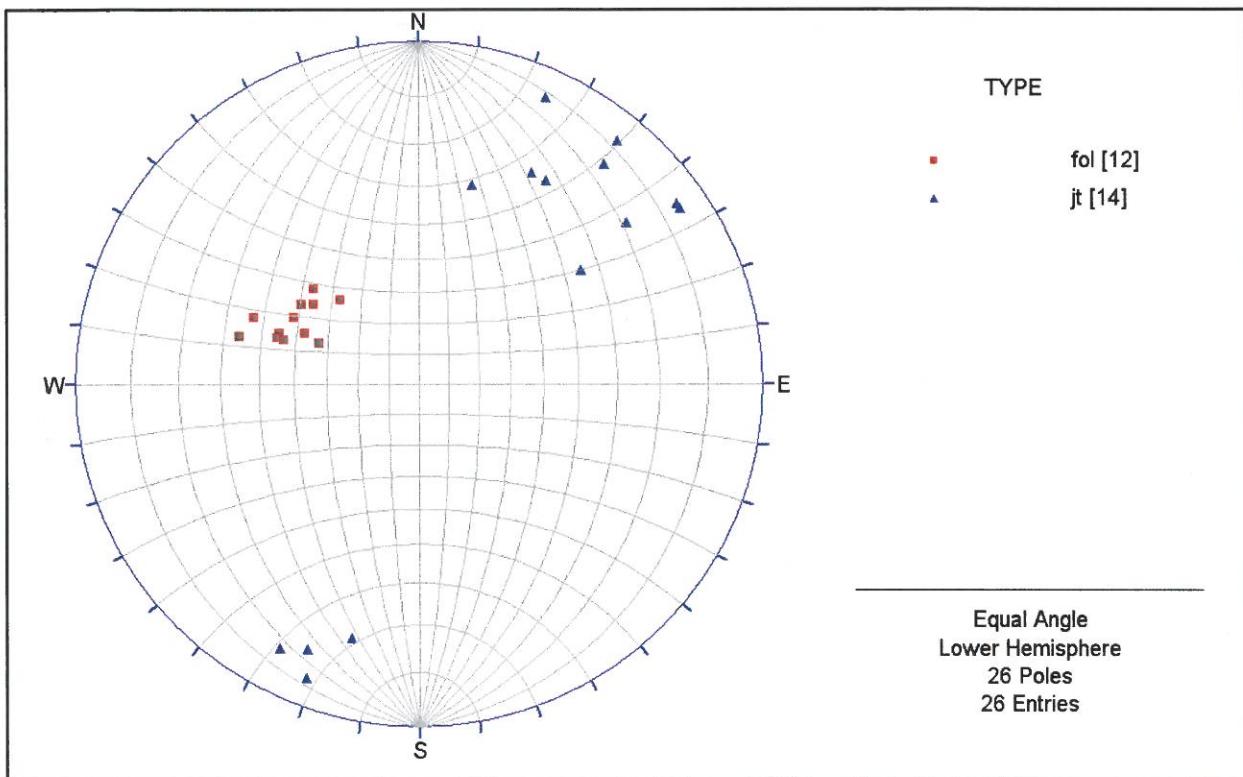
CTP11

Stereographic projection of discontinuity data

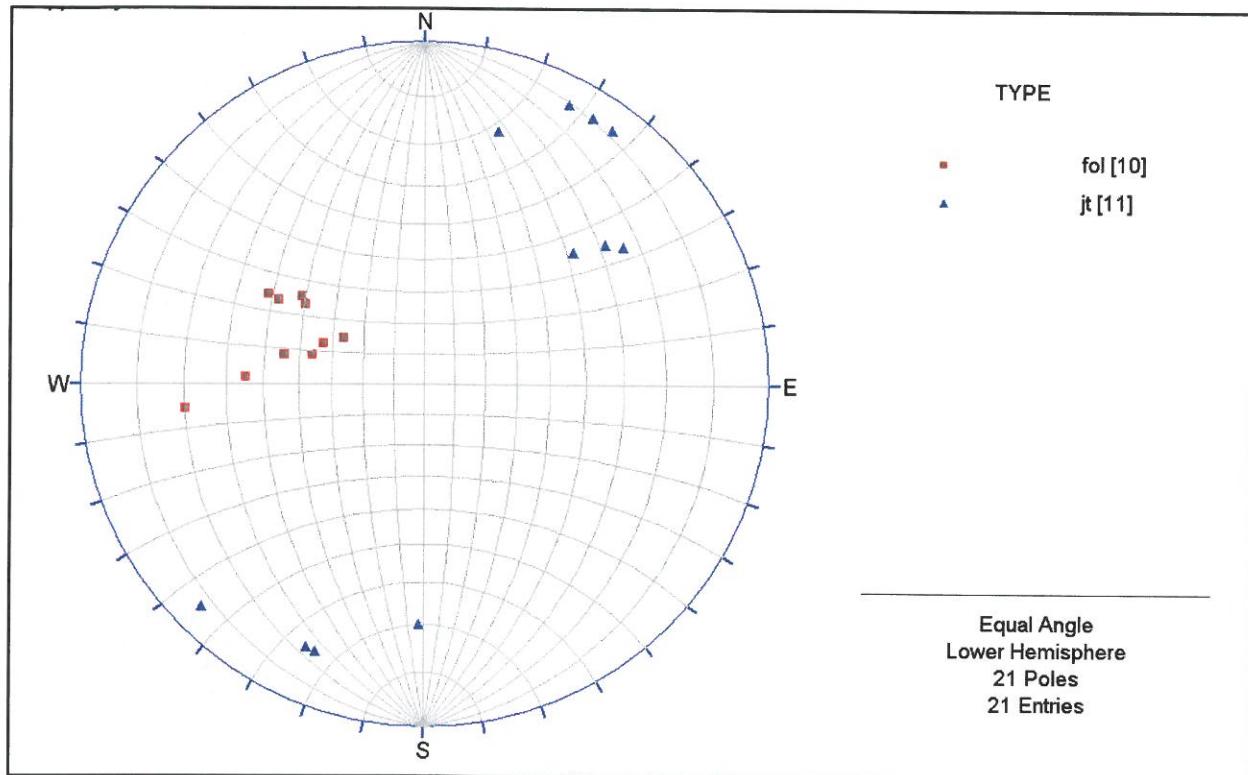
CTP13

Stereographic projection of discontinuity data

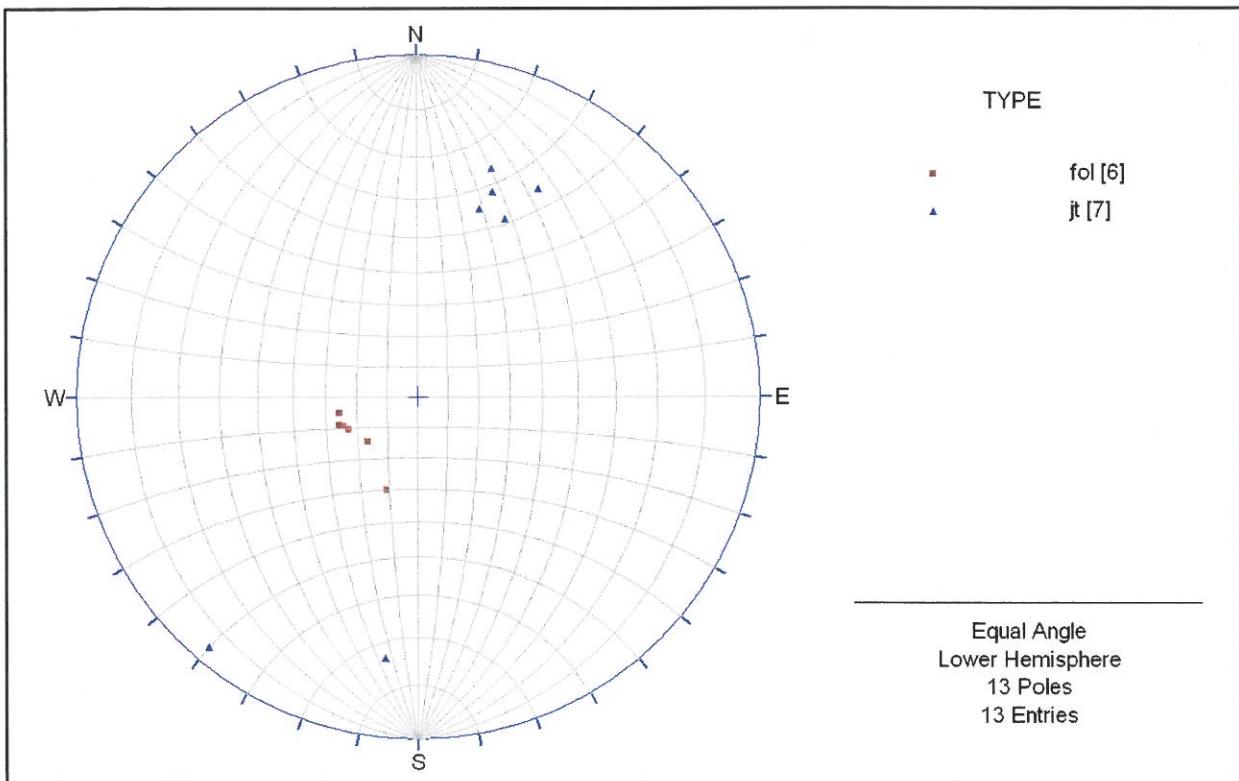
CTP25

Stereographic projection of discontinuity data

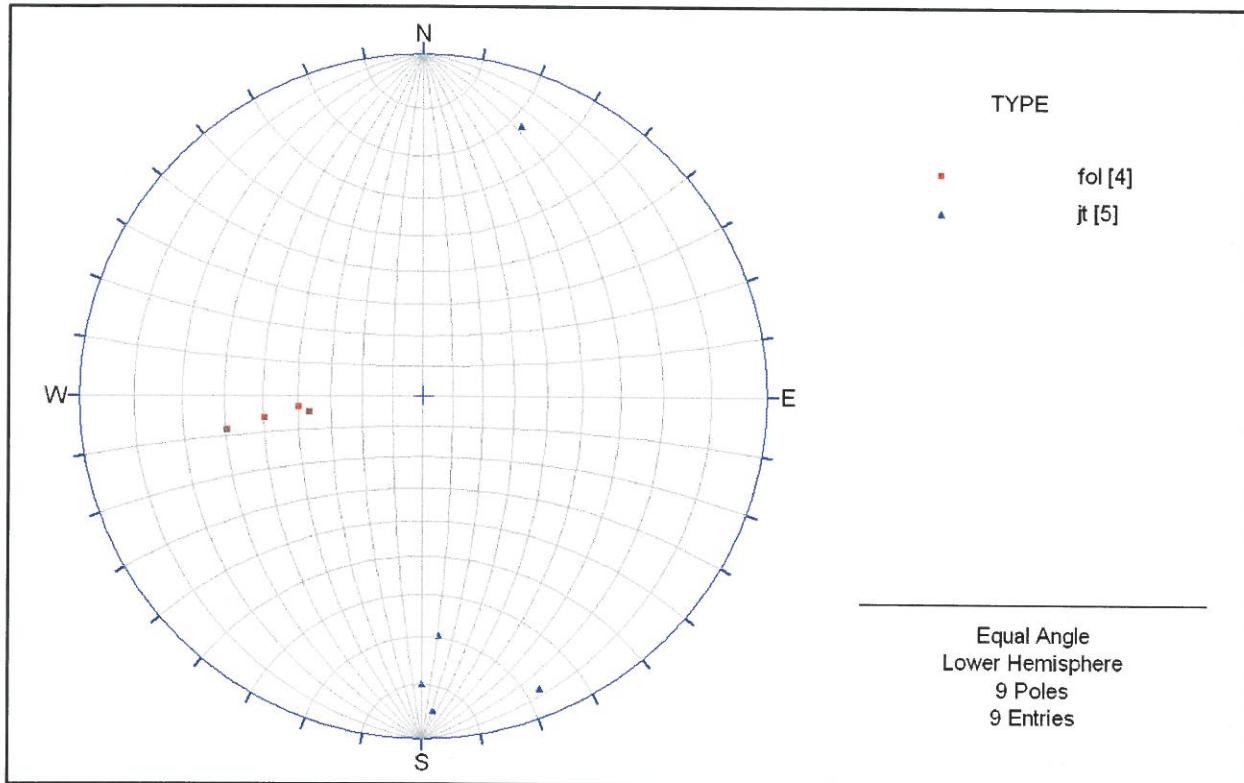
CTP27

Stereographic projection of discontinuity data

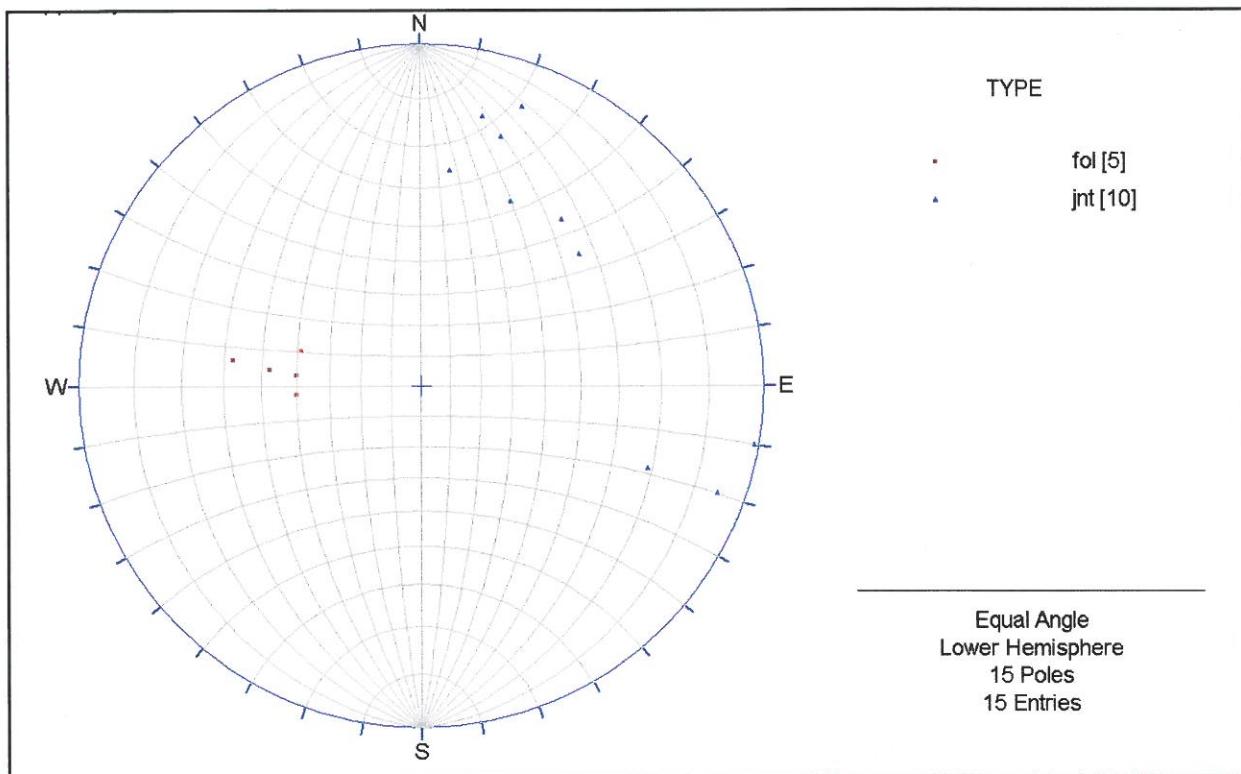
TP02

Stereographic projection of discontinuity data

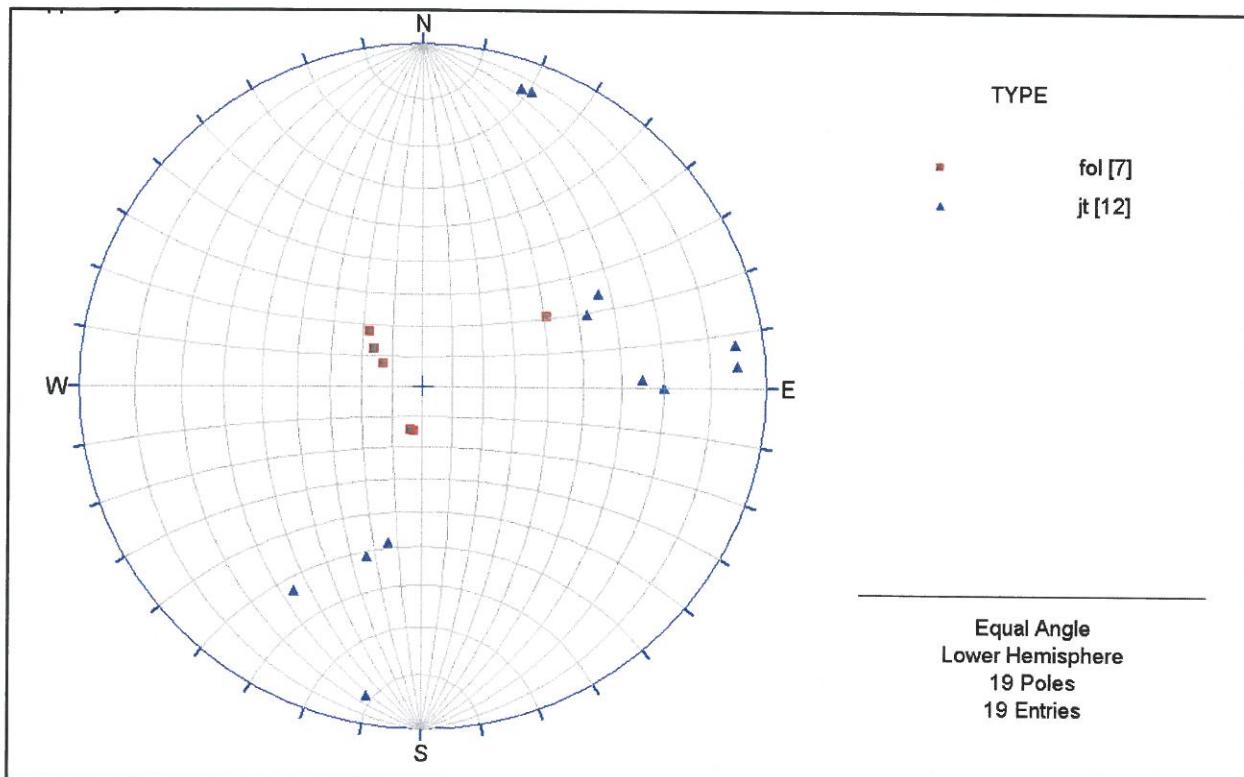
TP04

Stereographic projection of discontinuity data

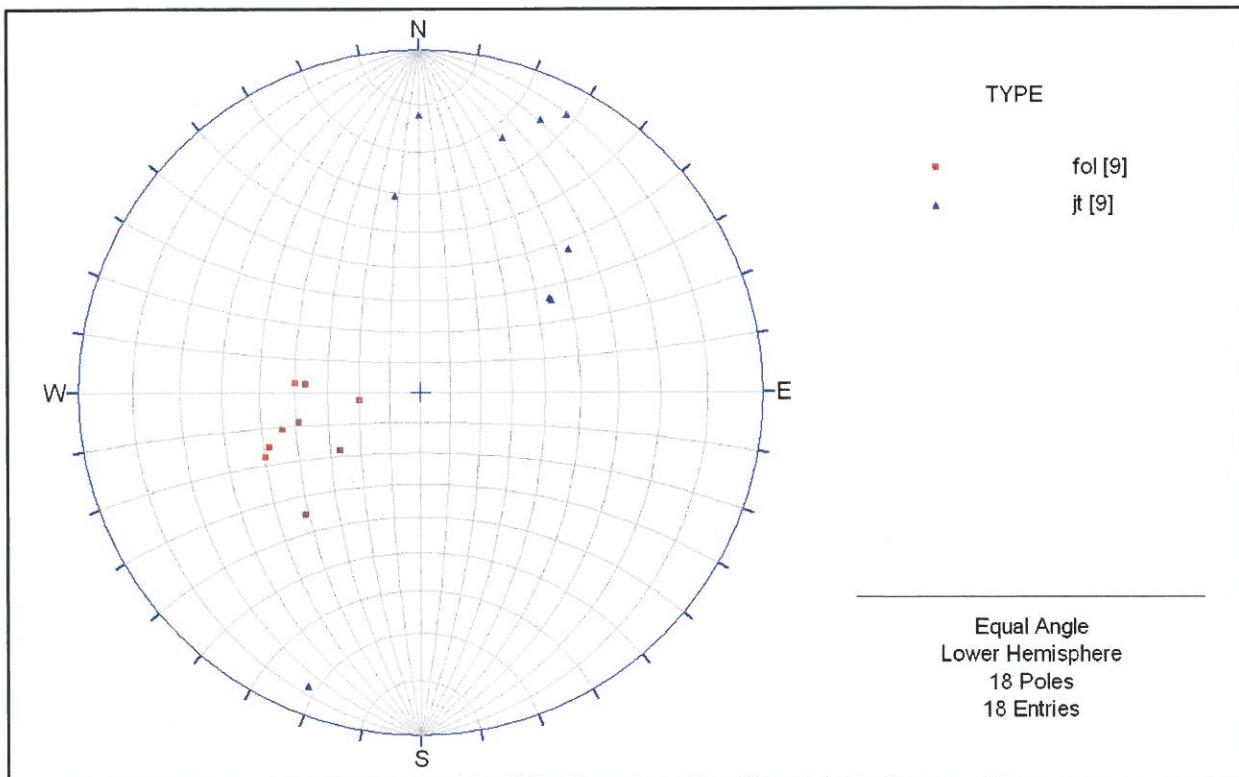
Trench 2

Stereographic projection of discontinuity data
